# **Loss of Control - Inflight (LOC-I)**

## **Investigation Report**

**BogdanFly X-wing Paraglider**

**IVR-2026-03**

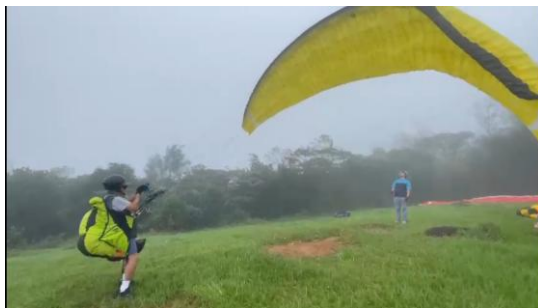
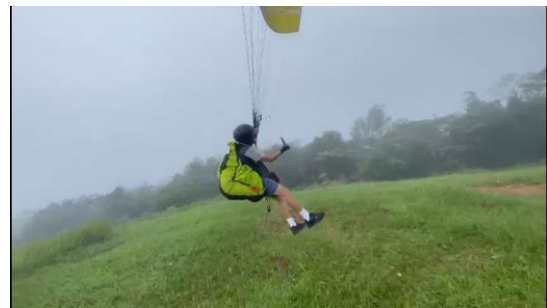
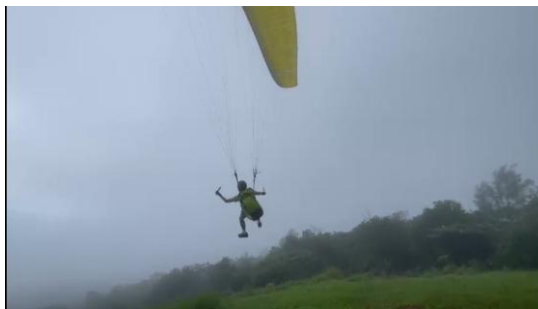
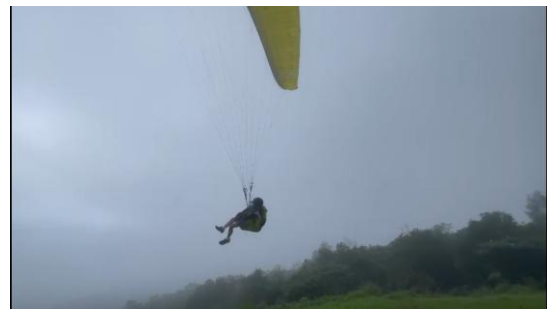
**Figure 1: Reverse Launching by the Pilot**

The video of the accident flight revealed that the Pilot struggled to stabilise his paraglider on the ground in a windy condition before take-off. His paraglider was lifted off from the ground while his back was still facing Cheung Sha Beach. He managed to turn his body to face forward shortly after take-off ((b) - (d) in Figure 1).

The video of the early part of the accident also revealed that the take-off site at Sunset Peak was misty when the paraglider took off ((b) and (c) in Figure 1). In comparison with a photo of the surrounding area in a sunny day, the visibility was poor at the time the paraglider took off.

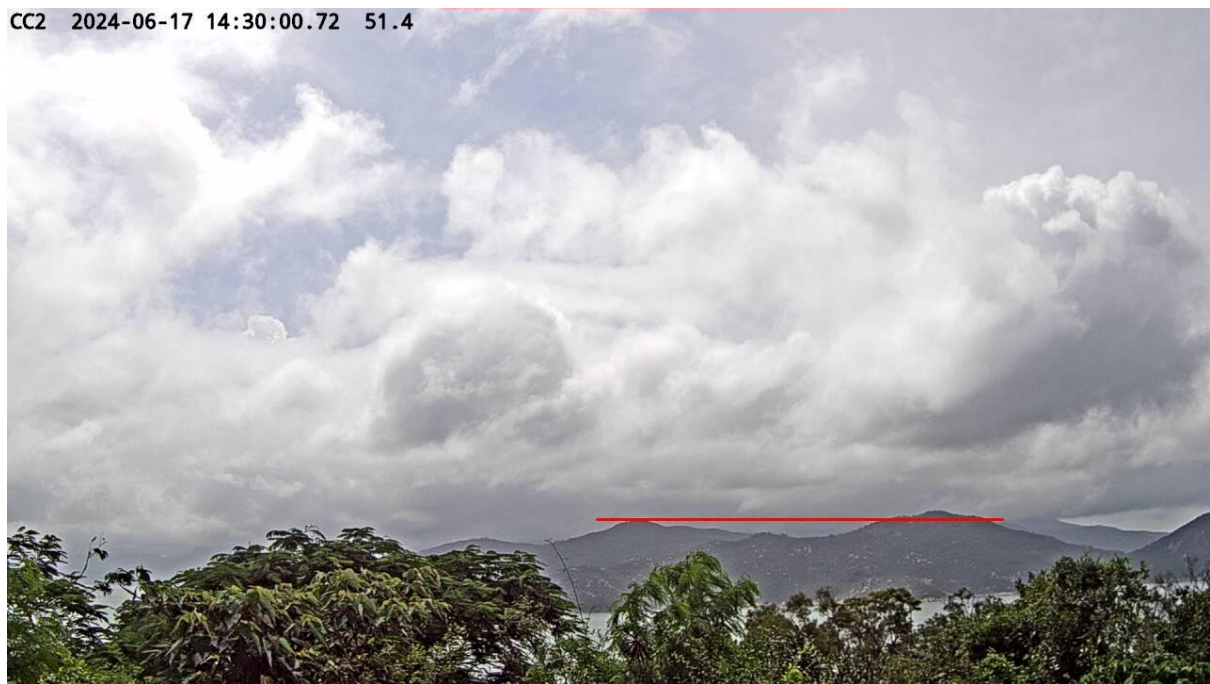
**Figure 13: Photo of Sunset Peak Taken at 1430 Hrs of 17 June 2024**

- (2) According to the weather photo taken at CCH station (Figure 13, looking towards the northwest) at 1430 hrs of 17 June 2024, the hill top of Sunset Peak was fully covered by cloud.

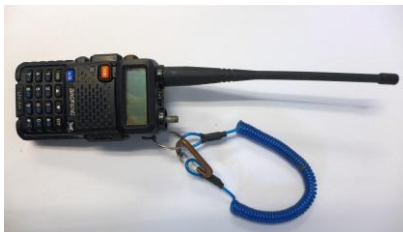
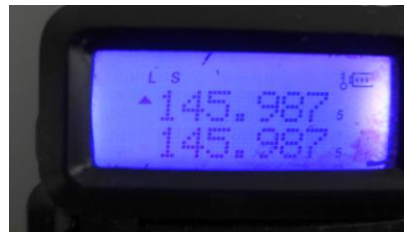
**Figure 15: The Pilot's Transceiver and the Pre-set Frequencies**

The Pilot carried a two-way radio transceiver. During the examination by the investigation team, it was noticed that both the active and standby frequencies were set to HKPA's local safety frequency 145.9875 MHz. The transceiver was tested and functioned normally.

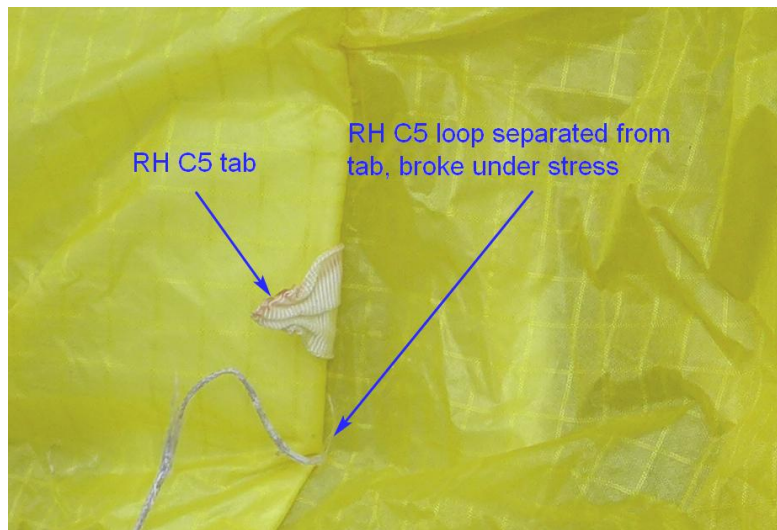
**Figure 18: Right-hand C5 Loop Broken and Separated**

- (1) The BogdanFly X-Wing 23 Paraglider was examined. The right-hand (RH) C5 loop was found broken due to stress and separated from the tab. The left-hand (LH) StU line and the RH C6 line were found broken due to stress. The line check results are in paragraph 1.16.1.

- (1) An aging check of paraglider lines was carried out to determine their conditions with the assistance of the HKPA expert.
- (2) The results indicated that the canopy was intact. The RH C5 line, the RH C6 loop, and the LH StU line broke probably due to stress. Due to the aging of the Dyneema<sup>®16</sup> lines, the C group has shrunk by an average of 22mm on the LH side and 14.5mm on the RH side of the wing. The lines at the centre of the wing have shrunk less than those on the sides and the tips of the wing, reflecting a normal aging process as the middle wing took more weight and shrunk less.
- (3) The angle of attack of the wing was found increased by comparing the length of different groups of lines, which is 18mm on the LH and 14.5mm on the RH.

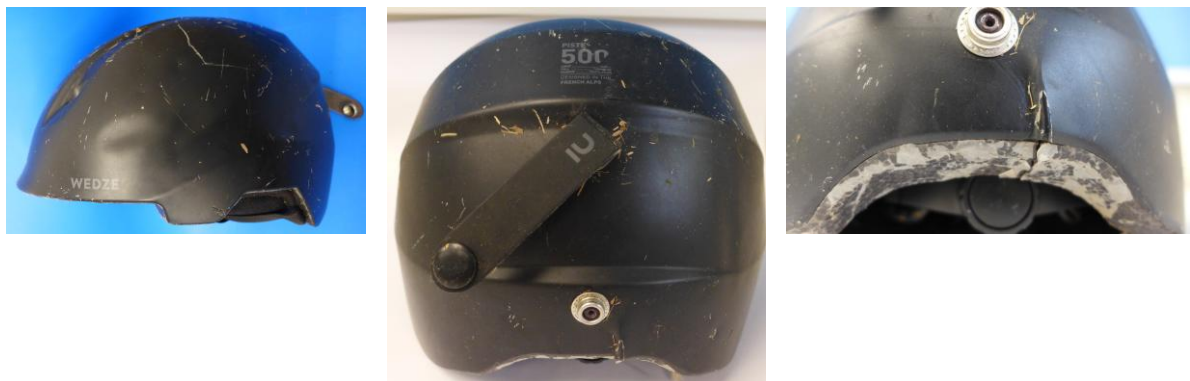
**Figure 21: The Pilot's Helmet**

- (1) The helmet of the Pilot, Model “PST 500” of size M, was made by Decathlon (refer to paragraph 1.15.3).
- (2) An obvious crack could be observed on the aft edge of the helmet.

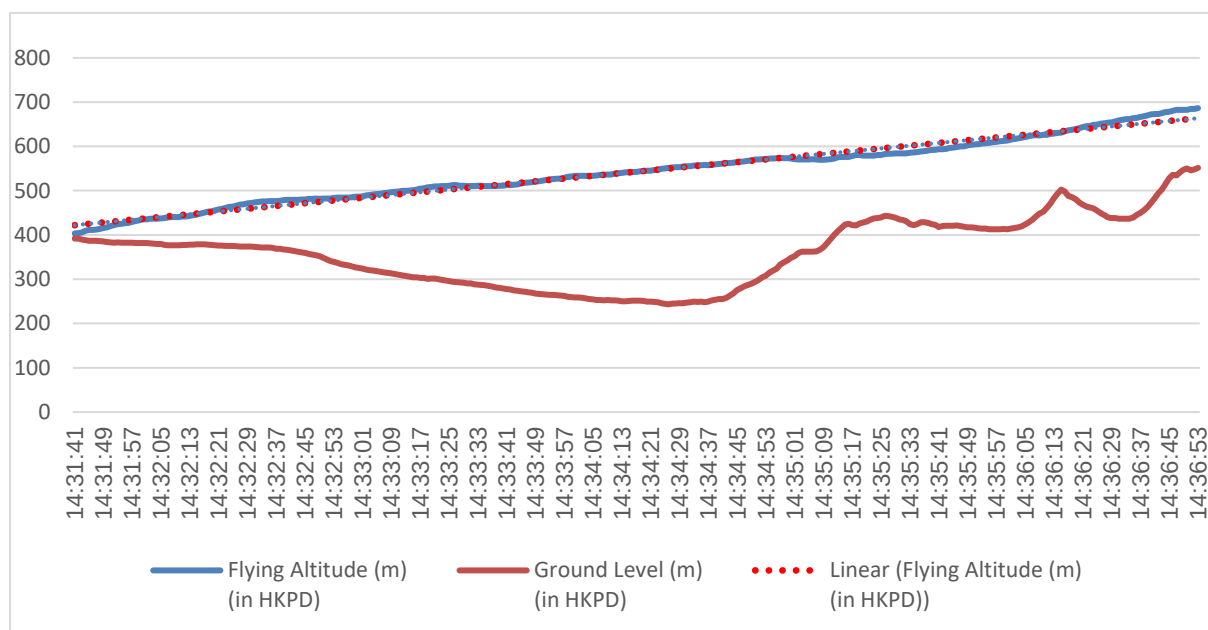
Figure 35: Flying Altitude and Ground Level

- (1) The IGC data of the flight was recorded from 1431:41 hrs to 1436:53 hrs and the duration was 5 minutes and 12 seconds. It can be seen in the following plot that the flying altitude was increasing at an average rate of climb of about 0.77 m/s.
- (2) Between 1431:41 hrs and 1434:26 hrs, the paraglider had a flight trajectory to Cheung Sha Beach. After that, the paraglider changed heading towards the north direction and the hillslope. The differences between the flying altitude and the ground level kept decreasing.
- (3) The flying altitude and the ground level data did not merge at the last point of recording. It was because the variometer stopped recording data in the mid-air<sup>26</sup>.

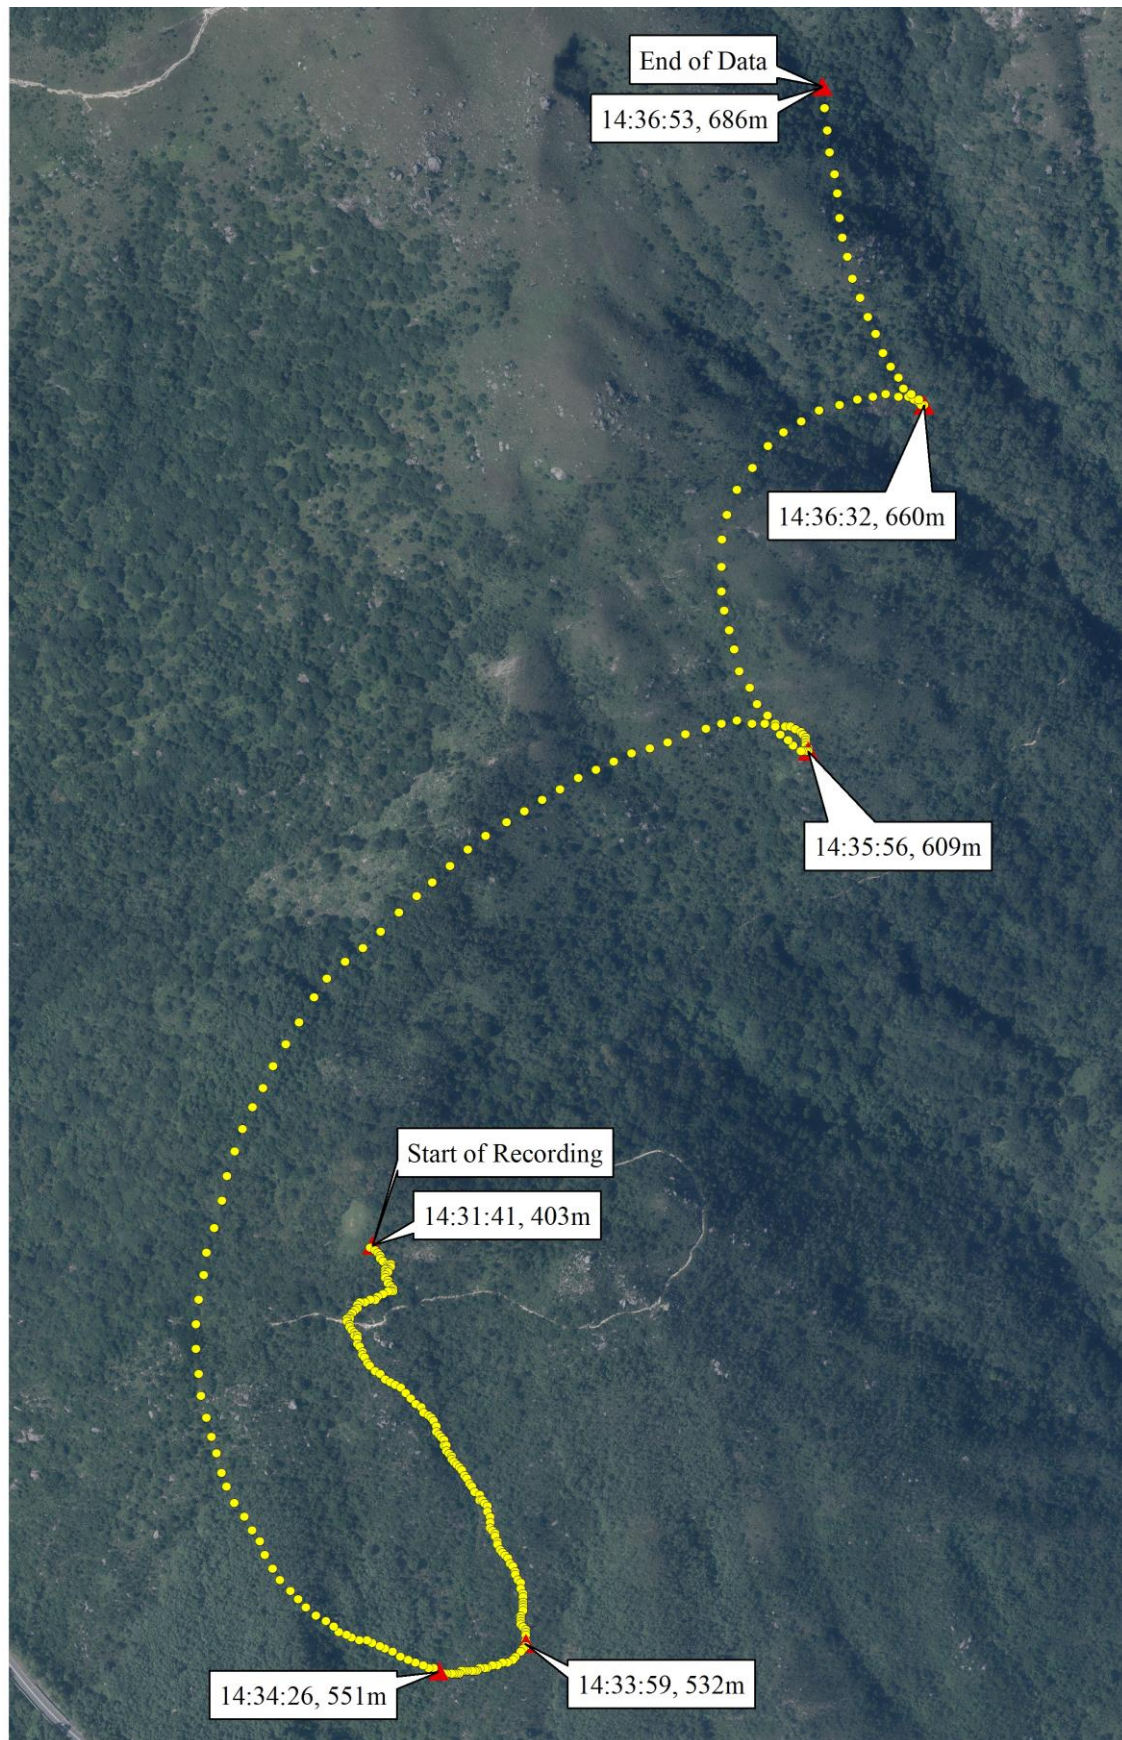
**Figure 36: Path of the Accident Flight**

- (2) It could be seen from the first part of the flight (1431:41 hrs to 1433:59 hrs) that the paraglider headed straight to Cheung Sha Beach as he previously agreed with his companions. However, the flying altitude increased slowly instead of decreasing.

- (4) Between 1433:59 hrs and 1434:26 hrs, the paraglider made a turn towards the west and kept ascending. The wind condition (direction and speed) at this moment were basically the same as that in the beginning of the flight. It was likely that the Pilot no longer had Cheung Sha Beach visual and was disoriented in the air. He could be trying to maintain a straight trajectory towards the beach but indeed gradually turning to the right under his control. In this situation, the compass and the variometer would no longer be able to provide navigation information effectively.
