AIRCRAFT ACCIDENT REPORT 1/2019

AIR ACCIDENT INVESTIGATION AUTHORITY

**Report on the accident to Robinson R22 Beta II Helicopter
Registration B-HJU operated by the
Hong Kong Aviation Club Limited
at Shek Kong Airfield, Yuen Long
on 23 October 2016**

June 2019

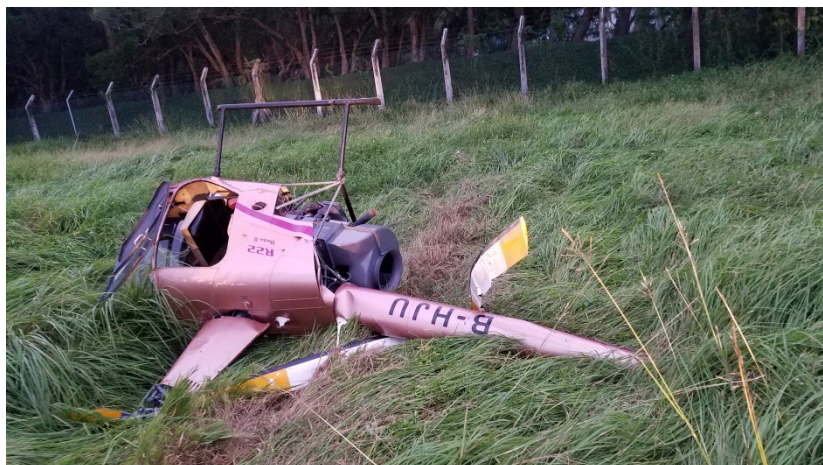
Photograph 1 – The Wreckage

The helicopter sustained substantial damage. The forward end of the right skid tube was found broken.

Severe damage to the Perspex canopy, tail boom, main rotor blades, engine mount, and deformation of the engine firewall were evident.

2.2.1.3 The damage of the helicopter was consistent with the direction and the impact marks made on to the ground during a dynamic rollover. The damage was consequential to the dynamic rollover.

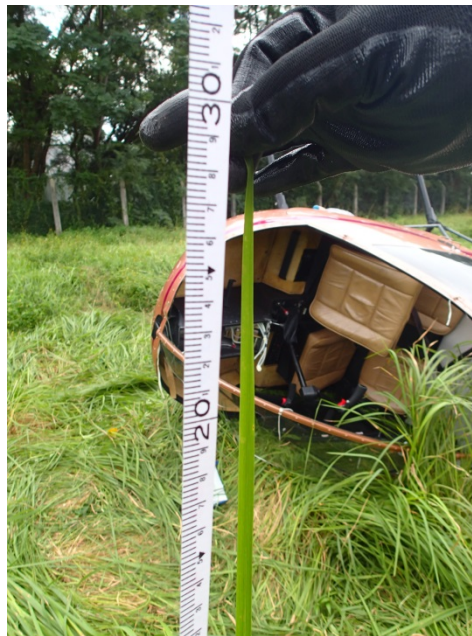
Photograph 2 – Length of Grass

2.1.4 The Instructor, the Student and the witness all described the grass in the airfield was long on the day of the accident. During the investigation, the measurement on the length of the grass at the accident site was found to be about 1.3 m (see Photograph 2). The surface of the accident site was made up of deep grass with large ‘clumps of grass’ embedded. No foreign objects were found.

It is recommended that the HKAC should regularly inspect the grass area in the Shek Kong Airfield, which is used for takeoff and landing by its helicopters, so as to ensure that the length and density of the grass will not affect the safety of helicopter operations.

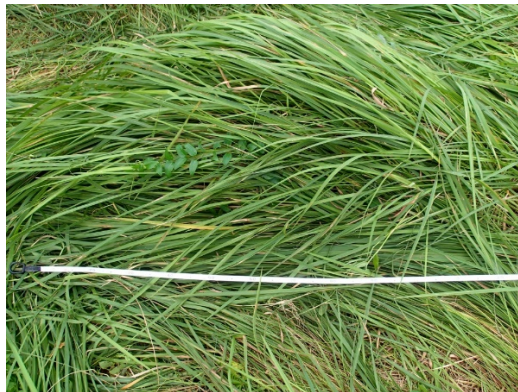
Photograph 3 – Overlaying of the Long Grass

2.1.6 During the landing, the length and the overlaying of the grass under the downwash of the helicopter would have been dense and deep enough to prevent the Instructor from seeing the ground texture, thus judging the height of the skids above the ground would have been difficult (see Photograph 3). Although he was unsure about the exact height of the helicopter from the ground and the depth of the grass, he decided to land the helicopter with the collective control fully down, putting both skids into the grass.

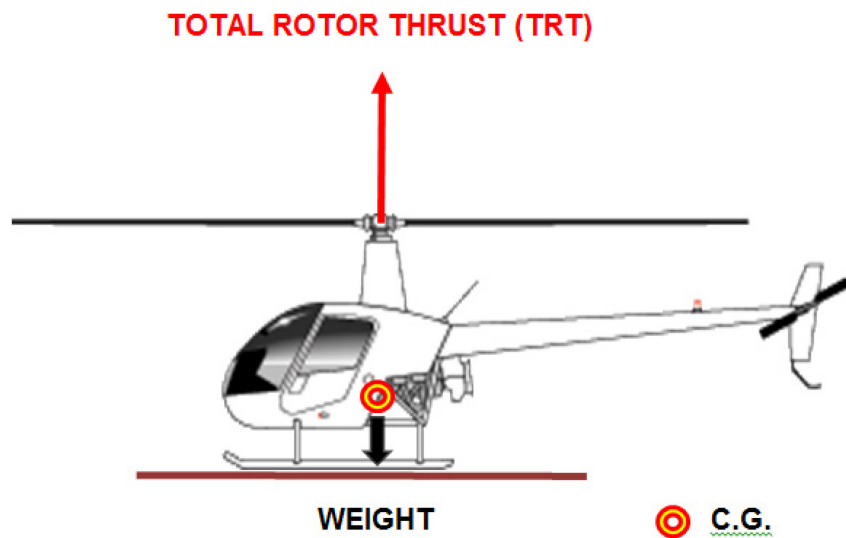
Figure 2

2.1.9 To lift off a helicopter under normal circumstances, the pilot would raise the collective control, thus increasing the Total Rotor Thrust (TRT). The higher the collective control is raised, the more TRT is created. When the TRT equals the weight of the helicopter, the helicopter would start lifting off from the ground (see Figure 2).

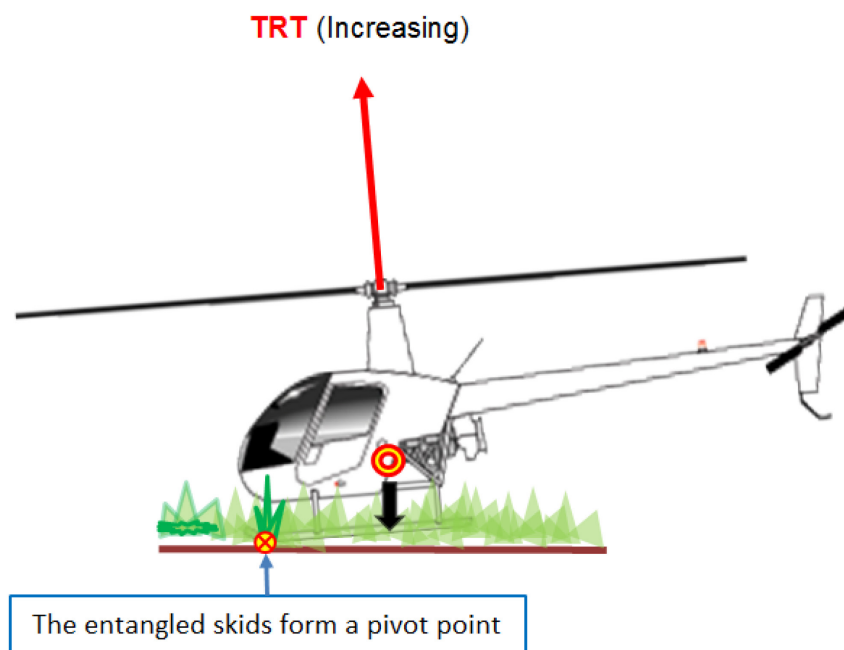
Figure 3

2.1.10 In this accident, the fronts of both skids of the helicopter were entangled with the fluttering deep grass. The Instructor thought the grass would come loose by lifting up the helicopter. As the fronts of both skids still remained entangled while raising the collective control, he thus attempted to get the skids untangled by raising the collective control more than that would have been required for a normal liftoff. It did not work and yet this additional collective input would inevitably create more TRT. As the TRT was increasing, more downwash was being generated. It was probable that the increasing downwash was pressing down on the overlaying grass, thus holding the skids even firmer. Simultaneously, with the skids still being entangled thus serving as a pivot point on the ground, the helicopter would start tilting forward (see Figure 3).

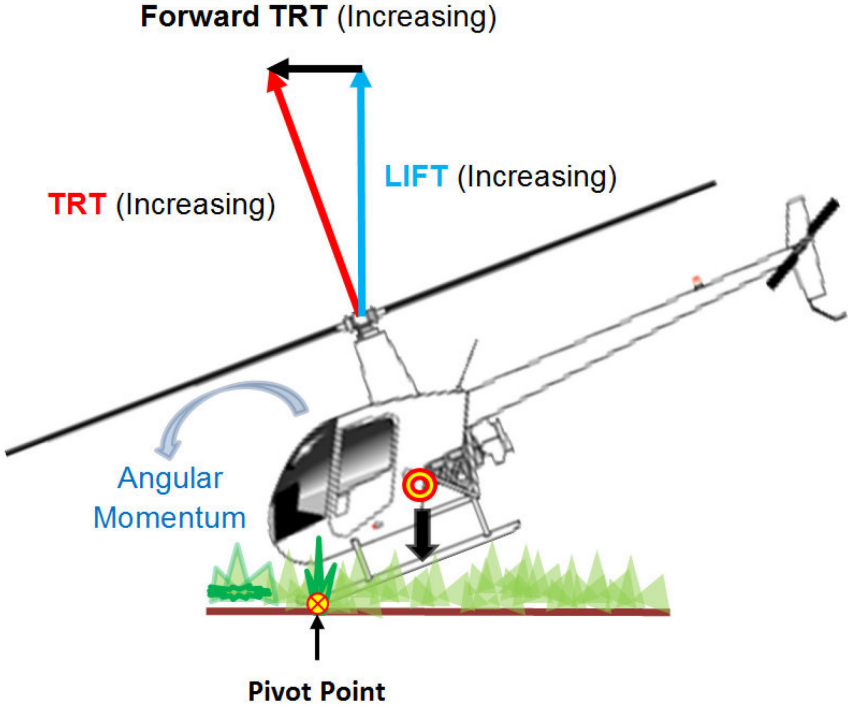
Figure 4

2.1.11 As the helicopter had already tilted forward and the TRT was increasing, a forward component of the TRT (Forward TRT) would be formed, thus generating an angular momentum that rolled the helicopter further forward (see Figure 4).

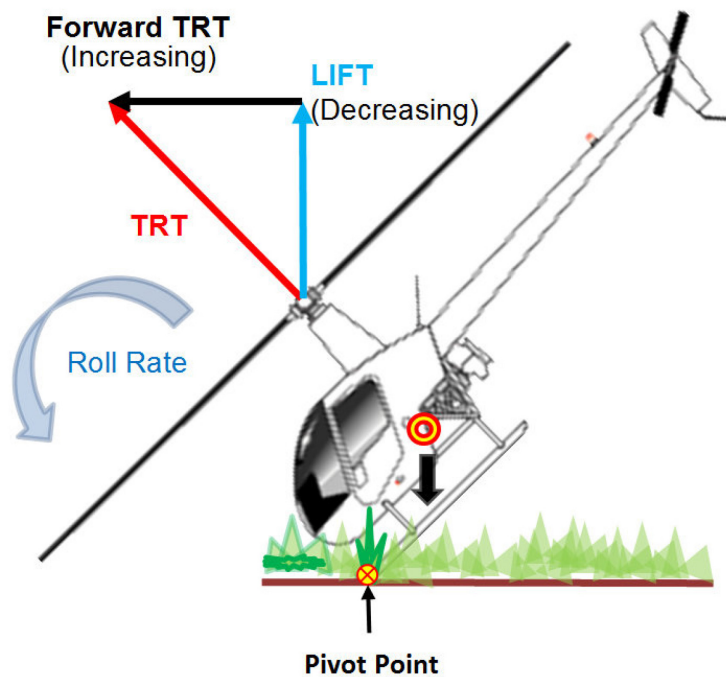
Figure 5

2.1.12 As the roll angle increased, the Forward TRT increased, thus increasing the roll rate. The Instructor stated that he was aware of this happening and he had lowered the collective control in response. However, at this particular moment, the roll rate had reached a magnitude that the control authority available from the cyclic control would not have been sufficient to arrest the rollover. This is confirmed by the Instructor's statement that he had tried using the cyclic control to level the helicopter but to no avail. As a result, the helicopter rolled over eventually (see Figure 5).

2.2.1.2 As the helicopter was rolling forward, the Forward TRT would increase whereas the Lift would decrease even the Instructor did not lower the collective control to decrease the TRT. With the fronts of the skids in contact with the ground, the weight of the helicopter being exerted on the contact points would increase as the roll angle increased. It was probable that the front end of the right skid could no longer support the weight of the helicopter and broke because of the decrease of Lift at an acute roll angle (see Figure 5).
