**Collision between Aircraft  
and Tow Tractor  
(Ground Handling)**

**Serious Incident Investigation  
Final Report**

**Airbus A330-343, B-HLT,  
Hong Kong International Airport  
24 January 2020**

**01-2021**

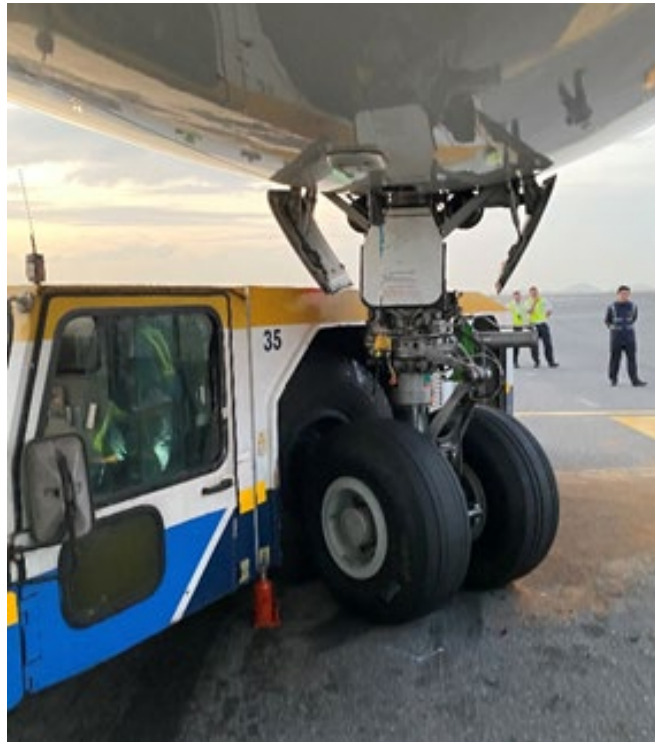
received the message for setting the parking brake to stop the aircraft movement. The NLG was damaged during the collision. (See Photo 1.)

Photo 1: NLG impacted with the Left Hand Side of the Tractor

The nose steering actuators of the NLG and the NLG door were damaged. There is no other structural damage evident. The investigation team did not establish any evidence of aircraft system fault that might be relevant to the serious incident.

- (6) Without parking brake set and chock in place, the aircraft, with both engines in idle power, rolled forward and collided with the tractor. [1.1(6)]

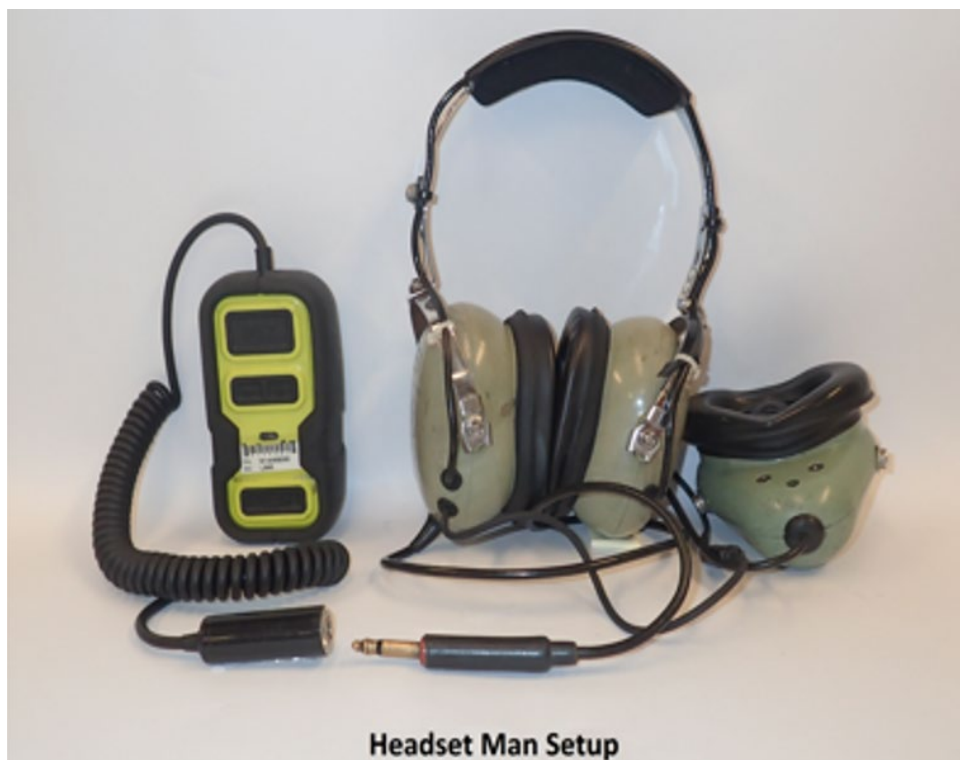
Photo 2: Wireless Headset Setup for Headset Man

- (2) The headset man stated in the interview that the wireless headset operation was normal for communication with the flight crew at the commencement of the pushback and during the engine start. However, no response or acknowledgement was received from the flight crew on his instruction to set the parking brake after the aircraft had stopped on the taxilane.
- (3) After the serious incident, the functions of the headset and the two Bluetooth transceivers were checked and found normal.

The wireless headset setup, including the Bluetooth transceivers were checked and found normal after the serious incident. The cause of the communication interruption between ground and cockpit could not be identified. However, the possibility of system interruptions during the pushback operation could not be ruled out.

It is recommended that the Hong Kong Aircraft Engineering Company Limited establishes procedures in SOP for guiding ground handling personnel in case of loss of interphone communication with the flight crew during pushback operation.

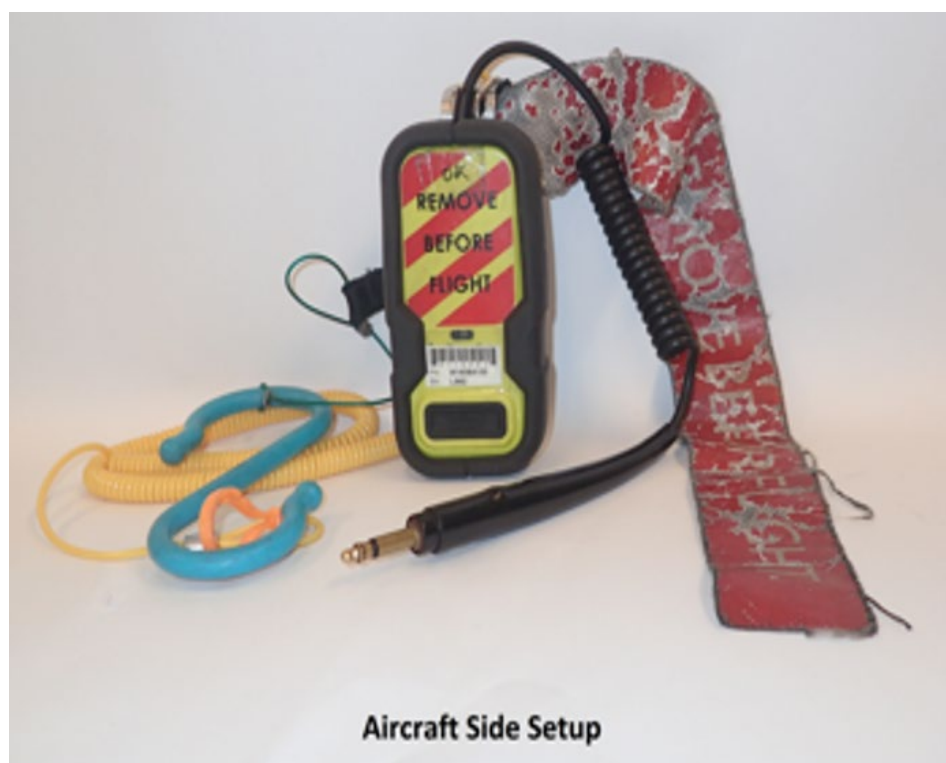
Photo 3: Wireless Headset Setup for Aircraft Side

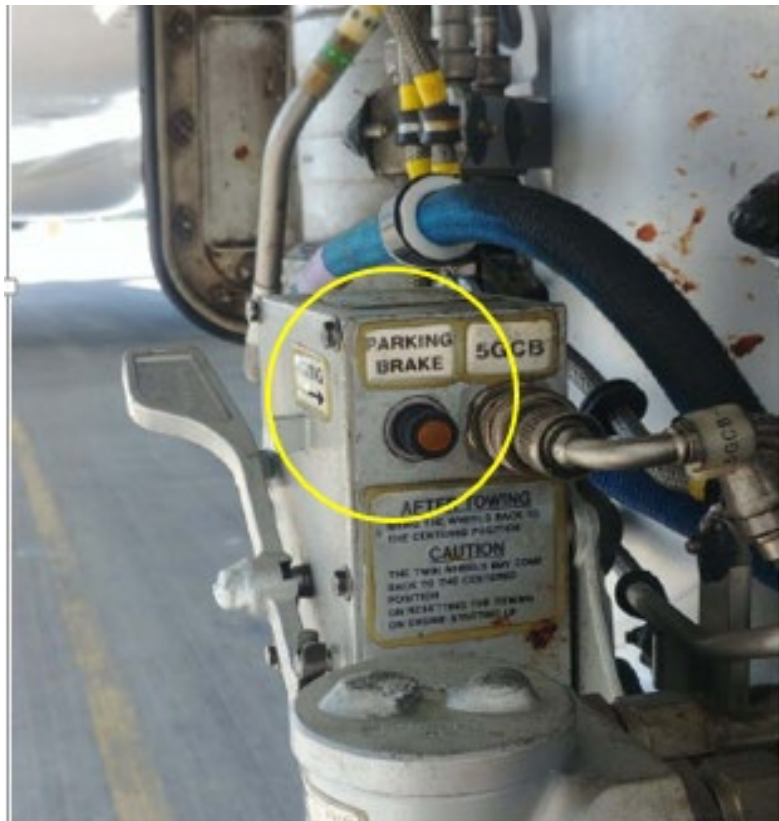
Photo 4: Parking Brake Light on the NLG

- (f) Both the headset man and the wing walker did not confirm the parking brake light on the NLG was ON before disconnecting the towbar.

- (1) The ground handling crew disconnected the towbar without confirming the parking brake light on the NLG was ON. [3.1.(4)]
- (2) A chock was not placed in front of the NLG wheel before disconnecting the towbar. [3.1.(2)]
