Loss of Control Inflight

Accident Investigation Final Report

Zlin-Z-242-L
Hong Kong
February 2016

02-2020

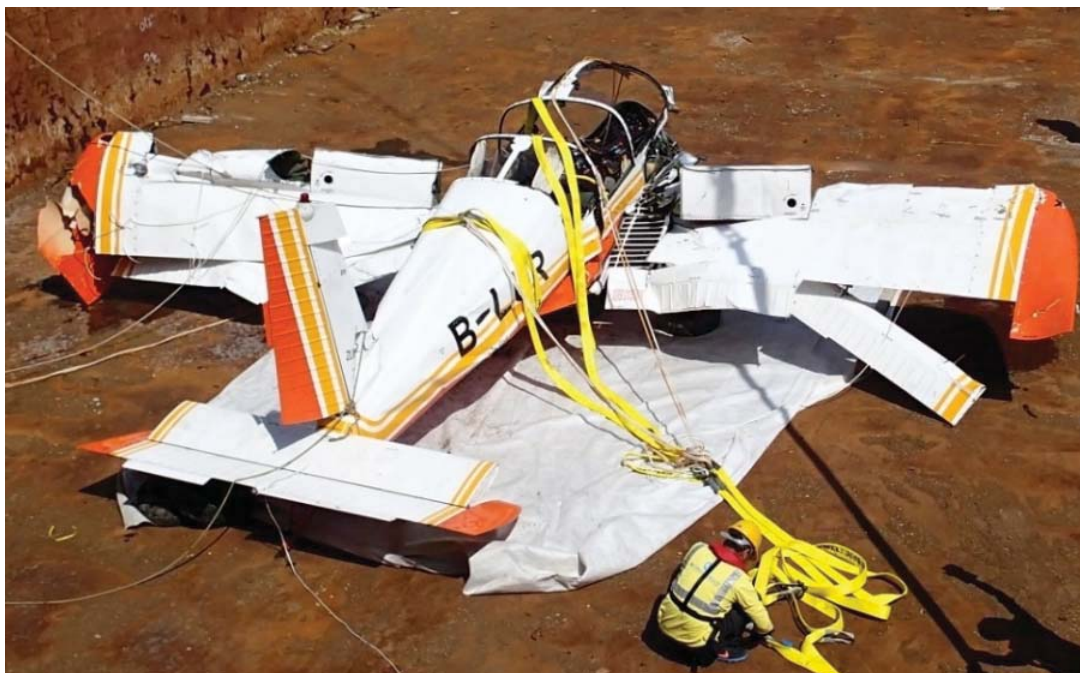
Figure 6 - Aircraft as Recovered

All control surfaces and assemblies were accounted for with all damage to the aircraft due to the impact with the sea.

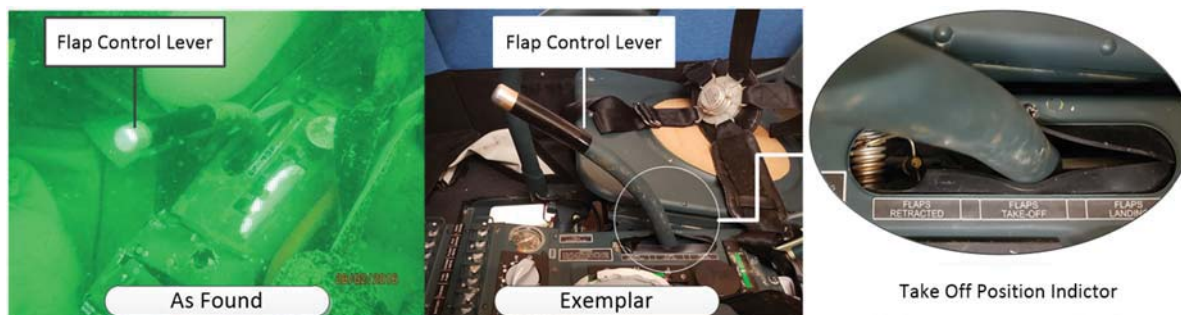
Figure 9 – (Left) Flaps control lever as found underwater. (Right) exemplar for reference

The photo taken prior to the wreckage recovery shows that the flaps control lever is not in the retracted position.

The position of the flap handle as found was between “Flap Retracted” and “Flaps Take-Off” when the wreckage was discovered under the water.

The position of the flap handle was found to be between "Flap Retracted" and "Flaps Take-Off" when the wreckage was discovered under the water.

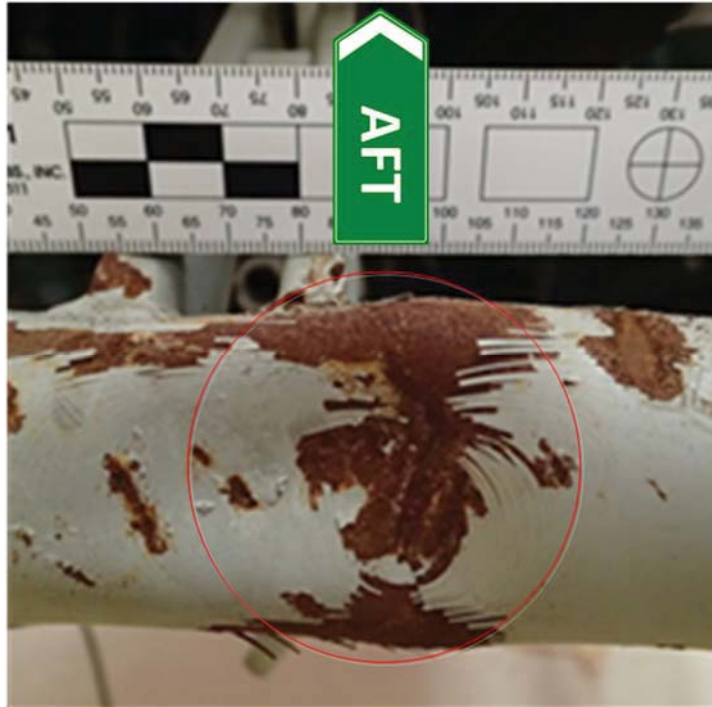
Figure 10 – Countershaft Damage

This deformation was found at about the middle of the forward side of the countershaft that connects laterally to both control sticks.

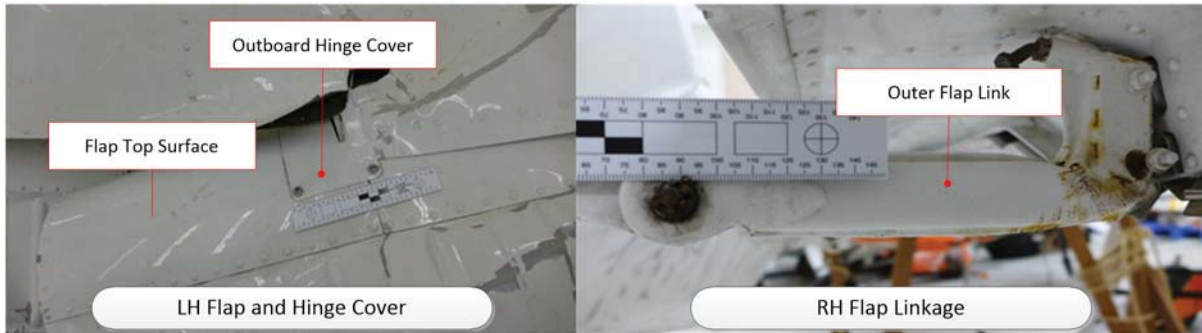
Figure 12 – LH Flap and Hinge Cover/RH Flap Linkage

Both flaps were severely damaged during the impact with the sea.

The trailing edge of the left wing was lodged into the outer hinge cover of the flap.

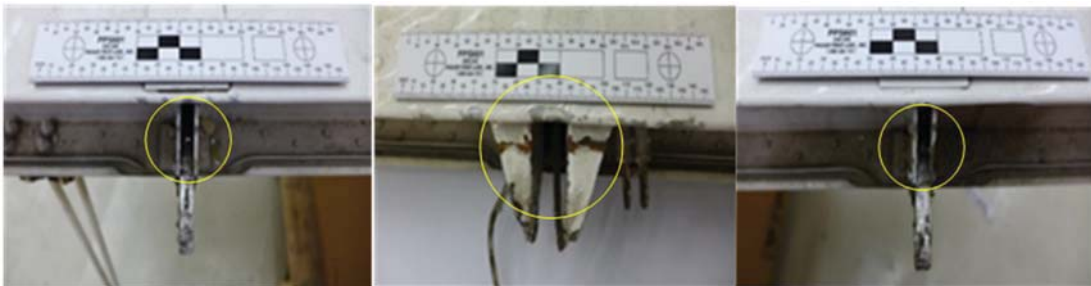
Figure 13 - Witness marks on the top of all elevator support hinge brackets

Witness marks were found on the top of the left, centre and right elevator support hinge brackets (Yellow outline).

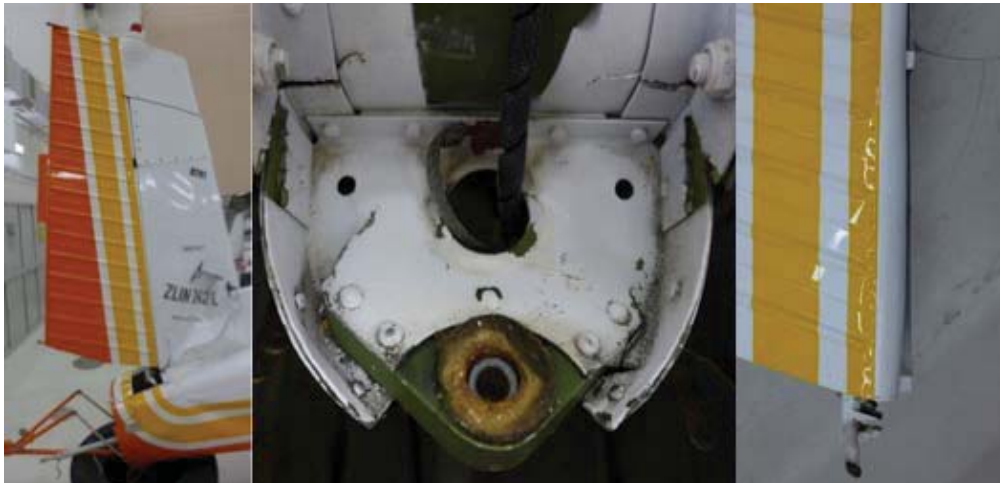
Figure 14 - Rudder and Vertical Stabiliser Deformation

The vertical stabilizer and the rudder deformation is consistent with a high speed water impact.

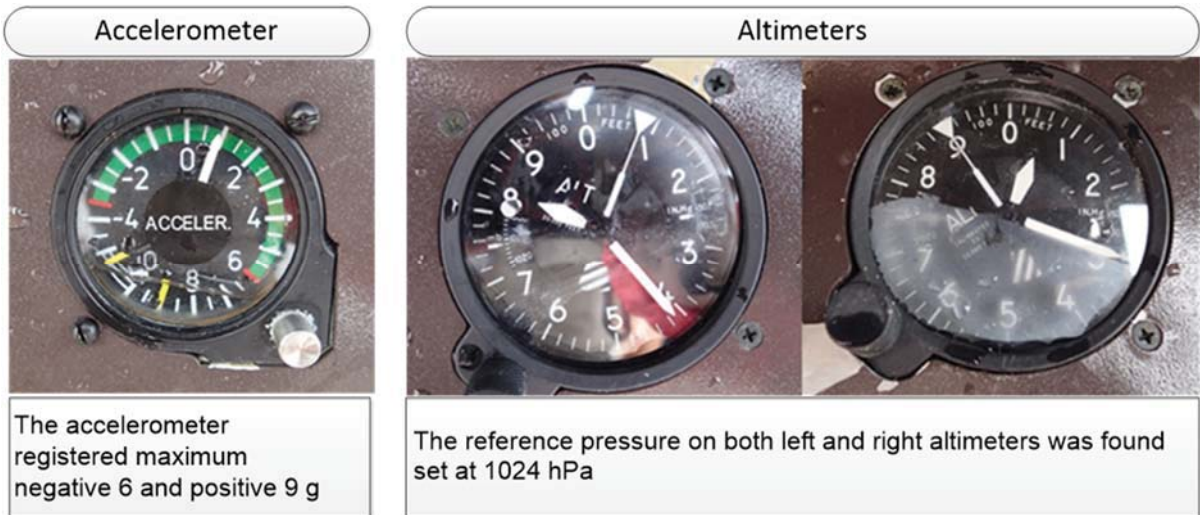
Figure 16 - Instruments

The instrument panel was recovered, the instruments were damaged in the impact and subsequent salt water immersion.

The instrument settings and indicator locations as recovered were recorded.

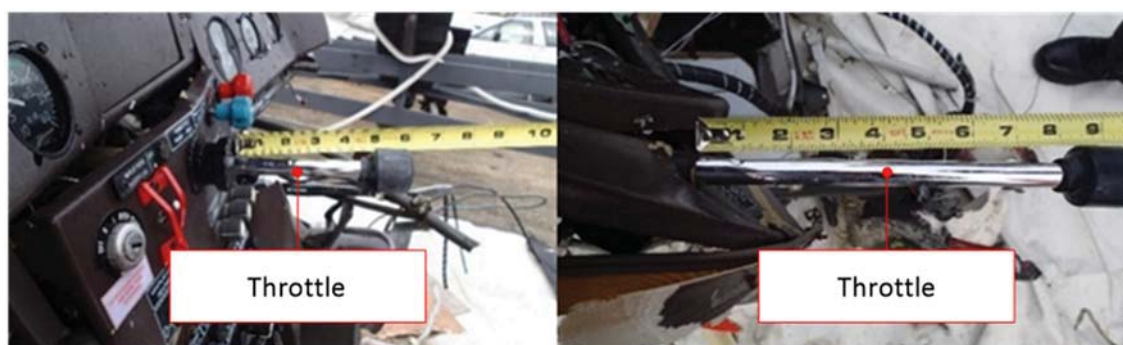
Figure 17 - Throttle Position

The instrument panel was deformed during the accident sequence, including around the engine throttle areas.

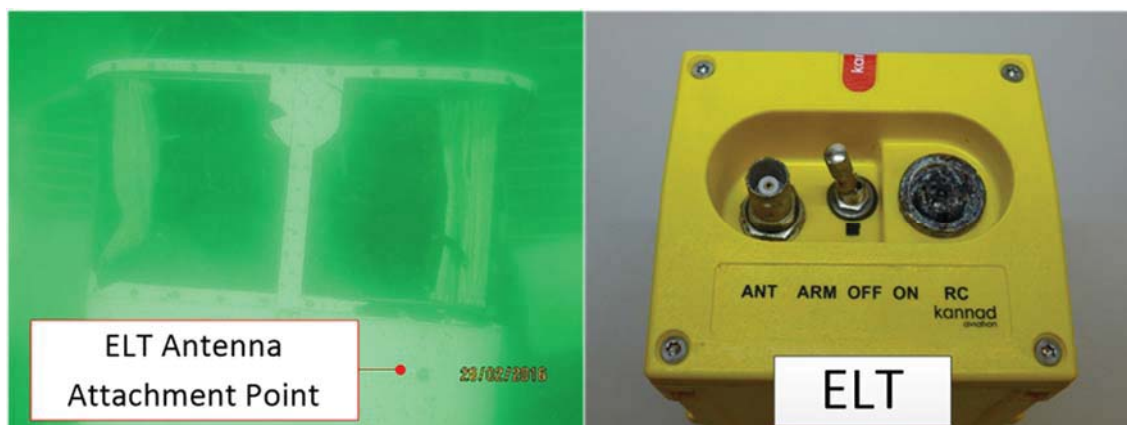
Figure 18 - ELT Location and ARM Switch

The photo on the left taken prior to the wreckage recovery shows that the antenna of the ELT has detached from the upper fuselage.

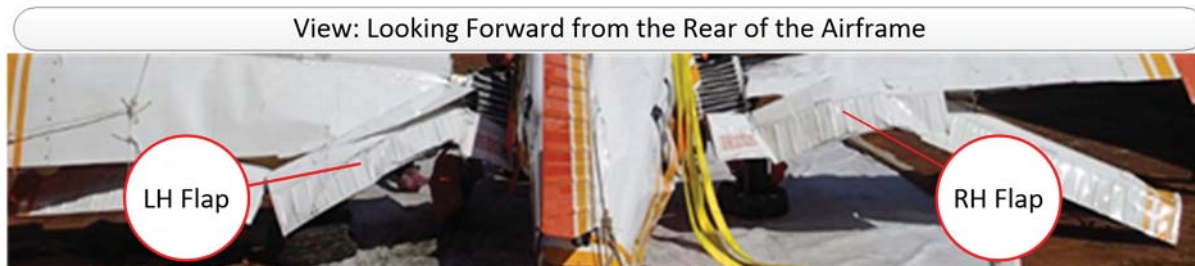
Figure 22 - Aft View of the Recovered Airframe

The non-uniform lateral deformation of the flaps in conjunction with the position of the flaps and the damage indicates the flaps sustained high energy damage due to impacting the sea during the rotation of the spin.

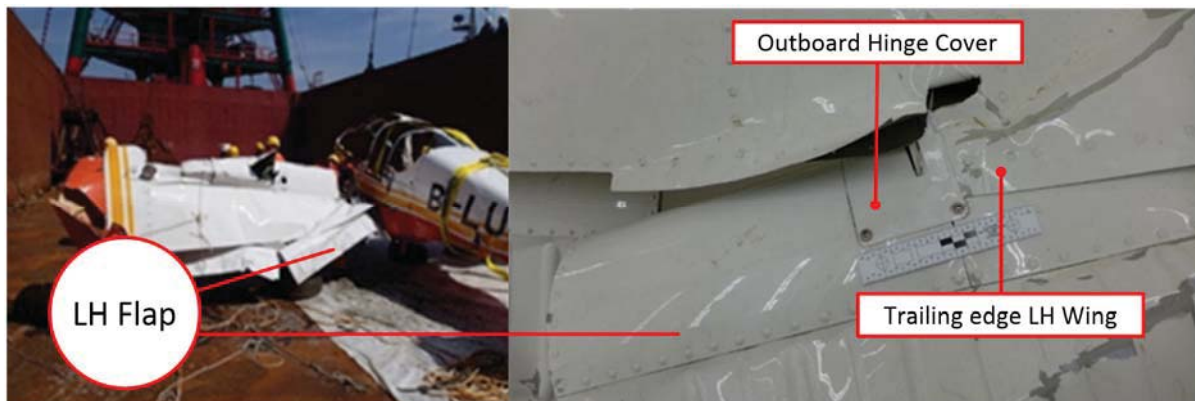
Figure 23 - Flap Damage

The trailing edge of the left wing is under the outer hinge cover of the flap.

There are no witness marks found underneath the trailing edge of the right wing, indicative that the flap was not in the retracted position (the flap has a flush profile with the wing at impact which would leave residual witness marks on impact).

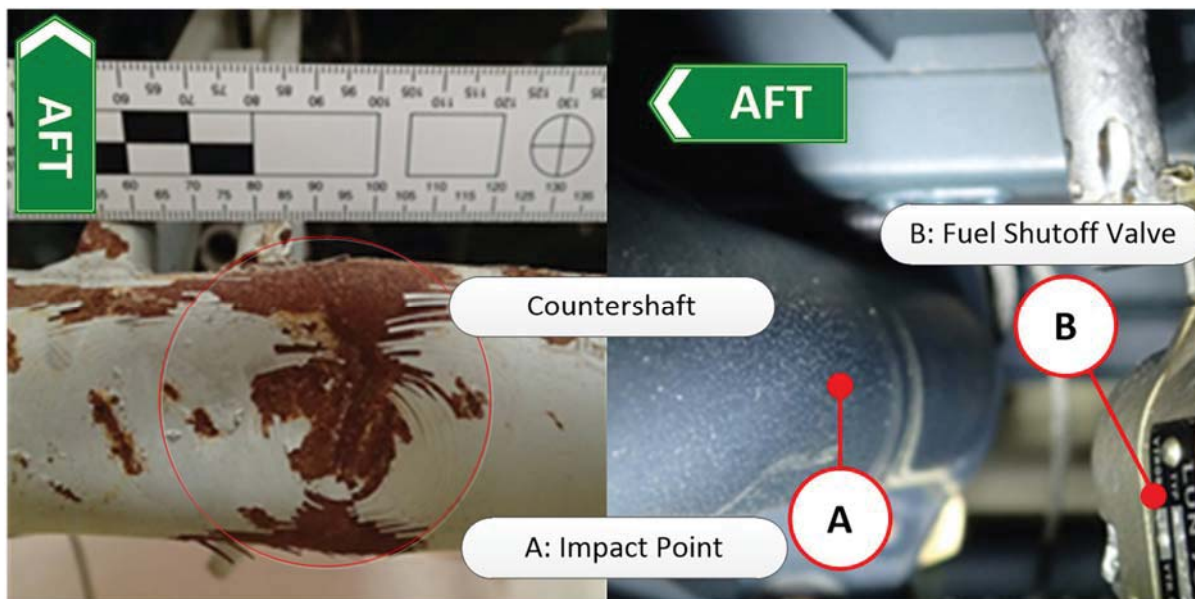
Figure 24 - Control Countershaft Damage

The fuel shutoff valve is located on the same horizontal plane and directly in front of the countershaft.

It was found that only when the control stick was held at the full aft position, at which the relative position of the fuel shutoff valve and the countershaft would have matched the impact location of the witness mark, indicating the control column was at the full aft position at the point of impact.
