Runway Incursion (RI)

Serious Incident Investigation Final Report

**Air Cargo Global Boeing 747-400SF,
OM-ACB and Hong Kong Airlines
Airbus A330-343, B-LNS at
Hong Kong International Airport
22 September 2017**

02-2021

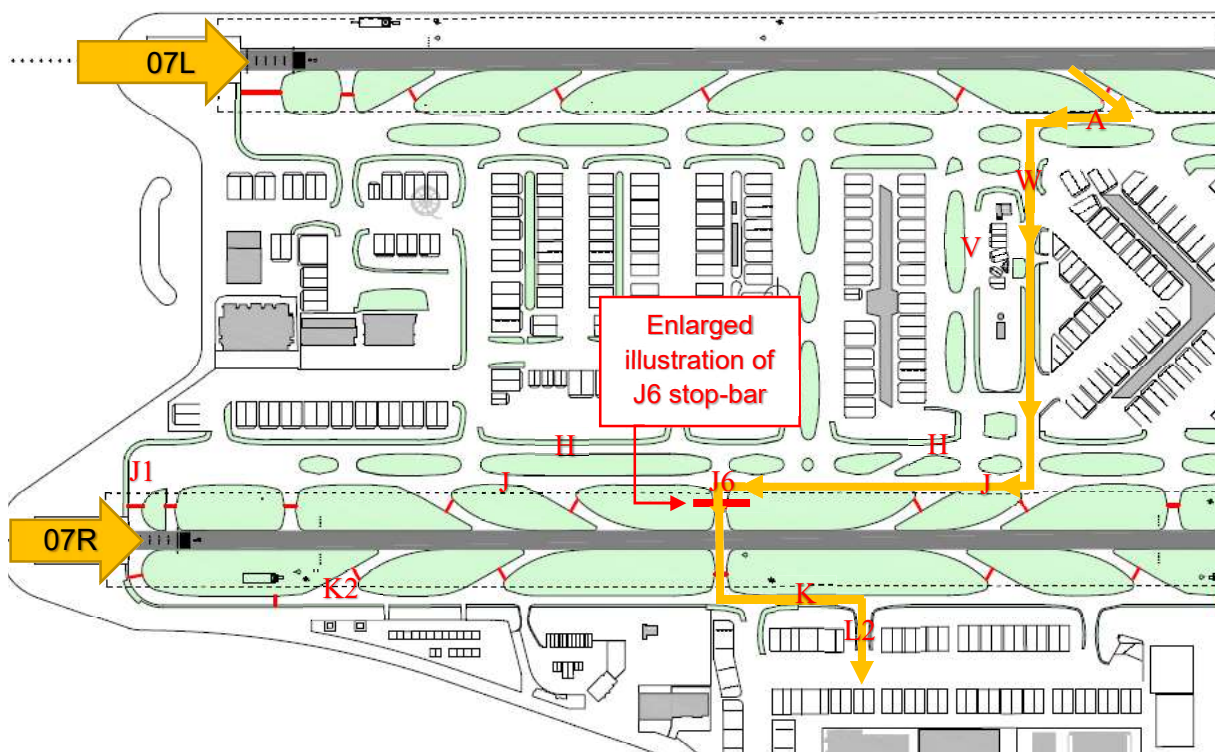
1.1.4. At 08:48:41 after vacating RWY07L, the Pilot Monitoring of Aircraft 1 contacted GMC and the instructor, who had momentarily taken over control from the trainee, issued progressive taxiing instructions to Aircraft 1 to taxi via Taxiway A, W, J to J6 holding point which was on the north side of RWY07R. (See Figure 1 for depiction of the taxi route assigned to Aircraft 1)

Figure 1: Taxi route of Aircraft 1 depicted on Hong Kong International Airport Chart

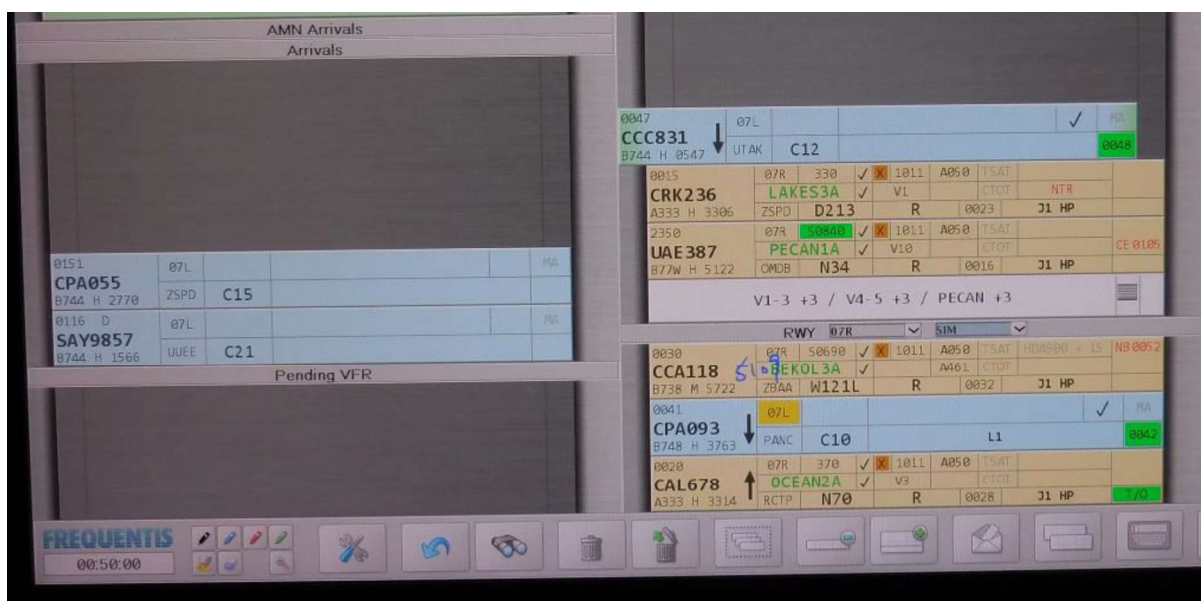
2.2.7.2 The fact that this earlier arrival followed ATC instructions and crossed RWY07R via J6 onto Taxiways K and L1 without any incident indicated that there had been close coordination between GMC and AMS. (See Figure 3 for the actual traffic situation at UTC 00:50:00 (Local Time 08:50:00) as illustrated by the TEFS display at the AMS workstation.)

2.2.7.3. However the runway incursion in which Aircraft 1 was involved showed that if standard procedures were not followed as a result of distraction or other factors, the built-in procedure-based defence may not work as expected. (2.2.5.2) (2.2.6.1)

**Figure 3: Electronic flight strips displayed at AMS workstation
at UTC 00:50:00 (Local Time 08:50:00)**

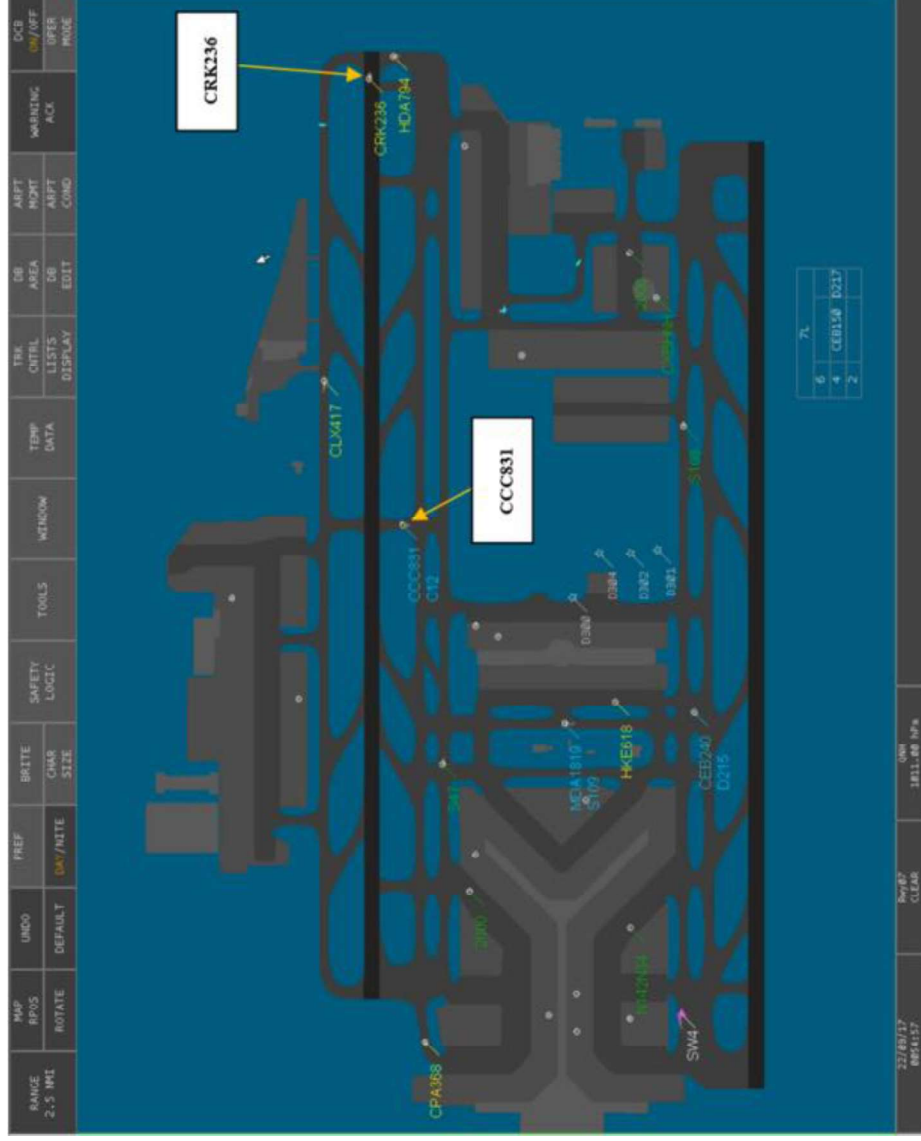
1.1.9. At 08:54:57 Aircraft 2 commenced its take-off roll on RWY07R. A few seconds later, Aircraft 1 started to enter RWY07R from J6 holding point.

Figure 4: CRK236 commenced take-off on Runway 07R at UTC 00:54:57 (Local Time 08:54:57) and the location of CCC831

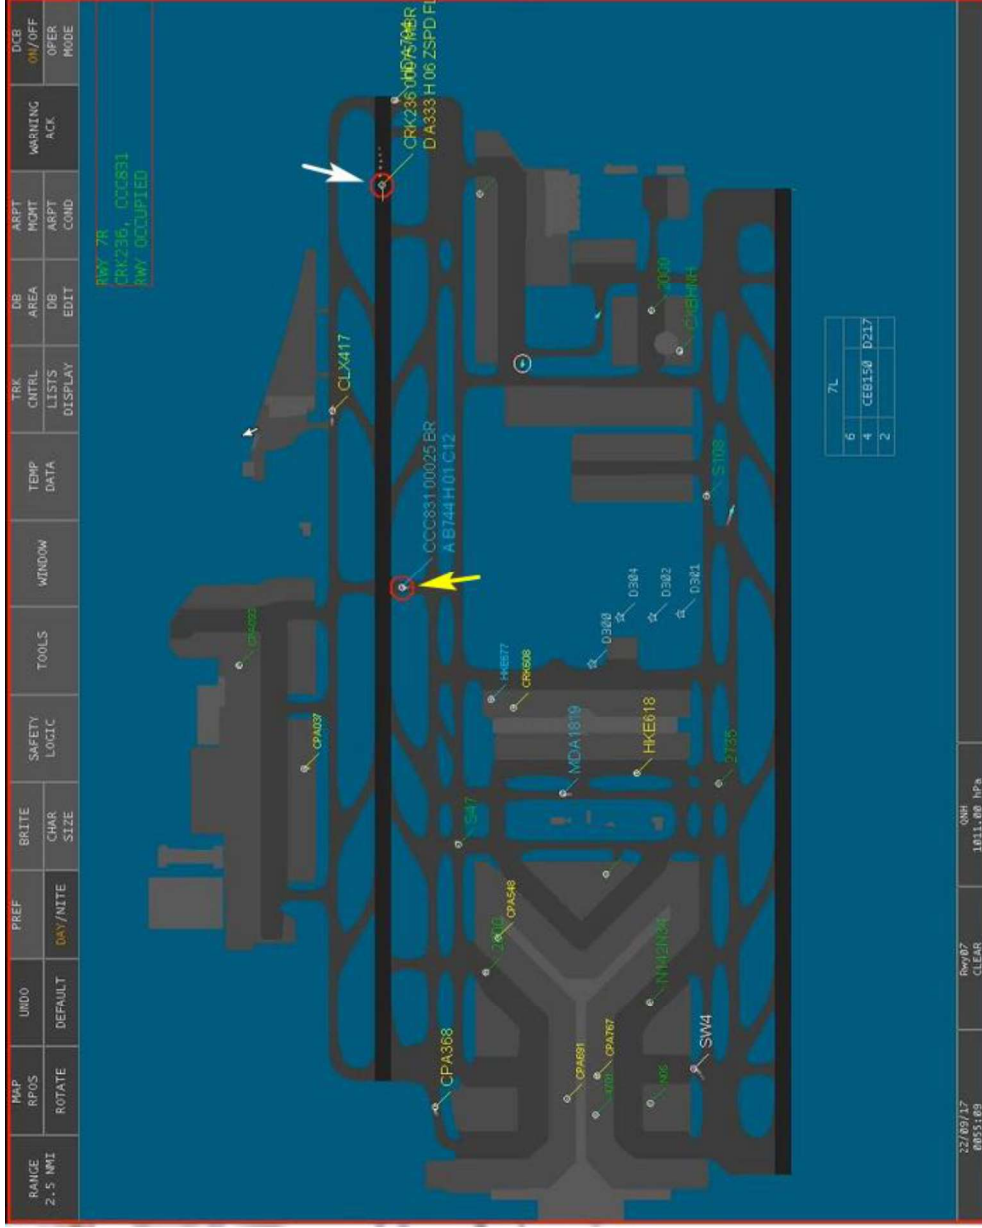
1.1.10. At 08:55:08 a visual red conflict alert was triggered and displayed on the Advanced Surface Movement Guidance and Control System (A-SMGCS) at the workstations of AMS and GMC (see Figure 5 at Appendix 9.1), but no audio alarm was heard.

Figure 5: Positions of CRK236 and CCC831 when Runway Incursion Warning was displayed at UTC 00:55:09 (Local Time 08:55:09)

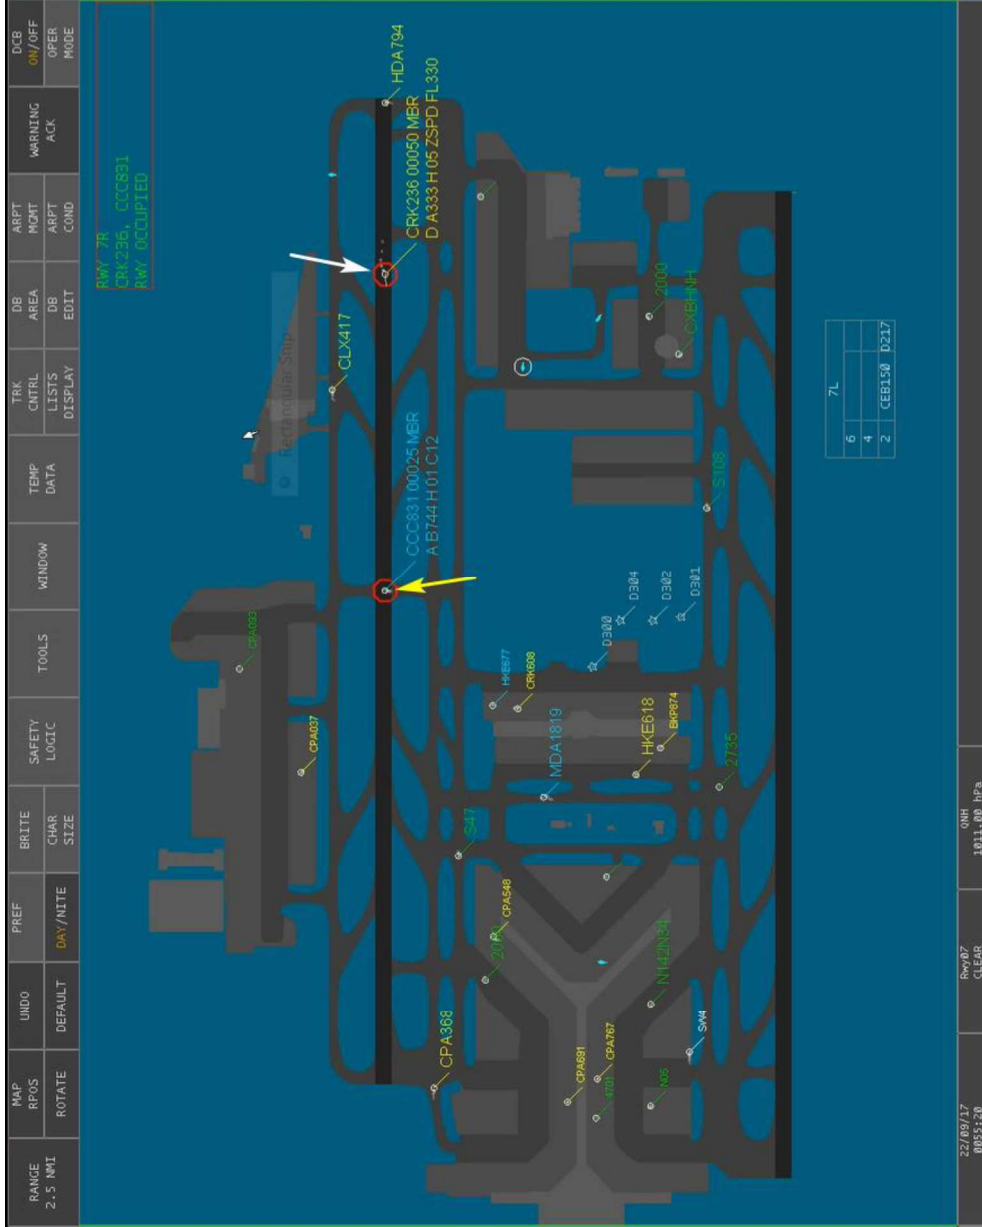
1.1.12. At 08:55:19 Aircraft 2 reported to AMS rejecting the take-off due to another aircraft on the runway. AMS instructed Aircraft 2 to stop immediately and provided traffic information to Aircraft 2. The A-SMGCS red conflict warning ceased after 08:55:21.

Figure 6: Positions of CRK236 and CCC831 when Runway Incursion Warning was displayed at UTC 00:55:20 (Local Time 08:55:20)

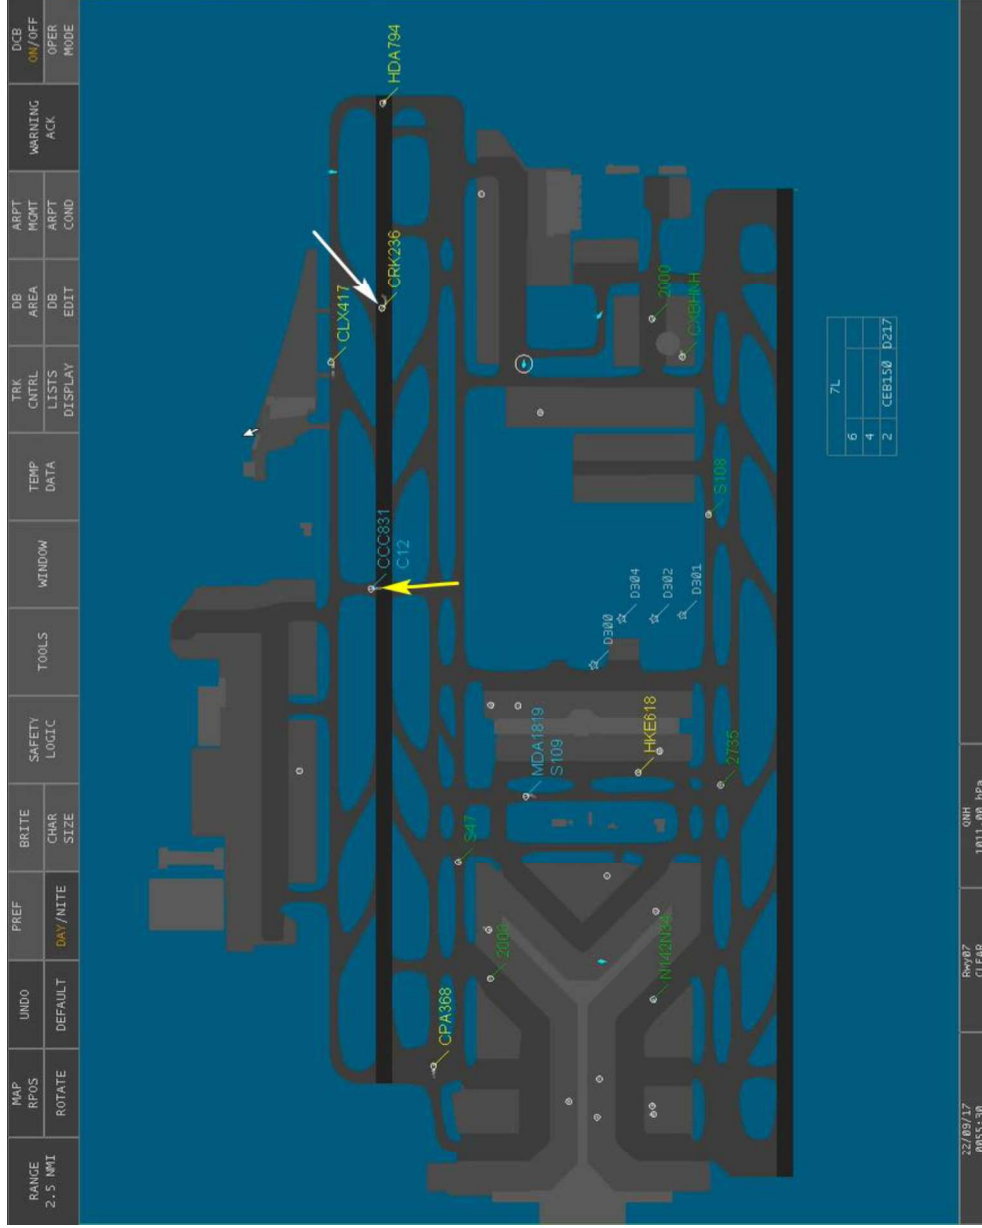
1.1.13. At 08:55:30 Aircraft 2 came to a halt on RWY07R abeam Taxiway K2. Aircraft 1 also vacated RWY07R about the same time and continued taxiing to cargo parking bay C12. The closest distance between the two aircraft was about 1,100m. (See Appendix 9.1 Figure 4-7 for records of the A-SMGCS display)

Figure 7: Display of A-SMGCS at UTC 00:55:30 (Local Time 08:55:30) when CRK236 came to a halt and CCC831 vacated Runway 07R
