Abnormal Runway Contact (ARC)

Serious Incident Investigation Final Report

**Boeing 747-47UF
Hong Kong International Airport
Hong Kong
30 August 2018**

03-2020

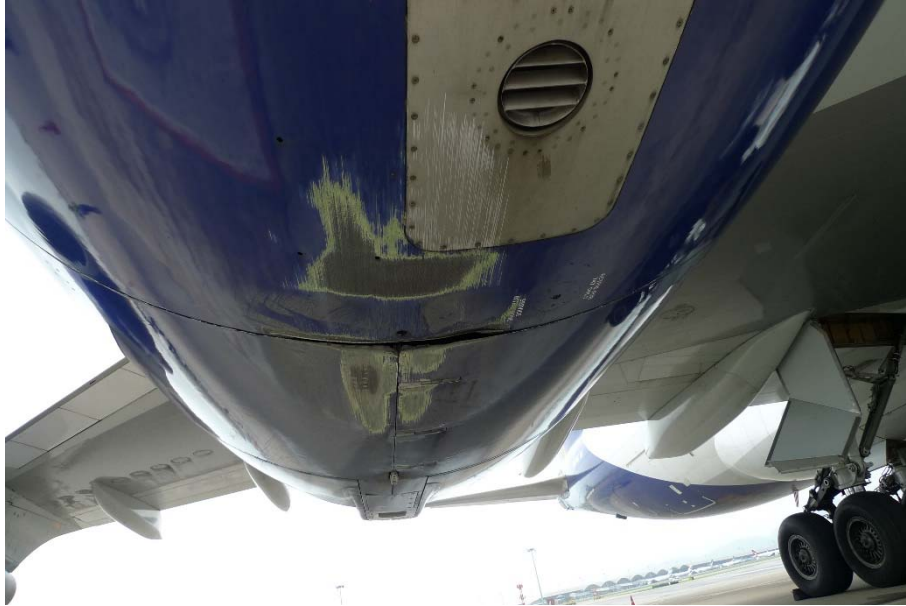
Photo 1: Damage at the Underside of No.3 Engine

The underside of the inlet cow, fan cowl, and reverser translating cowl of No.3 and No.4 engines sustained scuffing and abrasion damage. The drain masts of both engines suffered heavy abrasion damage. The damaged parts on No.3 engine and No.4 engine were replaced.

The damage to the underside of the inlet cowl, fan cowl and translating cowl of No.3 and No.4 engines was due to the combined effects of a sharp right yaw and significant right roll corresponding to the exaggerated inputs made by the PF.

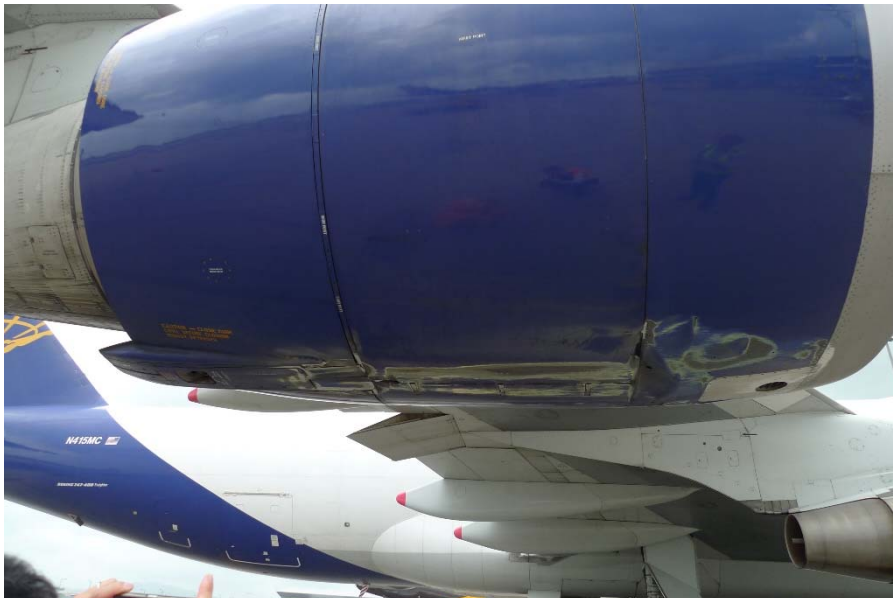
Photo 2: Damage at the Underside of No.4 Engine

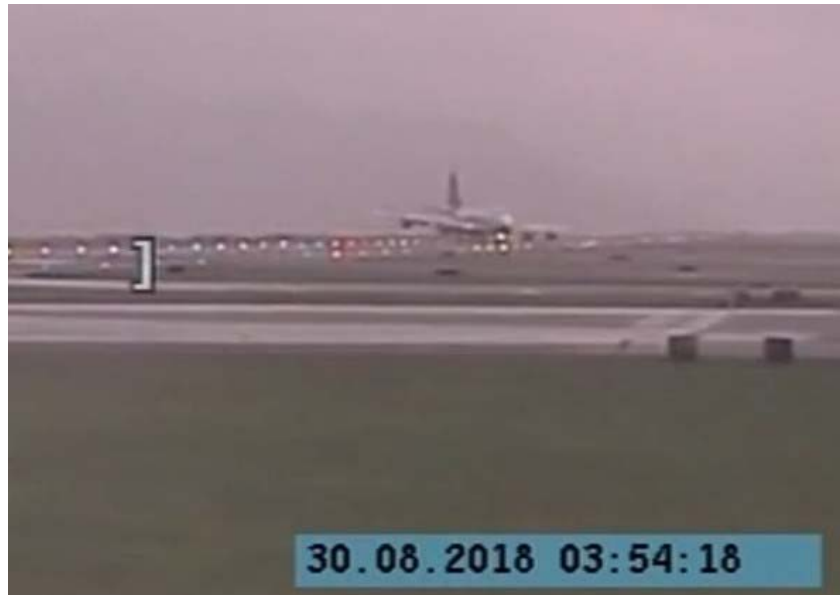
Photo 3: Aircraft Banking to the Left (Looking from 07L Direction)

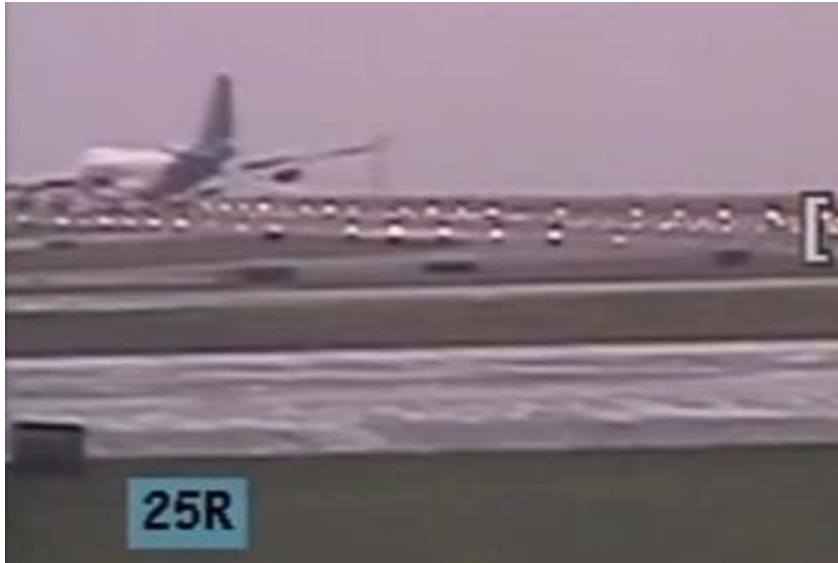
Photo 4: Aircraft Banking to the Left (Looking from 25R Direction)

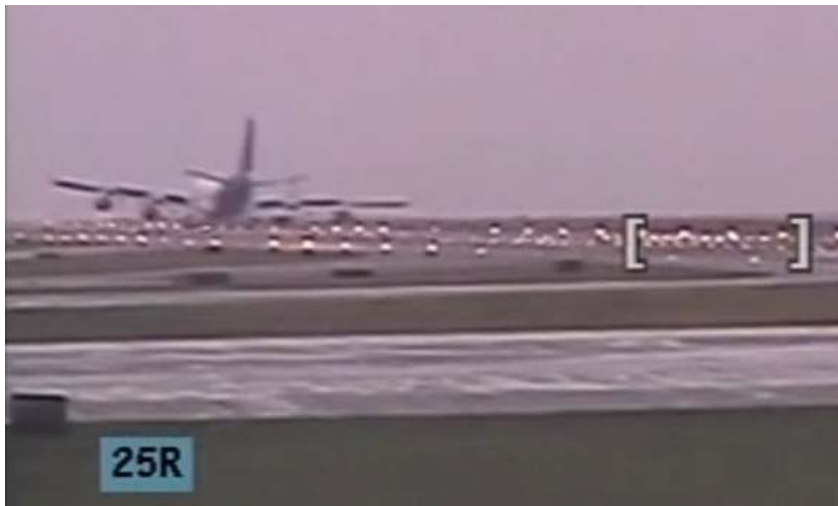
Photo 5: Aircraft Banking to the Right (Looking from 25R Direction)

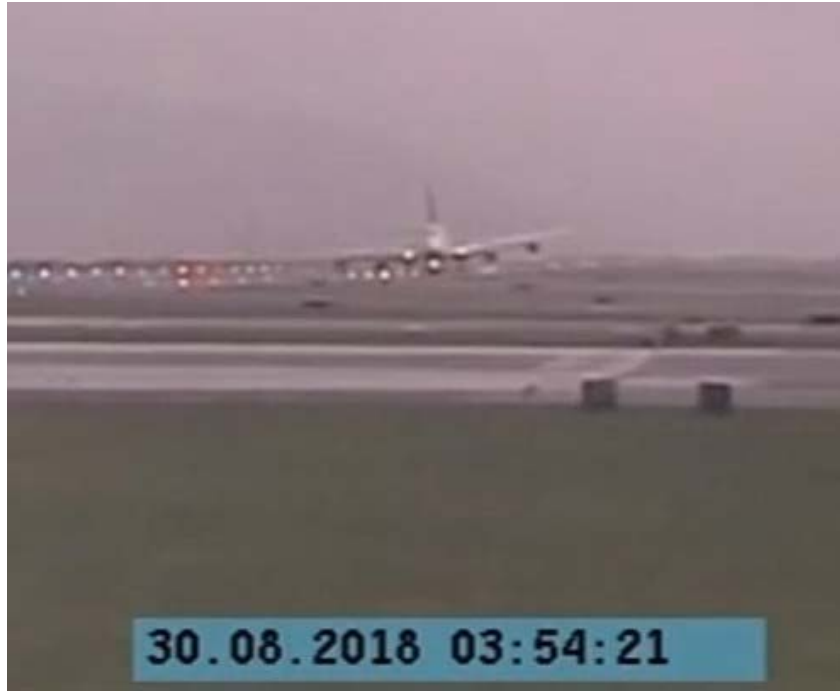
Photo 6: Aircraft Banking to the Right (Looking from 07L Direction)

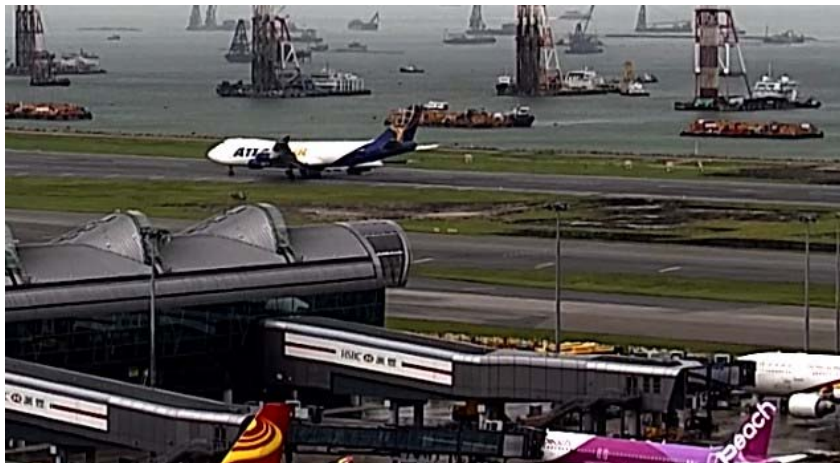
Photo 7: Veering to the Right, Left Wing High (Looking from 25R Direction)

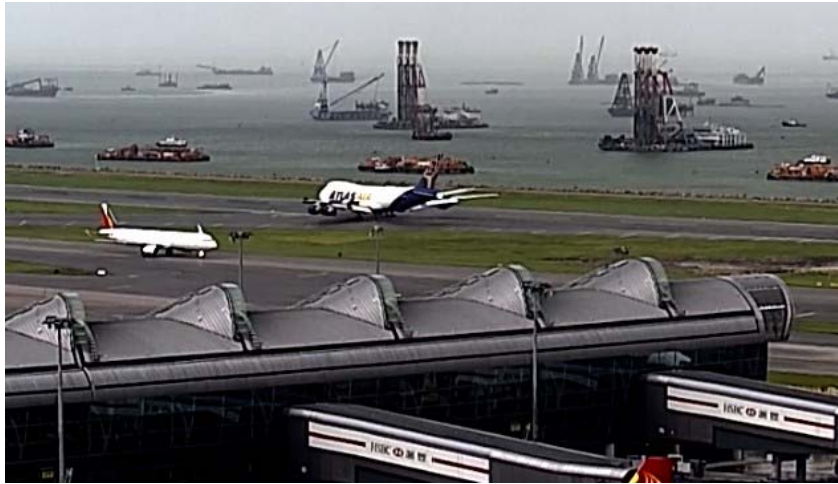
Photo 8: Aircraft Returning to Normal Attitude (Looking from 25R Direction)

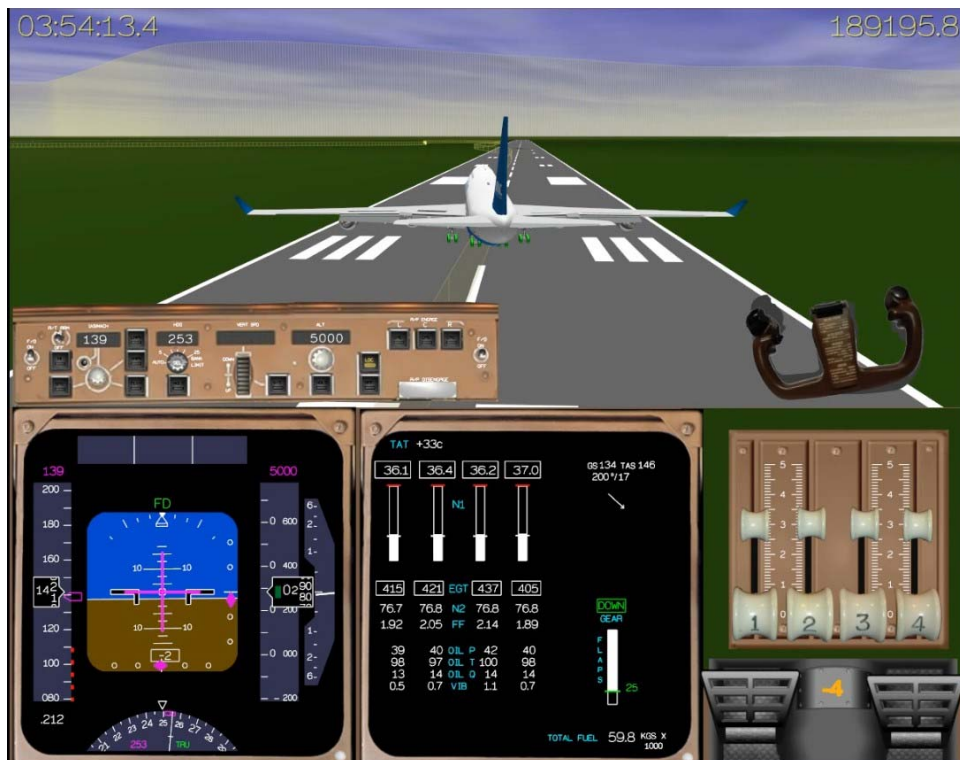
Figure 1: Aircraft in a Crab at Touchdown

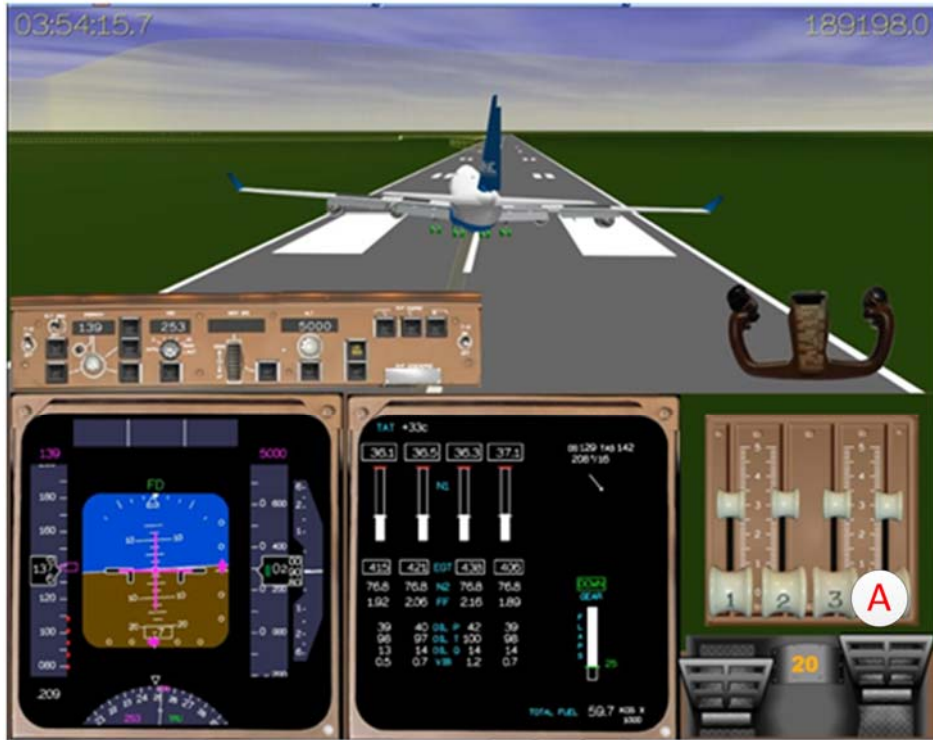
A: Right rudder pedal at full travel

Figure 2: Full Right Rudder Applied

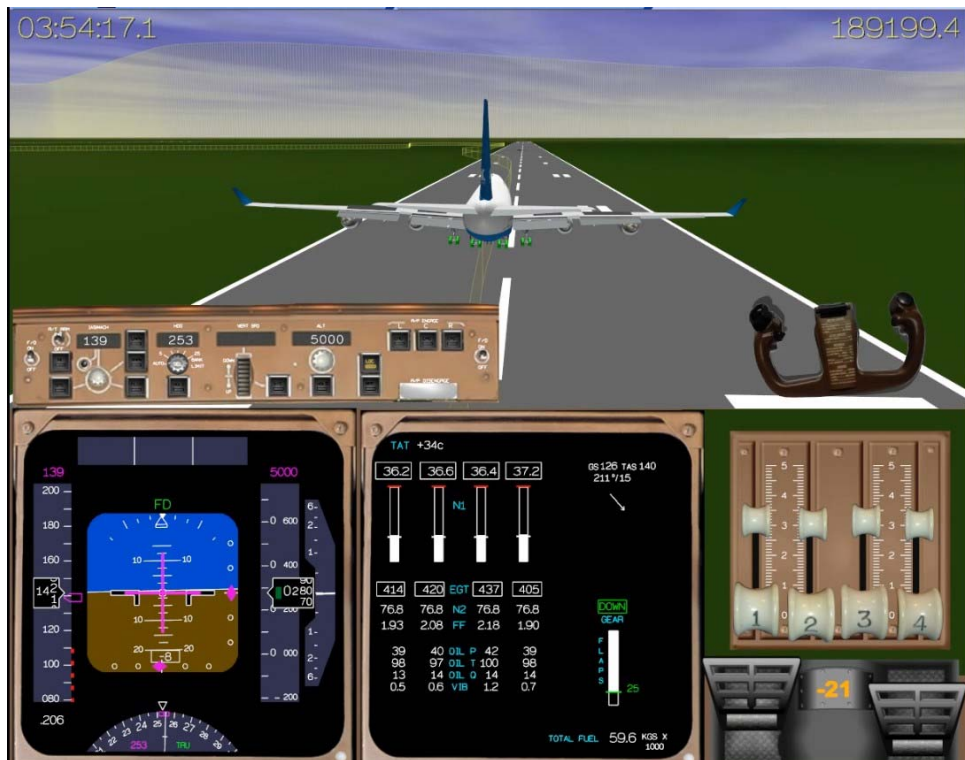
Figure 3: Full Left Rudder Applied

Figure 3 showed that the aircraft was on the centreline with ailerons neutral and full left rudder applied.

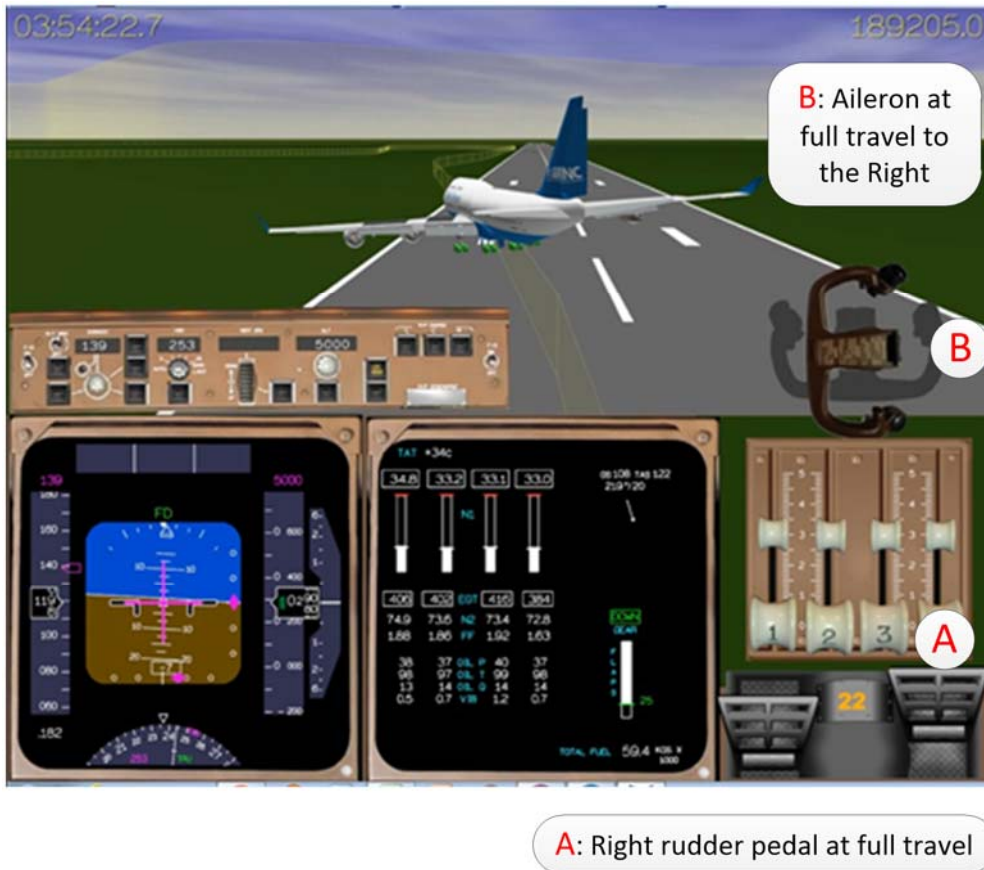
Figure 4: Full Right Aileron Applied

The aircraft was at approximately 30 degrees to the left of the centreline with the control column at full right deflection and full right rudder applied.

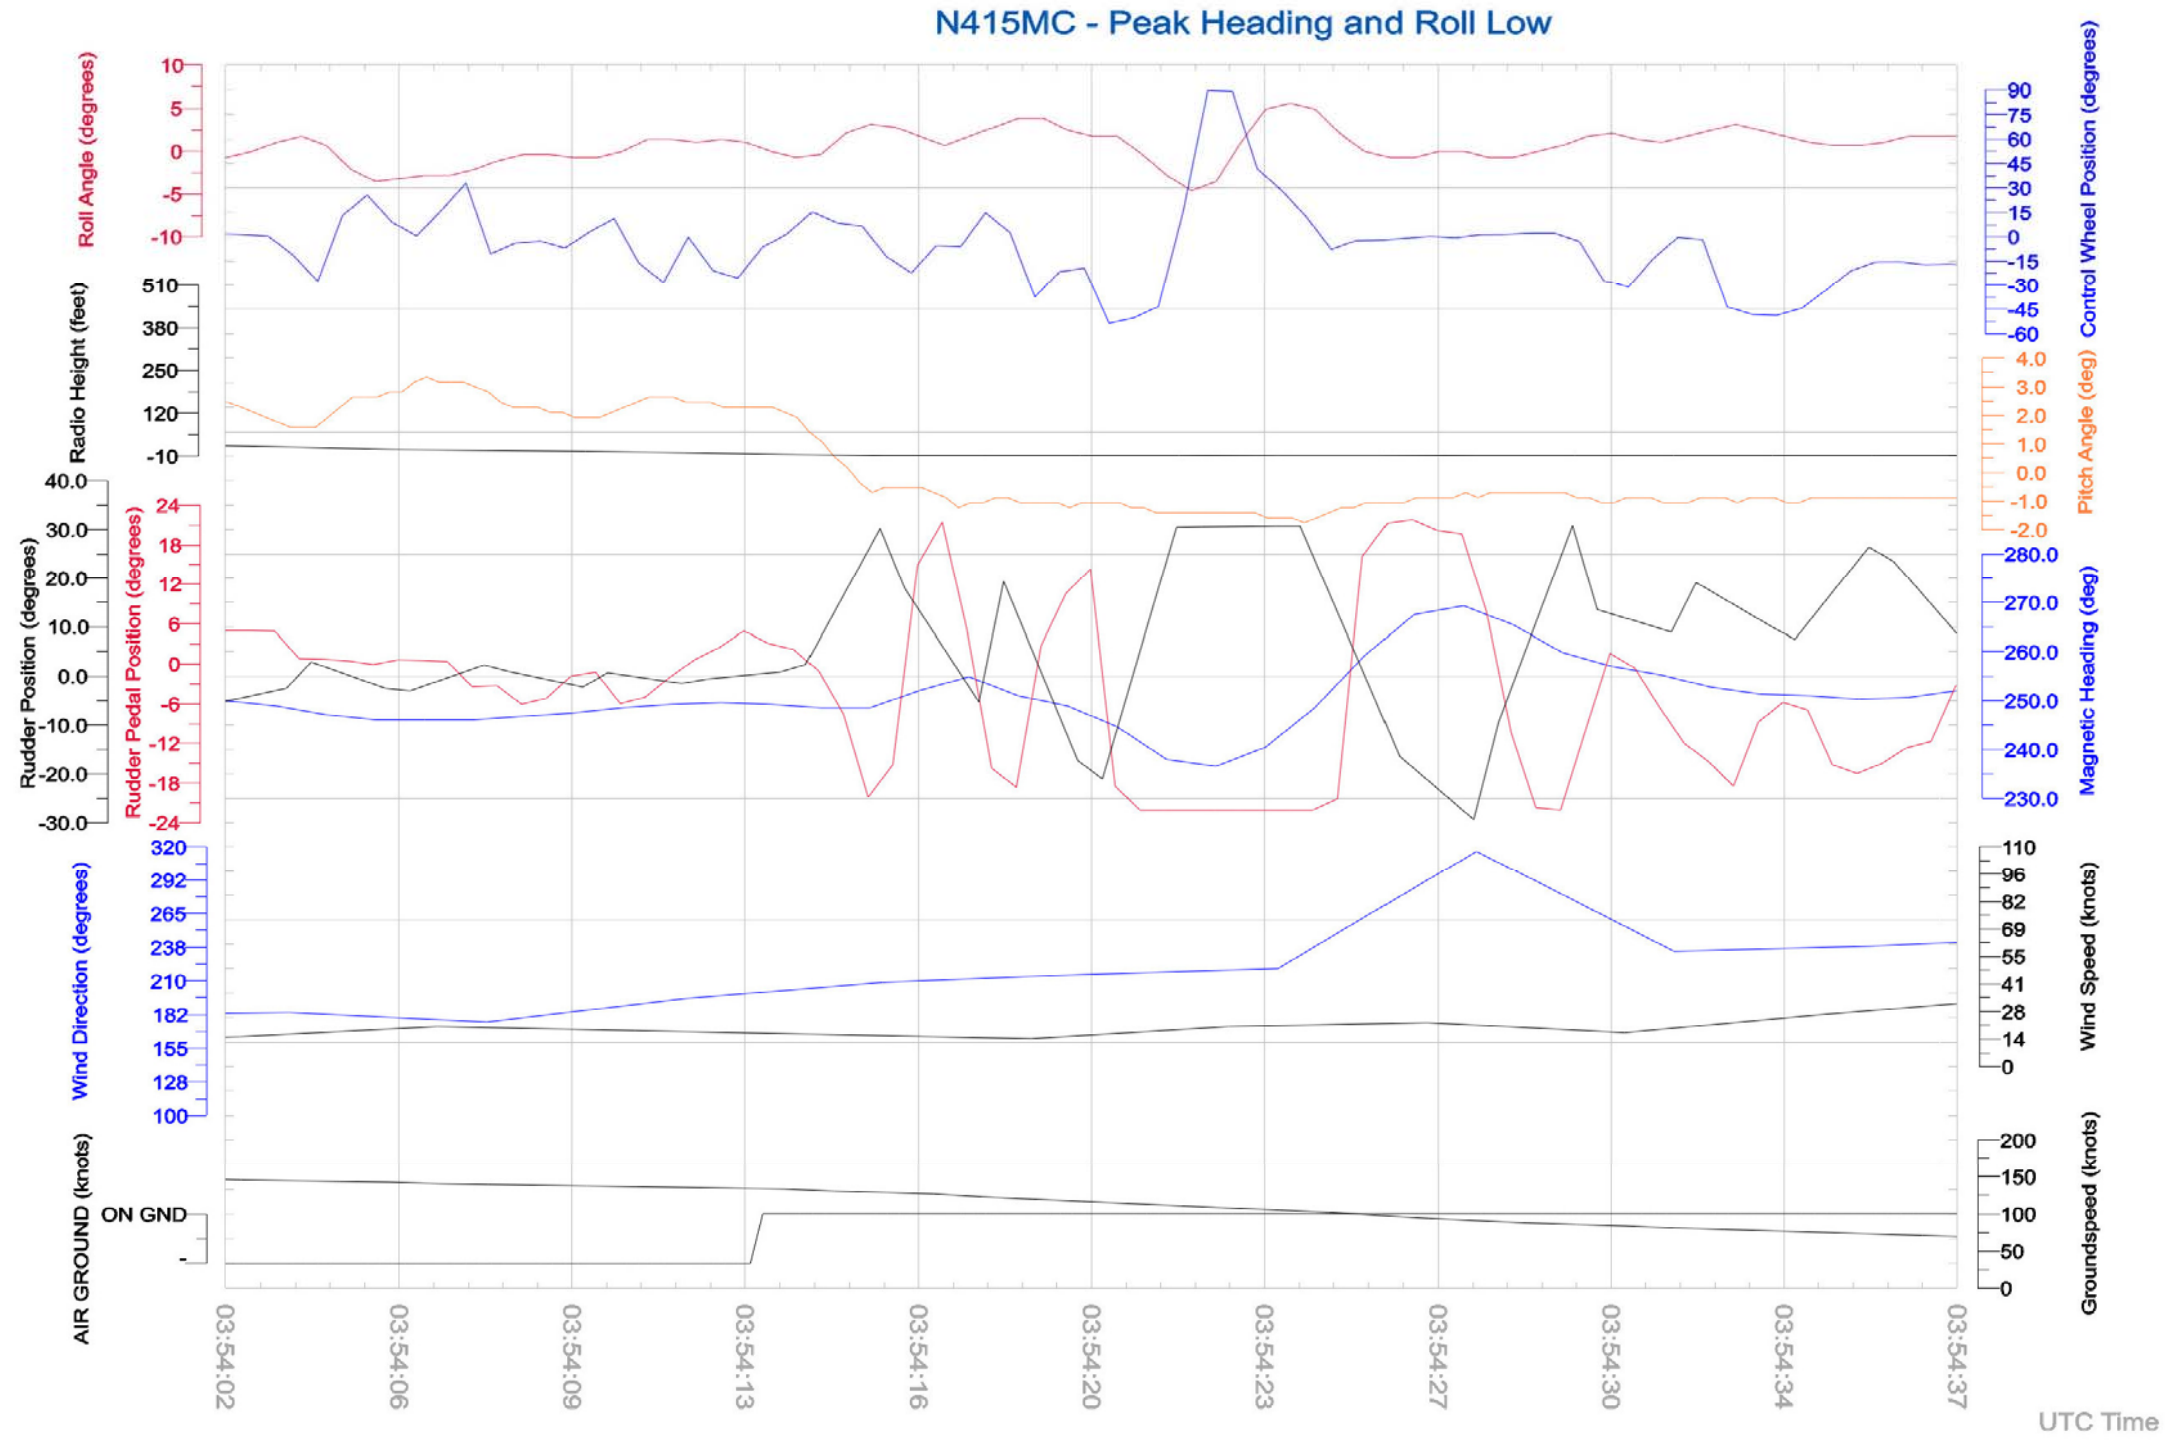
A time history of relevant FDR parameters for the final approach and landing roll is shown in Appendix 9.1. It can be seen that, up to about 10 seconds before touchdown, the recorded

wind direction was generally from the south (actual direction about 200°), with a wind speed that varied from about 17 to 20 knots.

The descent rate was maintained primarily at an average of around 900 feet/minute (fpm) until just prior to flare initiation, with a momentary excursion to 330 fpm and 1320 fpm at 450 feet radio altitude. The aircraft was crabbed (negative drift) into the left crosswind with an angle of about 7 degrees during the approach.

Figure 5: Flight Data Plot of Selected Parameters
