Aborted Takeoff on an Engaged Runway

Investigation Report

**Serious Incident to
Hong Kong Airlines Airbus A330-343,
B-LNU and Cathay Pacific Airways
Boeing 747-867F, B-LJK at
Hong Kong International Airport
23 December 2017**

03-2022

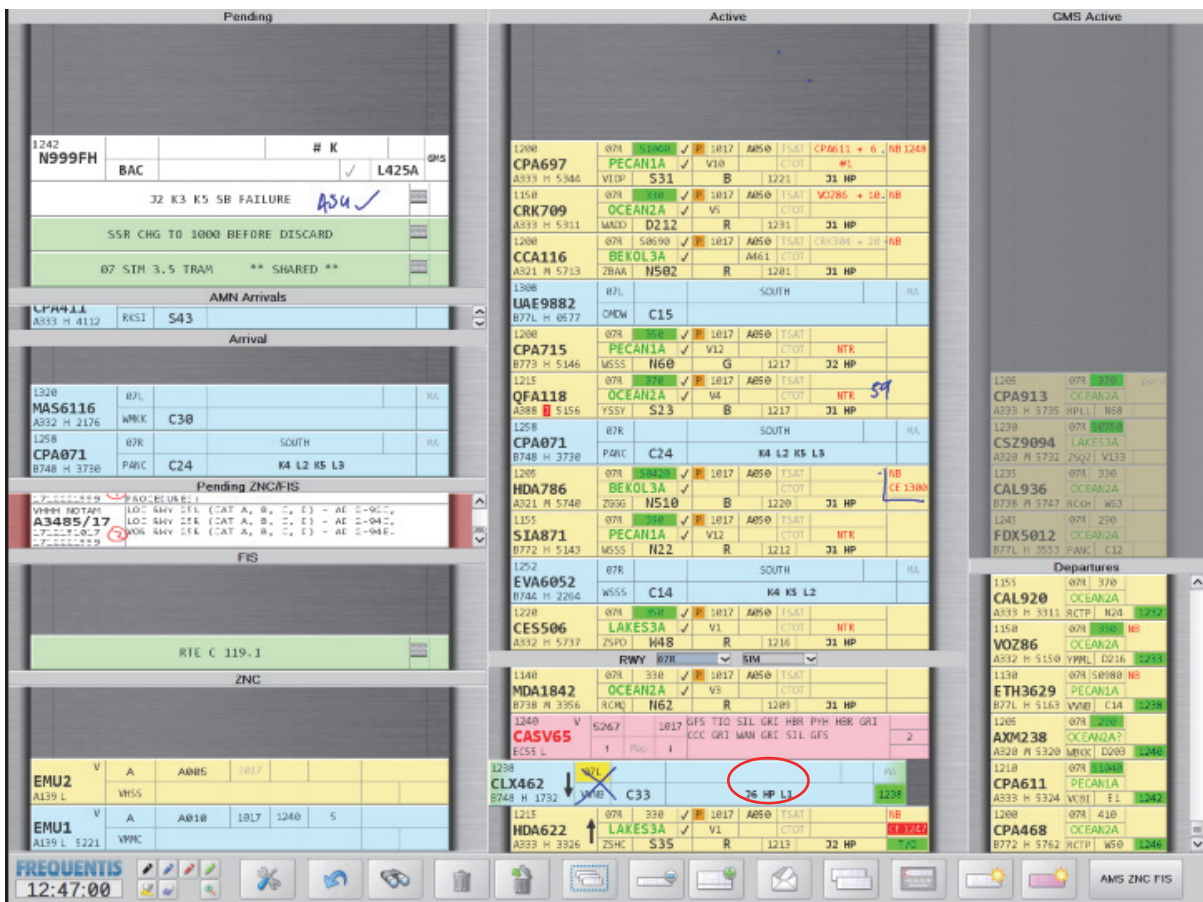
Figure 4 : AMS Electronic Flight Strip display board at 20:47 Local Time

HDA622 (bottom yellow EFS) was given take-off clearance.

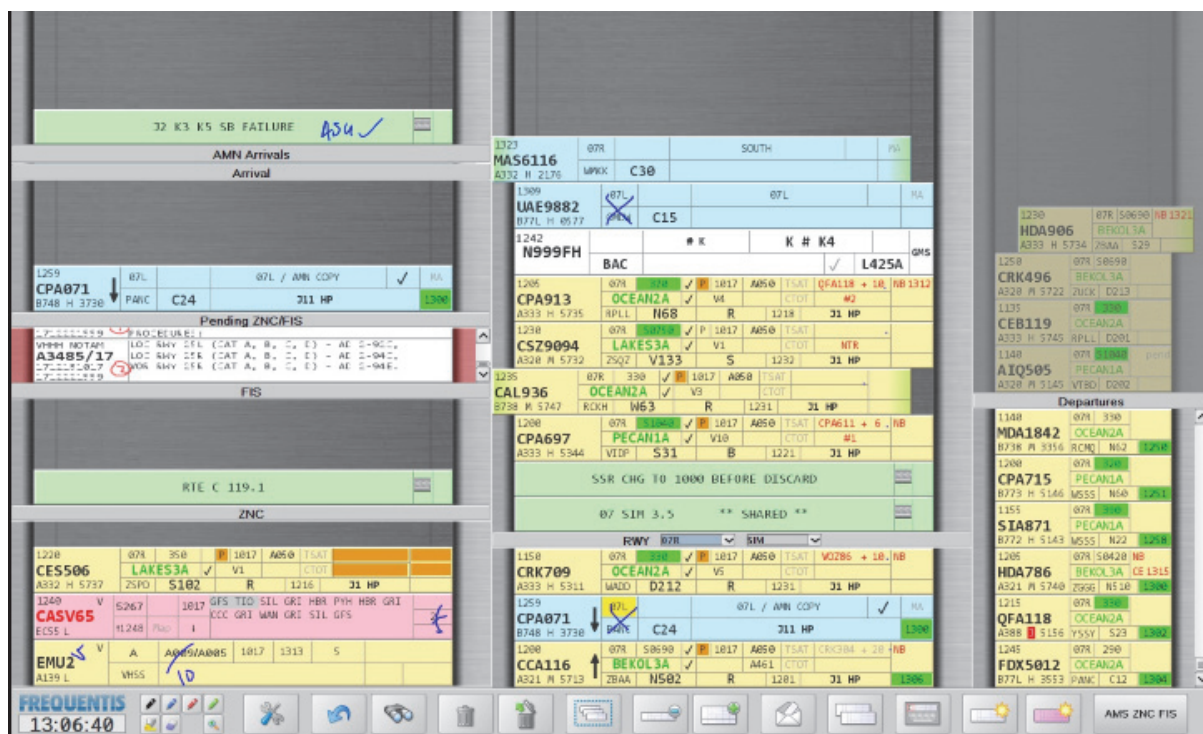
Figure 5 : AMS Electronic Flight Strip display board at 21:06:40 Local Time

- (2) The controller stated that he was not looking at the AMS EFS display board before issuing the take-off clearance to AC-DEP. Figure 5 is a screen capture illustrating the AMS EFS display board at 21:06:40, shortly after the controller gave runway crossing clearance to AC-CROSS. The EFS arrangement indicated that the plan of the controller was to cross AC-CROSS (CPA071) in between the first departure aircraft (CCA116) and the second departure aircraft (CRK709). By omitting to scan the EFS display board at a critical time, the controller lost the opportunity to acquire an up-to-date situational awareness.

CCA116 (bottom yellow EFS) had been cleared for take-off at 21:05. CPA071 (AC-CROSS) (blue EFS) was cleared to cross runway at 21:06:30. CRK709 (AC-DEP) (yellow EFS) would depart in sequence after CPA071 completed crossing the runway. CAL936 (AC-MED) (yellow EFS) was indented indicating 'sequence not confirmed'. (There was no red 'Runway Blocked' strip.)

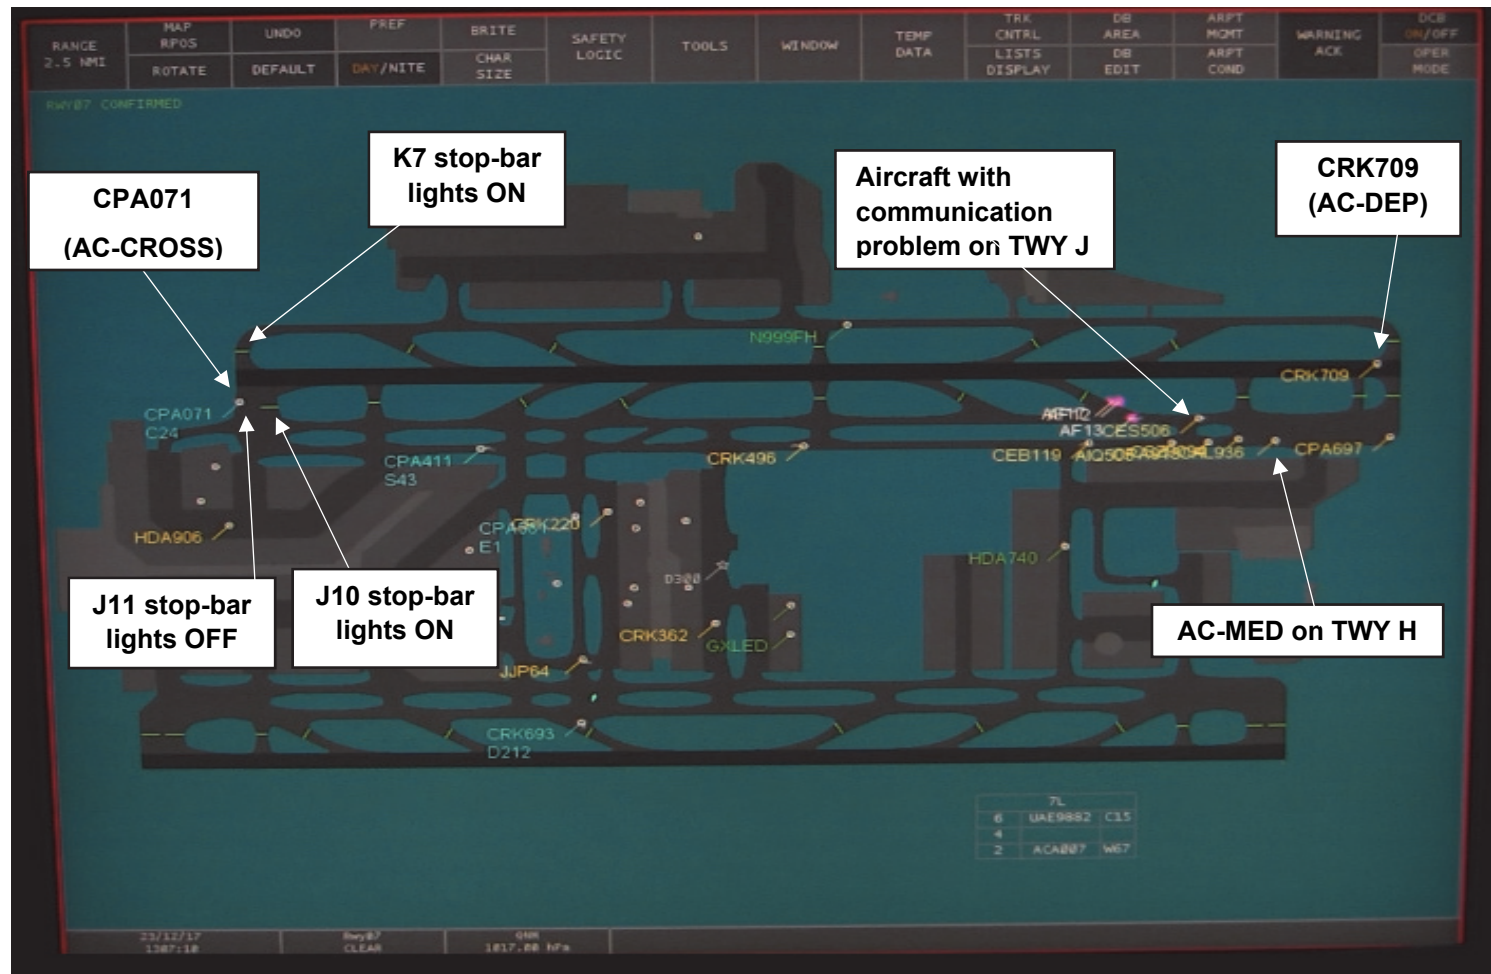
Figure 7 : AC-DEP (CRK709) on Runway 07R acknowledged take-off clearance at 21:07:10 Local Time. AC-CROSS (CPA071) had taxied past J11 holding point and J11 stop-bar lights had been switched off.

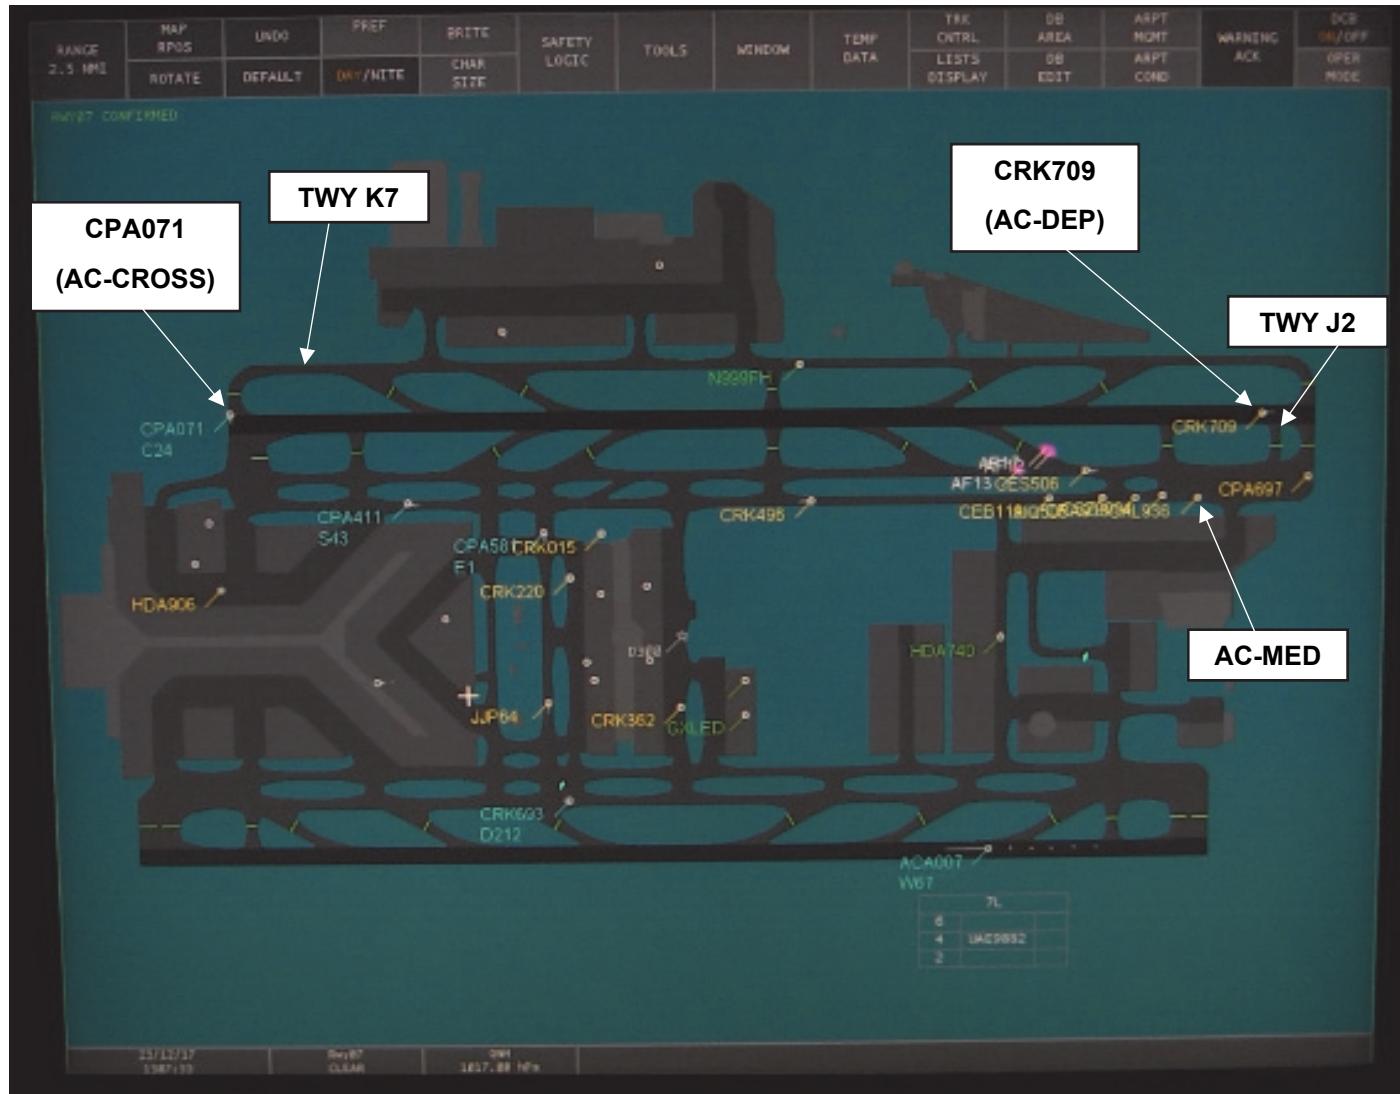
Figure 8 : AC-DEP (CRK709) reported stopping abeam TWY J2 at 21:07:33 Local Time. AC-CROSS (CPA071) was about to enter TWY K7.
