Incident Investigation Final Report

Airbus A330-343

Hong Kong International Airport,

1 February 2018

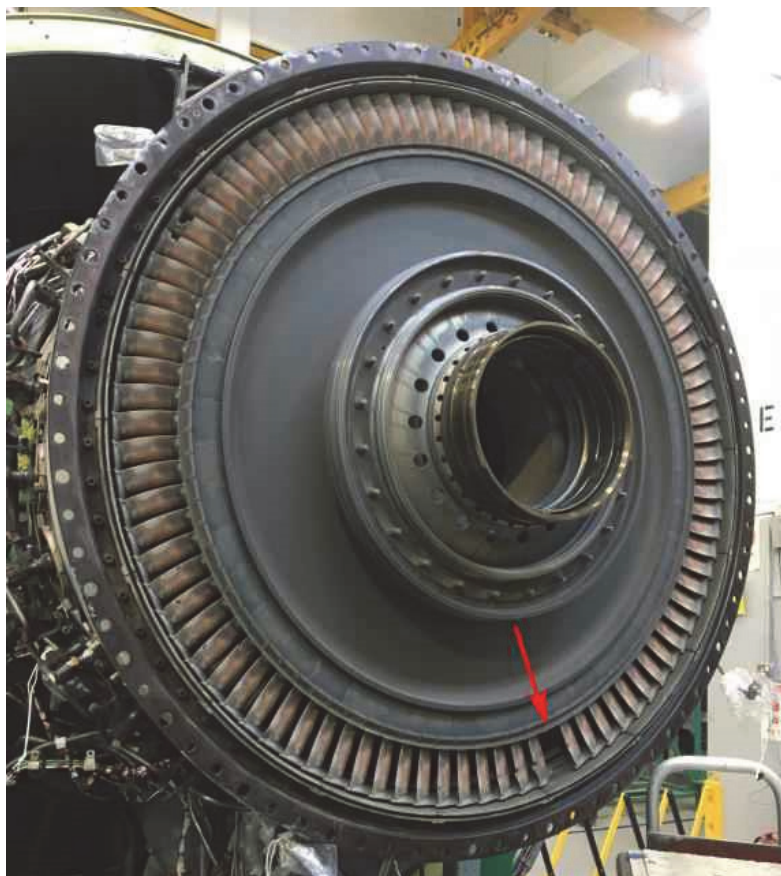
Photo 1: Rear Face of the HPT Rotor Assembly

The engine was stripped down at the engine manufacturer's local overhaul facility. The HPT blade at position 64 had fractured and been released in the aerofoil, just above the inner platform. The inner platform and root section was retained in the turbine disc. Impact damage was noted on other HPT blades, the whole set of IP turbine blades and some of the LP turbine blades. The whole set of HPT blades was sent back to the engine manufacturer for further analysis.

- (1) After engine strip-down, the HPT blade at position 64 was found fractured in the aerofoil, just above the inner platform. Only the inner platform and root section remained in the turbine disc.
- (2) The safety analysis will examine the flight operations, the details of the crack and its formation, the assessment against unsafe condition, risk reduction, and regulatory oversight.

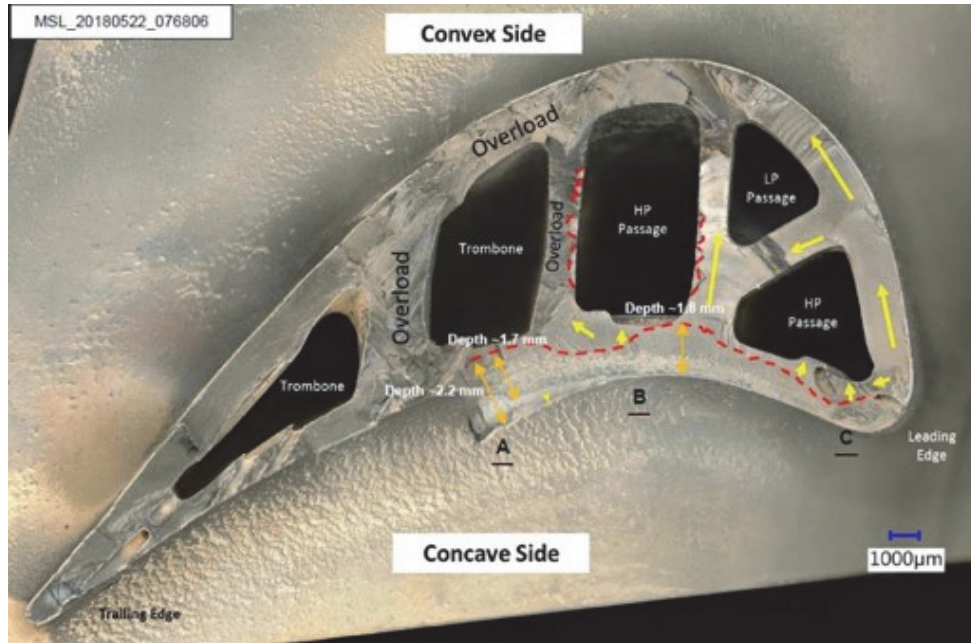
Photo 3: Close-up of the Fractured Blade

- (1) The fractured blade exhibited primary corrosion initiation from the exterior of the concave aerofoil which transited into High Cycle Fatigue (HCF) and incidental release of the blade. Energy-dispersive X-ray spectroscopy (EDX) analysis found Calcium-Sulphur rich layer on the exterior of the blade. Small levels of corrosion were also found in the internal passages.

- (2) The failure mode was corrosion cracks in the aerofoil exterior which transited into High Cycle Fatigue and incidental release of the blade. The primary corrosion initiation was considered to be from the concave aerofoil exterior. Sulphates stuck to the blade shank and melt at temperature resulting in chemical attack on the protective oxide on the blade surface. The crack propagation was chemically driven.
- (3) The corrosion was associated with Type 1 sulphidation as the temperature of the annulus gas blowing on the aerofoil surface was in the range of 800°C. The root shank pocket was more effectively cooled by HP 6 air and its operating temperature would be susceptible to Type 2 sulphidation.

The IFSD was due to HPT blade fracture caused by sulphidation corrosion and High Cycle Fatigue. [3.1 (6)]

To improve HPTB reliability, RR has developed a modified HPT blade by introducing a revised blade shank coating. The diffused platinum coating on the current standard of blade is being replaced with a pack aluminised coating to offer enhanced protection against oxidation and sulphidation. This design change will be introduced under Service Bulletin SB 72-K414. RR advised that the SB would be introduced later in 2021. This is one of the effective means of managing the risk.

- (2) After RR issued alert NMSB RB.211-72-AK165, which was mandated by EASA AD 2018-0291, the schedule for HPT blades replacement has been reduced to 5,800 FC based on RR's data analysis. This is one of the effective means of managing the risk.
- (3) The design change mentioned in 2.5.1 will be the terminating action for the life limitations on Group 2 blades of this NMSB.
