Runway Excursion (RE)

Investigation Report

**Serious Incident to
Airbus A321-211, B-6366
Hong Kong International Airport
Hong Kong
24 May 2017**

04-2022

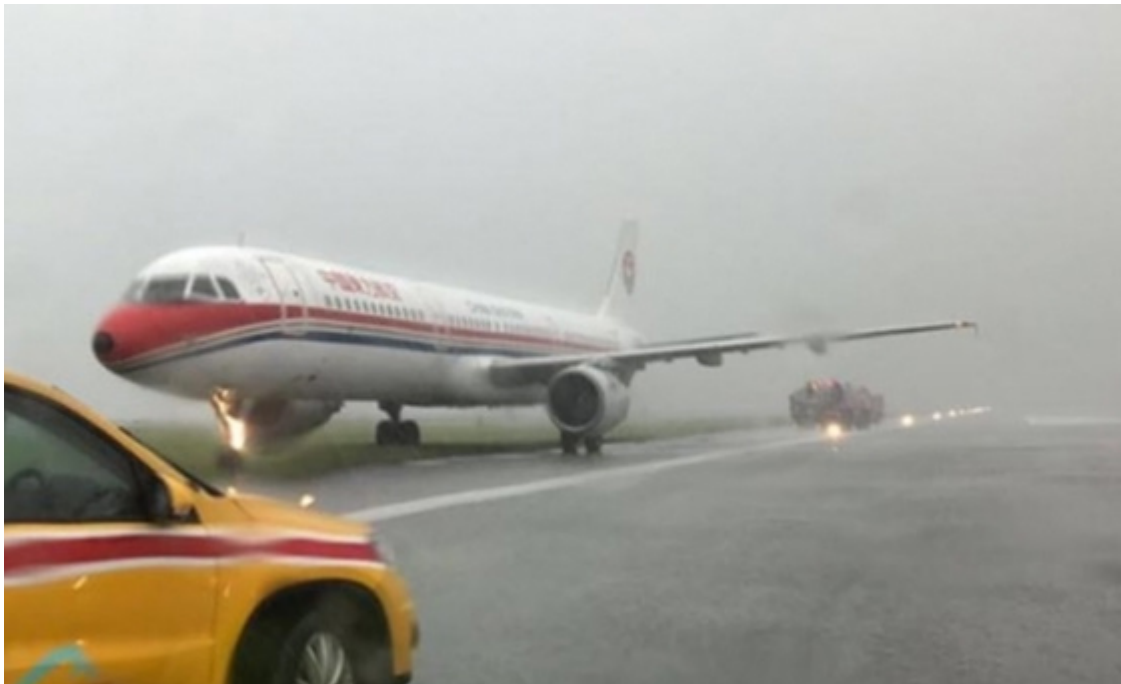
Photo 1: Aircraft Position after the Excursion

- (3) On noting that CES765 did not exit the runway at Rapid Exit Taxiways (RET)¹ A6 and A5 after touchdown, ATC instructed it to vacate via Taxiway (TWY) A4 which was another RET. However, the aircraft also missed TWY A4 and veered off the runway centreline to the grass area on the right-hand side of the runway. The aircraft eventually stopped with its nose wheel and right-hand main landing gear (MLG) resting on the grass area

slightly beyond the northern runway edge between TWYs A4 and A3 at about 1051 hrs (see Figure 2).

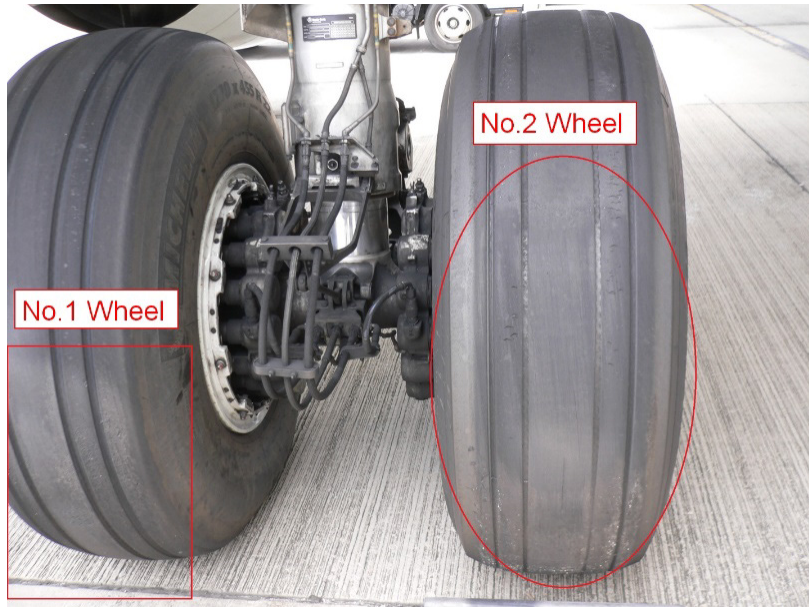
Photo 3: Damage on Left MLG Tyres

- (2) Heavy abrasion and significant longitudinal scratches were found on their tread ribs. The left MLG tyres had evidence of skid damage and rubber reversion. The sidewalls of the right MLG tyres showed foreign object damage. Further details are in paragraph 2.6.2.

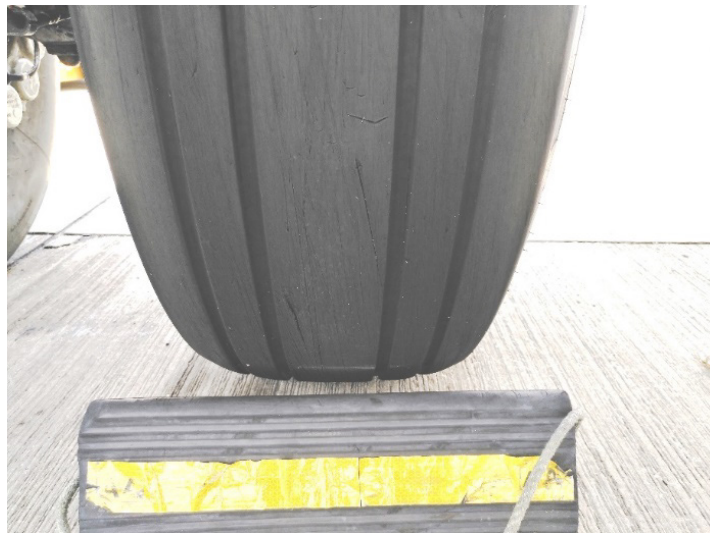
Photo 4: Significant Longitudinal Scratch Marks on No. 3 Tyre

- (4) The damage on the No.3 tyre and the No.4 tyre was similar. The tread of two tyres showed a pattern of abrasion, and signs of less obvious rubber reversion, heavy abrasion, significant scuffing with longitudinal scratches, and heavy braking (see Figures 23 and 24). There was heavy chevron cutting on the centre tread rib around the most of the circumference. The chevron cutting in some areas was deep. Damage was found on both sides of the sidewall but did not extend to the casing plies. The damage was probably caused by foreign objects in the grass area.

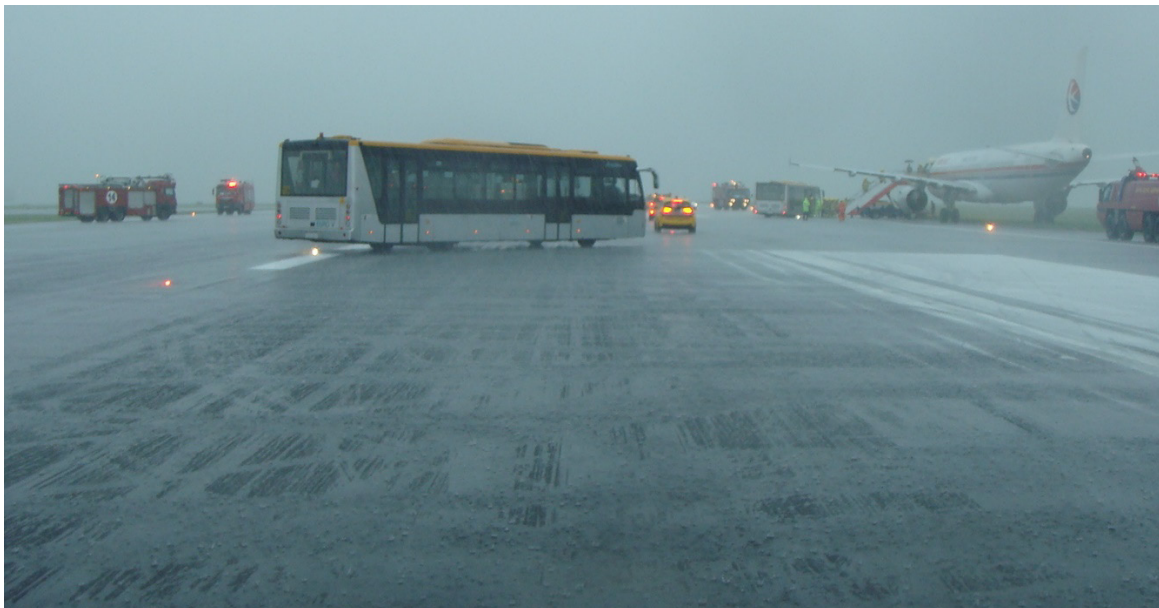
Photo 8: Water Accumulated in the Vicinity of the Aircraft Last Position

The photos taken during the rescue phase shortly after the incident, such as Photos 8 and 9, showed noticeable water on the runway in the vicinity of the last position of the aircraft. Photo 8 showed the reverse angle of Photo 9.

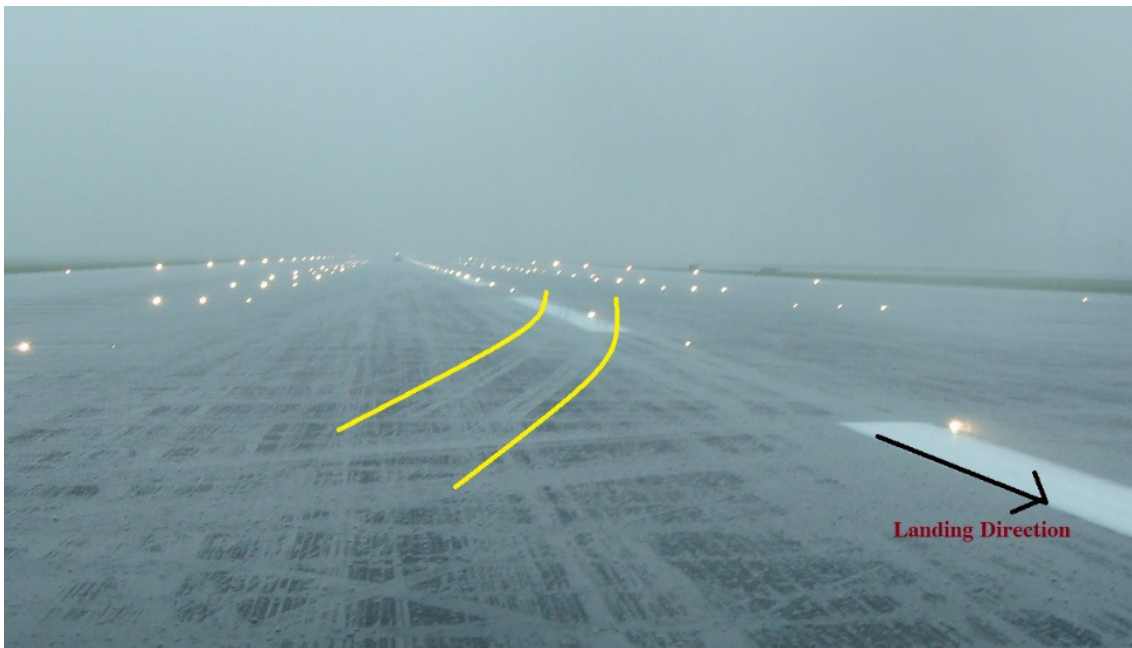
Photo 9: Aircraft Tyre Marks of Deviation from the Runway Centreline

Tyre tracks could be traced from the aircraft back along the runway indicating that the aircraft started to skid to the right side before reaching the 1 500 ft touchdown marking for RWY 07L.

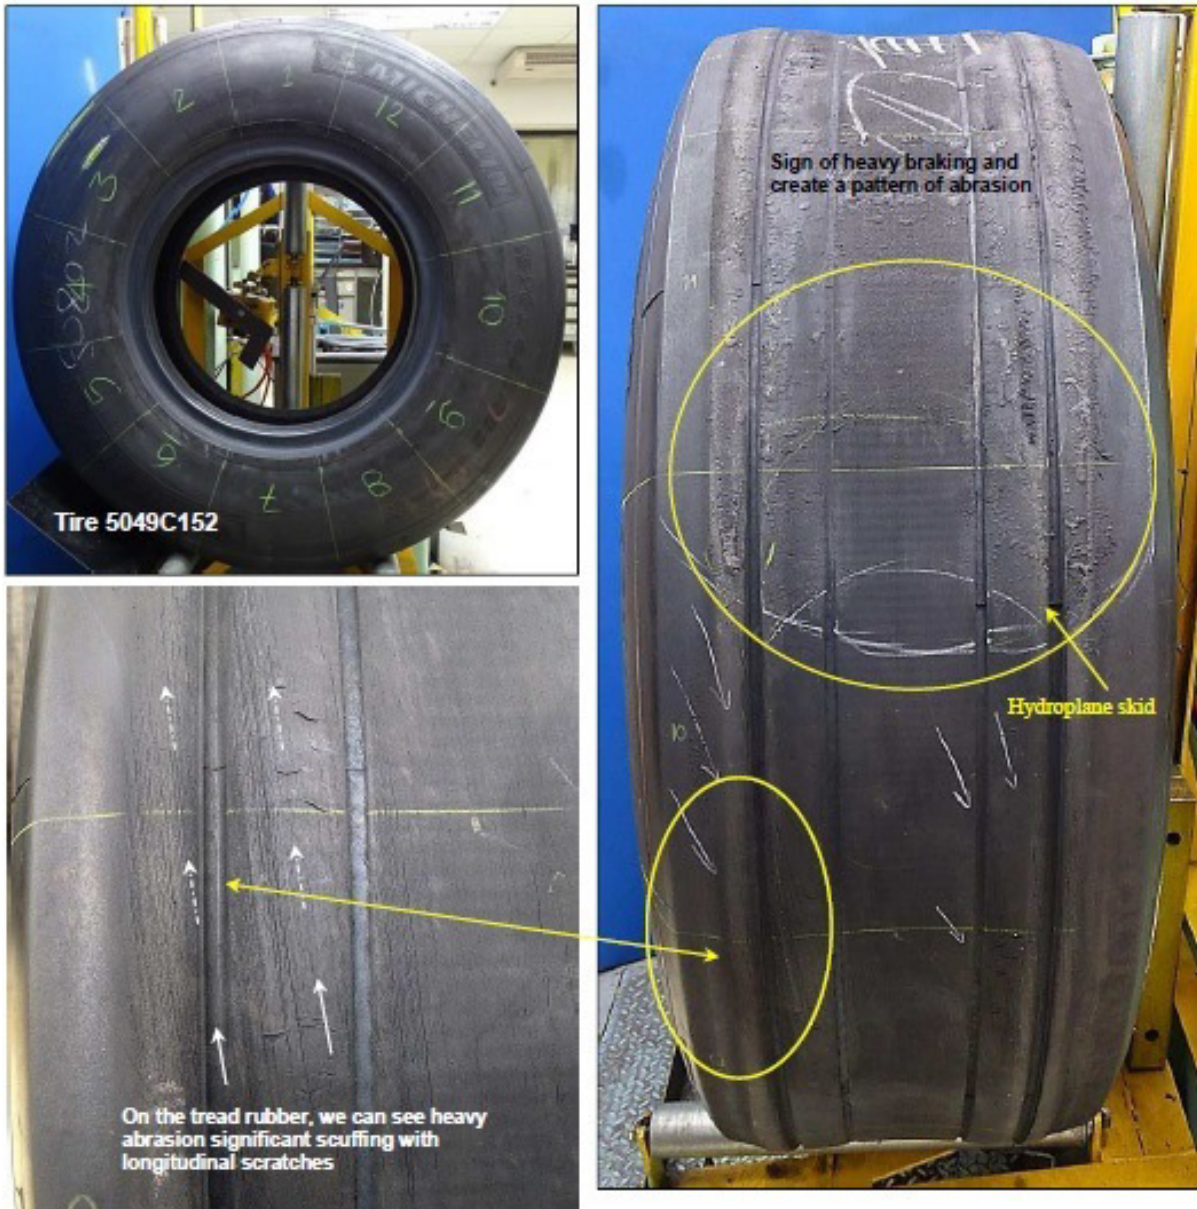
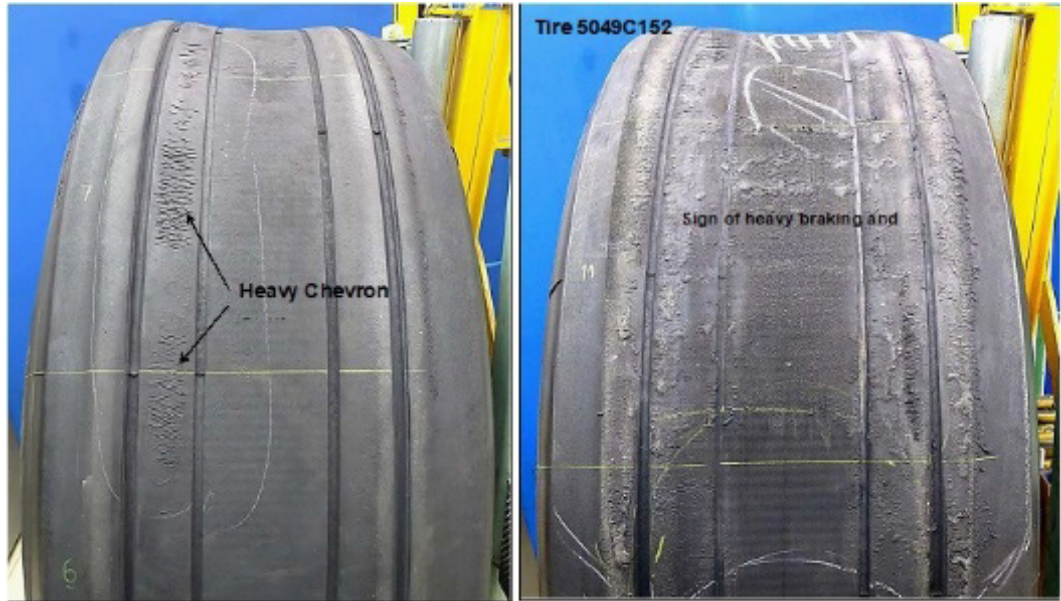
Figure 21: Damage on No.2 Tyre

- (3) The No.2 tyre worn on the centre and the shoulder of the tread. Similar single hydroplane skid burn and rubber reversion were found on the tread (see Figure 21). Sign of heavy braking and a pattern of abrasion were found on the tread centre in one of the sectors (see Figure 22). There were heavy chevron cutting on the centre tread rib around the most of the circumference. Heavy abrasion and significant scuffing with longitudinal scratches were also found on the tread rubber.
