# **Abnormal Runway Contact (ARC)**

## **Accident Investigation Final Report**

**Boeing 777-333ER, C-FITW,  
Hong Kong International Airport,  
Hong Kong  
11 December 2018**

**05-2021**

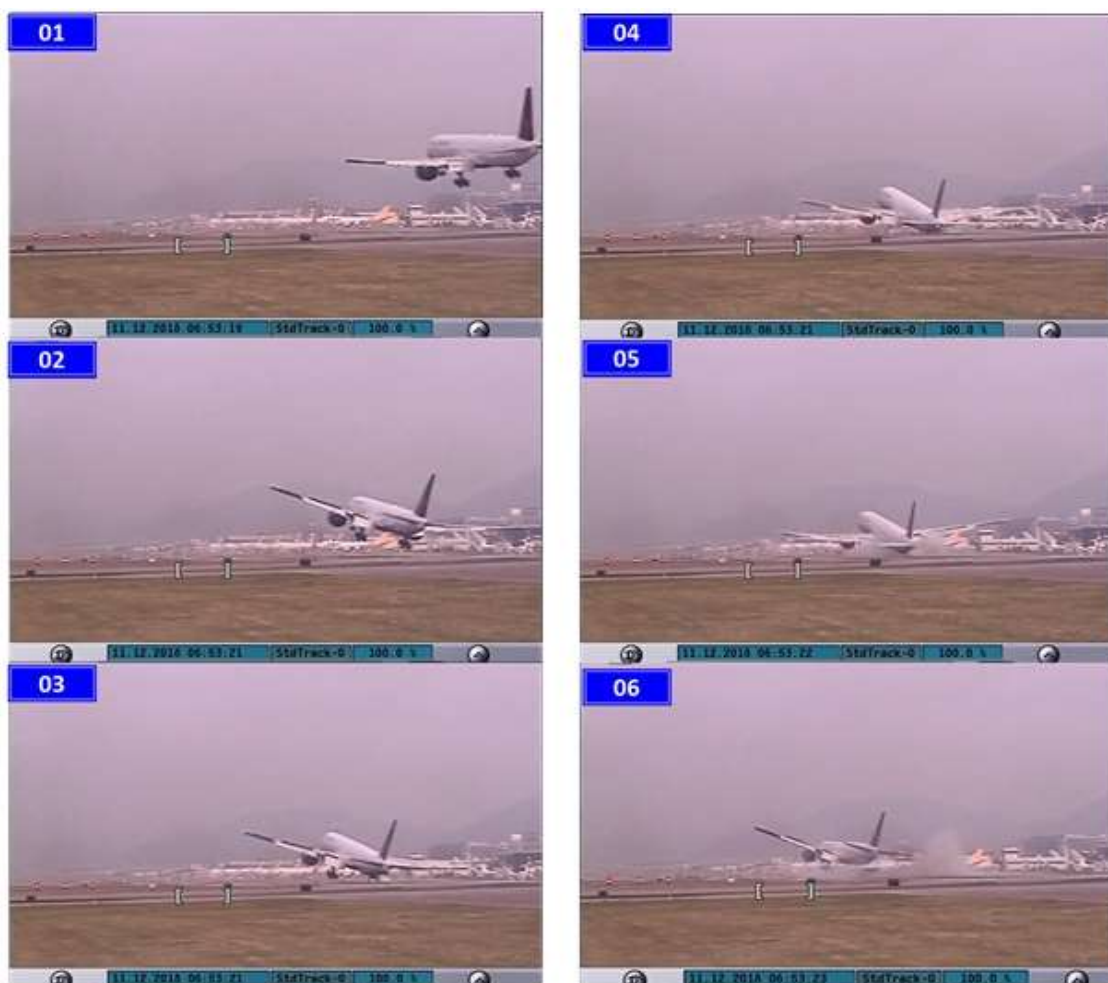
**Photo 1: Last Stage of the Approach and Runway Contact**

landing with the right main landing gear contacting the runway followed by the left main gear while the aft lower fuselage contacted the runway surface. The aircraft bounced with the right-hand main landing gear contacting the runway first. The aircraft bounced again, landing on the nose gear followed by both main gears.

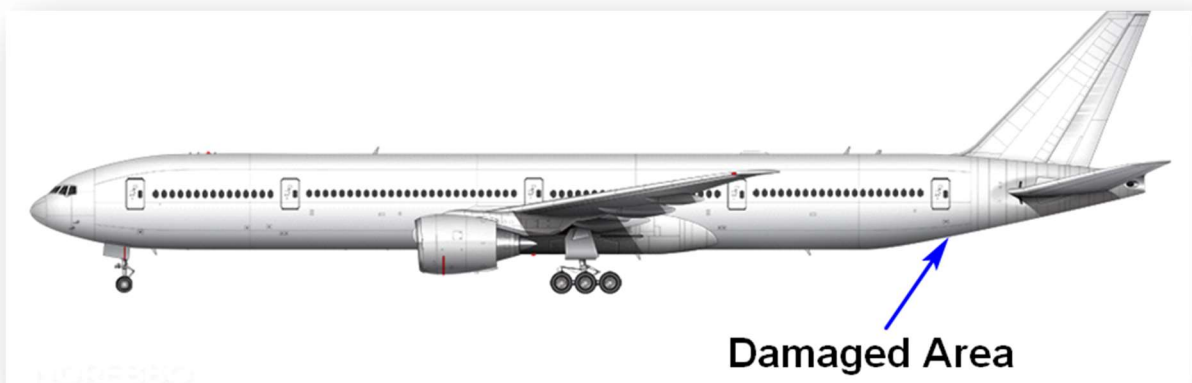
**Figure 1: Lower Fuselage Damaged Area**

- (1) Subsequent inspection of the underside of the rear fuselage indicated the aircraft sustained damage to the rear lower fuselage requiring major repair or replacement of the affected components. The aircraft was declared unserviceable and underwent a major repair process to rectify the lower fuselage damage prior to a return to operational service.
- (2) The aircraft rear aft fuselage sustained significant impact damage to the aft fuselage and various internal structural deformation. This model was fitted with a tail skid which assisted in absorbing the impact.

A damage assessment survey was conducted by the aircraft manufacturer. A comprehensive damage assessment report detailed the structural repair and modification requirements.

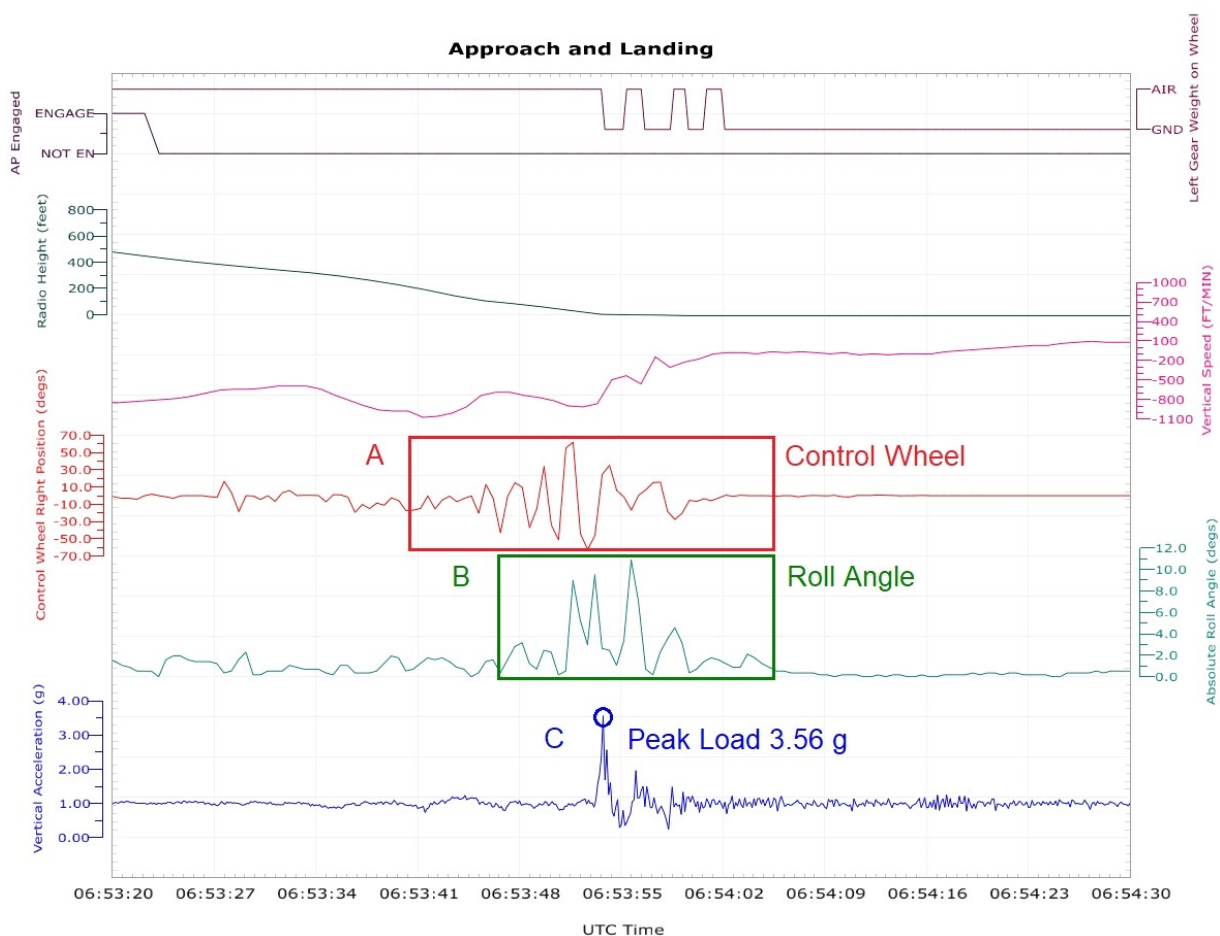
Figure 4: Flight Data Recorder Parameters

The data obtained from the Digital Flight Data Recorder was analysed for the last stage of the approach and runway contact. The aircraft had become slightly high above the glideslope but overall the approach was stable until the oscillations commenced.

- (1) Area “B” demonstrates the onset and continuation of the roll condition and PIO. The aileron inputs produce excessive roll rates which leads to the PF overcorrecting as they increase in magnitude.
- (2) The oscillation increases resulting in a roll angle on touchdown of 10° right.
