Air Accident Investigation Authority

Investigation Report

**Accident to Ozone Buzz Z5 Paraglider,
Shek O, Hong Kong**

05-2022

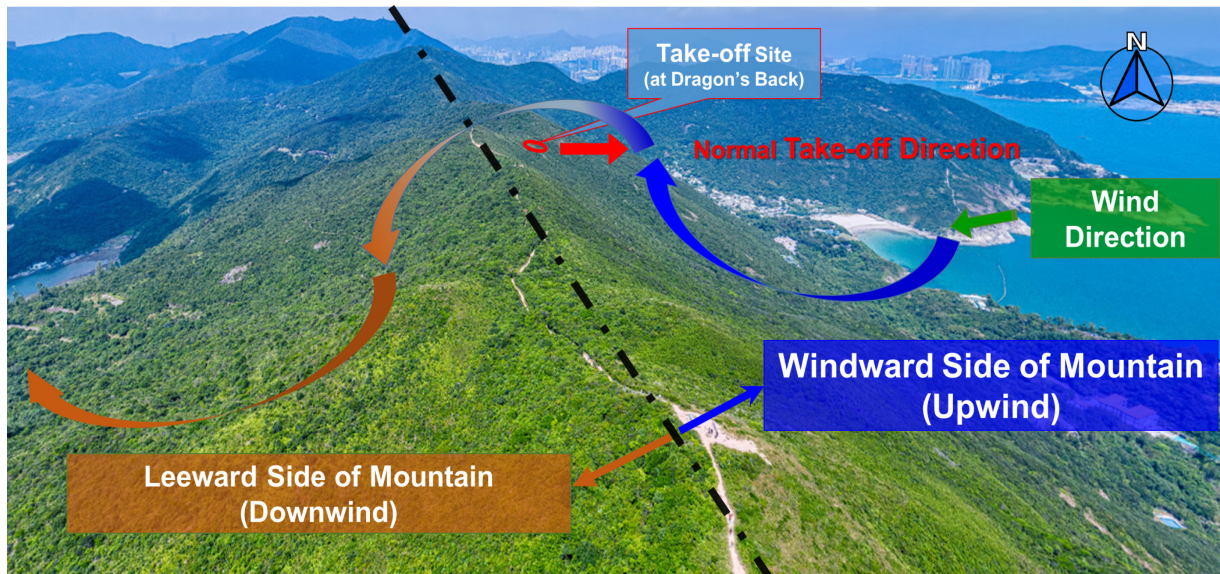
Figure 2: Leeward Side of Dragon's Back

- (4) He immediately turned 180 degrees, and moved his upper body facing the normal take-off direction, but he could not make the paraglider move forward. The paraglider continued to move backward and flew into the leeward side of the mountain.

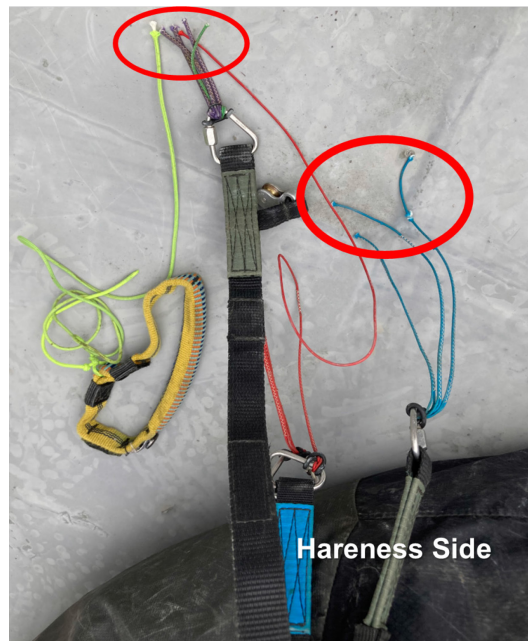
Figure 24: Lines Connecting Canopy and Harness

- (1) The paragliding canopy, Model “Ozone Buzz Z5”, and the harness, Model “Advance Progress 3”, were examined and found in good shape.
- (2) All lines connecting the canopy to the harness were cut during the rescue operation.

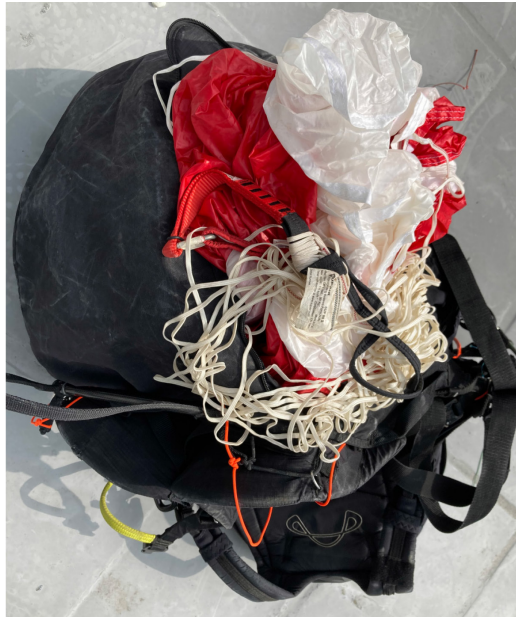
Figure 25: Paragliding Reserve Parachute in Harness

- (1) The paragliding reserve parachute, Model “Sup’air Sup 08” of S size, was intact inside the reserve compartment of the harness.
- (2) The investigation team removed the reserve parachute from the reserve compartment for inspection and did not identify any abnormal findings.

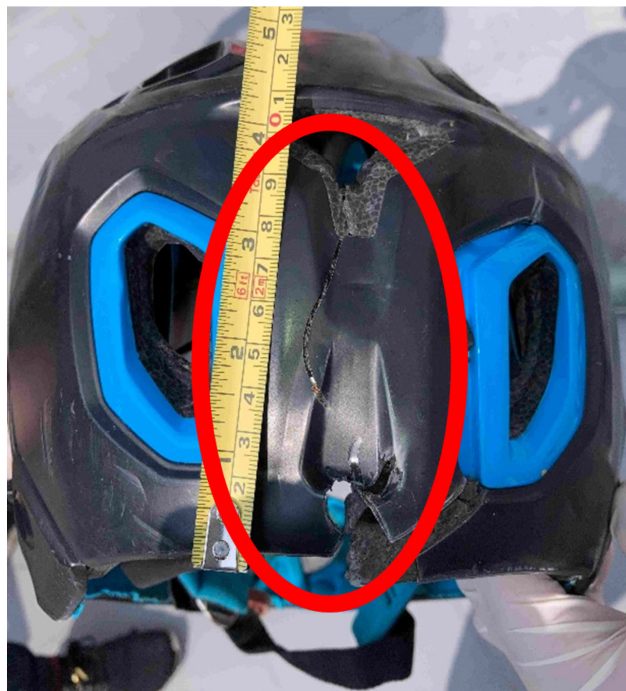
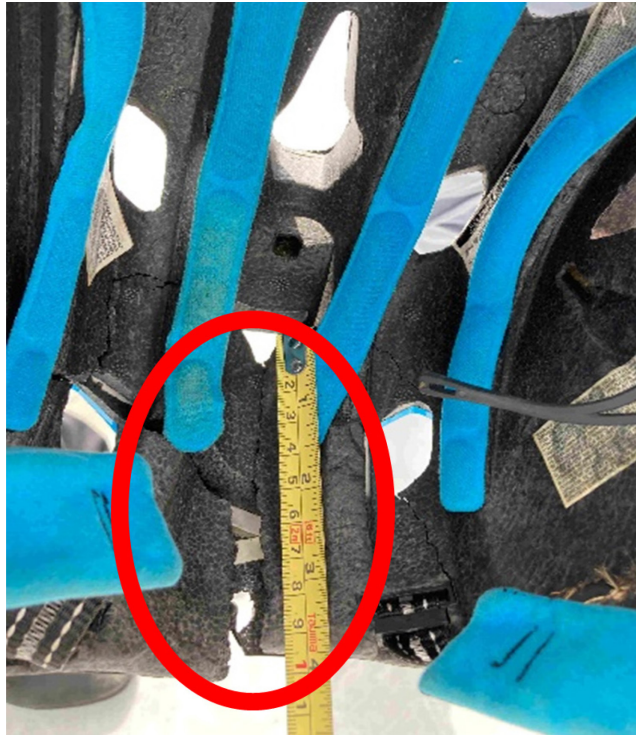
Figure 29: Damage on the Backside of the Helmet (Outer View)

- (4) The examination identified damages on the backside of the helmet, including a crack of 9 cm long in the middle of the backside, and a crack of 14 cm long propagated from the backside to the right-hand side.

- (8) The cause of death as shown by the autopsy appears to be traumatic compression of the cervical spinal cord due to neck injury. (1.13) (2.5.1)
- (9) The helmet of the Pilot was neither designed nor certified for paragliding. (1.15.1) (2.5.2.1)

It is recommended that the CAD coordinates with the paragliding organisations:

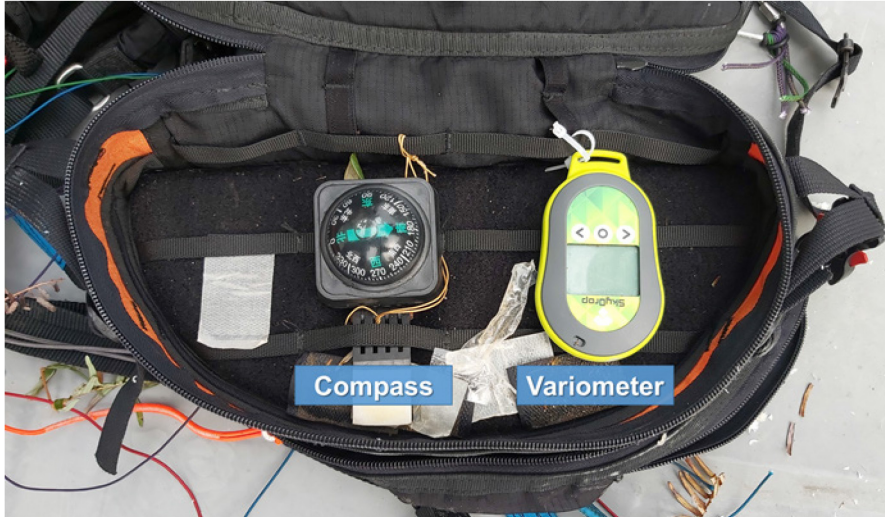
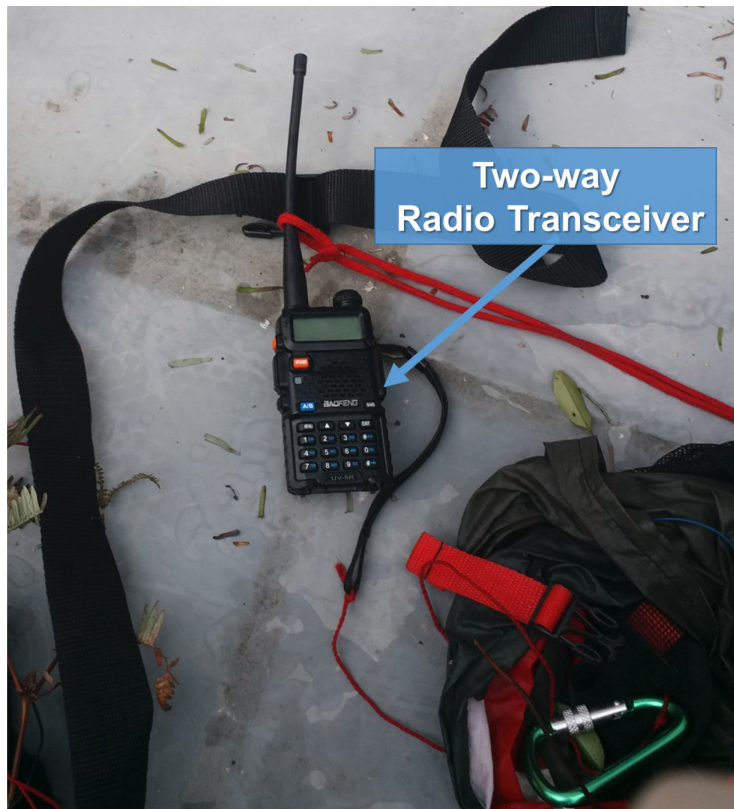
- (2) During the wreckage examination on 3 January 2022, the compass, the variometer and the radio transceiver were inspected and no damage was identified.

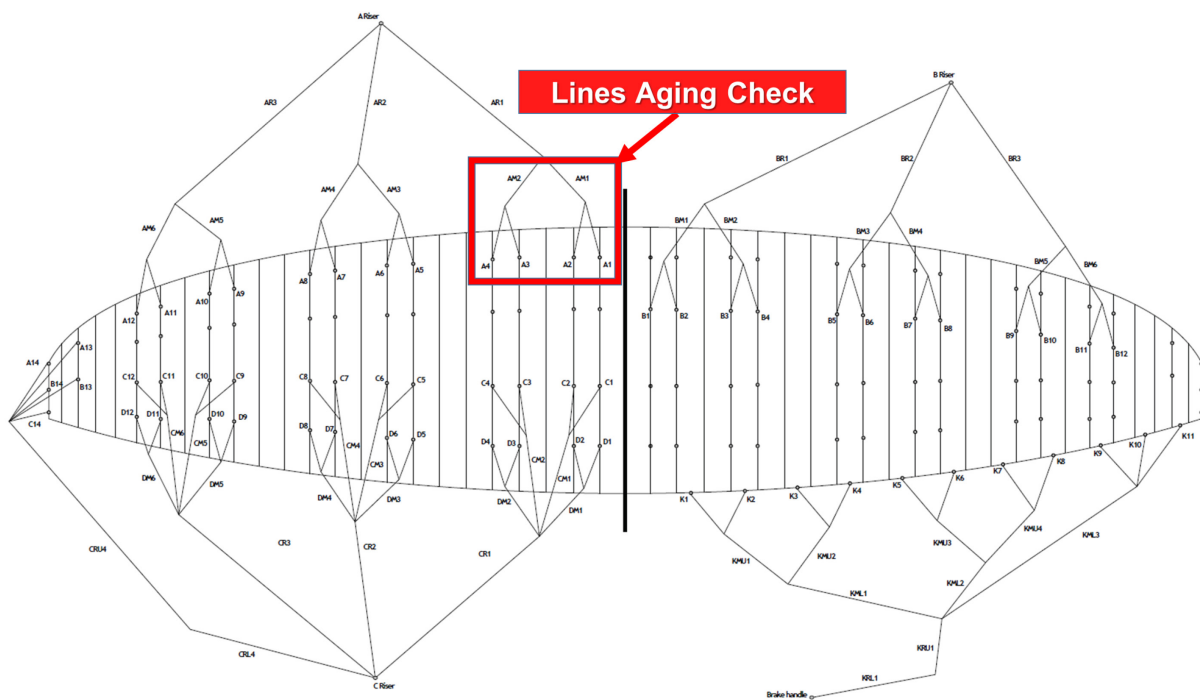
Figure 34: Lines Aging Check at the Upper “A Gallery”

- (1) An aging check of paraglider lines was carried out with the assistance of HKPA Safety Officer on the upper “A gallery”. The difference between the manufacturer’s length and the calibrated measurement should not be greater than 10 mm.
- (2) The check revealed that the differences of the four “A gallery” lines were all less than 10 mm. There was no sign of significant aging or wear observed on the paraglider lines.

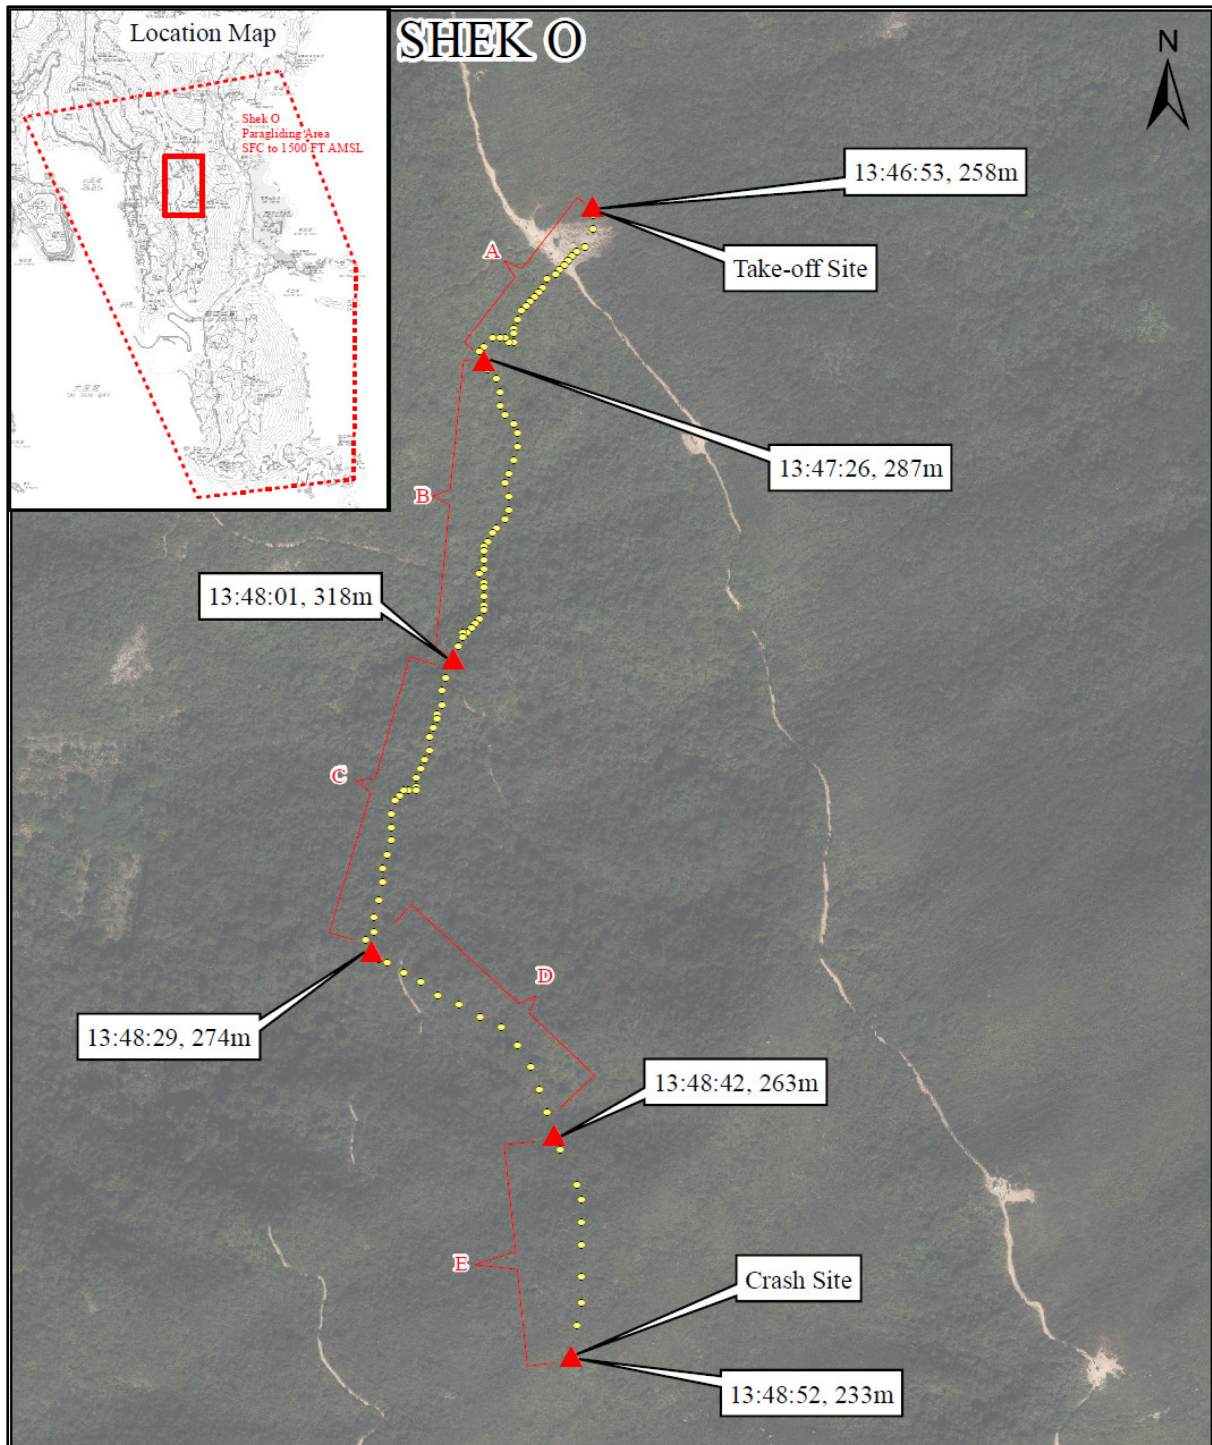
Figure 36: Reconstruction of the Accident Flight Path

- (1) The flight path was reconstructed based on the data in the IGC file and has been divided into five sections (A to E) for analysis. The flight path was within the Shek O paragliding area defined in the AIP HK published by the CAD.
