# **Collision with Obstacle During Landing**

## **Investigation Report**

**Serious Incident to  
Geronimo<sup>2</sup> M-27 Paraglider  
Sai Kung, Hong Kong  
28 April 2020**

**06-2022**

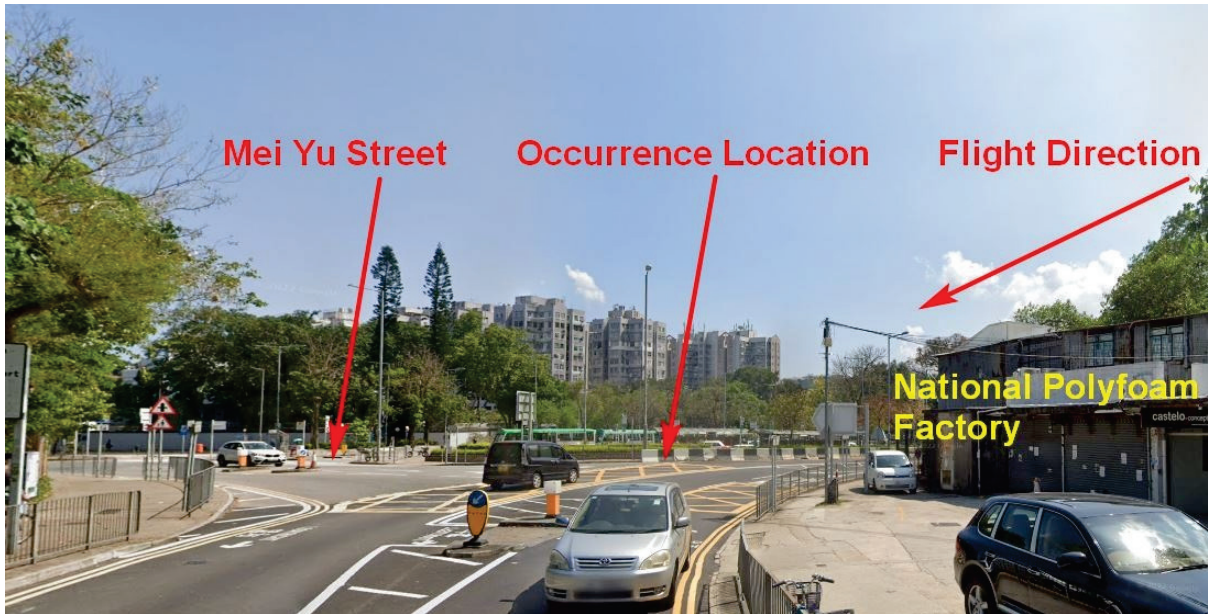
**Figure 3: Junction at Mei Yu Street**

- (7) He could not identify suitable landing area in the vicinity of the SKM village area whilst he kept gliding down in the south-east direction. He was getting closer to the ground and flying over the roof of the National Polyfoam Factory (see Figure 3). He tried to avoid hitting the roof of the factory and therefore headed towards the junction of Tai Mong Tsai Road and Mei Yu Street.

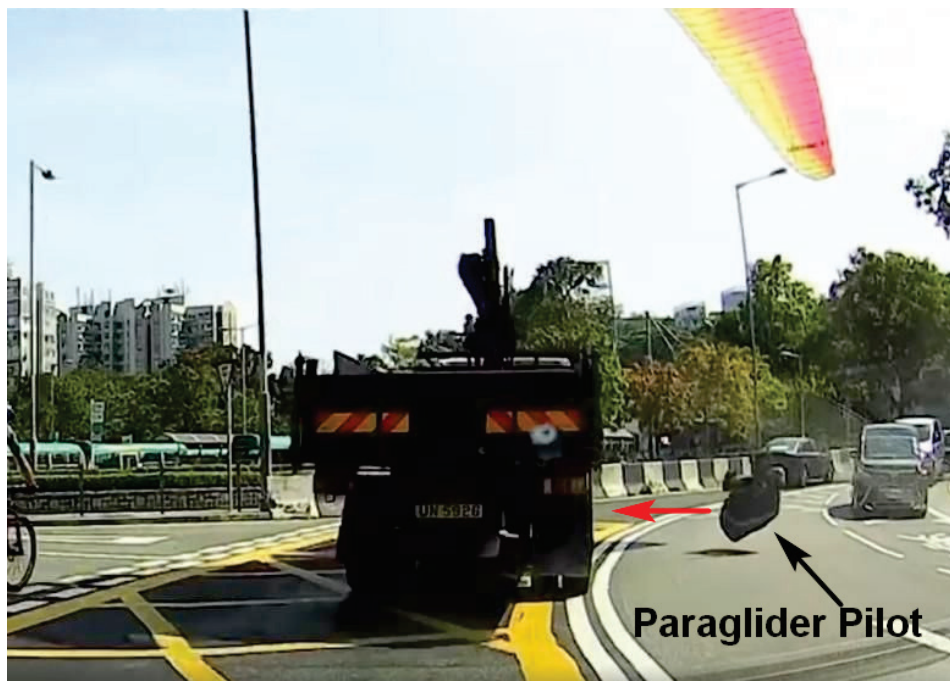
**Figure 4: Paraglider Collided with the Lorry**

- (8) He eventually collided with the right front part of a lorry moving southbound at the junction of Tai Mong Tsai Road and Mei Yu Street, which is about 626 metres south-east of the planned landing area at SKM (Figure 4). The lorry driver was able to stop the lorry immediately after the impact by the paraglider.

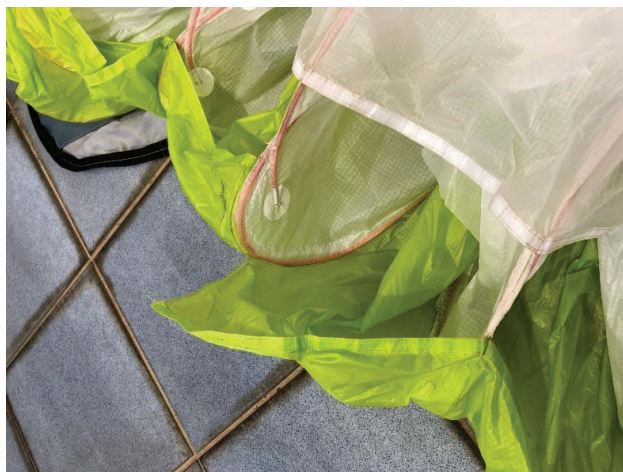
**Figure 5: Damaged Canopy Leading Edge Cell Opening**

One canopy leading edge cell opening was damaged.

- (9) One canopy leading edge cell opening was damaged, probably during its impact with the lorry or when the canopy was pulled to separate from the lorry after the crash.

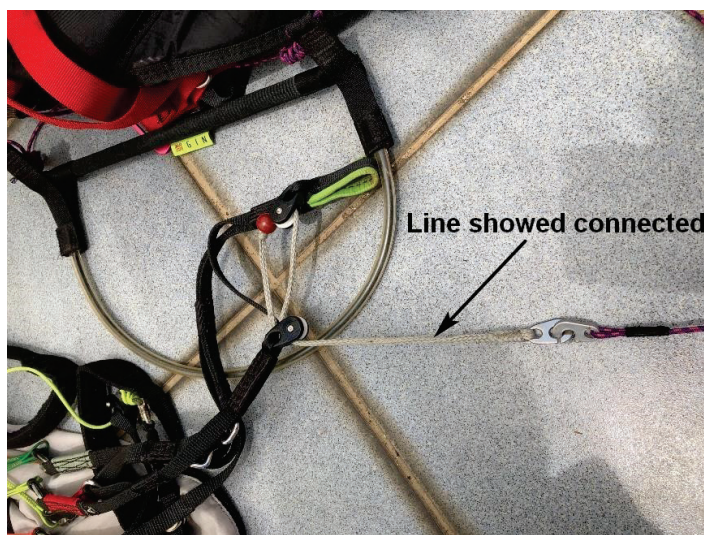
**Figure 6: Line Connection of the Speed Bar (for Reference)**

- (5) The Pilot had conducted a pre-flight check of his paraglider and harness package prior to the second flight, but he was unable to discover the

disconnection of the LH line of the speed bar. Paraglider pilots should strictly follow the general guidance on pre-flight check on equipment published by the CAD to ensure flight safety.
