Investigation Report

**Accident to Cessna 152, B-HHN
Sam Pui Chau, New Territories,
Hong Kong
26 February 2017**

07-2022

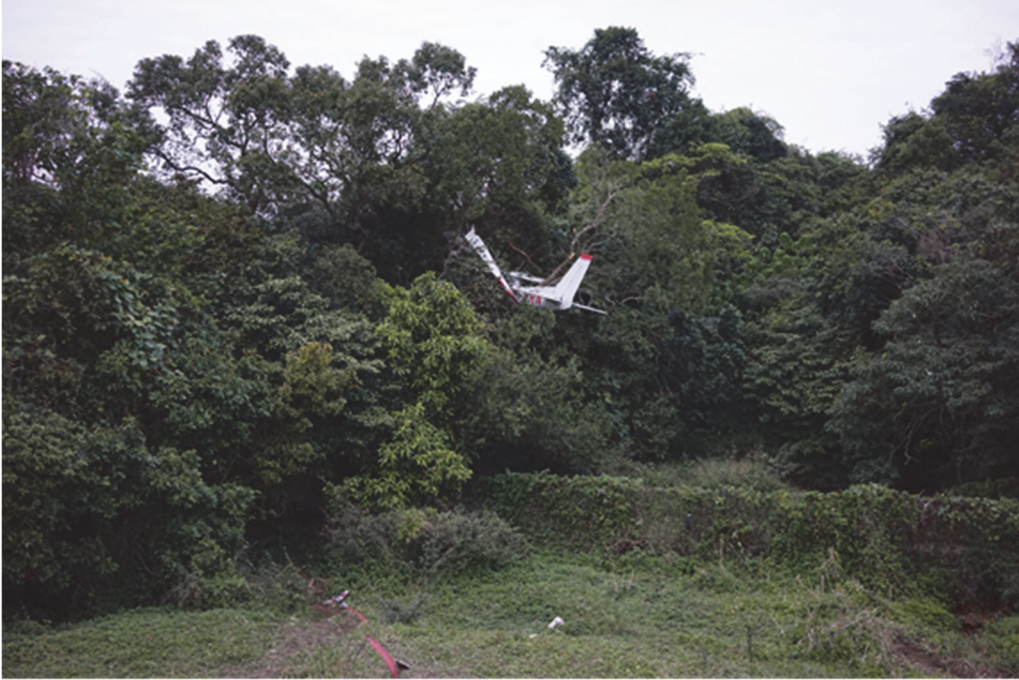
Photo 1: Aircraft Location (Ground View)

The aircraft was in the tree line and the outboard section of the left wing had separated from the fuselage with the main aircraft assembly embedded into the trees.

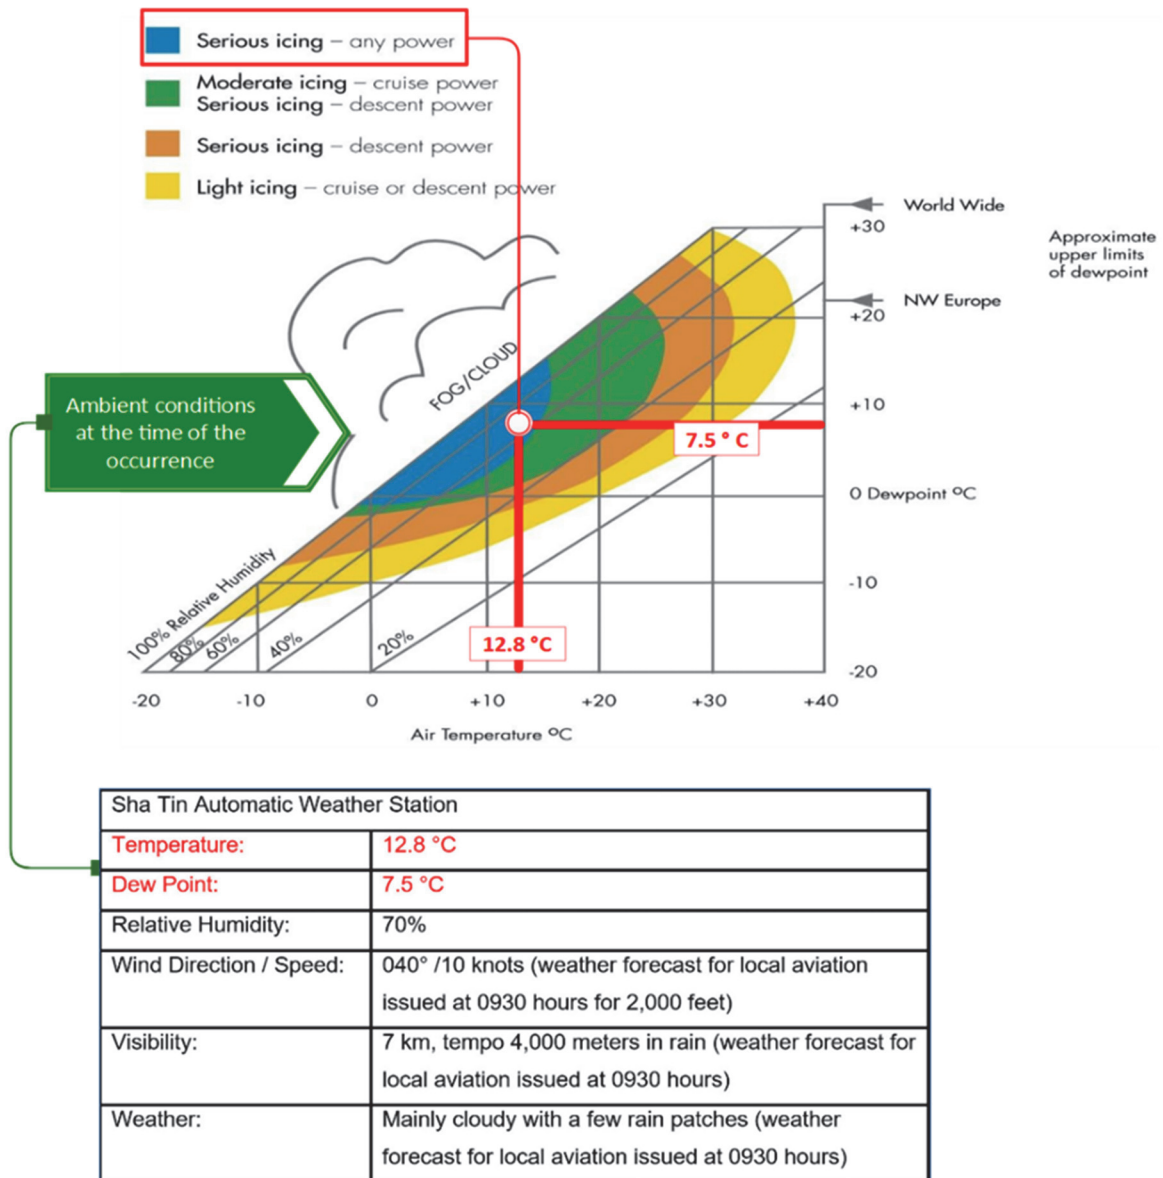
Figure 7: Carburettor Icing Vs Ambient Conditions¹²

Figure 7 is based on the carburettor icing probability predictive chart, which shows the wide range of ambient conditions in which carburettor icing is most likely, in the UKCAA document. The combination of temperature (12.8 °C), dew point (7.5 °C) and relative humidity (70%), as reported around the time the aircraft was airborne, indicate a serious carburettor icing risk at any power.

- (7) The weather conditions were within the limits for VFR operations. [2.1 (4)]
- (8) The engine operation was vulnerable to serious carburettor icing at any power setting given the prevailing ambient conditions. (2.2.1)

The engine operation was vulnerable to serious carburettor icing at any power setting given the prevailing ambient conditions. [3.1 (8)]

It is recommended that the HKAC applies SMS principles to thoroughly review their operations in order to identify safety hazards, assess the risk associated with a given hazard, recommend steps to mitigate the hazard, and disseminate safety information to the HKAC community. [3.1 (16)]
