Air Accident Investigation Authority

Deviation from Intended Flightpath Inflight

Investigation Report

**Serious Incident to
Boeing 787-8, ET-ASG
Waypoint RIVER of Hong Kong
18 July 2019**

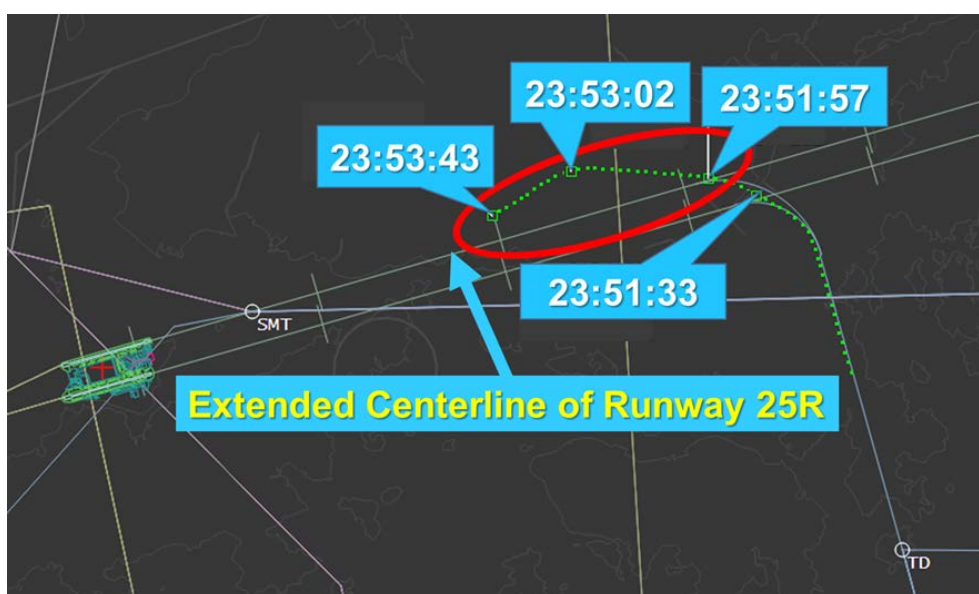
Figure 2: Radar Plot of Flight Track

- (4) At 23:51:57 hrs, while the aircraft was turning left to intercept the LOC from the south, it overshot the LOC course and continued to deviate to the north towards terrain and descended below the MSA of 4,300 ft. The flight crew identified the deviation from the LOC course, and at 23:53:02 hrs, the Pilot Flying (PF) immediately disengaged the autoflight system and assumed manual control of the aircraft to climb back to MSA.

- (5) On noticing the course deviation, ATC warned the aircraft of its approach towards terrain, and shortly after, at 23:53:43 hrs, instructed the aircraft to go around. No EGPWS warnings were triggered.

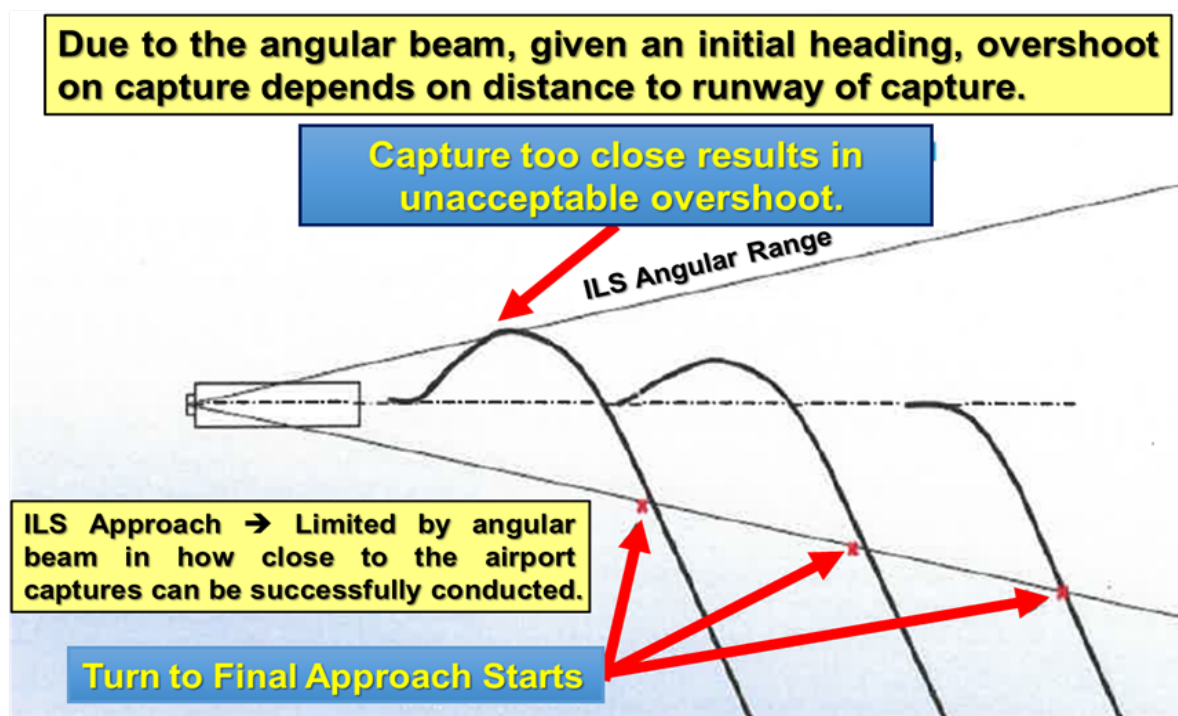
Figure 8: Effect of Intercept ILS Close to RWY

- (2) ILS approach LOC captures that occur too close to the RWY can result in LOC trajectory overshoots as shown in the graphic below.

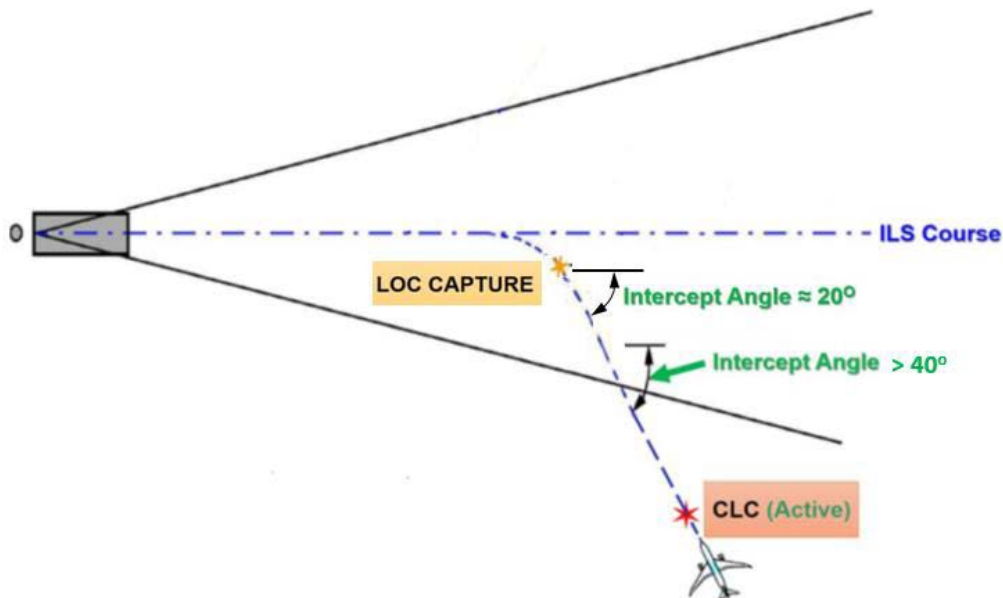
Figure 10: CLC Mode to LOC Capture Mode

- (7) CLC has enough authority to turn the aircraft up to 20 degrees off of the LOC course. This results in the aircraft turning to a LOC intercept angle of approximately 20 degrees.
- (8) During the turn, CLC will automatically transit to the LOC capture control law when the LOC is within parameters for capture and "LOC" will continue to be visible on the FMA.
