Controlled Flight into Terrain Marginally Avoided

Serious Incident Investigation Final Report

**B747-87UF
Lo Fu Tau, Lantau Island,
Hong Kong
24 September 2017**

03-2021

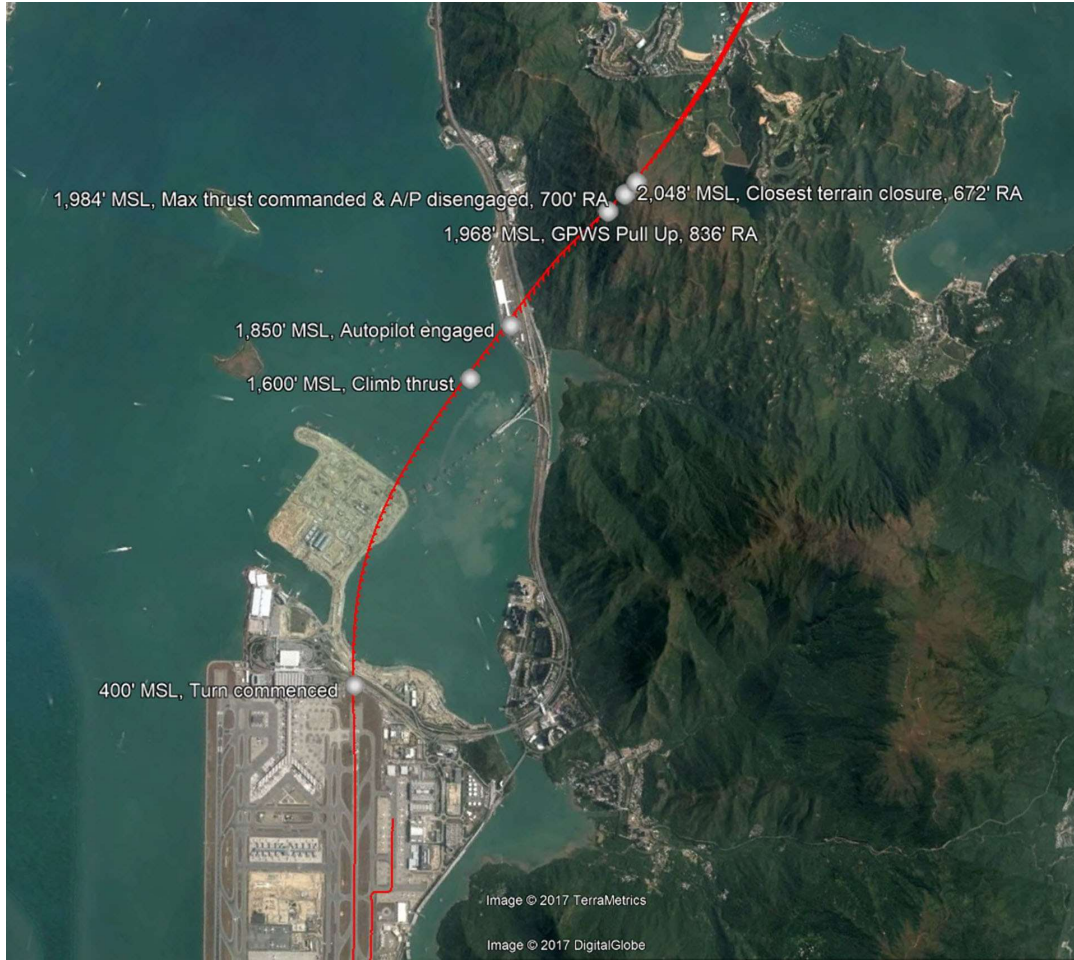
- (2) At 23:44 hrs, once the aircraft took off from Runway 07R, it commanded a right turn towards the first active waypoint PORSH.
- (3) Climbing through approximately 1,800 ft AMSL, the PF called for PM to select the Left Autopilot (A/P) to command while the aircraft continued turning right towards the high ground at Lo Fu Tau. At 23:45:14 hrs, ATC informed the flight crew that the aircraft was off track and instructed the crew to turn left to resume the RASSE 1E SID. The PF started making a HDG Select heading change leaving VNAV engaged. Shortly afterwards, ATC informed the flight crew of terrain to the right of the aircraft and instructed the crew to expedite the climb to 5,000 ft AMSL (see Appendix).

- (4) At approximately 2,000 ft AMSL, the Enhanced Ground Proximity Warning System (EGPWS) on board the aircraft was triggered with a Mode 2A visual alert and the aural warning “TERRAIN, TERRAIN; PULL UP” annunciated. In response, the PF immediately disconnected the A/P and increased pitch and thrust. The aircraft passed over the high ground by approximately 670 ft AGL. Subsequently, the aircraft re-established the SID track at approximately 23:46 hrs and continued without further incident. There was neither injury to personnel nor damage to the aircraft involved and no other air traffic was affected.

- (1) Neither the Cockpit Voice Recorder (CVR) nor the Flight Data Recorder (FDR) data was available from Atlas Air. Atlas Air provided the investigation with Figure 2: Aircraft track in this report and a flight animation based on the Quick Access Recorder (QAR)⁷ data.
- (2) No Secondary Surveillance Radar (SSR)⁸ data was available from CAD. CAD provided the investigation with a manually recorded radar screen replay.

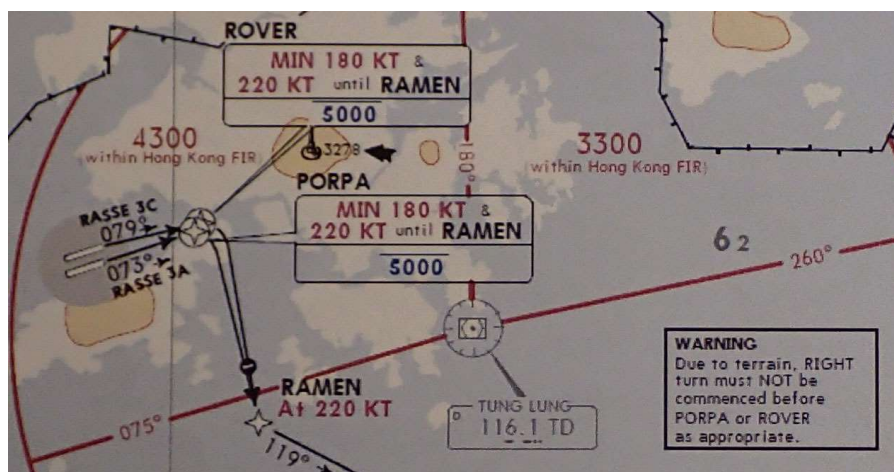
Figure 3: RASSE 3A SID

For the RASSE 3A SID, PORPA is a flyover waypoint and the departure chart includes a WARNING regarding right turn must not be commenced before waypoint PORPA.

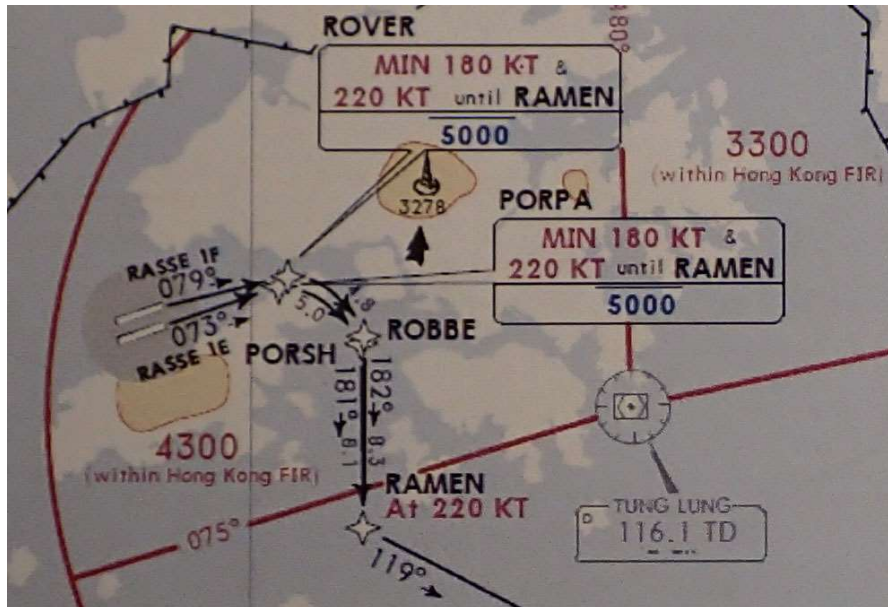
Figure 4: RASSE 1E SID

In comparison with the RASSE 3A SID, despite the WARNING regarding PORPA is not stated, the aircraft Radius-to-Fix (RF) capability will ensure aircraft flying the RASSE 1E SID tracking overhead waypoint PORPA.

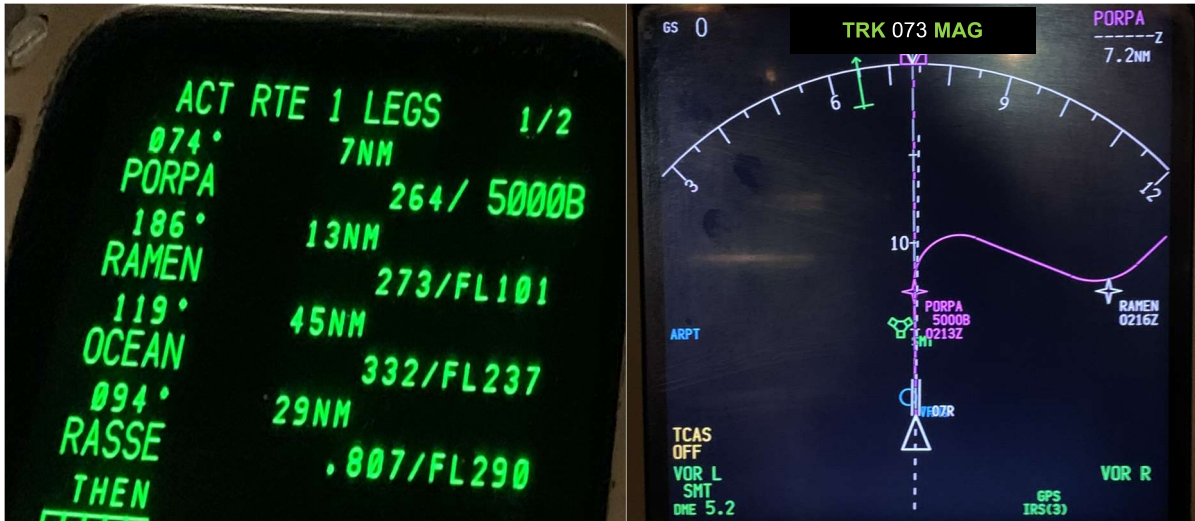
Figure 5: Simulated RASSE 3A SID that displayed on the CDU and ND

Before push-back as part of his pre-flight duties, the PIC had already loaded the company filed flight plan, the anticipated Runway 07R and RASSE 3A SID in the FMS. Also, he gave a preliminary departure briefing to the PM. The PM then did an independent route verification including the RASSE 3A SID. At that stage, the crew were mentally prepared for the RASSE 3A SID that they were anticipating. The names and symbols of the waypoints and the SID course magenta line that would have displayed on the CDU and ND with respect to the RASSE 3A SID are depicted in Figure 5.

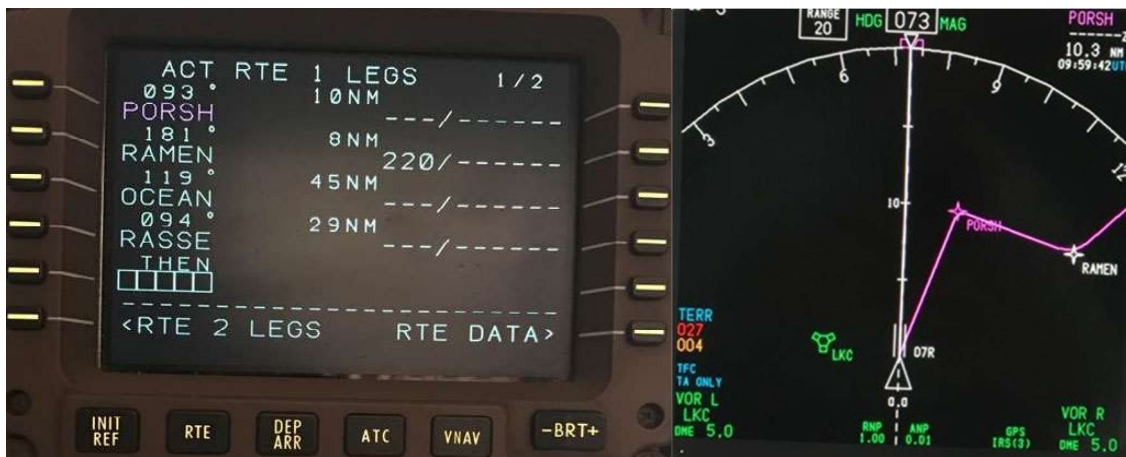
Figure 6: Simulated modified RASSE 1E SID that displayed on the CDU and ND

The crew was not familiar with the RF RASSE 1E SID and it was the first time that the crew received this clearance. Having been given the RASSE 1E SID that was unanticipated, unfamiliar and compounded with time pressure, the crew accepted the clearance. After discussion amongst the crew and possibly due to the perceived time constraint, it was eventually decided that waypoint PORPA was not part of the SID. The SID was thus manually modified, making waypoint PORSH as the first active waypoint after takeoff. By doing so, the SID course magenta line would have veered to the right (see Figure 6).

Modification of the RF SID RASSE 1E while programming the SID into the FMC by overwritten waypoint PORPA, making PORSH the first active waypoint (paragraphs 1.8.3 and 2.6).

It is recommended that SID procedures should not be manually modified (paragraph 3.2).

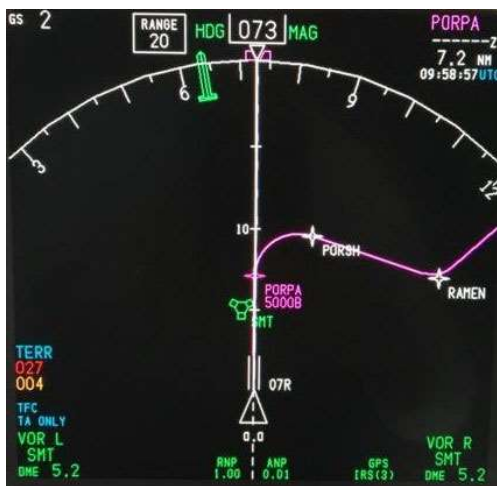
Figure 7: RASSE 1E SID

- (3) Had the RASSE 1E SID not been amended and a cross-check been done with either ND selected on the Map display mode, the crew would have seen the illustration of RASSE 1E SID (see Figure 7). As the crew amended the SID with both NDs on the AMM display mode, they would not have seen the illustration of the un-amended RASSE 1E SID in the first place. When the NDs were eventually selected to the MAP display mode at the very last moment just prior to takeoff, the right veering of the SID course would appear to be less conspicuous as the crew had not looked at the depiction of the un-amended RASSE 1E SID, with which they could compare to notice the difference. It was also not noticed that the display indicated that the first active waypoint PORSH was not on the runway heading (see Figure 8).
