# **Propulsion System Fire (SCF–PP–PSF)**

## **Investigation Report**

**Serious Incident to  
Boeing 747-8F, N624UP  
Hong Kong International Airport**

**20 July 2021**

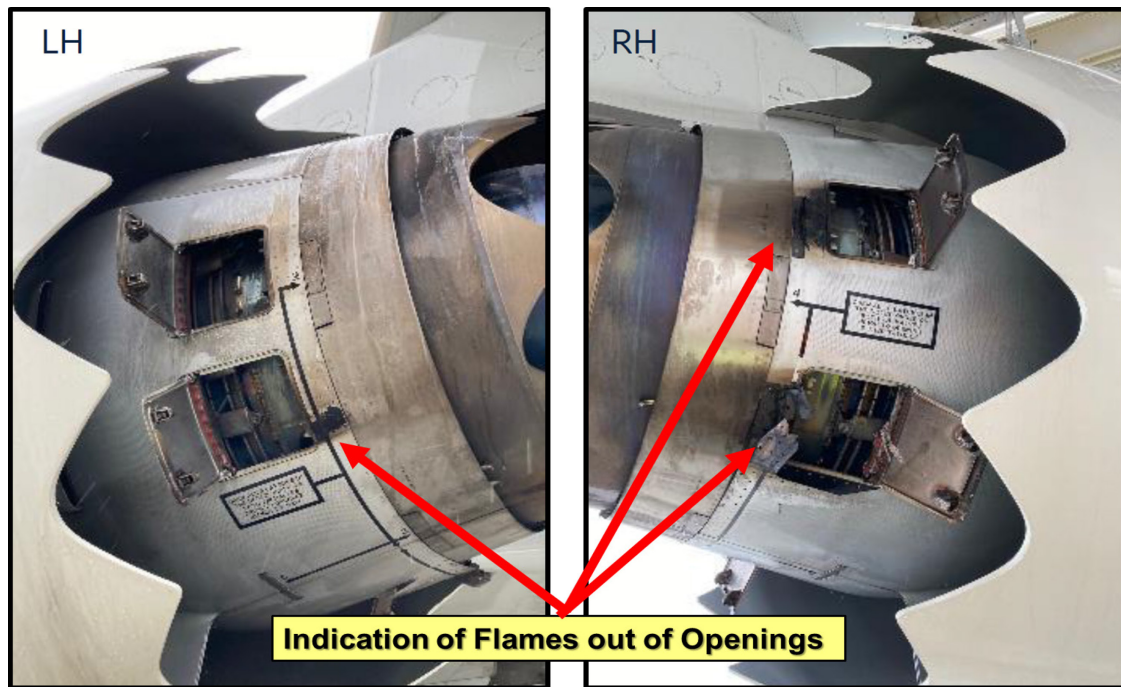
- (1) The aircraft was not damaged except thermal damage observed at the exterior core section of the No. 1 Engine.
- (2) The soot shown at the openings of the thrust reverser (T/R)'s four pressure relief doors on the No. 1 engine.

**Figure 8: Soot shown at the Openings of T/R Pressure Relief Doors**

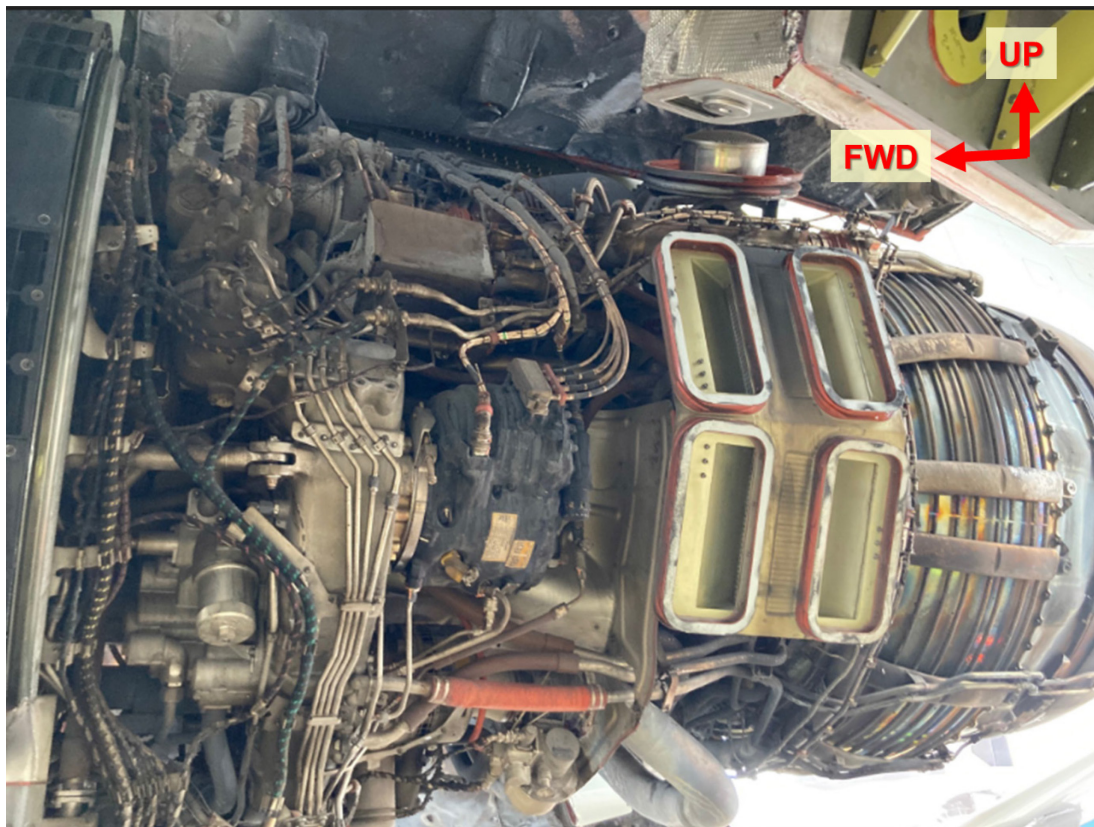
- (3) After opening the engine core cowling, thermal damage was observed on both sides of the exterior engine core. Details are in Section 1.16.1.: Powerplant Examination at GE Facility.

**Figure 9: Left-Hand Side of the Exterior Engine Core**

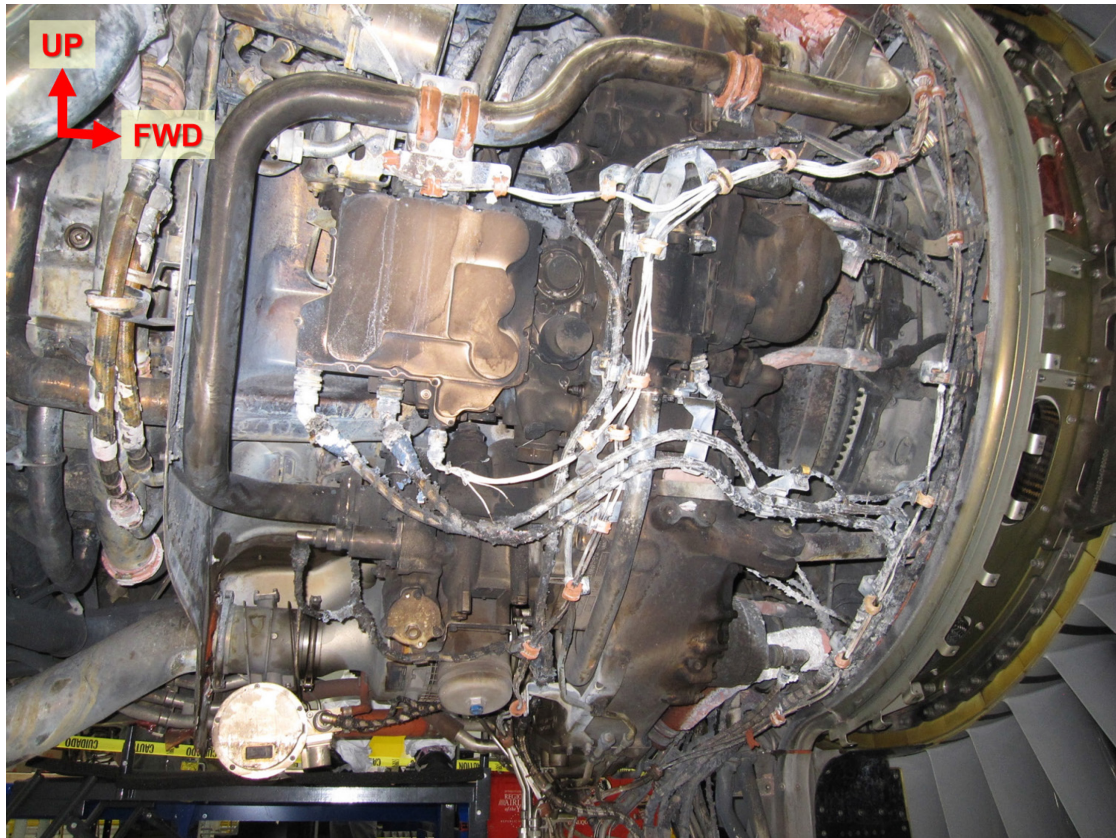
**Figure 10: Right-Hand Side of the Exterior Engine Core**

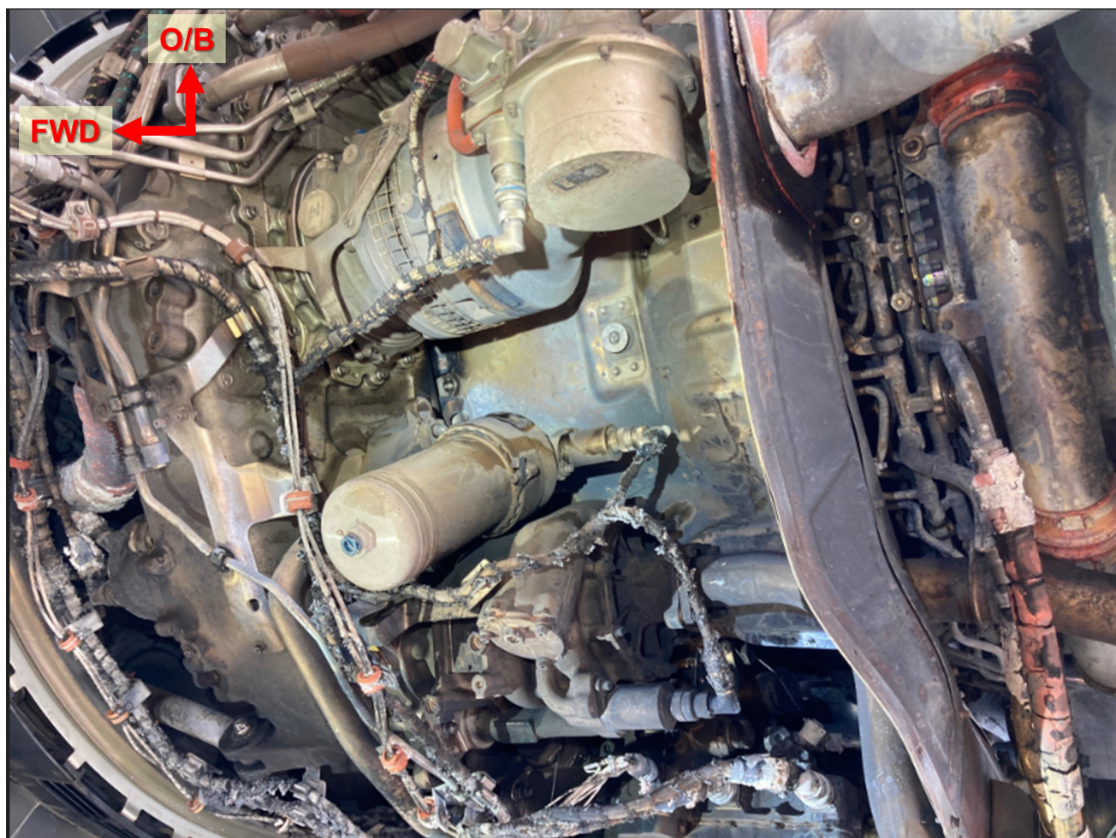
**Figure 11: Under Section of the Exterior Engine Core**

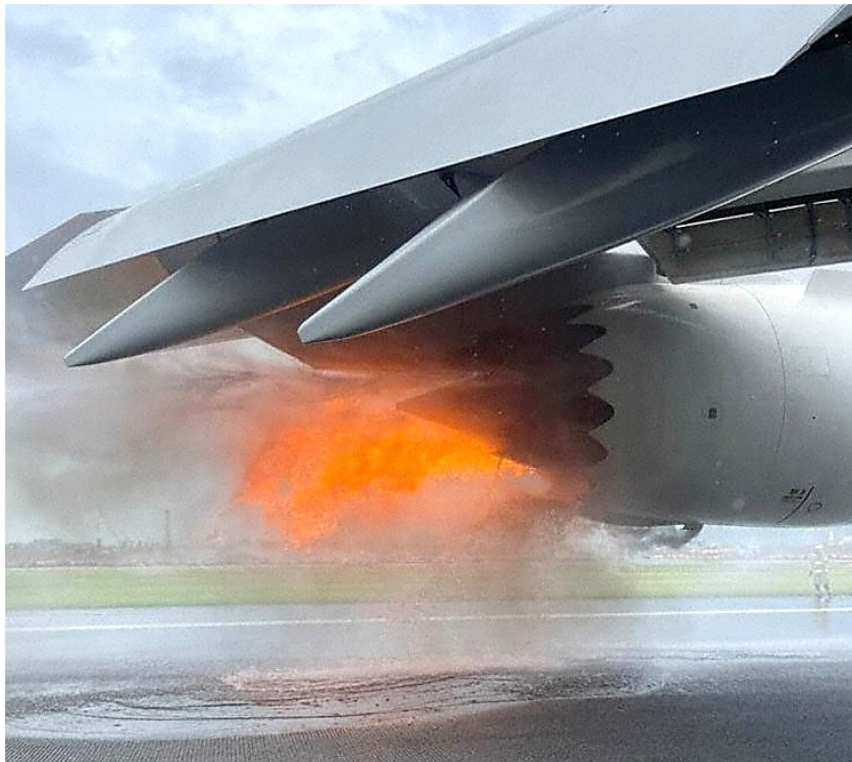
- (1) At 1220 hours, the “FIRE ENG 1” EICAS warning message appeared for 12 seconds after the No. 1 engine shutdown. The flight crew pulled the No. 1 engine fire handle and discharged two fire extinguisher bottles, but the fire warning continued.
- (2) The fire warning ended shortly before landing. The total fire alarm time lasted for approximately 9.5 minutes. After the aircraft landed safely on Runway 07L, the AFC inspected the No. 1 engine and brakes and found no fire.
- (3) About 22 minutes after landing, at 1252 hours, the AFC noticed white smoke and then fire in the No. 1 engine when water was being applied to the engine surrounding to maintain cooling effect. Additional fire suppressants were applied to the engine and the fire was extinguished within 40 seconds.

**Figure 12: No.1 Engine Ground Fire**

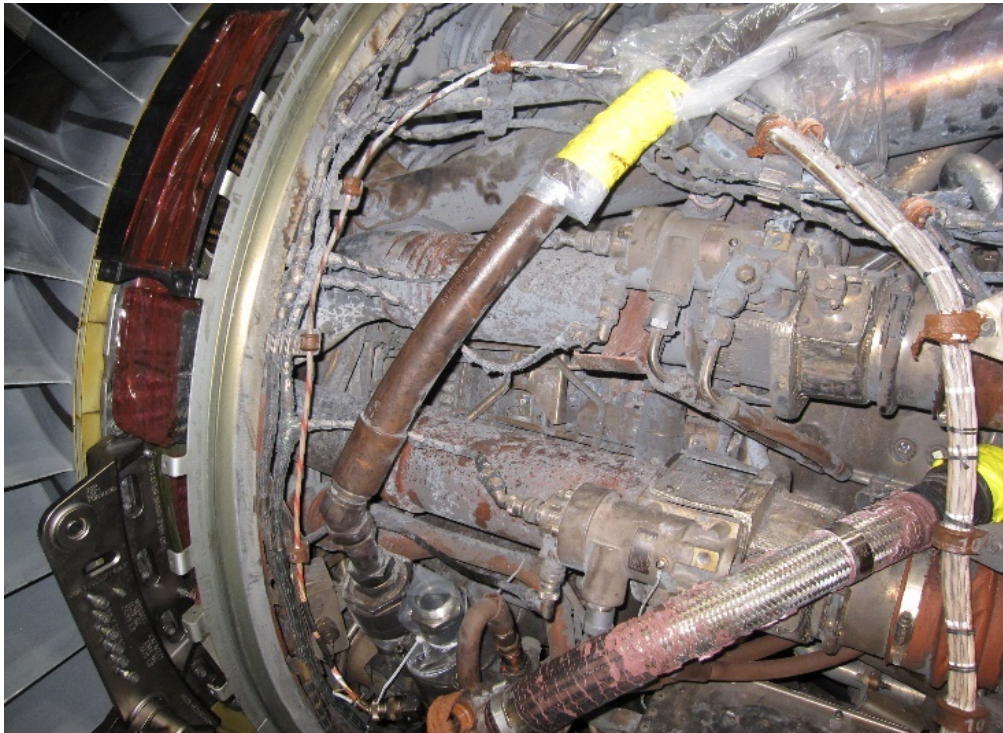
- (3) The thermal and fire damage consisted of sooting and melted or consumed c-clamp/p-clamps cushions, fire loop rubber isolators, electrical cable outer sheathing, and fire sleeves.

**Figure 15: Left Side Close-Up of Thermal and Fire Damage**

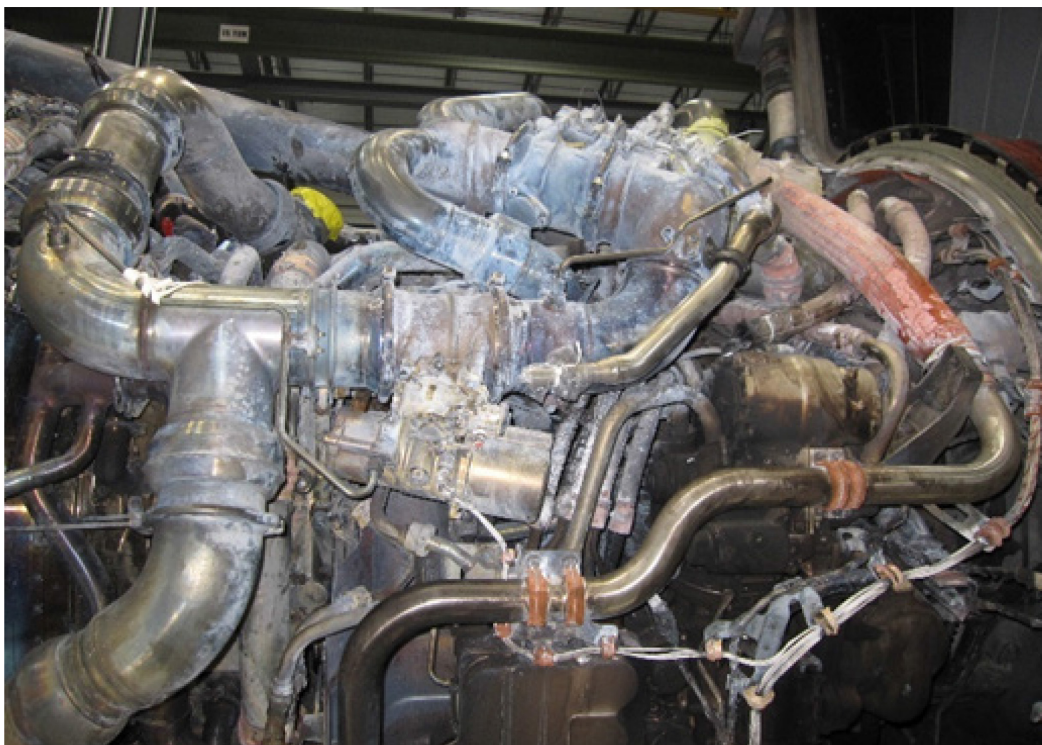
**Figure 16: Right Side Close-Up of Thermal and Fire Damage**

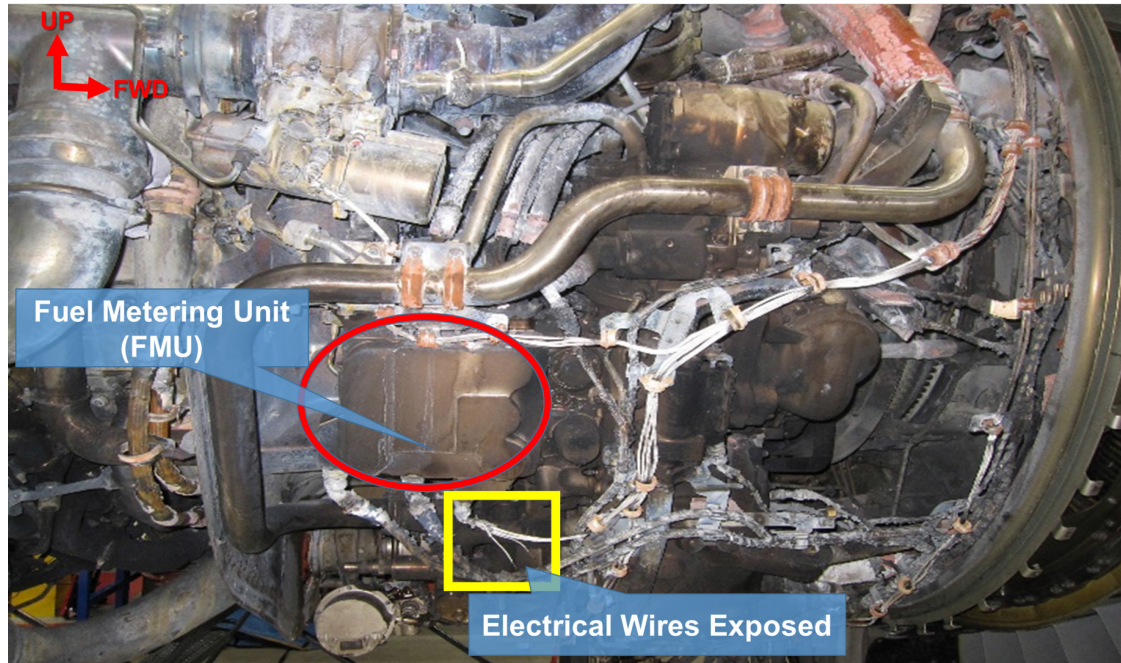
- (4) All the fire loops, overheat detectors, and responders appear to be continuous and intact. Below the FMU at about the 5 o'clock position, the conductors of the electrical wires appeared to be exposed.

**Figure 17: Electrical Wires Exposed below FMU**

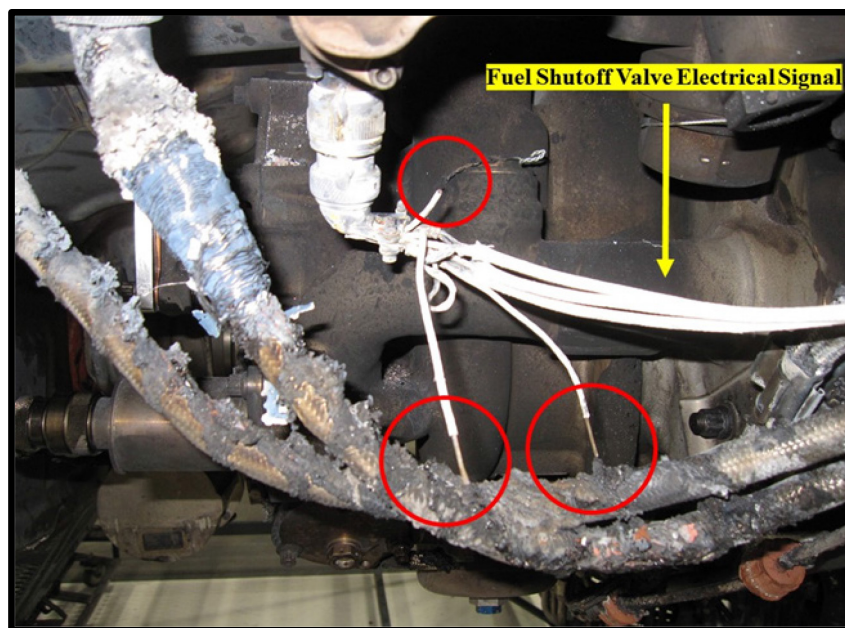
- (5) A detailed inspection revealed that the electrical wires exposed were from the fuel shutoff valve electrical connector, which was still installed and connected to the FMU.

**Figure 18: Fuel Shutoff Valve Electrical Signal Wires Exposed**

- (8) The end caps of the electrical wires likely melted as a result of thermal damage. Thus, the electrical wires became exposed.
- (9) The top of the engine, from about 9 o'clock to 3 o'clock position, was covered in a bluish powder residue, and yellowish powder residue at about the 1 o'clock position on the environmental cooling manifold.

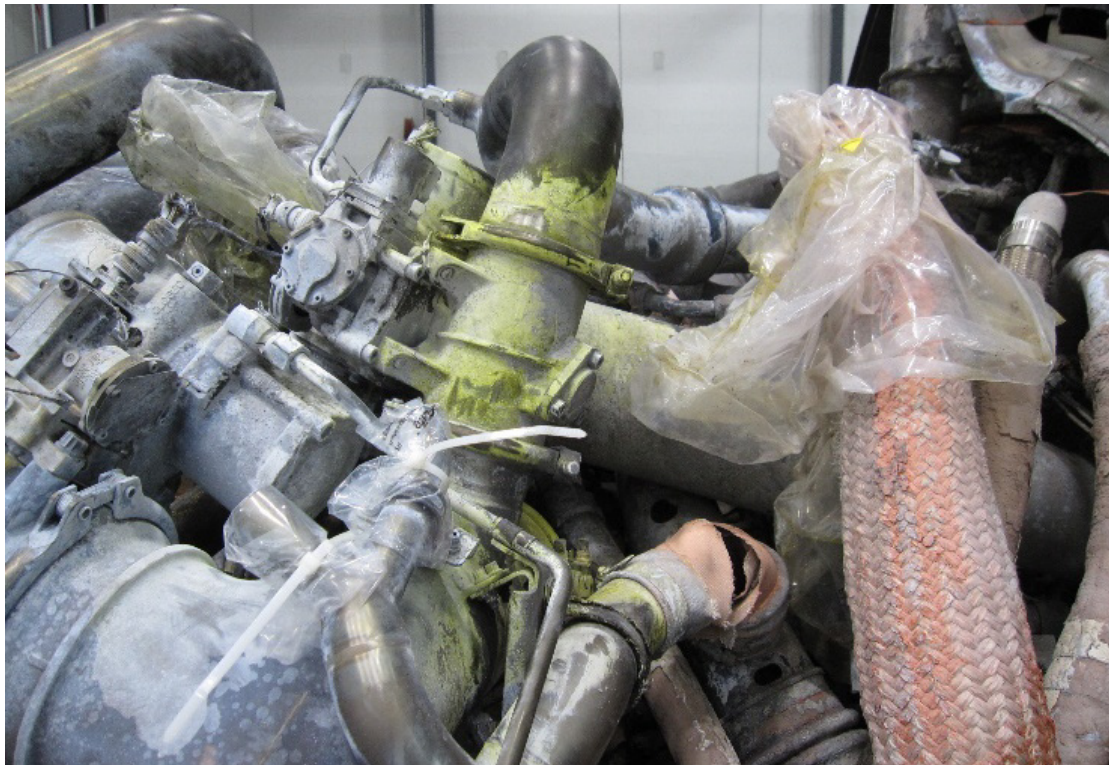
**Figure 20: Yellowish Residue Near Top**

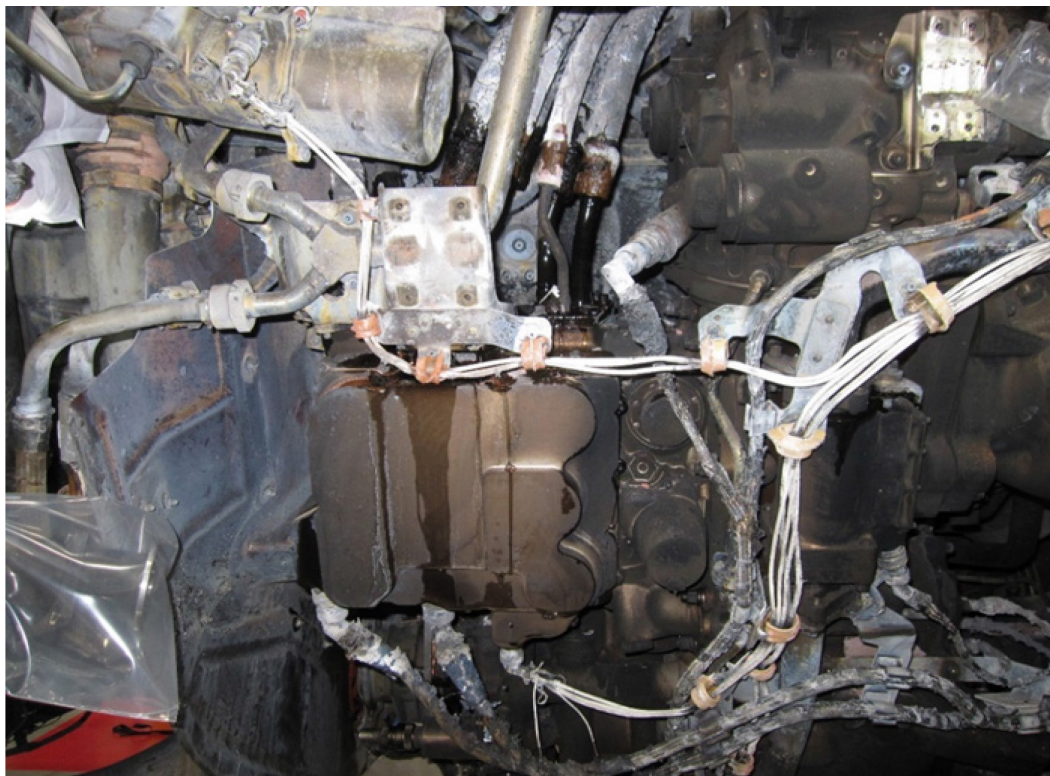
**Figure 23: Fuel Leaking from Multiple Locations of FMU**

- (6) The leaks were observed coming from:
- a) the variable bleed valve (VBV) fuel manifold
  - b) the variable stator vane (VSV) fuel manifold
  - c) the core compartment cooling (CCC)-start bleed valve (SBV)-heated servo pressure (PHS) fuel manifold
  - d) two pressure taps on the back side of the FMU.
- (7) Due to multiple fuel leaks from the FMU, it was decided to isolate the FMU by installing cover plates on the manifold ports labelled A, B, and C in the figure below.

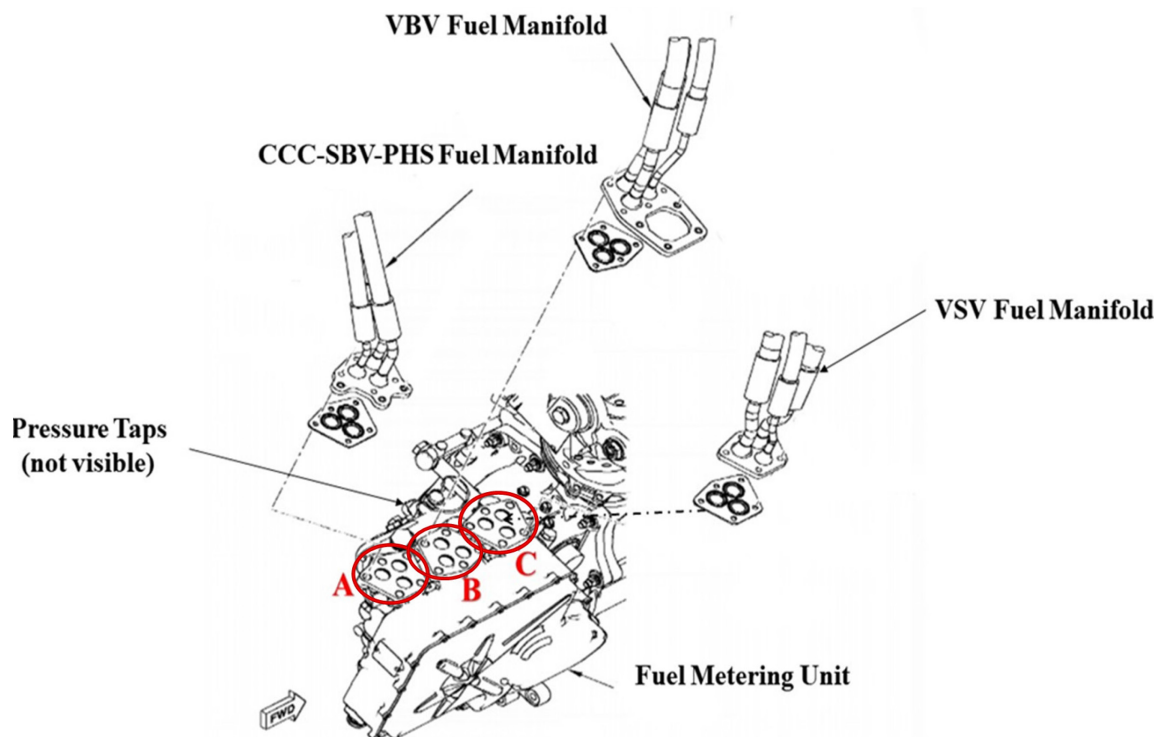
**Figure 24: Leak locations of Fuel Metering Unit**

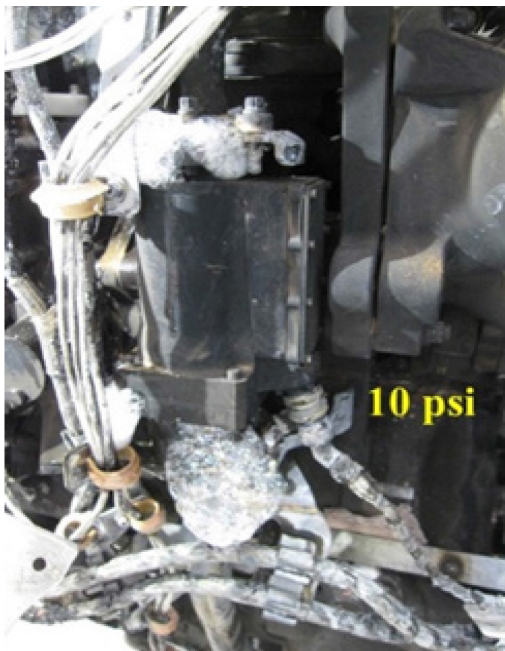
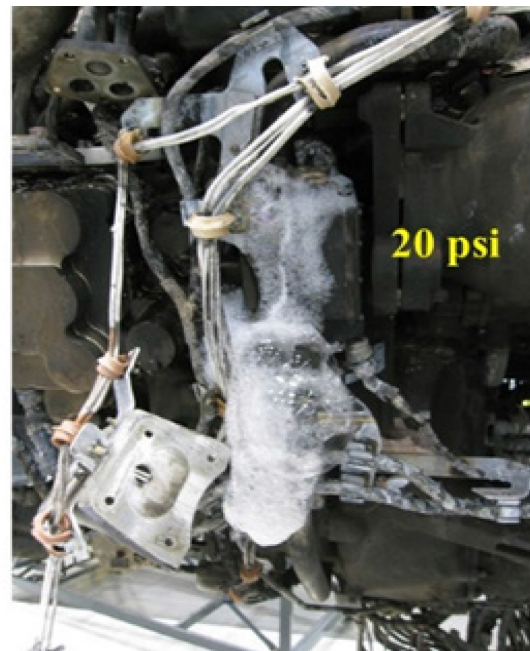
- (11) Using Leak-Tek fluid, nitrogen was seen leaking from the top and bottom of the fuel flow transmitter (FFT). No other leaks were noted. The nitrogen pressure was increased in 10 psi increments up to 30 psi. No additional leaks were observed other than what was observed coming from the FFT.

**Figure 26: Leaking from Top and Bottom of FFT**

- (12) These flexible portions of the fuel lines have a plastic inner core that during the testing was found to have melted due to fire, so fuel leaked through the metal outer braid.

- (13) The fire damage to the fuel lines did affect the integrity of the tube and would definitely leak during the leak check. These interface leaks were considered to be a result of the fire, not the cause.
- (14) The results of the engine leak check are shown in the table below.

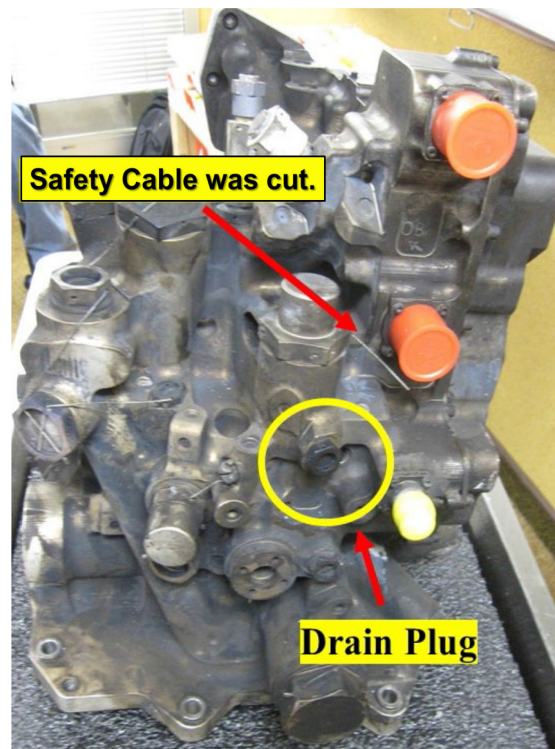
- (2) The FMU was completely sooted, but there were no signs of thermal distress to the housing.
- (3) Visual inspection of the FMU revealed that the safety wire from one of the drain plugs was found broken; it appeared to be a clean cut.
- (4) According to GE Field Support, the FMU was drained in Hong Kong for engine shipment; thus, the safety wire was cut to drain the unit. This was confirmed and photographed at the engine.

**Figure 28: Cut Drain Plug Safety Cable**

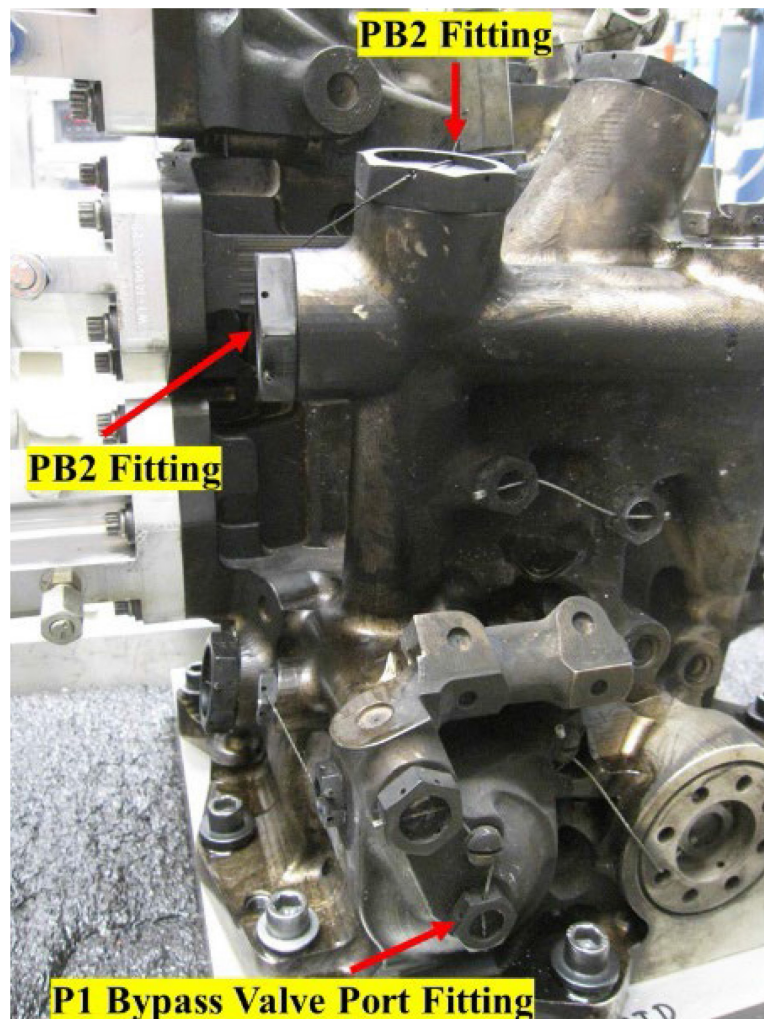
- (4) Leaks were observed coming from two PB2 bypass fittings<sup>3</sup> and the P1 bypass valve port fitting. At all three leak locations, the fittings were loose. No other leak locations were identified.

**Figure 36: Nitrogen Leak Locations**

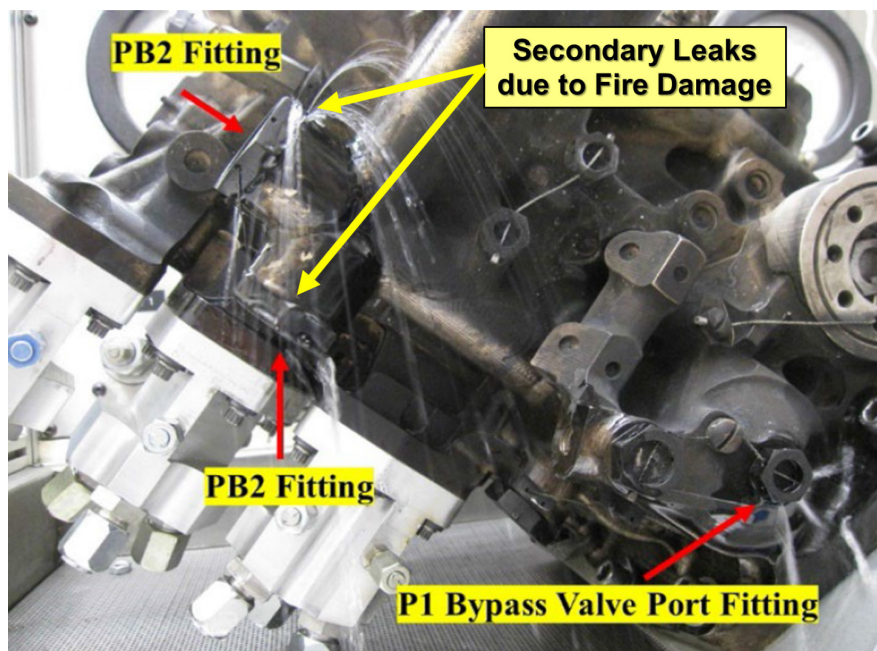
- (3) Calibration fluid at about 12 psi was introduced and leaks were observed from the same two PB2 bypass fittings and the P1 bypass valve port fitting that was observed in during the nitrogen leak check. No new leaks were observed.

**Figure 38: Calibration Fluid Leak Locations**

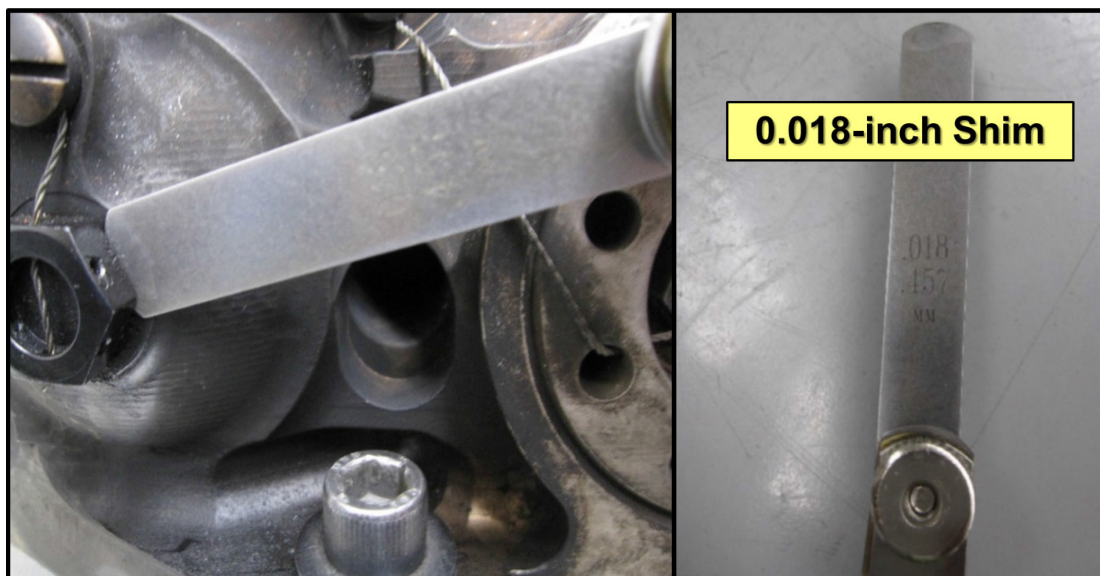
- (1) The gap between the P1 bypass valve port fitting and the housing was measured. To measure the gap between the housing and the P1 bypass valve port fitting, several different feeler gauge were placed between the bottom of the P1 bypass valve port fitting and the FMU housing.
- (2) The largest (thickest) feeler gage that was able to be inserted into the gap between the bottom of the P1 bypass valve port fitting and the FMU housing was 0.018-inch (0.457 millimetres) thick.

**Figure 41: Feeler Gage Between FMU and P1 Bypass Valve Port Fitting**

- (3) For a normal installation, there should be no gap. Since the fitting thread is 0.4375-20, i.e. 0.050" per turn, the 0.018-inch gap would equal to 1/3 turn loosen. To torque the fitting to specification, an additional 1/3 turn is required.
- (4) There was no noticeable gap between the PB2 bypass fittings and the FMU housing. Thus, no measurements were taken.

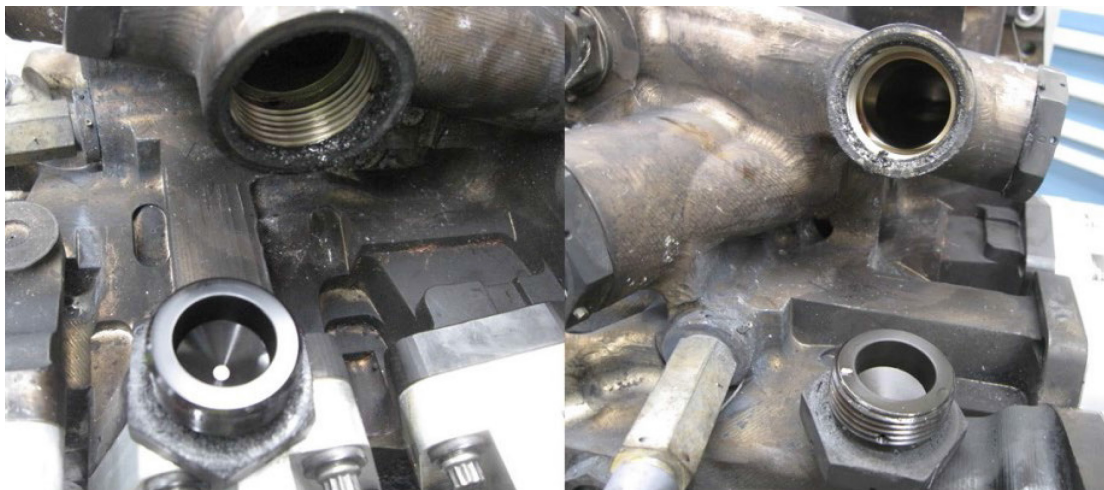
- (1) The PB2 bypass and two P1 bypass valve port fittings were removed to access the condition of the packings; these were the locations that leaked during the nitrogen and the calibration fluid leak tests.
- (2) Before removing the fittings, all three were marked to document their "original" position prior to removal. i.e. how "tight" they could get with the as-installed lockwire.
- (3) Due to fire damage, the packings were entirely consumed at both PB2 bypass fitting locations. All that remained was the residue of the packings were noted.

**Figure 42: PB2 Bypass Packings Consumed**

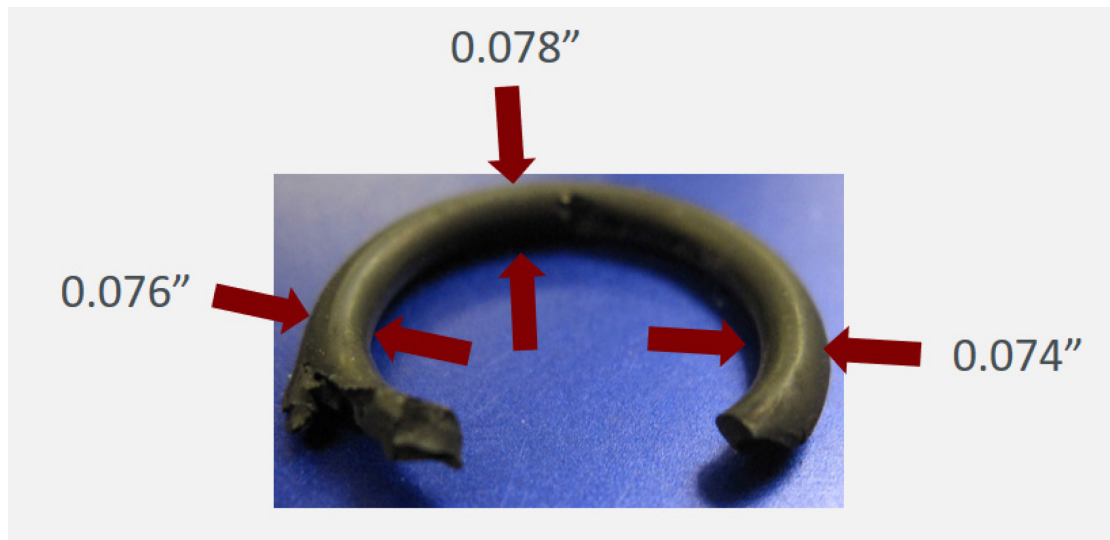
The investigation found that this serious incident was caused by improper installation of the P1 bypass valve port fitting on the fuel metering unit, resulting in a fuel leak that rendered the engine fire.

- (4) The packing for the P1 bypass valve port fitting was present and still had a reasonably round cross-section. However, a section of the packing, less than 1/4, of the circumference, was missing. Signs consistent with nibbling and extrusion damage at the broken edges of the packing were noted.

**Figure 43: Damaged P1 Bypass Valve Port Fitting Packing**

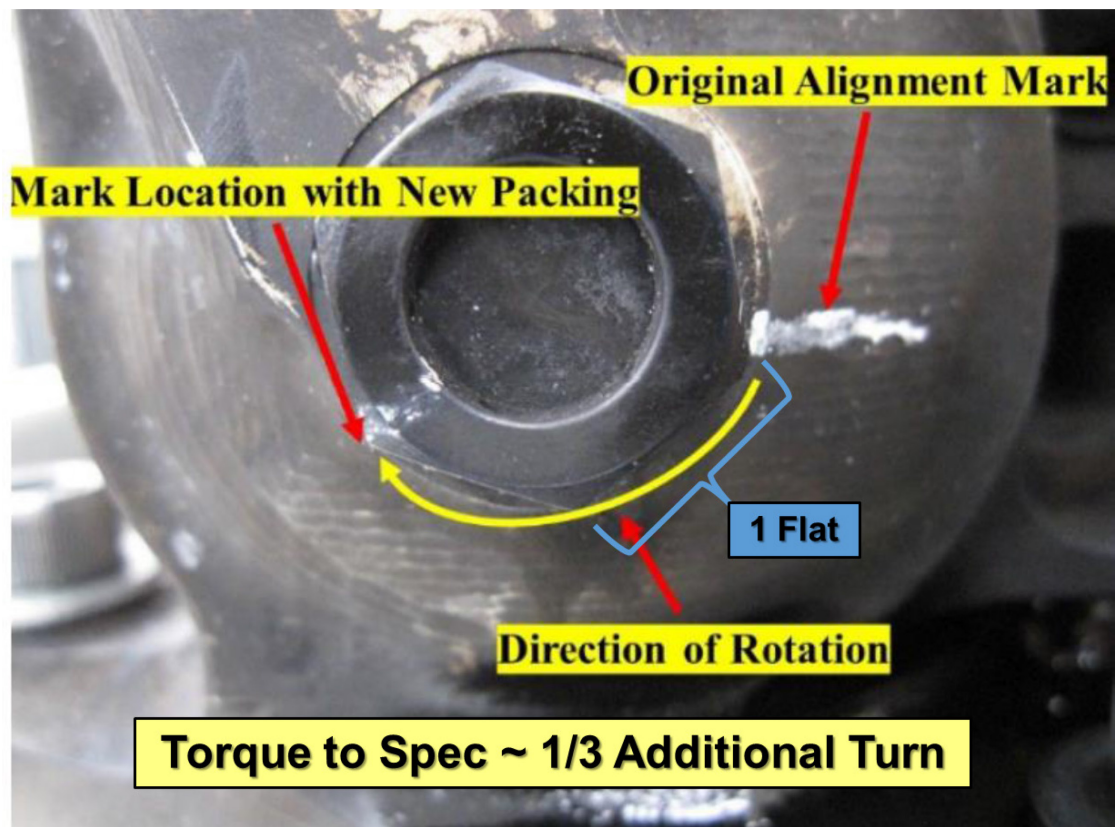
- (7) With a new packing installed on the P1 bypass valve port fitting and the fitting reinstalled to the specified torque, the new position of the alignment mark on the fitting was about two flats from the original “tight” position in the tightening direction.
- (8) Installing and torquing the fitting with new packing eliminated the 0.018-inch gap observed previously. Two flats of additional rotation corresponds to 0.018-inch gap based on the thread pitch, as noted in Section 1.16.2.4.

**Figure 45: P1 Bypass Valve Port Fitting Alignment Mark With New Packing Installed**
