# **Turbulence Encounter**

## **Investigation Report**

**Accident to Airbus A330-243, B-LHA  
Nansha District, Guangzhou City,  
Guangdong Province, China  
18 June 2019**

**01-2023**

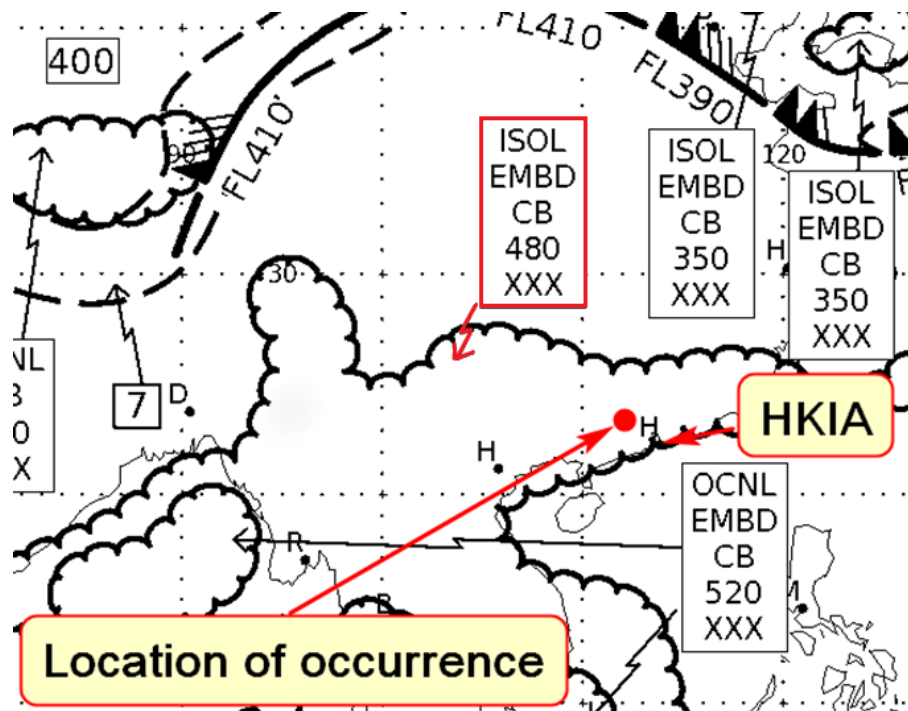
Figure 4: Weather Forecast at the Location of Occurrence

- (k) Moderate rain showers
  - (l) Base of few cumulonimbus at 1200 ft
  - (m) Scattered clouds at 2200 ft
- (3) Figure 4 is a section of the Significant Weather Forecast chart provided to the crew pre-departure. The 'call-out' box, outlined in red, specifying ISOL EMBD CB 480 XXX, points to the relevant area of black 'scalloped' lines. The delineated area indicates that isolated cumulonimbus (CB) cloud embedded within other types of cloud layers, and not readily apparent to flight crew, could be expected in less than 50% of that area up to FL480.

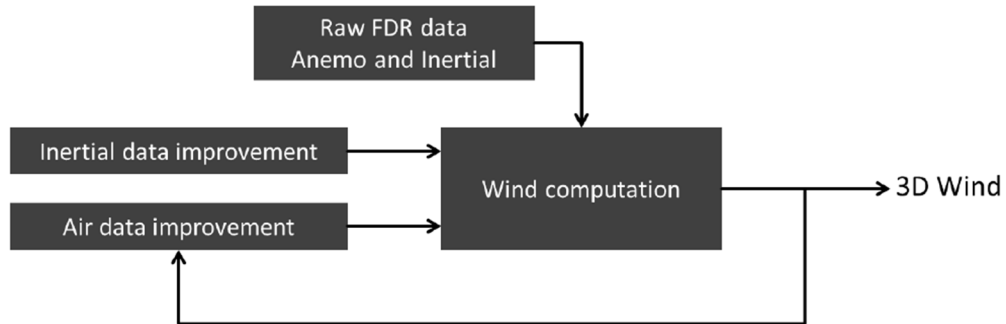
Figure 5: Wind Reconstruction

- (1) A specific wind reconstruction computed by Airbus to determine the influence of the wind on the aircraft behavior during the event is shown in Figure 5.

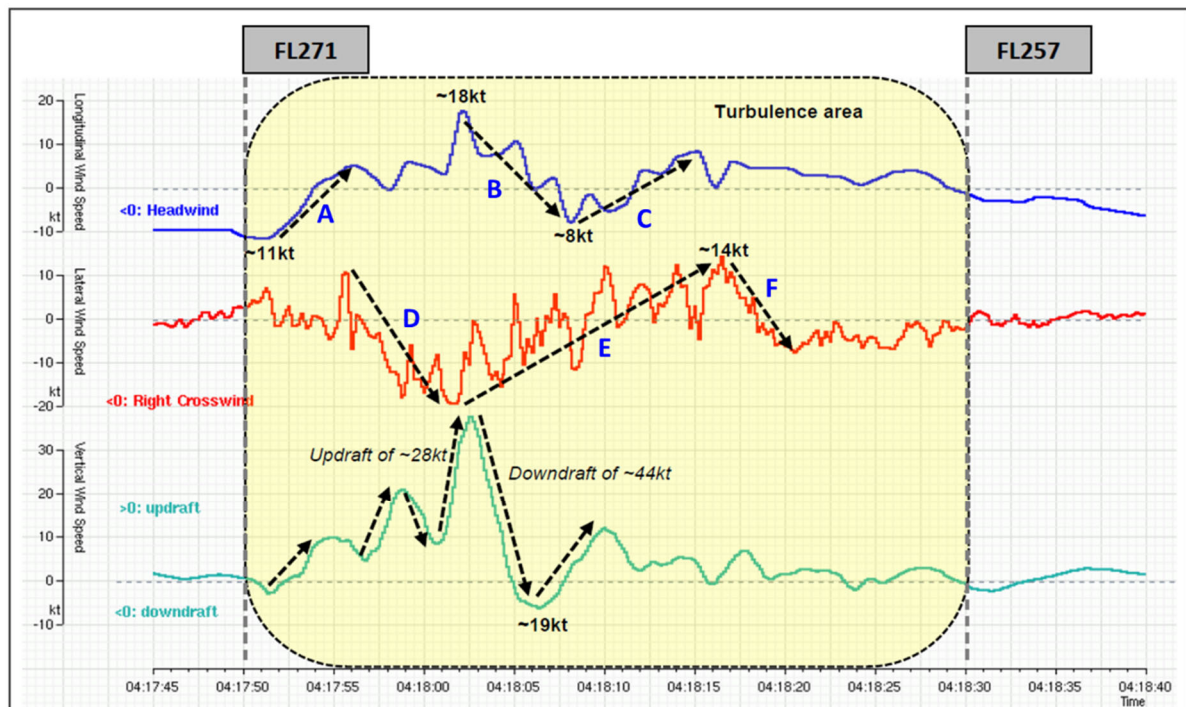
Figure 6: Reconstructed Wind along the Aircraft Axes

- (2) Figure 6 shows the result of the wind reconstruction along the three aircraft axes. The wind reconstruction was based on:
- Anemometric and Inertial data from FDR
  - Anemometric correction: estimation of sideslip
  - Inertial bias reconstruction

The recomputed wind evolution in Figure 6 highlights that the aircraft experienced adverse wind conditions during descent.

- (1) On the longitudinal axis, 3 significant wind gradients were recorded:
  - (a) A tailwind gradient of 17kt (A in Figure 6)
  - (b) A headwind gradient of 26kt (B in Figure 6)
  - (c) A tailwind gradient of 16kt (C in Figure 6)
- (2) On the lateral axis, 3 significant wind gradients were recorded:
  - (a) A right gradient of 29kt (D in Figure 6)
  - (b) A left gradient of 34kt (E in Figure 6)
  - (c) A right gradient of 21kt (F in Figure 6)
- (3) On the vertical axis, the variations in vertical wind speed highlight severe turbulent weather conditions with several updraft and downdraft including an updraft of ~28kt followed by a significant downwind gradient of ~44kt in 3 seconds.

- (6) The wind reconstruction based on the raw wind data recorded by the FDR indicates significant wind variations between 04:17:50 and 04:18:42. The variations in vertical wind speed highlight severe turbulent weather conditions with several updraft and downdraft. (2.6.1)

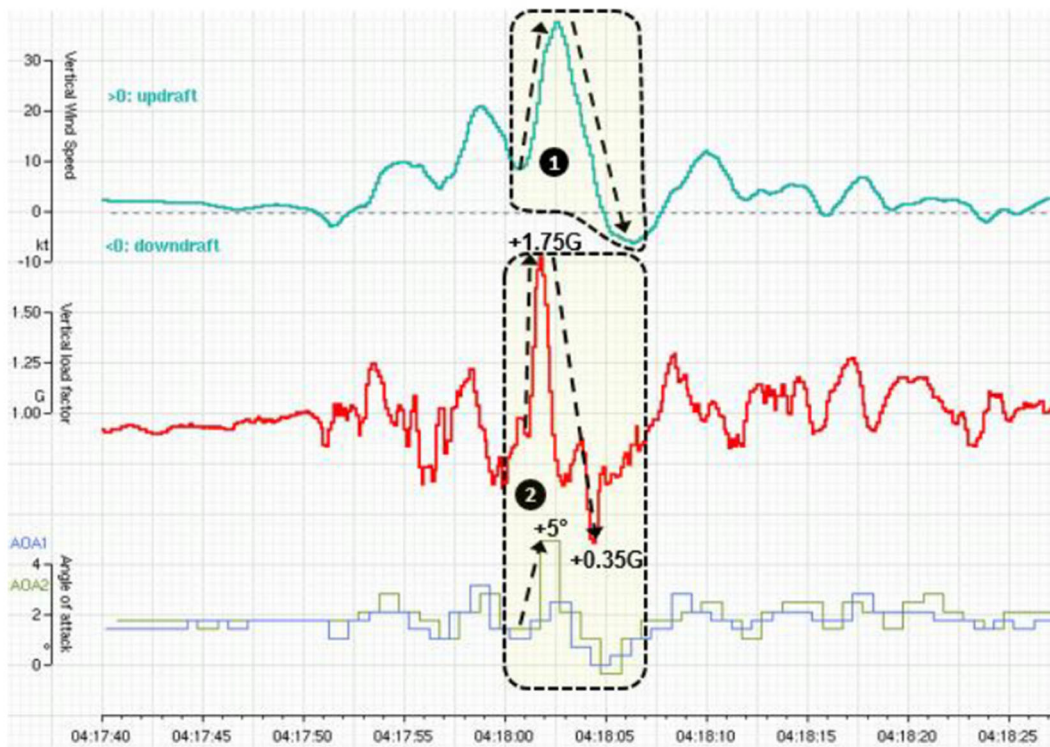
**Figure 7: Variation of Vertical Wind Speed, Vertical Load Factor and Angle of Attack during Turbulence**

- (1) Figure 7 is an extract from the FDR data report (from 04:17:40 to 04:18:30) showing the variation on vertical wind speed, vertical load factor and angle of attack during the turbulence period from 04:17:50 to 04:18:42.

- (2) The FDR analysis established the following during the turbulence:
- Vertical load factor varied between +0.35G and +1.75G (maximum  $\Delta$ VRTG<sup>11</sup> of +0.90G / -1.15G).
  - Lateral load factor varied between -0.1G and +0.1G (maximum  $\Delta$ LATG<sup>12</sup> of +0.15G / -0.15G).
  - Angle of attack varied between -0.5° and +5.0°.
