Loss of Control – Inflight

Investigation Report

Robinson R44 Clipper II, B-KTK,

19 May 2019

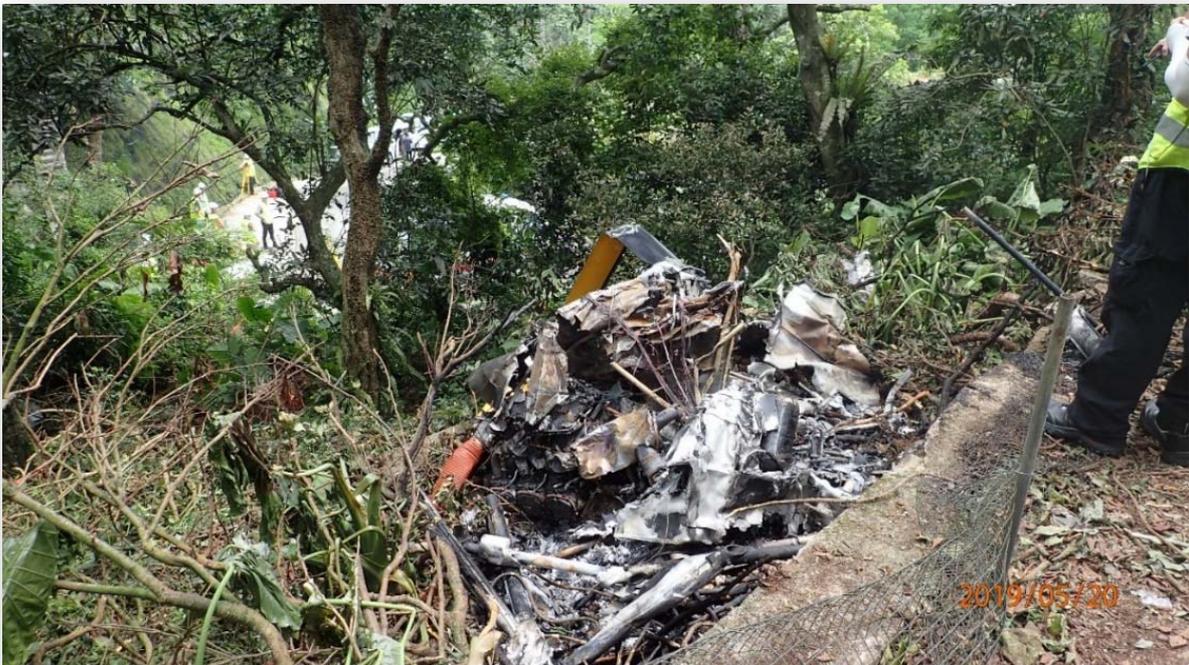
Figure 3: The Main Wreckage

- (1) The helicopter was destroyed during the inflight breakup and subsequent ground impact with a post-crash fire.
- (2) The known wreckage debris trail extended approximately 500 m from where the fuselage impacted. Refer to 1.12 for details.

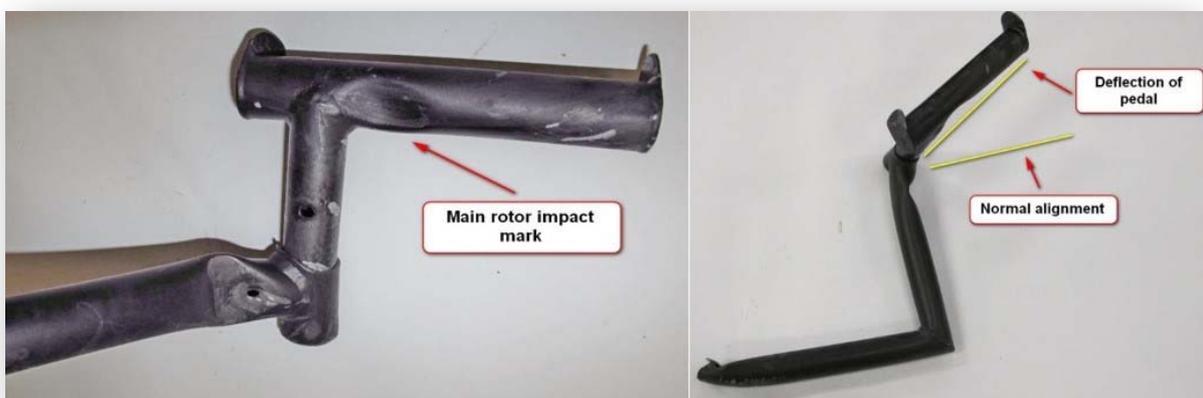
Figure 5: Pilot Side Right Tail Rotor Pedal

- (3) Seat belt components were recovered with the main wreckage and sustained extensive thermal damage.
- (4) The tail rotor pedals were with the main wreckage and sustained thermal damage with the exception of the pilot side right pedal, which was recovered separately (see Figure 5). The surface of the fracture was angular and jagged. The adjustable portion of the pedal remained in the pedal socket although the retaining pip pin was no longer present. The pip pin was sheared and the head was located inside the pilot's cyclic grip. The left pedal pip pin remained in the left pedal. Impact marks suggest that the rotor blade impacted the pedal.

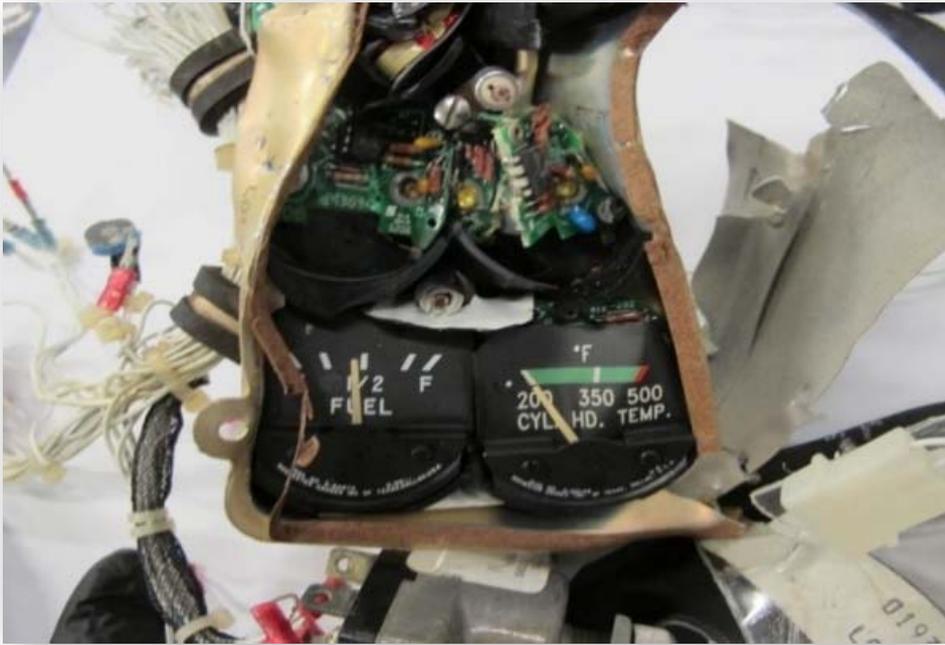
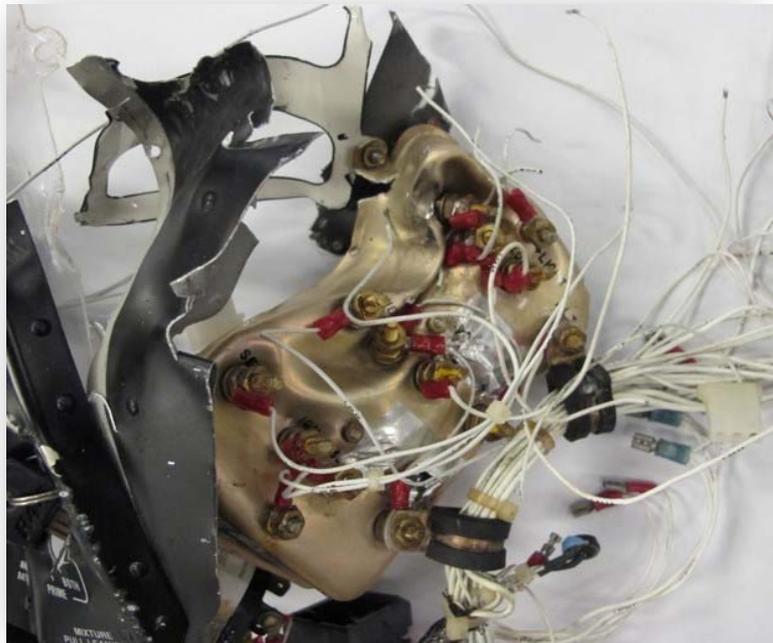
- (2) The lower panel sustained direct impact damage separating the panel into several sections and leaving a dent in the right side of the instrument cluster which appeared to match the size and shape of the leading edge of the main rotor blade. The wires remaining attached to the lower panel were also aggressively disconnected or damaged along with associated switches, lights, and instruments. The avionics were recovered with the main wreckage and sustained only thermal damage.

- (4) The forward right seat bottom and the forward right floor carpets were recovered separately from the main wreckage with no thermal damage.
- (5) The lower instrument panel sustained direct impact damage separating the panel into several sections and leaving a dent in the right side of the instrument cluster which appeared to match the size and shape of the leading edge of the counter clockwise rotating main rotor blade (see Figures 6 and 7).

Figure 6: Lower Instrument Cluster

Figure 7: Dent in Right Side of Instrument Cluster

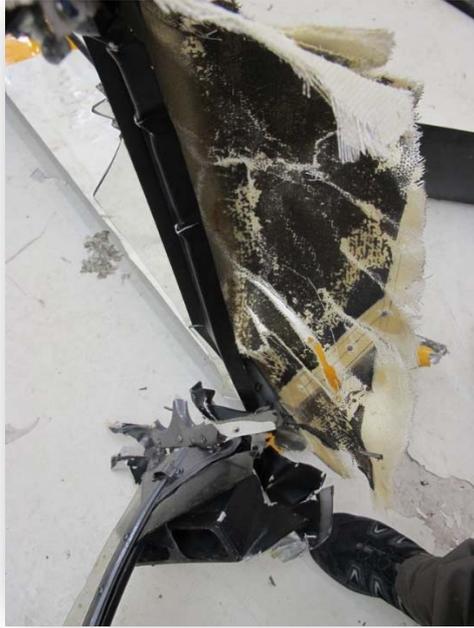
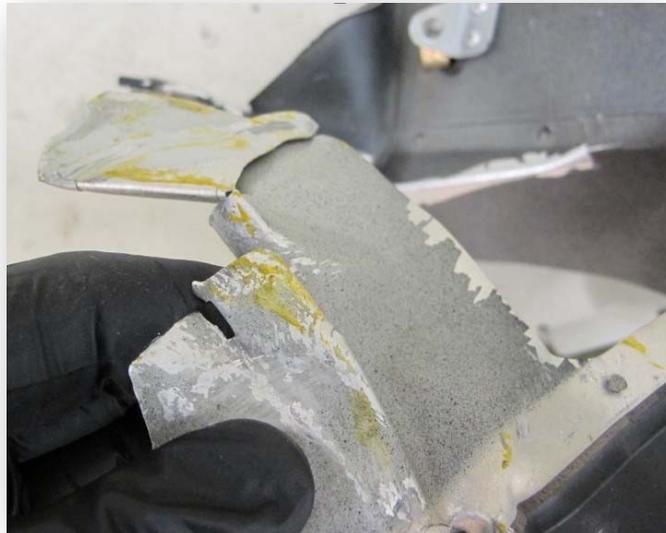
- (6) The witness marks on the windshield frame, the impact dent on the right of the lower instrument panel, and the yellow paint transfer from the rotor blade revealed that the advancing main rotor blade (i.e. the forward

moving blade at the starboard side of the rotor plane viewed from above) had flapped down to this extreme angle (see Figures 8 and 9).

Figure 8: Yellow Paint Transfer on Cockpit Canopy Bow

Figure 9: Yellow Paint Transfer on the Cockpit Structure

- (7) It is highly likely that the front of the cockpit had been hit by the diverged advancing blade at the initial breakup of the helicopter.

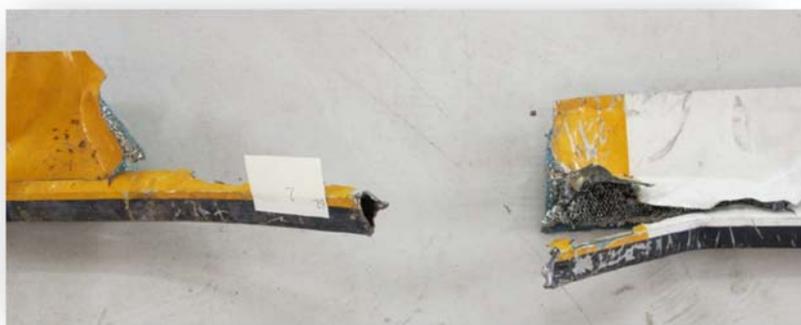
Figure 10: Main Rotor Blade Section

- (1) Main rotor blade serial number 4684 had a disconnect 2 feet from the hub with a downward bend in the spar. At 6 feet from the tip, it had a disconnect in the spar with upward bending and there was approximately 15 inches of afterbody separated from the blade with many dents and scuff marks running chordwise throughout the area. The fractured surfaces at the disconnects were angular and jagged.
- (2) In the area of disconnection, yellow paint transfer was evident (see Figure 10).

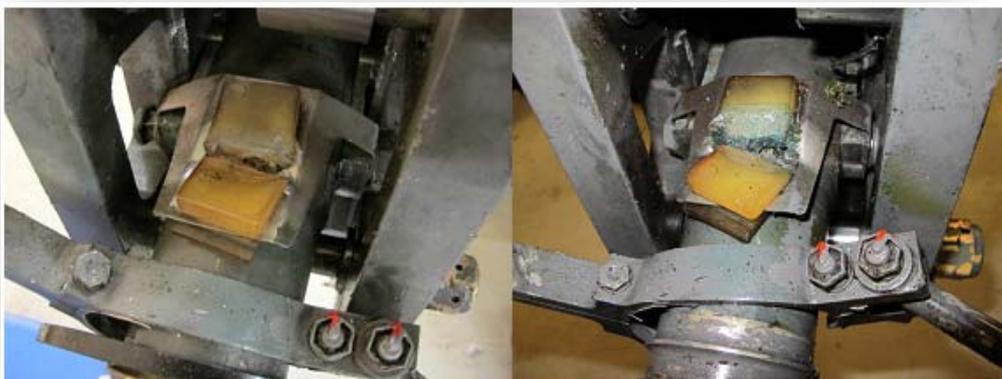
Figure 11: Teeter Stops of B-KTK

- (3) Main rotor blade serial number 4686 was bent upward approximately 80° at 3 feet from the hub with a partial fracture of the spar and another upward bend approximately 70° at 7 feet from the hub. The spar was completely fractured along with a portion of the afterbody, which was bent downward approximately 45° at 3 inches from the tip. The surface of the fractures were angular and jagged. There were multiple creases running chordwise along the length of the blade. The trailing edge sustained impact damage.
- (4) The damage to the cabin and main rotor blades indicated that one of the blades had entered the cabin under rotation. The outboard section of this blade had broken off when the leading edge made contact.
- (5) Both elastomeric teeter stops were damaged and had split in the middle in this accident (see Figure 11).

The main rotor and mast were inspected for evidence of inflight damage. Both elastomeric teeter stops had been crushed by the blade spindle compressing against the main rotor shaft. The damaged teeter stops were still held in position by the teeter stop brackets. The crushing of the teeter stops found on the mast head was a clear indication that the blades had teetered excessively beyond limits, and mast bumping had occurred.

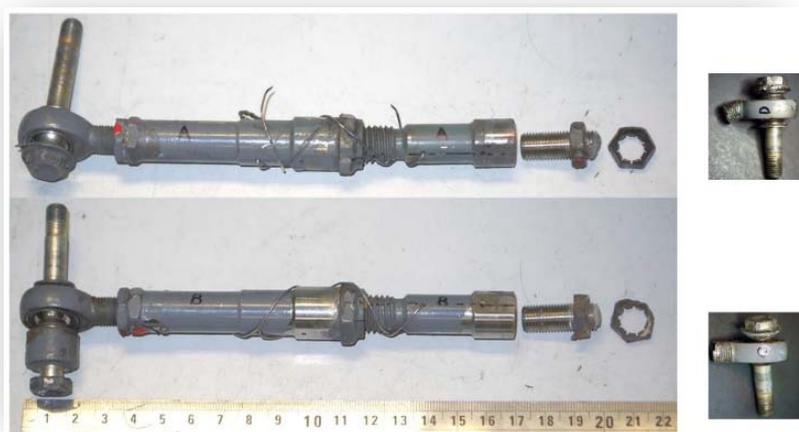
Figure 12: Broken Pitch Change Links

The upper rod ends of both pitch change link¹¹ assemblies were found broken. Non-destructive examinations were conducted on the fracture surfaces using a scanning electron microscopy (SEM) and an energy dispersive x-ray (EDS) Microanalyser in a Hong Kong laboratory. The results were communicated verbally to the AAIA in early January and the report was received on 15 January 2021. It observed metallurgical features and opined that fatigue cracking was initiated with a very small propagation rate.

- (2) The CAD proactively issued a CAD Safety Information Bulletin – Airworthiness (SIB) No. 2021-01 on 29 January 2021 for the upper rod ends of both pitch link assemblies to operators/owners of R44/R44 II & R66 helicopters in Hong Kong.
- (3) The SIB recommended two proactive safety measures on the pitch link assemblies. Regardless the part-numbers of the pitch link assemblies installed on R44/R44 II (SL-58) and R66 (SL-20) helicopters, operator/owner should consider either of the following safety measures and proactive maintenance actions:
 - (a) Carry out Magnetic Particle Inspection (MPI) in accordance with RHC Maintenance Manual on the upper rod end threaded portion of the pitch link assemblies; or
 - (b) Replace the pitch link assemblies¹² with P/N C258-5 in pair per the above-mentioned RHC Service Letters with new assemblies.

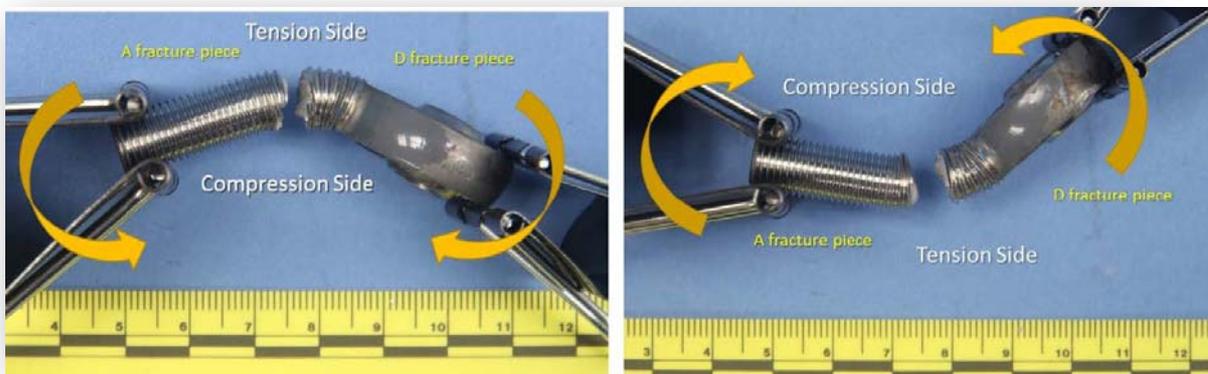
Figure 13: End Remnants A-D

- (1) In order to further augment the analysis, the link assemblies were later sent to the NTSB¹³ materials laboratory for non-destructive examination with a field emission scanning electron microscope (FESEM).¹⁴
- (2) After further analysis, the NTSB determined that the collective metallurgical features observed macroscopically and microscopically on the fracture surfaces were consistent with overstress fracture. End remnants A-D fractured from bending overstress (see Figure 13). End

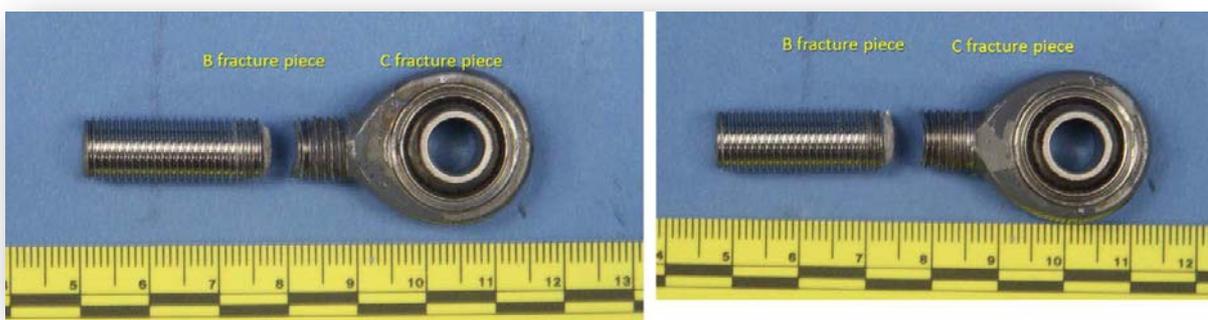
Figure 14: End Remnants B-C

remnants B-C fractured from torsional overstress (see Figure 14). The NTSB did not observe any features consistent with indications of pre-existing cracking.
