Runway Incursion (RI-VAP)

Investigation Report

**Bombardier Global 5000, P4-AVA and
Boeing 737-81B, B-1918**

13 November 2018

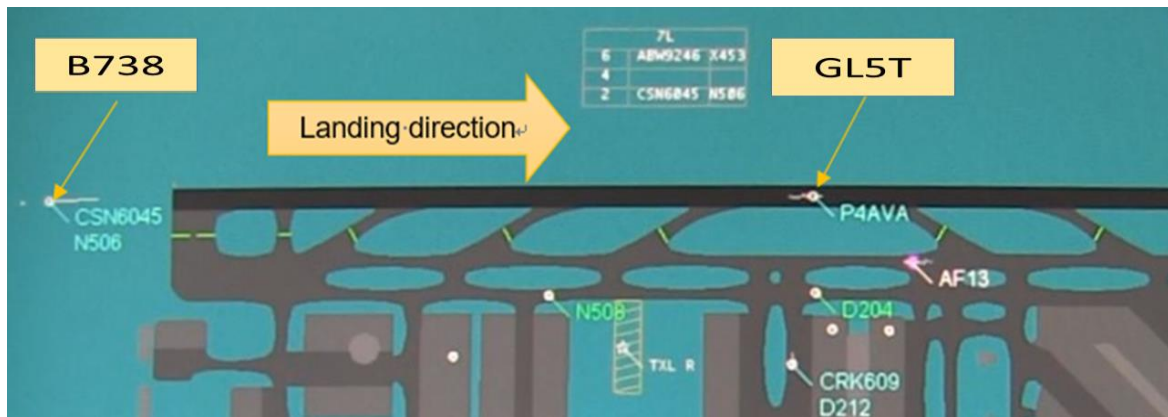
Figure 2: Screenshot of Controller's A-SMGCS Display when the B738 was cleared to land

- (12) At 19:47:12, the B738 was cleared to land by the controller when the aircraft was about to cross the beginning of RWY 07L. However, at that moment the GL5T was still taxiing on the runway more than 200 metres from RET A7, as shown in the screenshot of the controller’s Advanced Surface Movement Guidance & Control System (A-SMGCS) Display in Figure 2.

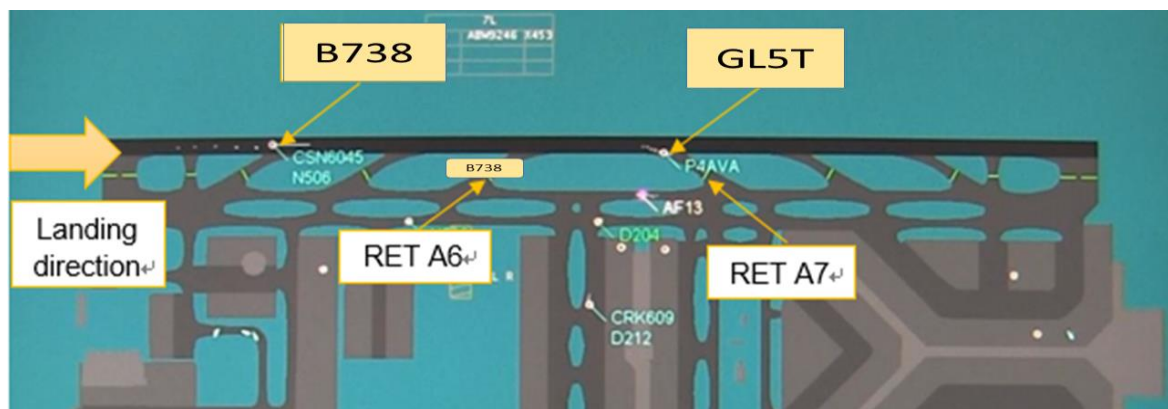
Figure 3: Screenshot of Controller's A-SMGCS Display when the B738 touched down

- (13) The B738 landed at 19:47:26 with the GL5T approaching RET A7. The screenshot of the controller's A-SMGCS display shows the moment when the B738 touched down on the runway while the GL5T was approaching the runway exit. The distance between the two aircraft at this moment was 1,470 metres. [See Figure 3.]

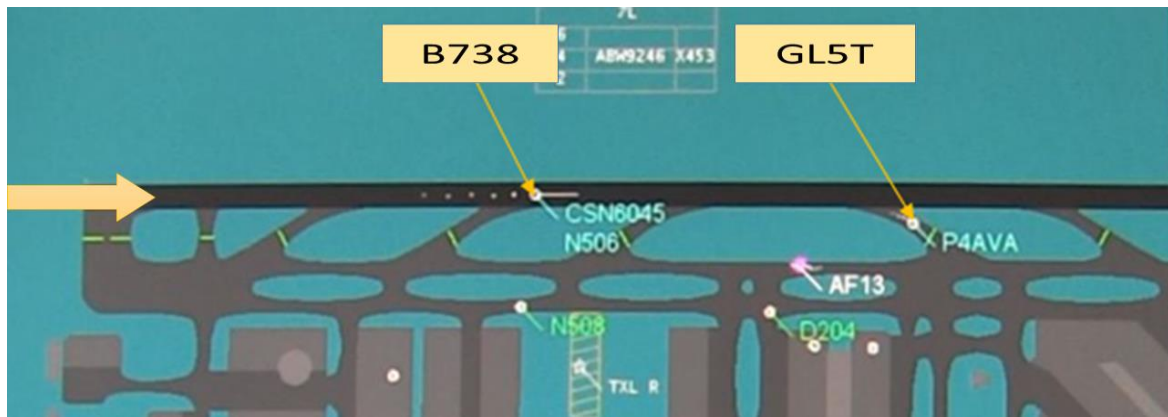
Figure 4: Positions of the GL5T and the B738 at 19:47:35

- (14) At 19:47:35, the GL5T entered RET A7 to vacate the runway. The distance between the two aircraft was just in excess of 1,000 metres. The screenshot in Figure 4 shows the positions of the GL5T and the B738 at that moment.

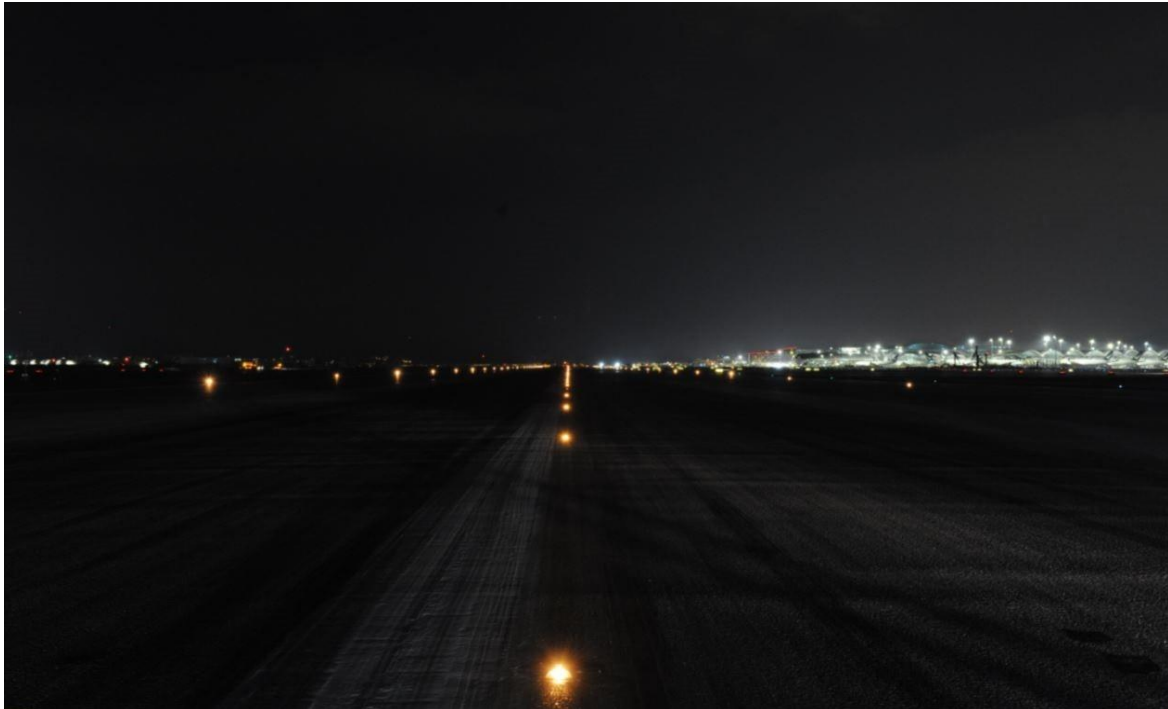
Photo 1: Cockpit View When Approaching RET A6 on Landing Roll

- (5) As RET A6 was designed for landing on RWY 25R, no lead off lights could be seen by the pilots at the location of the GL5T taxiing in the opposite (RWY 07) direction. [See Photo 1 below.]

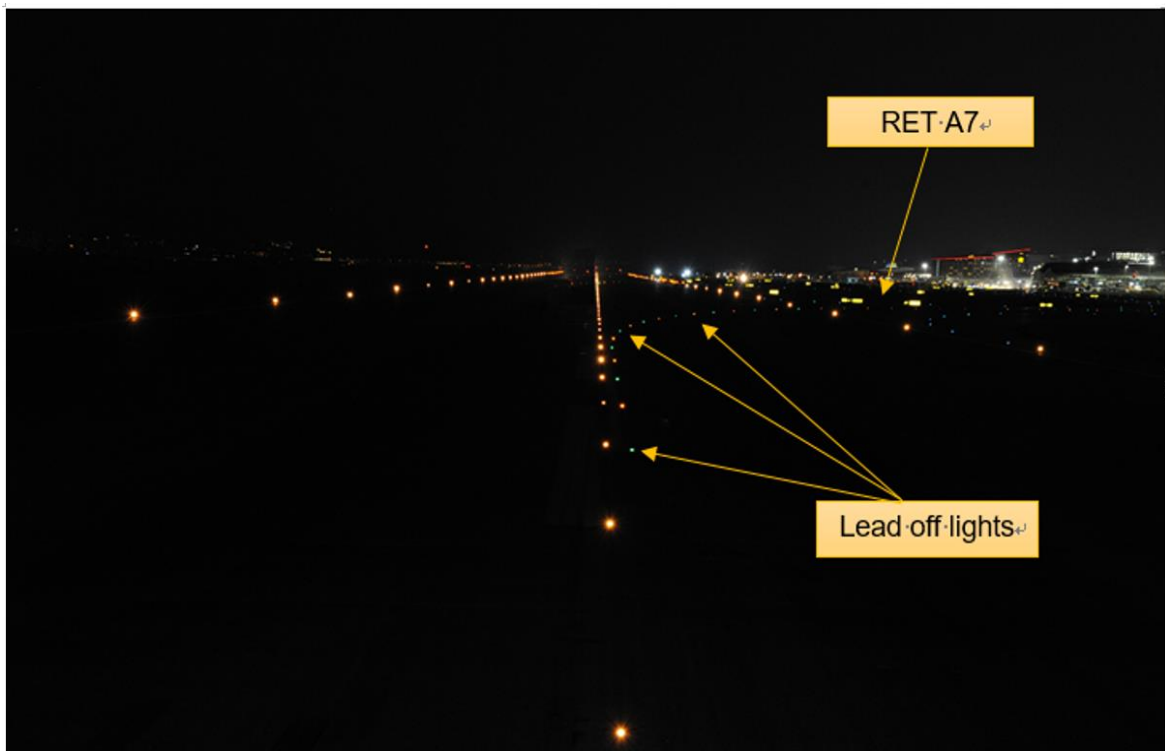
Photo 2: Lead off Lights Guiding Aircraft to RET A7

- (6) As an aircraft approaches RET A7, the lead off lights guiding the aircraft to vacate the runway can be seen in alternating green and yellow. [See Photo 2 below.]

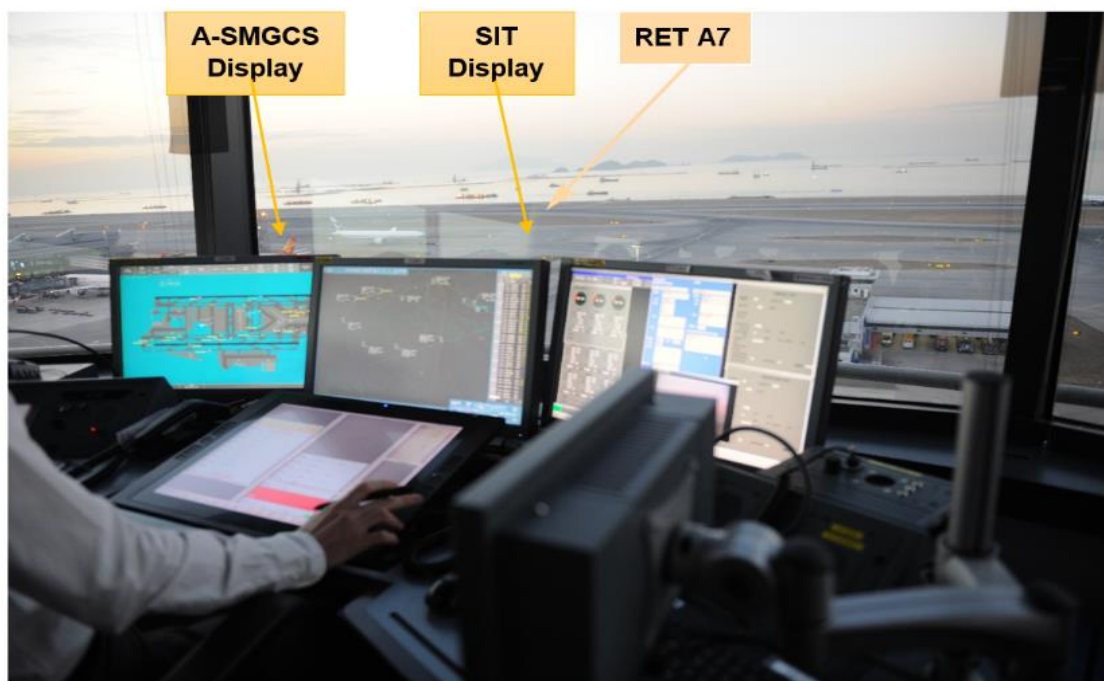
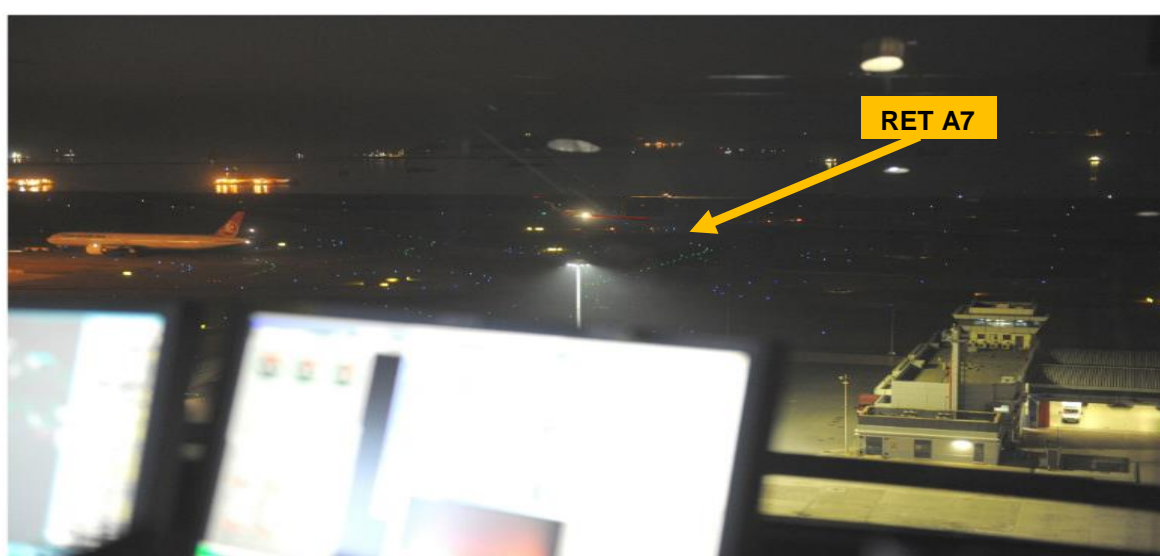
- (1) The views of the North Runway at the AMN control position during daytime and night-time are shown in Photo 3 and Photo 4 respectively.

- (2) Due to the relatively lower level of depth perception and visual reference during night-time as compared with daytime, it can be challenging for Tower controllers to readily determine the relative motion of an aircraft by solely relying on visual observation. Photos 5 and 6 show an exemplar aircraft in the process of vacating RWY 07L via RET A7 during daytime and night-time respectively. Tower equipment such as A-SMGCS can help Tower controllers in making such assessments.
