# Deviation from Intended Flightpath

## Investigation Report

**Serious Incident to  
Boeing 787-9, A6-BLF,  
Waypoint RIVER of Hong Kong**

**7 September 2019**

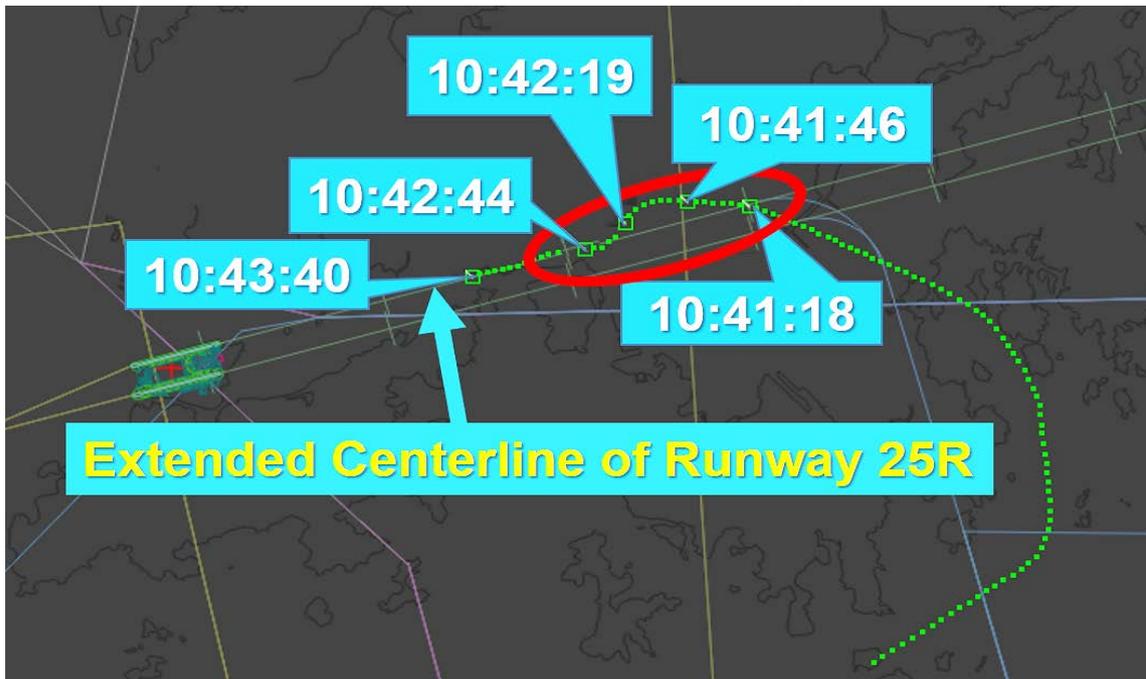
**Figure 2: Radar Plot of Flight Track**

- (3) During this ILS approach to RWY 25R in visual meteorological conditions (VMC), the aircraft with the autoflight system engaged proceeded to intercept the LOC at waypoint RIVER, which was 15 NM from the RWY, from the southeast on a HDG of 292 degrees. The aircraft made an initial turn to the left to capture the LOC.
- (4) However, at 10:41:18 hrs, the aircraft overshot the LOC and continued to deviate to the right towards terrain in the north and descended below the MSA of 4,300 ft. No EGPWS warnings were triggered.
- (5) About 30 seconds after overshooting to the north of the LOC course, the PF disengaged the autoflight system and assumed manual control of the aircraft. At 10:42:44, the aircraft was re-established on the LOC course approximately 11 NM from the RWY threshold and landed uneventfully.

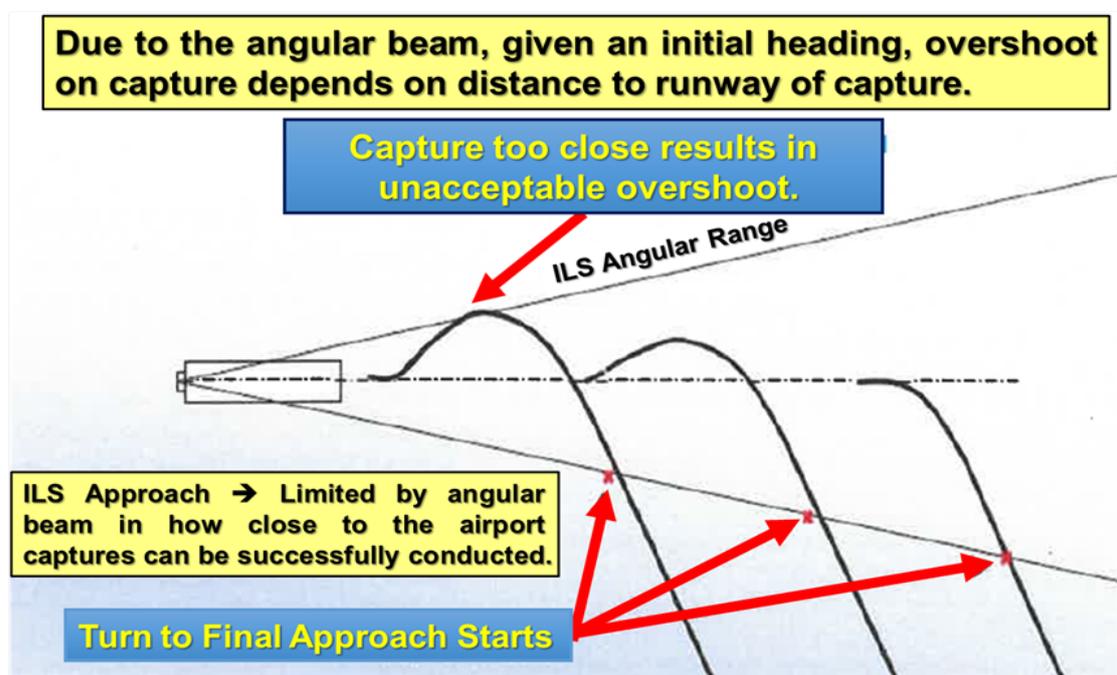
**Figure 8: Effect of Intercept ILS Close to RWY**

- (2) ILS approach LOC captures that occur too close to the RWY can result in LOC trajectory overshoots as shown in the graphic below.

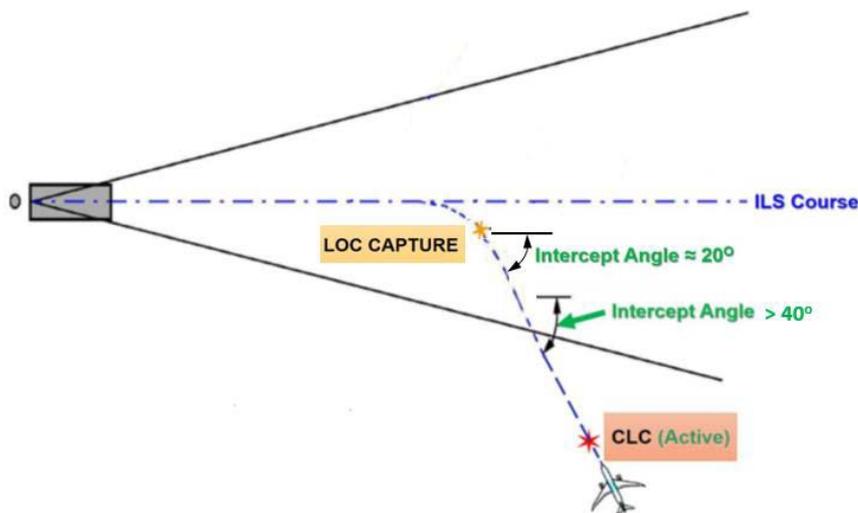
Figure 10: CLC Mode to LOC Capture Mode

- (7) CLC has enough authority to turn the aircraft up to 20 degrees off of the LOC course. This results in the aircraft turning to a LOC intercept angle of approximately 20 degrees.
- (8) During the turn, CLC will automatically transit to the LOC capture control law when the LOC is within parameters for capture and "LOC" will continue to be visible on the FMA.

- (4) This might result in the aircraft turning to a LOC intercept angle of approximately 20 degrees and flying through the LOC course on this track, rather than properly capturing the LOC.
- (5) "LOC" would remain on the FMA despite the failed capture and, in some circumstances, the aircraft might begin descent on the glideslope while it was deviating 20 degrees off the LOC course.
- (6) Boeing concluded that the occurrence was due to a software failure of the CLC which was a submode of the auto-flight function in AFDS.
