Air Accident Investigation Authority

Deviation from Intended Flightpath

Investigation Report

**Serious Incident to
Boeing 787-9, G-VOWS
Waypoint RIVER of Hong Kong
29 September 2019**

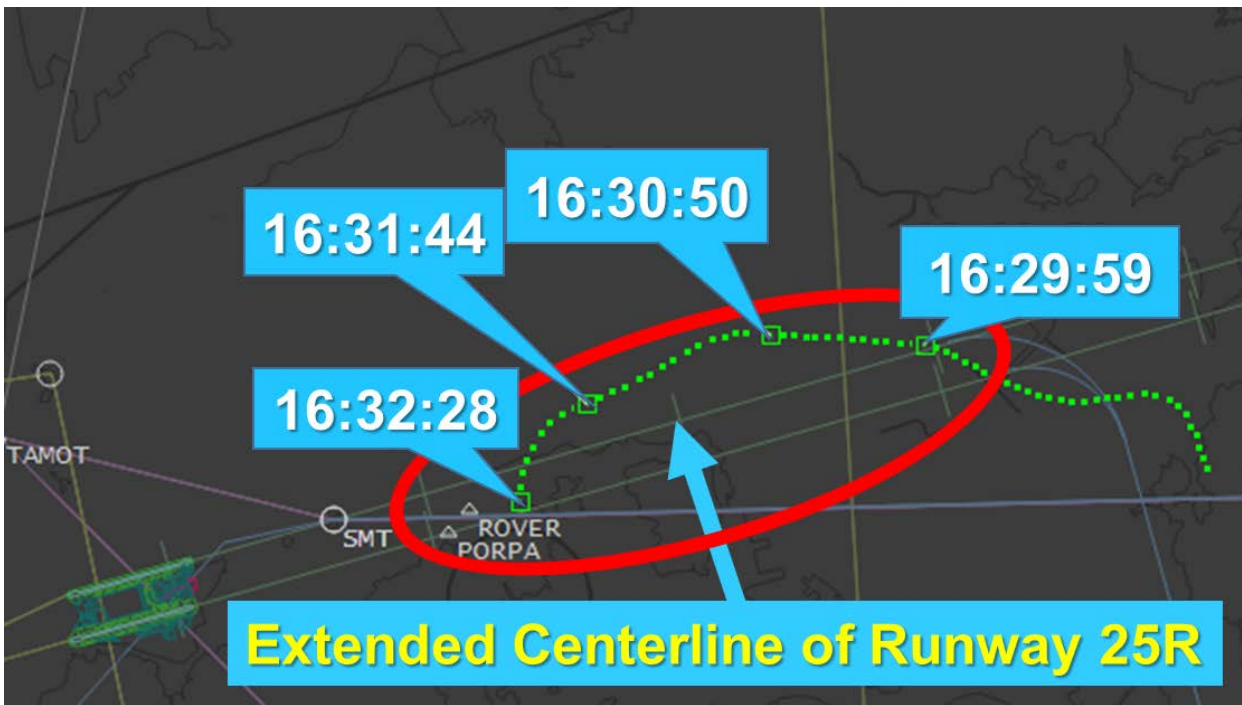
Figure 2: Radar Plot of Flight Track

- (3) The aircraft, with the autoflight system engaged, proceeded to intercept the LOC at the waypoint RIVER, which was 15 Nautical Miles (NM) away from the RWY, from the southeast.
- (4) At 16:29:59 hrs, while the aircraft was turning left to intercept the LOC from the south, it overshot the LOC course and continued to deviate to the north towards terrain and descended below the MSA of 4,300 ft. The flight crew identified the deviation from the LOC course and began to prepare for the missed approach (go around).
- (5) Shortly after, at 16:30:50 hrs, ATC instructed the aircraft to go around. No EGPWS warnings were triggered.
- (6) Following the go-around and the second approach to the same RWY, the aircraft landed uneventfully.

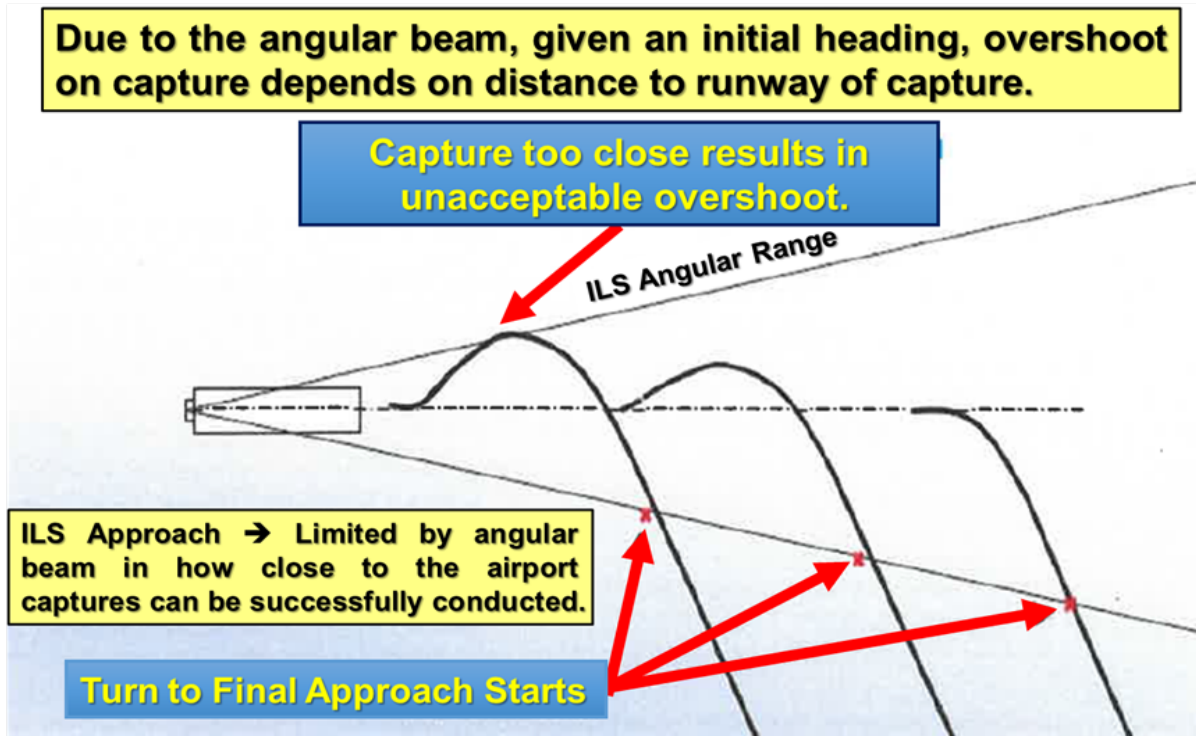
Figure 8: Effect of Intercept ILS Close to RWY

- (2) ILS approach LOC captures that occur too close to the RWY can result in LOC trajectory overshoots as shown in the graphic below.

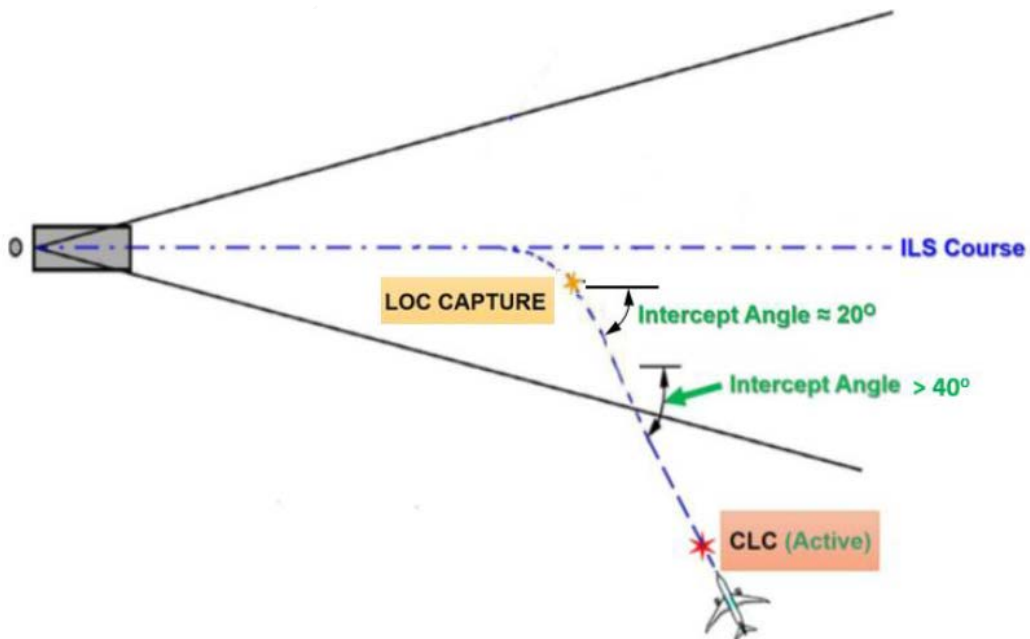
Figure 10: CLC Mode to LOC Capture Mode

- (7) CLC has enough authority to turn the aircraft up to 20 degrees off of the LOC course. This results in the aircraft turning to a LOC intercept angle of approximately 20 degrees.
- (8) During the turn, CLC will automatically transit to the LOC capture control law when the LOC is within parameters for capture and "LOC" will continue to be visible on the FMA.
