# Deviation from Intended Flightpath

## Investigation Report

**Boeing 787-9, G-VBOW**

**18 October 2019**

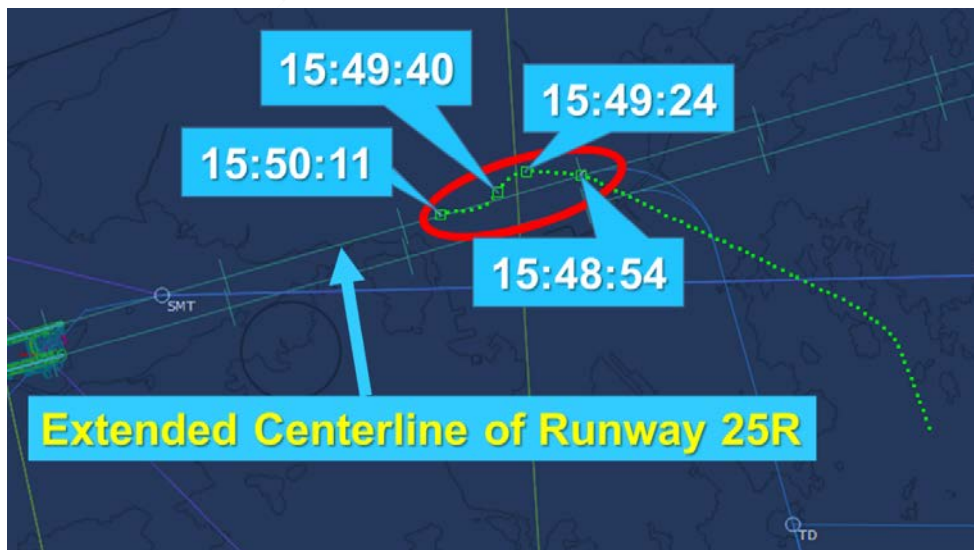
**Figure 2: Radar Plot of Flight Track**

- (4) While the movement of the LOC pointer was slow, there was a brief discussion in the flight deck between the PF and the Pilot Monitoring (PM), referring to the previous incident, as whether the gentle bank was sufficient to properly capture the centreline. When the aircraft crossed the LOC centreline at 15:48:54 and it did not completely turn onto the RWY, it was immediately agreed by both pilots that a pilot action was necessary, once the aircraft overshoot the intended HDG, diverging from the LOC course towards the terrain in the north. No EGPWS warnings were triggered.

- (5) The PF disengaged the autoflight system and assumed manual control of the aircraft, re-establishing the aircraft on the ILS HDG approximately 12 NM from the RWY threshold and landing the aircraft uneventfully.

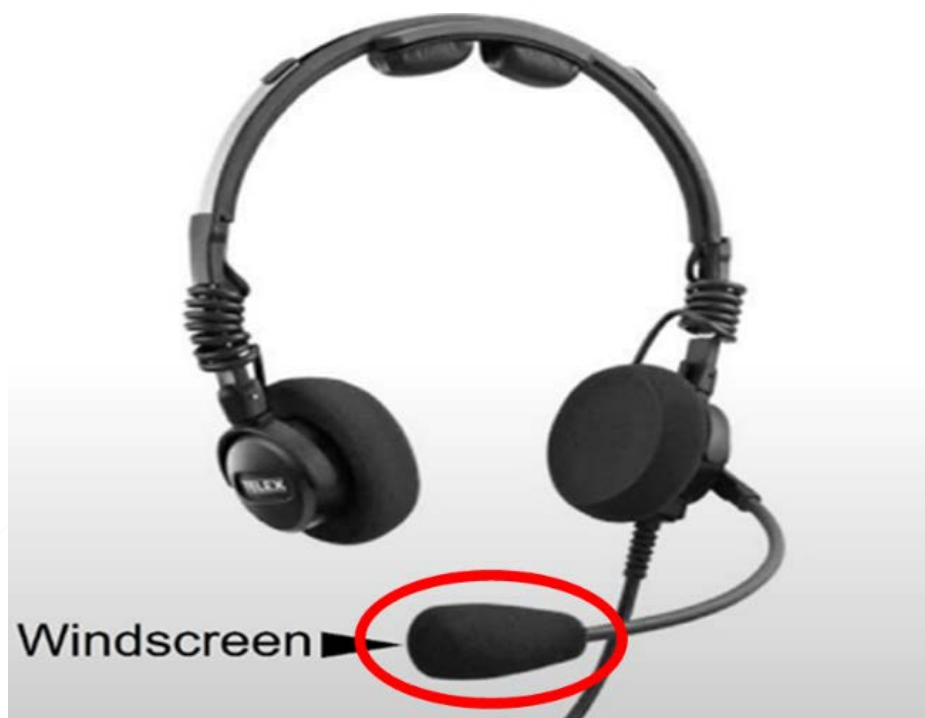
**Figure 11: Typical Windscreen**

- (1) To find out the cause of the quality issue of CVR audio recording, in April 2020, VAA carried out a flight in one of its Boeing 787 aircraft, during which the co-pilot's headset was fitted with a microphone windscreen but the commander's one was not.

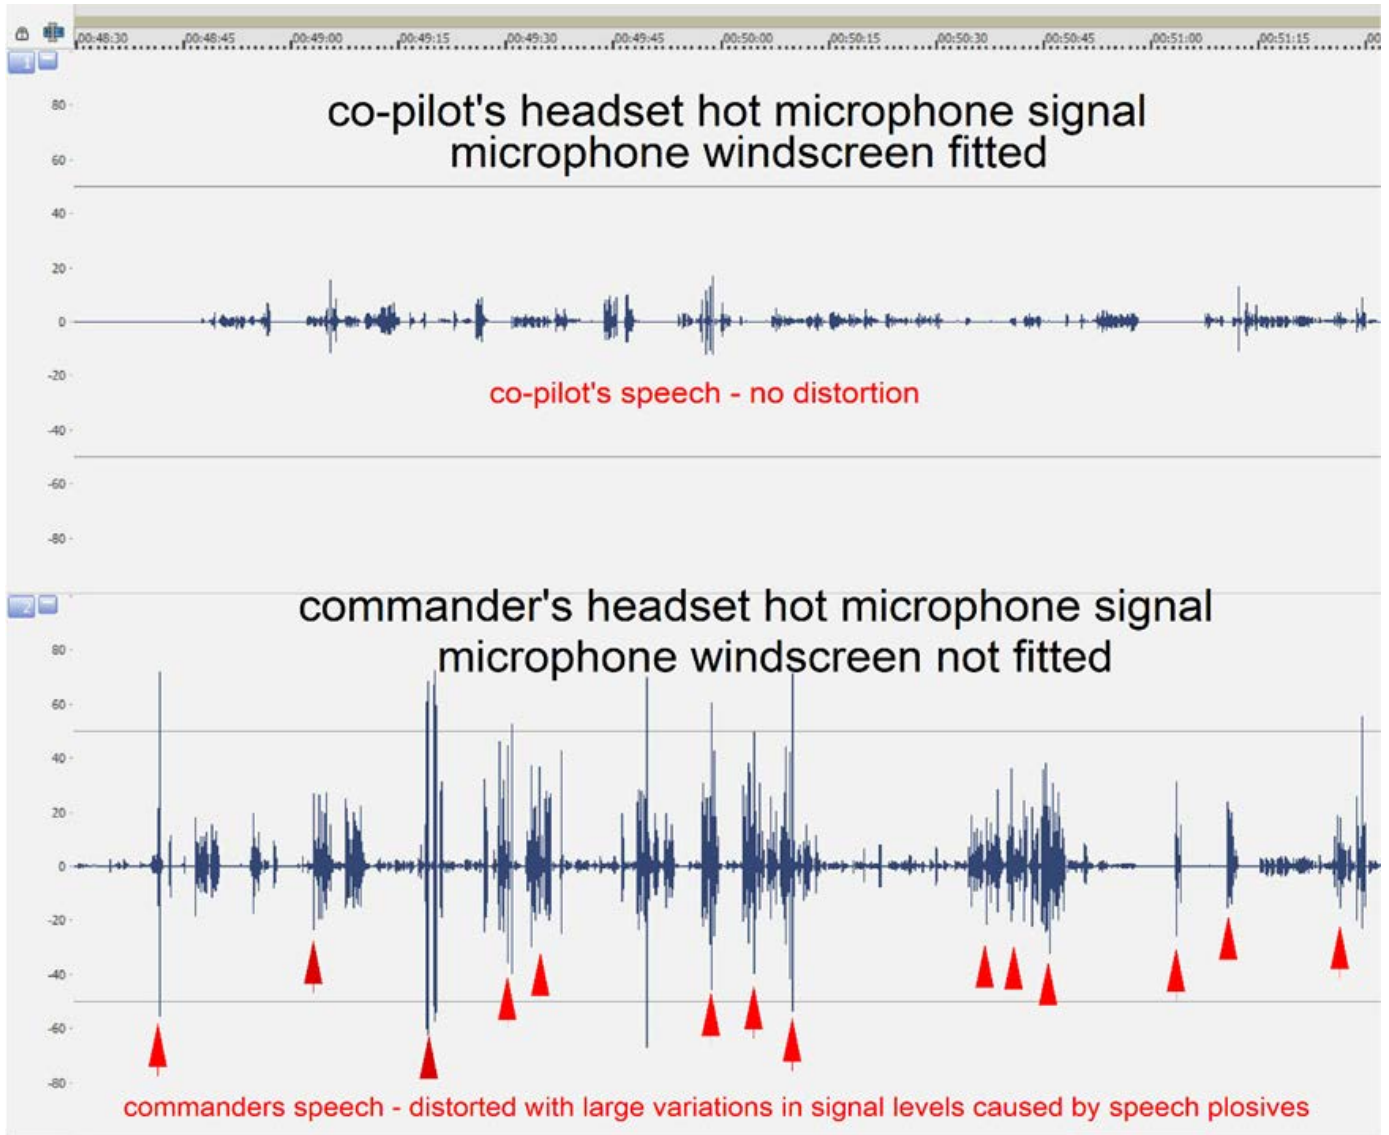
**Figure 12: Headset Microphone Signals with Windscreen Fitted/Not Fitted**

- (2) The CVR audio showed that the co-pilot's speech was clear of distortion, whereas the commander's speech was not, with large variations in signal amplitude when speaking.

- (3) The distortion of the commander's speech was consistent with the CVR recordings from G-VBOW aircraft.
- (4) This evidence showed that during the event flight, neither of the pilots' headsets were fitted with a microphone windscreen.
- (5) The flight crew were unaware that the absence of the windscreen could be an issue to the CVR recording.

It is recommended that Boeing study the effects of the fitment of microphone windscreens to cockpit headsets on the quality of the CVR audio recording. Boeing should inform operators of the significance of the windscreen fitment if the study notes any adverse effects on the CVR recording quality.

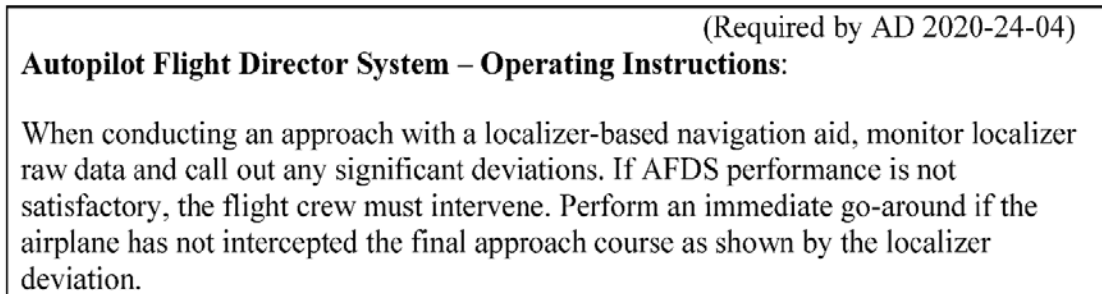
**Figure 14: Operating Instructions of AFDS**

- (4) The FAA issued AD No. 2020-24-04 Correction dated 9 December 2020 to correct errors in AD related to certain references to the AFM.
- (5) This AD required revising the existing AFM to incorporate procedures for conducting an approach with a LOC-based navigation aid, monitoring LOC raw data, calling out any significant deviations, and performing an immediate go around if the airplane has not intercepted the final approach course as shown by the LOC deviation.
- (6) The AD mandated the following changes made by Boeing in the Operating Instructions of the AFM with the effective date of 18 December 2020.

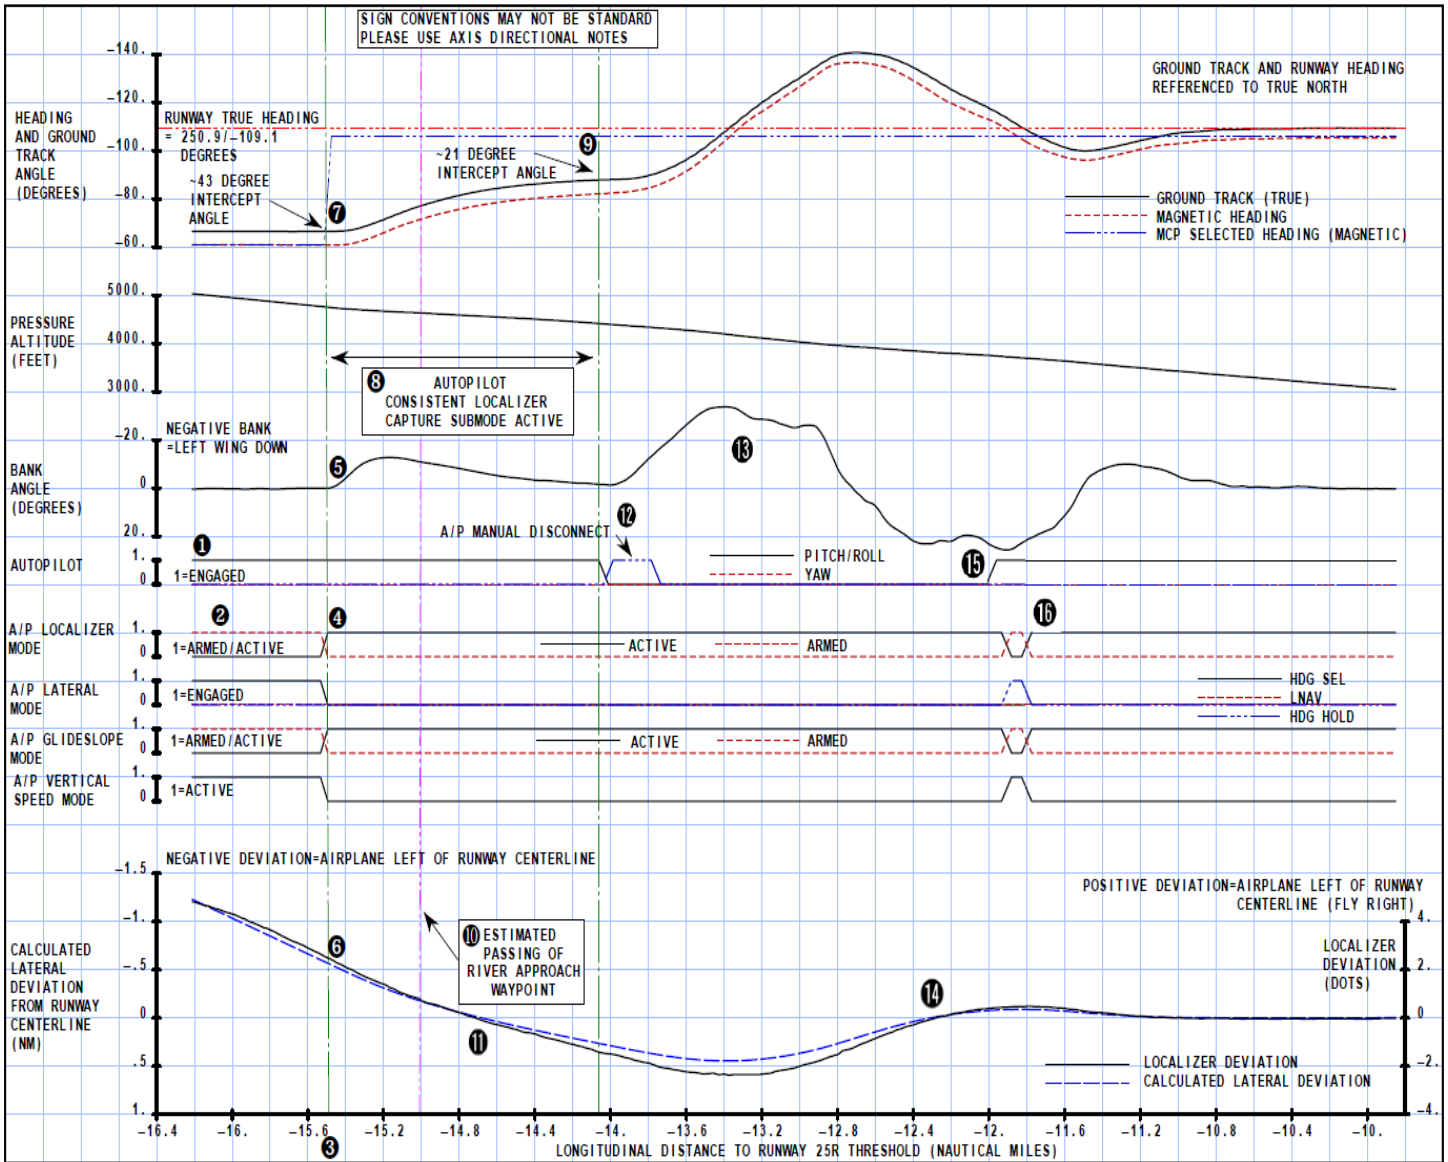
Figure 15: Ground Track of EAFR Data

AAIA analysed the flight data from the EAFR in conjunction with AAIB and Boeing. The main purpose of the analysis was to establish the cause of the LOC course deviation during approach. A ground track analysis was generated to show the aircraft's path during the approach as shown in the figure below.

- (15) Then left control wheel was input by the flight crew and the aircraft was banked left wing down to re-capture the LOC. See ⑬ in Figure 15.
- (16) The aircraft crossed the LOC beam a second time (deviation value of zero) at the time 15:49:41. See ⑭ in Figure 15.

- (17) The A/P pitch/roll channel was re-engaged at the time 15:49:48. See ⑮ in Figure 15.
- (18) The aircraft was re-established on the LOC at the time 15:49:52 and about 11.1 NM from the RWY threshold without further incident and landed on RWY 25R. See ⑯ in Figure 15.

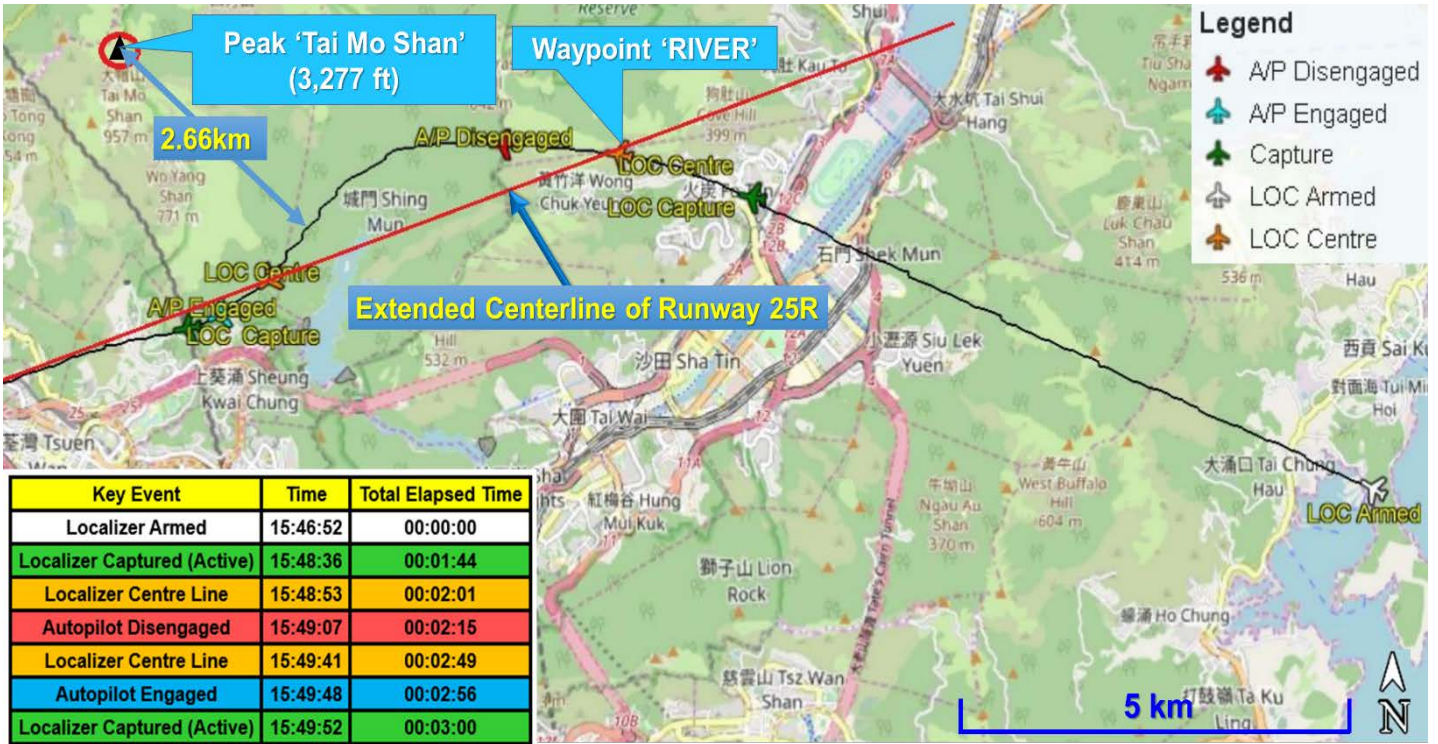
Figure 16: Flight Track with AFDS Status

- (1) Evaluation of the flight data suggested that the CLC AFF initiated the turn towards the RWY 25R LOC, as LOC annunciated the active roll mode.
- (2) After the CLC AFF had initiated the turn, the A/P transition to the LOC mode did not occur. This resulted in the aircraft HDG stabilised 20 degrees short of the LOC course and flying through the LOC course on this track, rather than properly capturing the LOC.
- (3) The recorded flight data was consistent with the LOC capture anomaly of the AFDS as described in the FTD 787-FTD-22-20001.
- (4) The LOC course deviation observed was due to the LOC capture anomaly of the AFDS.
- (5) The FTD stipulated that the issuance of a Flight Crew Operations Manual Bulletin and related FAA AD 2020-24-04, associated with the software modification released by Boeing via Alert SB B787-81205-SB270053-00 addressed this anomaly.
