Air Accident Investigation Authority

Investigation Report

**Incident to
Boeing 737-800BCF, VP-BEN,
Hong Kong International Airport
Hong Kong
14 October 2021**

IVR-2025-03

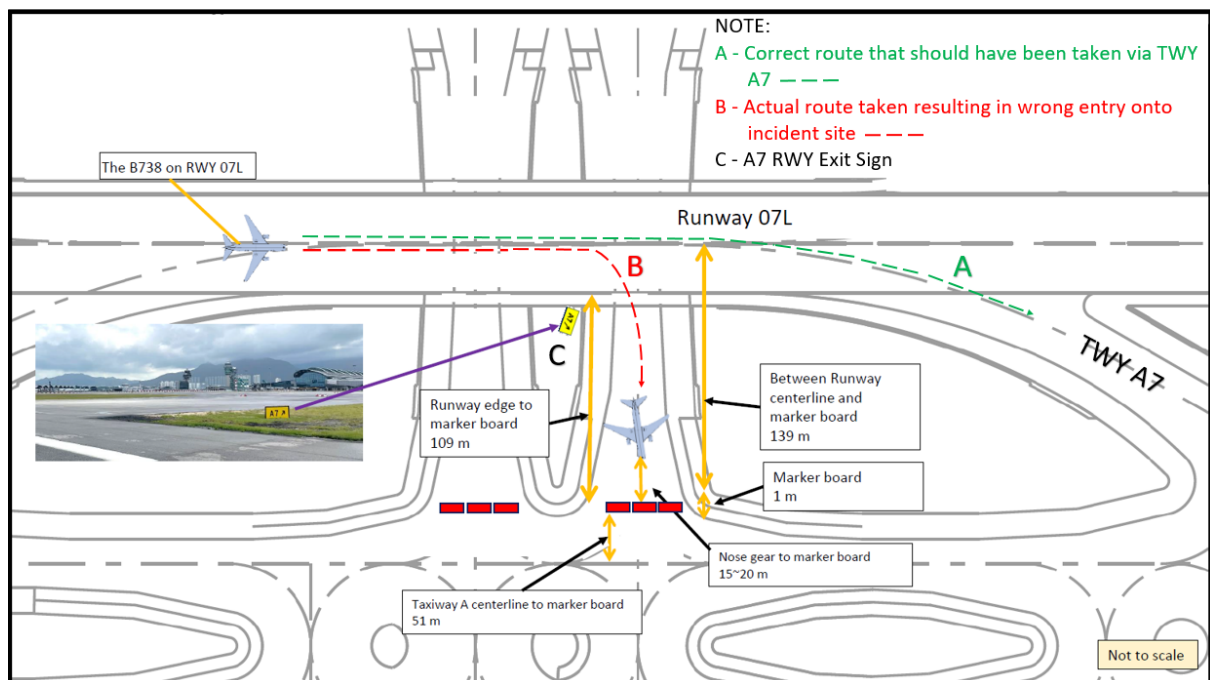
Figure 1 – Entry of the B738 onto the incident site

While following Air Traffic Control (ATC) instructions to vacate the runway via Taxiway (TWY) A7, the aircraft taxied onto a paved area between TWYs A6 and A7 (the incident site). The incident site was a section of a twin-taxiway system being built for future aircraft operations. The aircraft stopped in front of marker boards on the incident site and was instructed by ATC to shut down all engines.

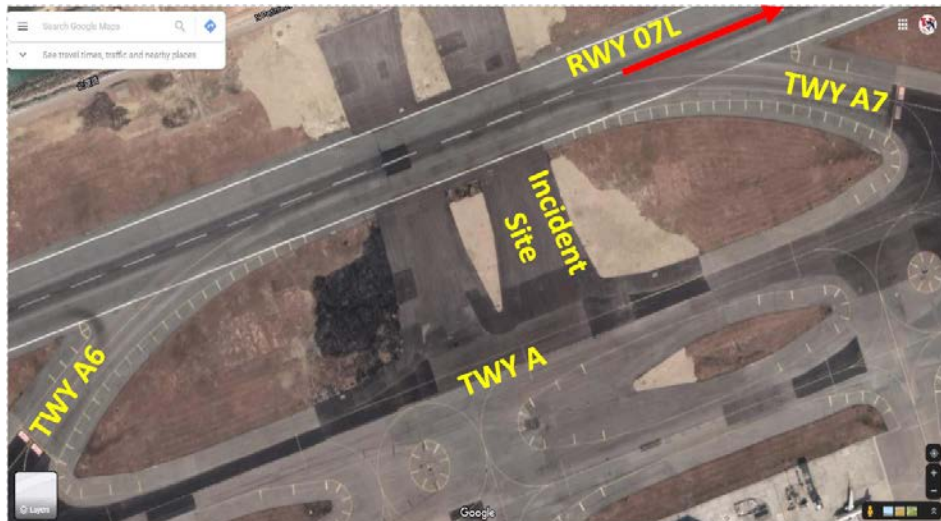
Figure 2 - Aerial view of the incident site

- (1) As part of the 3RS Project, a pair of dual taxiways on both sides of and across the original North Runway was constructed. These dual taxiways would provide a temporary crossing for aircraft ground movements between the new North Runway and those parts of the airport to the south of the original North Runway during closure of the latter runway for reconfiguration. These temporary taxiways would be decommissioned once the reconfigured Centre Runway and the wrap-around taxiways at both runway ends became operational.
- (2) The incident site was located between TWYs A6 and A7 on the southern side of the original North Runway (07L/25R) [see Figure 2 below].

- (3) The part of the project at the incident site commenced in April 2017 and was completed in June 2020. At the time of the incident on 14 October 2021, there were no ground markings or aerodrome ground lights on the incident site as it had not yet been commissioned for aircraft operational use, which was scheduled for the 3rd quarter of 2022. As stated in 1.8.2, marker boards with unserviceability lights were placed at the site.

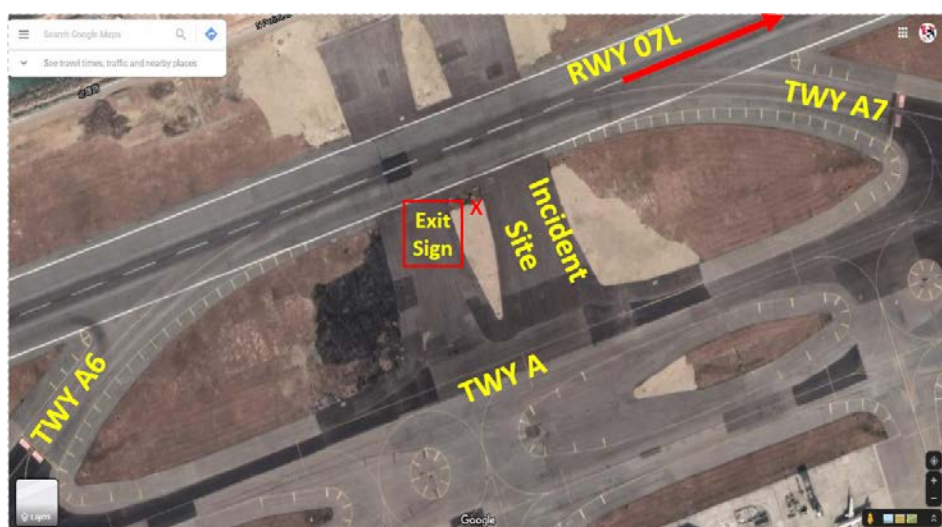
Figure 3: Location of RWY Exit Sign for TWY A7

- (a) Standard aerodrome ground lights (AGL) and ground markings were provided along the surface of runways and exit taxiways.
 - (b) RWY Exit Sign for TWY A7 was placed *“prior to the runway exit point in line with a position at least 60 m prior to the point of tangency where the code number is 3 or 4”* as per ICAO Annex 14⁸, Volume 1, paragraph 5.4.3.17 [see Figure 3].

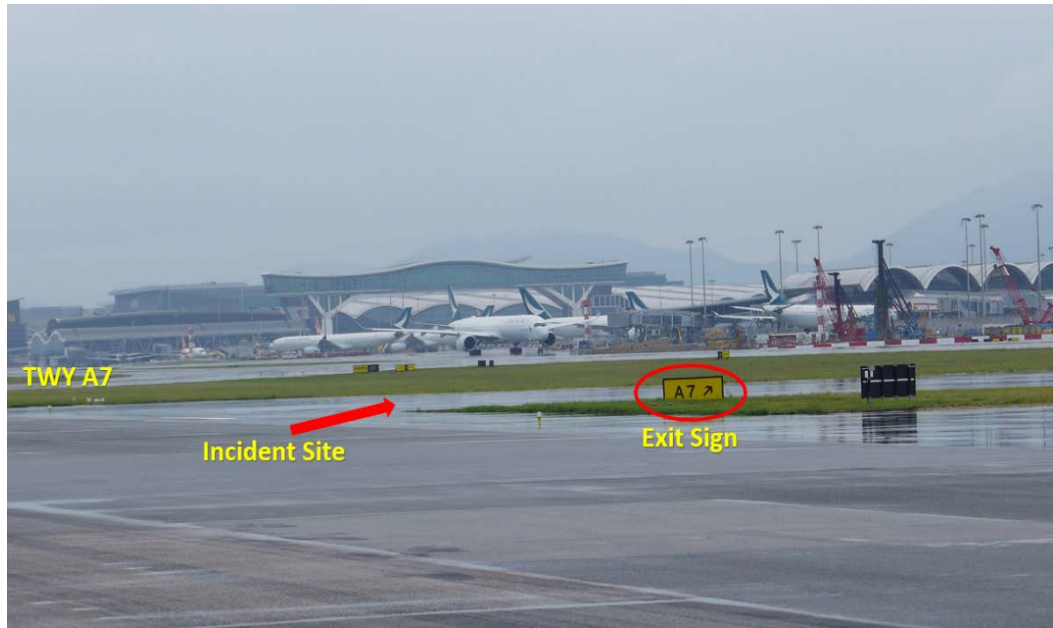
Photo 1: Inscription on RWY Exit Sign for TWY A7

- (c) The inscription on the RWY Exit Sign for TWY A7 consisted of an arrow with a 45-degree inclination to indicate the direction towards TWY A7 [see Photo 1].

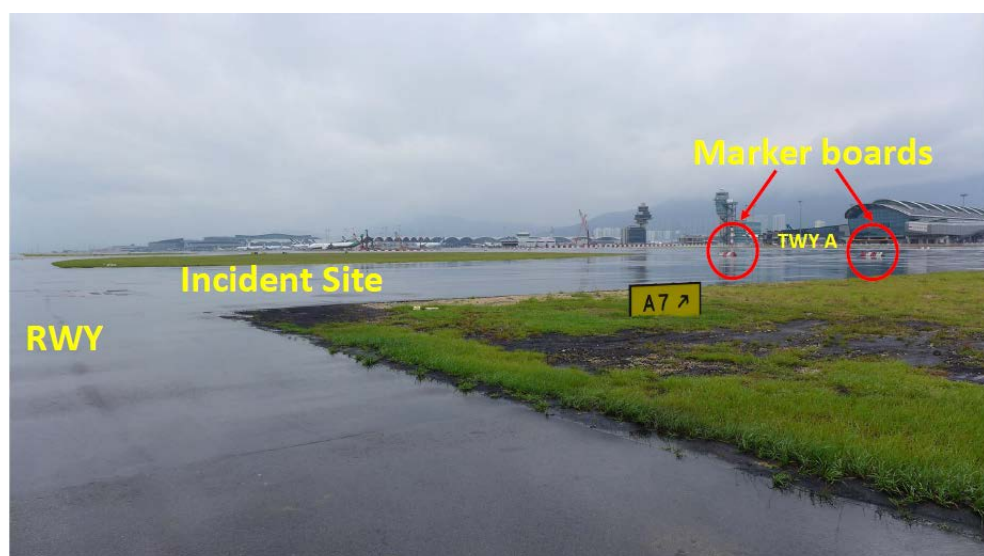
Photo 2: Location of marker boards on the incident site

- (d) As it was considered that the incident site had not yet been commissioned for operations, it had not been provided with any visual ground aids (i.e. ground markings and lighting). Marker boards and unserviceability lights (i.e. red fixed lights) were placed at the site.
- (e) These marker boards with unserviceability lights were placed at that end of the incident site close to the junction with TWY A at 51 m from the TWY A centreline and was far away from the other end of the incident site at its junction with the RWY at 140 m from RWY centreline and 109 m from RWY edge [see Photo 2].

- (f) The location of the marker boards as stated above was to avoid the risk of damage to aircraft in case of a runway excursion and impact due to jet blast generated by aircraft taking off. This consideration was based on ICAO Annex 14, Volume 1, paragraph 3.4.3 that *“A strip including a precision approach runway shall, wherever practicable, extend laterally to a distance of at least 140 m where the code number is 3 or 4 on each side of the centre line of the runway.....”* and paragraph 3.4.7 that *“No mobile object shall be permitted on this part of the runway strip during the use of the runway for landing or take-off”*.
