Loss of Control – Inflight (LOC-I)

Investigation Report

Ozone Rush 6 Paraglider,

Pyramid Hill, Hong Kong

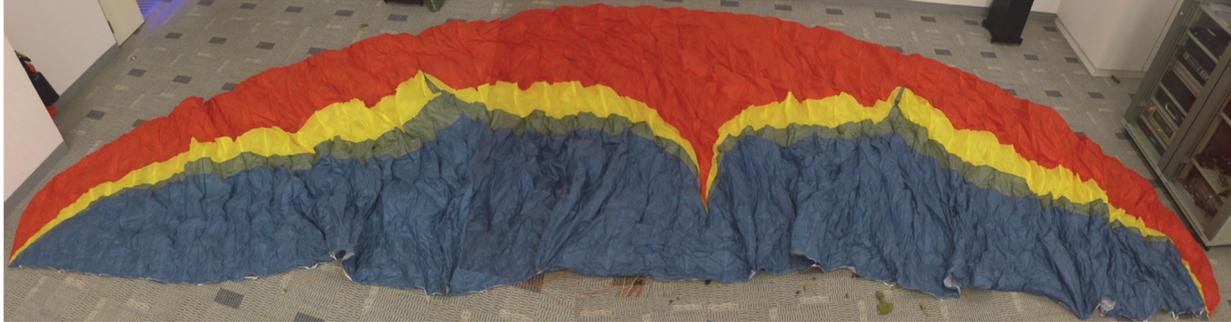
Photo 1: The Pilot’s “Ozone Rush 6” Paraglider Canopy

- (1) The paragliding canopy, Model “Ozone Rush 6”, were examined and found in good conditions.
- (2) All lines connecting the canopy to the harness remained intact.

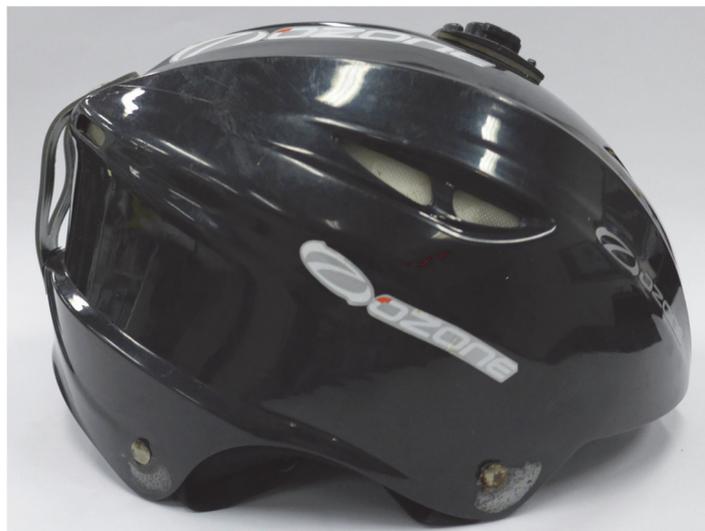
- (1) The helmet of the Pilot was attached with a label stating that its model number was SHM-001 and it was certified to EN 1077 standard. However, Ozone advised the investigation team that the helmet was not its product.

Photo 4: The Helmet of the Pilot

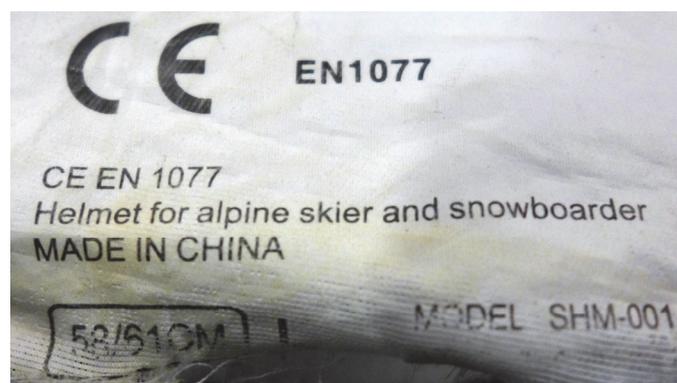
Photo 5: The Certification Label of the Helmet

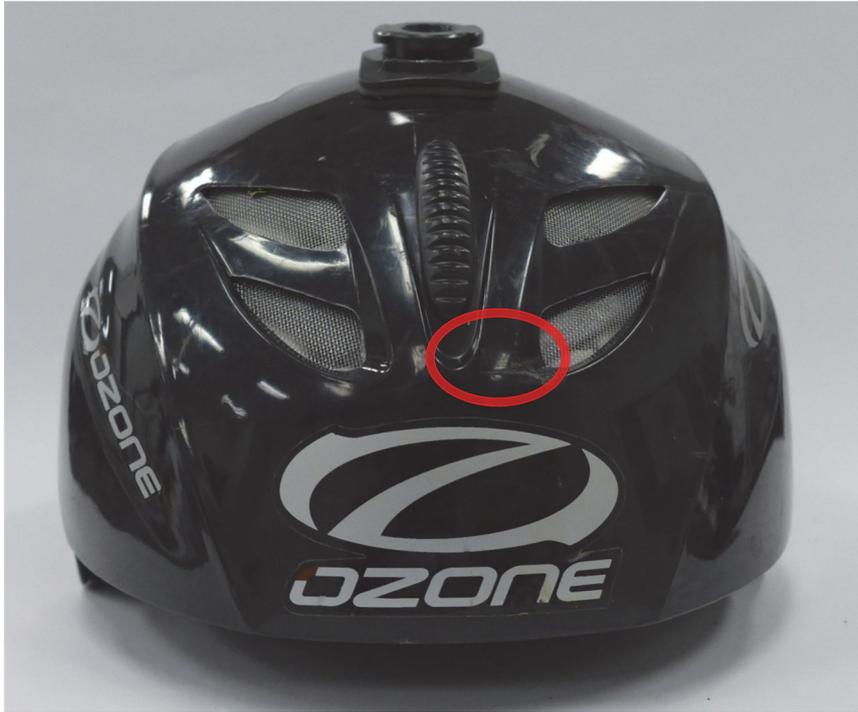
- (2) The examination revealed only a slight dent on the backside of the helmet.

Photo 6: A Slight Dent on the Backside of the Helmet

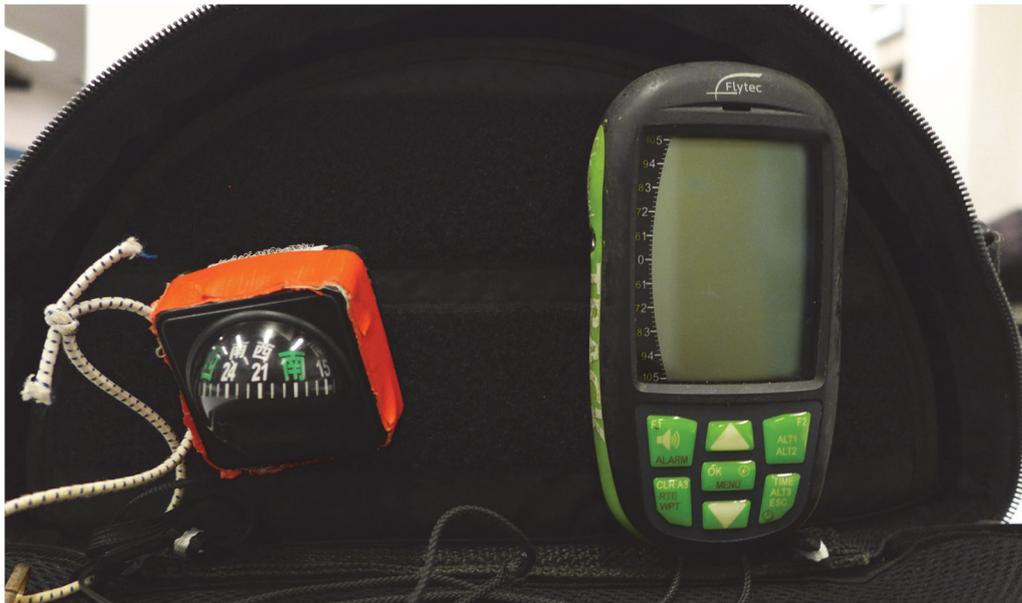
Photo 7: Compass and Variometer in the Flight Deck

- (2) The compass and the variometer were inspected and found operational.

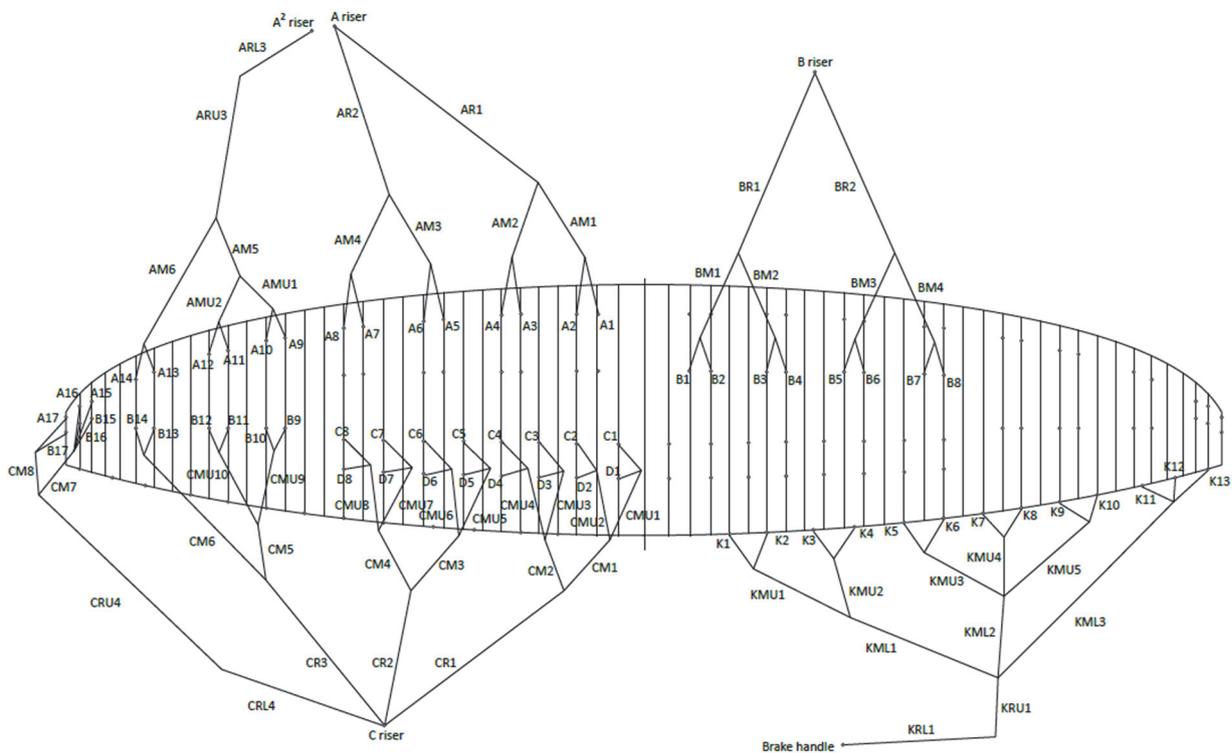
- (1) With the assistance of HKPA Safety Officer, a line check of paraglider lines was carried out in accordance with the manufacturer's rigging diagram and line chart. The difference between the manufacturer's design length and the calibrated measured length should not be greater than 10 mm.
- (2) The check revealed that the differences of all the lines were all less than 10 mm. There was no sign of significant aging or wear observed on the paraglider lines.

Figure 18: “Rush 6” Rigging Diagram for Line Check

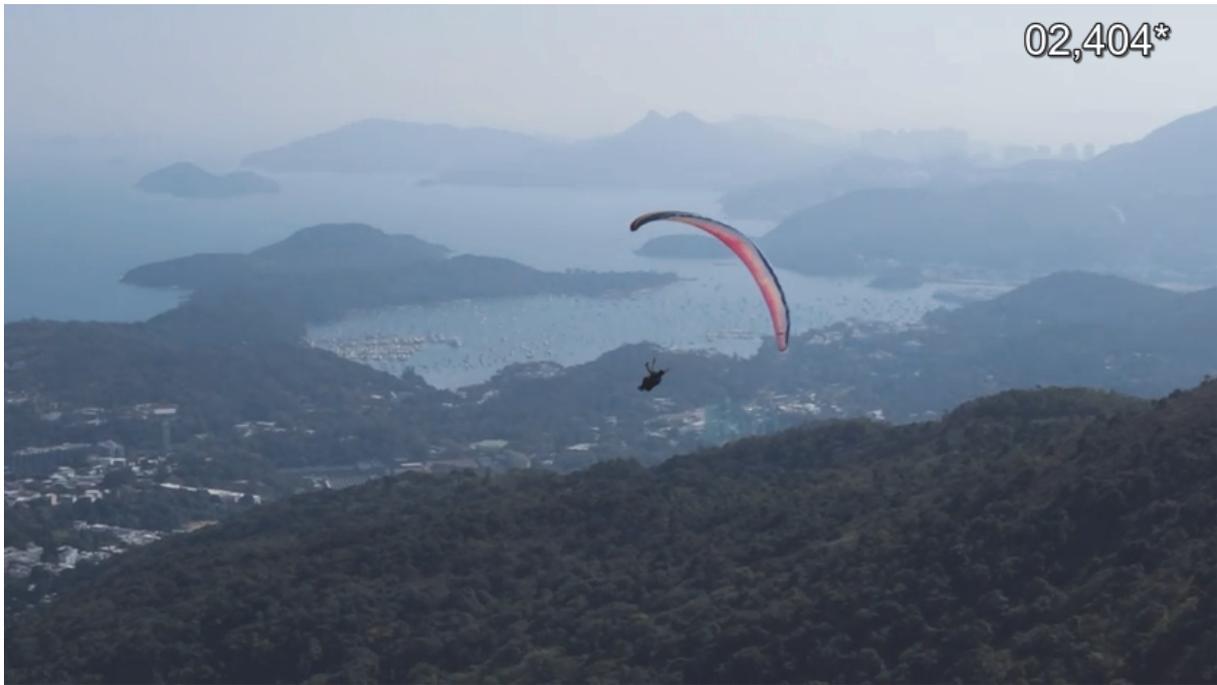
Figure 21: Video Image at 00:02.404 Seconds

- (3) From 00:01.402 to 00:02.404, the Pilot leaned his body to the right. At the same time, the Pilot released the left brake and pulled the right brake. The paraglider then started to roll and yaw to the right, resulting in a right turn.

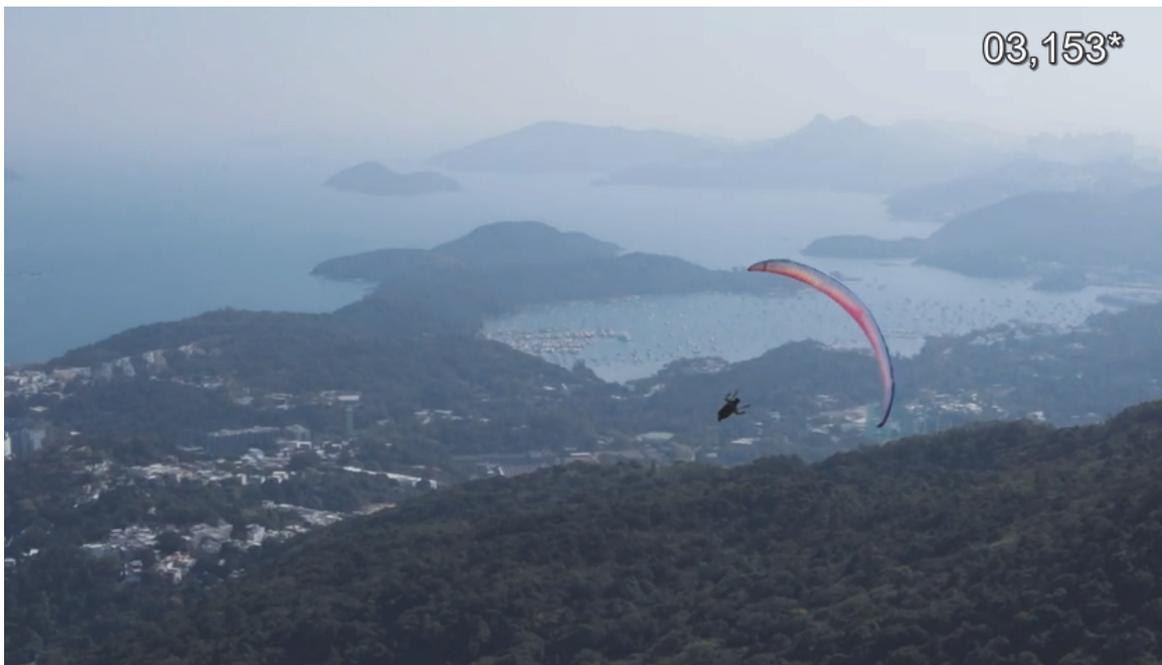
Figure 22: Video Image at 00:03.153 Seconds

- (4) At 00:03.153, the Pilot regained his body position to the centre of the harness. He released both brakes at the same time. Therefore, the paraglider stopped rolling to the right.

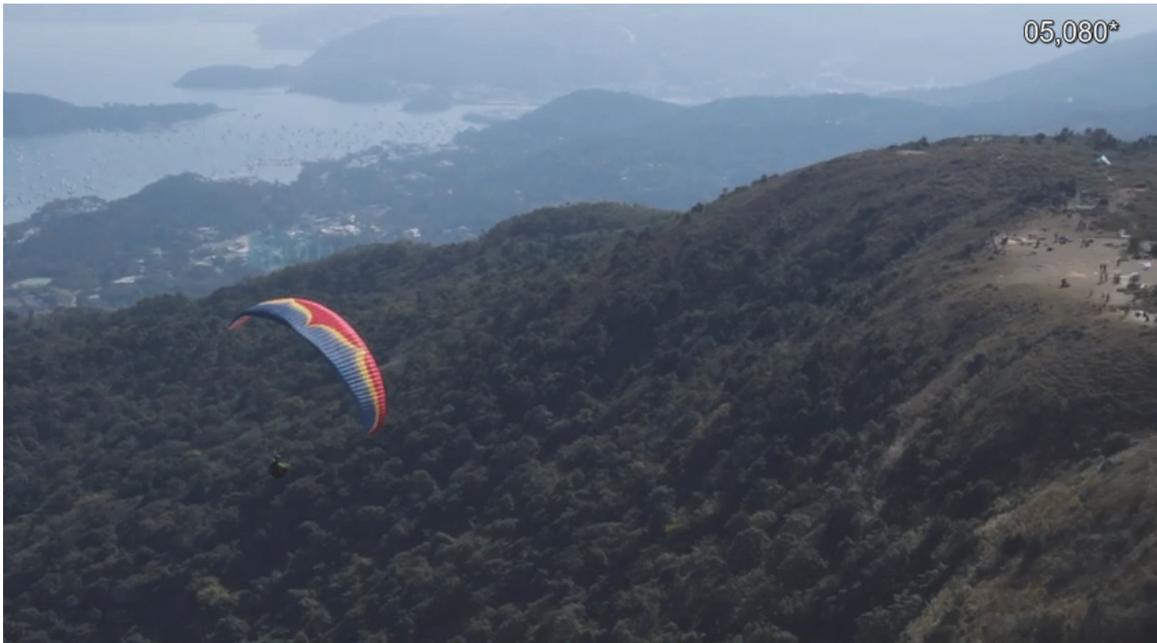
Figure 23: Video Image at 00:05.080 Seconds

- (5) From 00:03.153 to 00:05.080, the Pilot dived and followed the pendulum movement and started to dive and gain kinetic energy with his body weight due to the gravity.
- (6) At 00:05.080, the Pilot dived to the lower point of the pendulum movement. The paraglider gained kinetic energy with the increasing apparent weight due to gravity. Then the Pilot started to lean his body to the left. At the same time, the Pilot released the right brake and pulled the left brake.

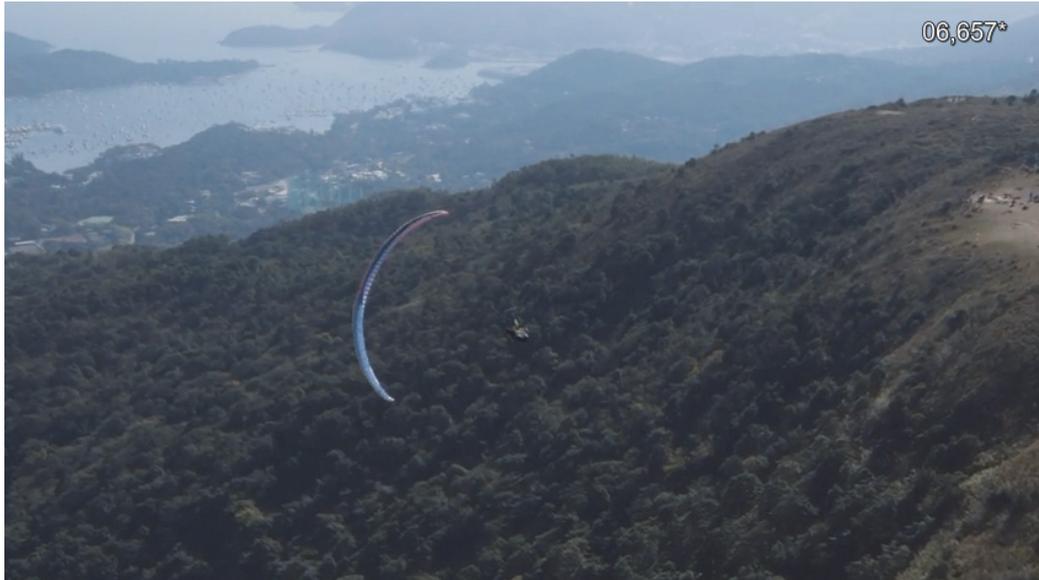
Figure 24: Video Image at 00:06.657 Seconds

- (7) From 00:05.080 to 00:06.657, the Pilot kept leaning his body to the left and pulled the left brake. The paraglider then started to roll and yaw to the left, resulting in a left turn.
- (8) At 00:06.657, the Pilot regained his body position to the centre of the harness. At the same time, he released the right brake and kept the left brake input, so that the paraglider kept rolling and yawing to the left.

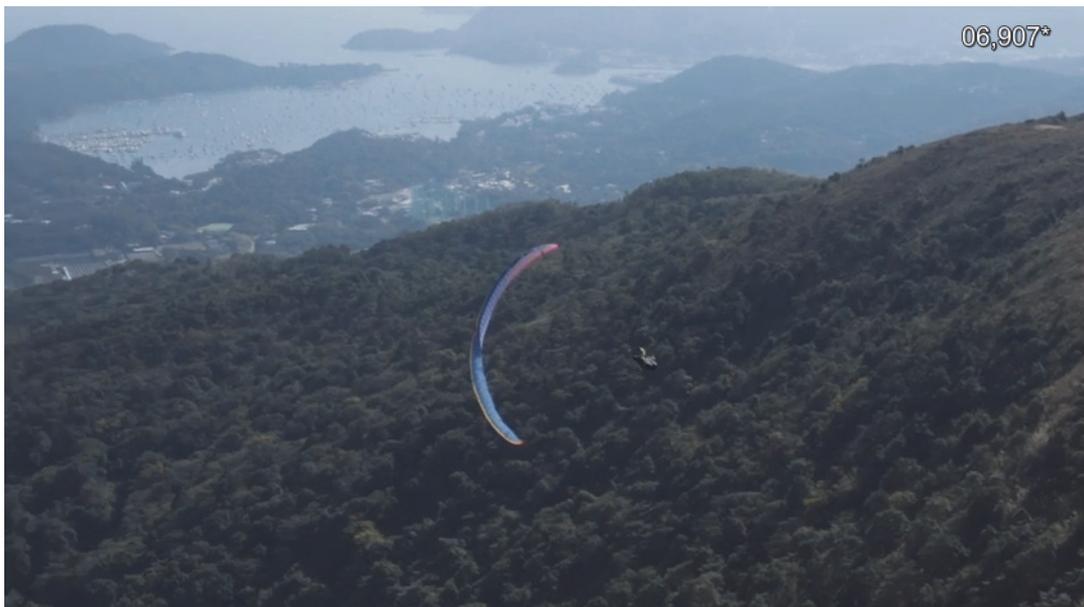
Figure 25: Video Image at 00:06.907 Seconds

- (9) From 00:06.657 to 00:06.907, due to the release of the right brake, the right side of the aerofoil accelerated and dived forward, resulting in a low angle of attack.

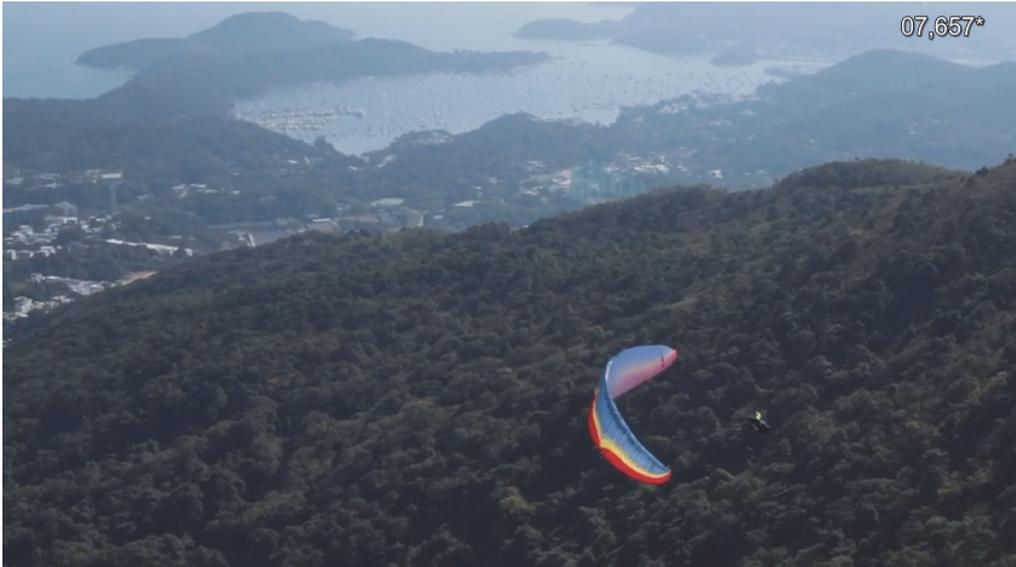
Figure 26: Video Image at 00:07.657 Seconds

- (1) At 00:07.657, due to low angle of attack, the relative wind could not get into the paraglider through the cell openings. The right side of the paraglider started to deflate and could not sustain the effective aerofoil shape. At the same moment, the Pilot started to follow the pendulum movement to dive. This indicated that he lost effective control of paraglider.

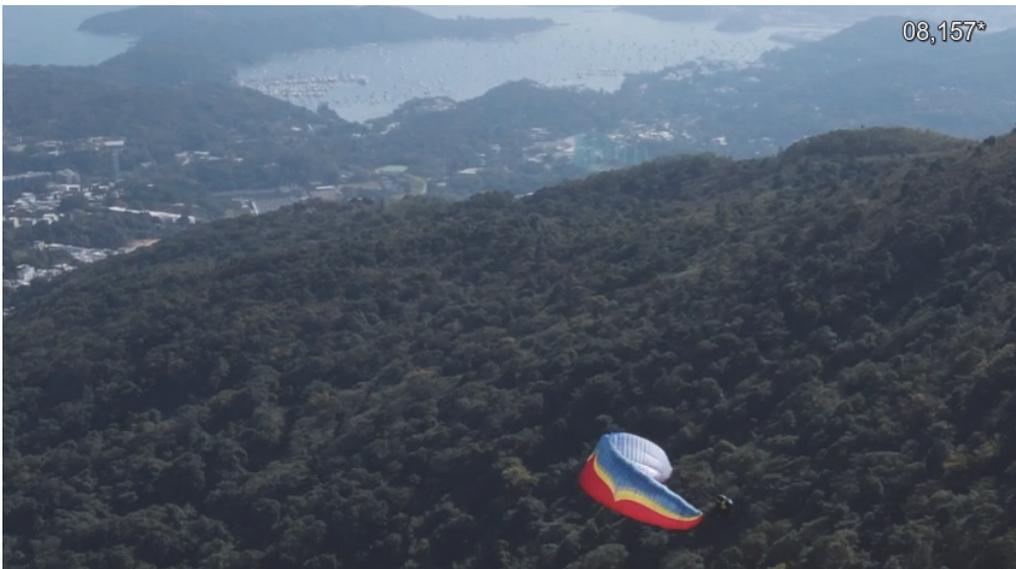
Figure 27: Video Image at 00:08.157 Seconds

- (2) At 00:08.157, the right side of the paraglider was completely deflated. The Pilot still held the left brake, causing the paraglider to keep rolling and yawing to the left. The Pilot was still following the pendulum movement to dive.

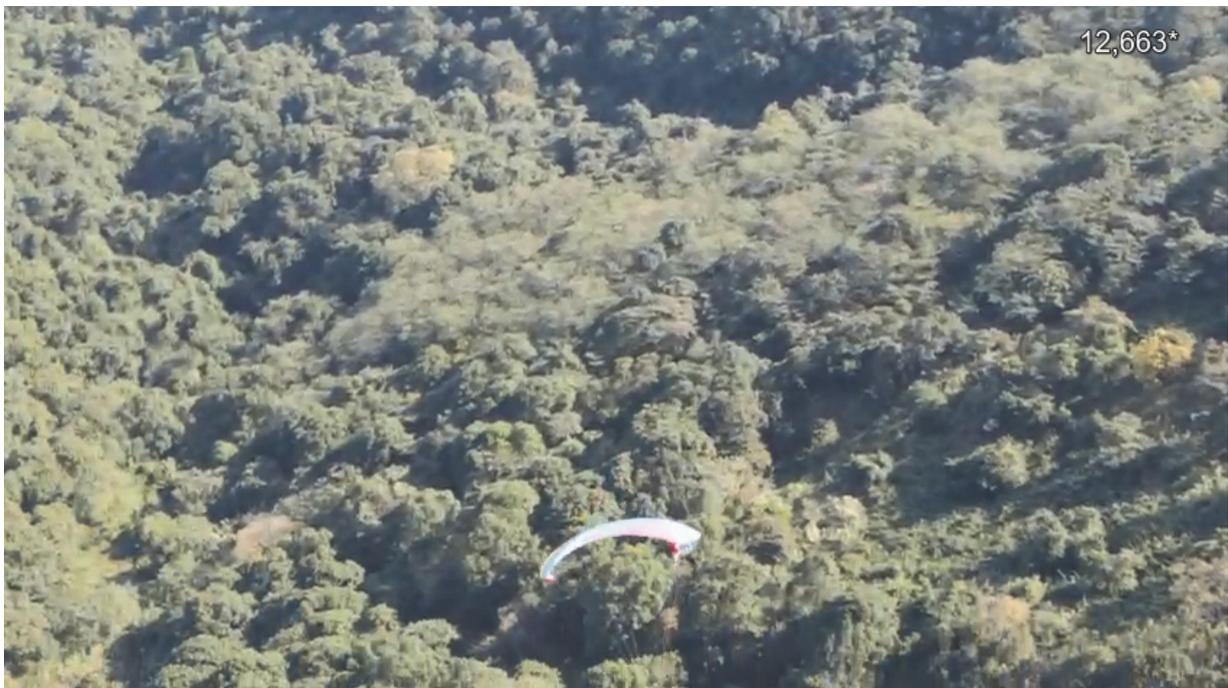
Figure 28: Video Image at 00:12.663 Seconds

- (1) From 00:10.159 to 00:10.910, the paraglider aggressively rolled to the right at 373 m AMSL.
- (2) At 00:10.910, both wingtips deflated and the paraglider entered a state of autorotation, that is, the paraglider flew forward and the Pilot flew backwards, and the centre of the rotation was between the Pilot and the paraglider.
- (3) From 00:10.910 to 00:12.163, the paraglider kept rotating.
- (4) At 00:12.163, the paraglider completed its first 360-degree rotation and continued to rotate, flying towards the ground.

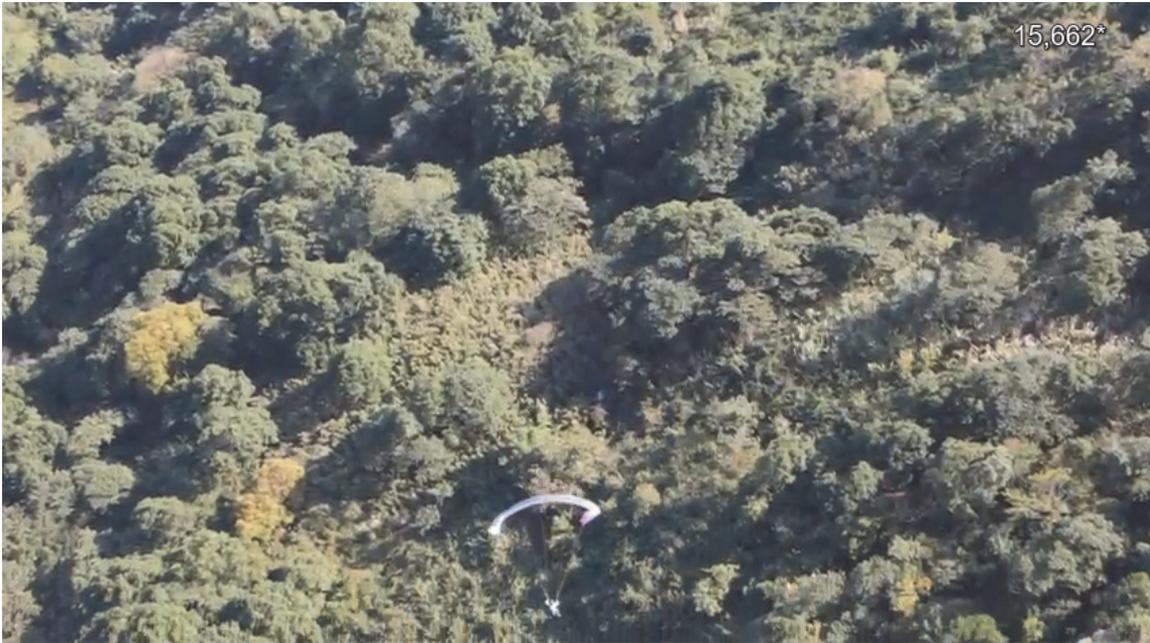
Figure 29: Video Image at 00:15.662 Seconds

- (6) At 00:15.162, the paraglider completed a 720-degree rotation and continued to rotate at a rate of approximately 20 revolutions per minute (RPM), maintaining a downward movement.

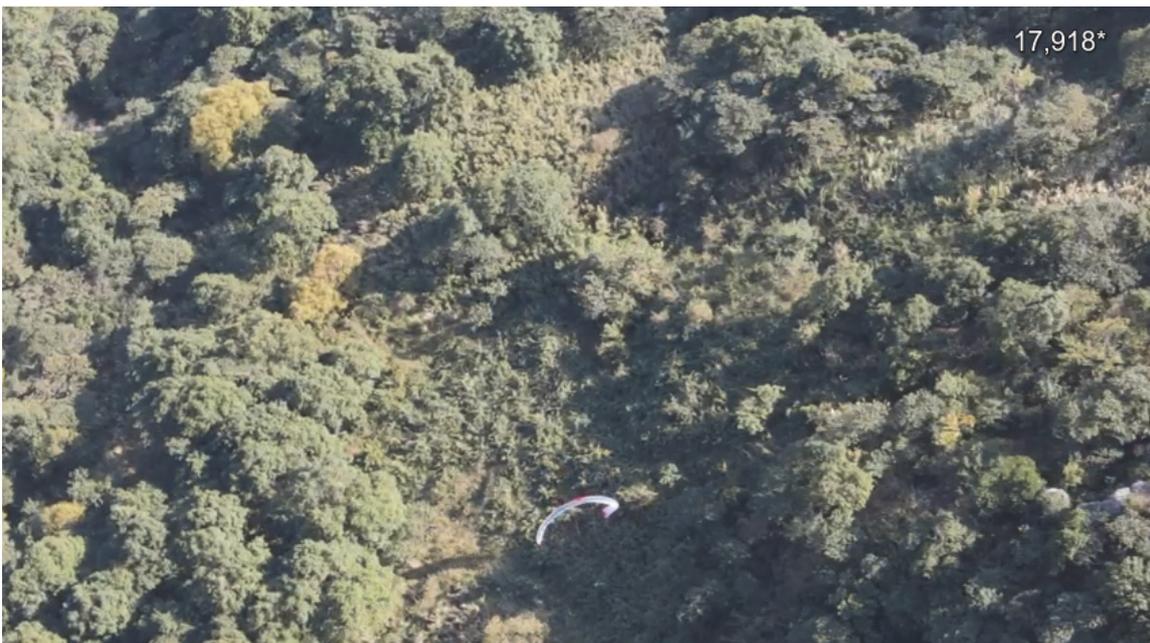
Figure 30: Video Image at 00:17.918 Seconds

- (7) From 00:15.162 to 00:17.918, the paraglider kept rotating.
- (8) At 00:17.918, the paraglider completed a 1,080-degree rotation and continued to rotate at a rate of approximately 20 RPM, maintaining a downward movement.

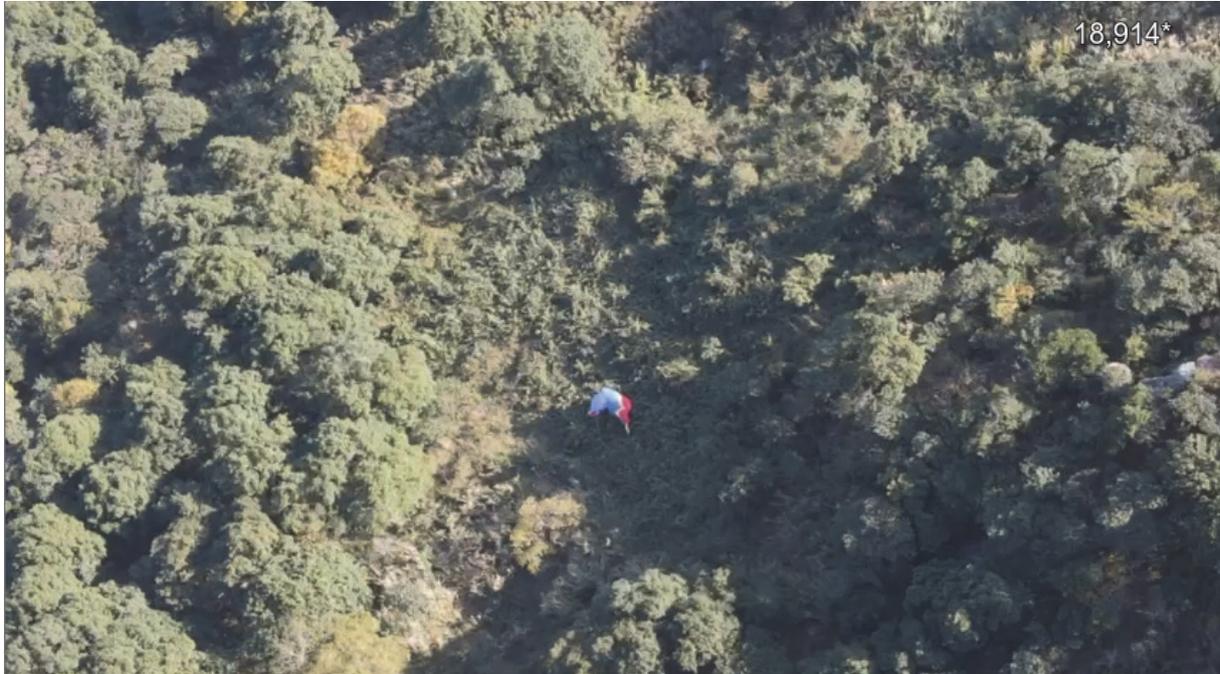
Figure 31: Video Image at 00:18.914 Seconds

- (9) At 00:18.914, the paraglider impacted the terrain at around 325m AMSL.
- (10) The entire rotation lasted for 10 seconds with an average rate of descent of 5 m/s.
