Loss of Lifting Conditions En-route (LOLI)

Investigation Report

**PHI Fantasia 22 Paraglider
Long Ke Wan, Sai Kung, Hong Kong
15 February 2023**

IVR-2025-05

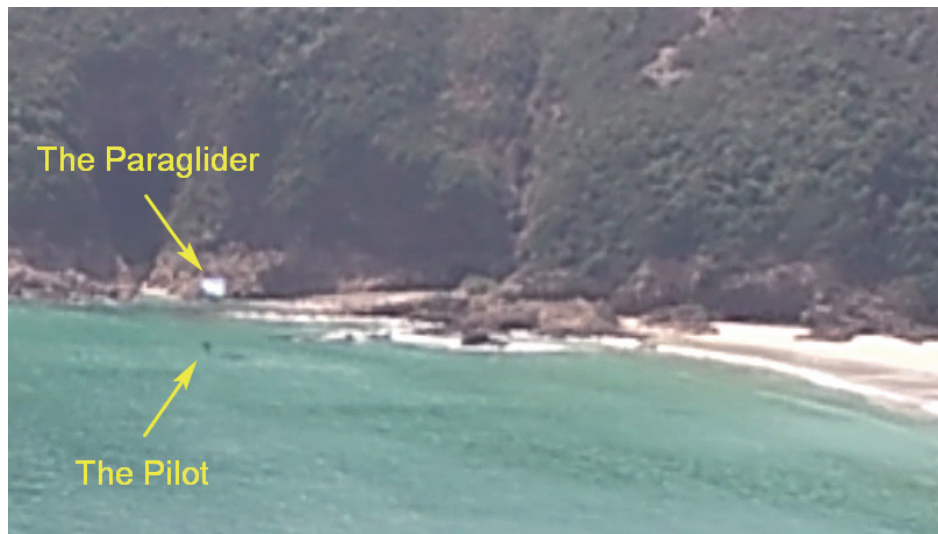
Figure 2: The Moment Shortly before the Water Landing

to the hiking trail below it. At about 1350 hrs, P2 found that the paraglider landed short of the beach and was in the sea about 60 meters from the beach shore.

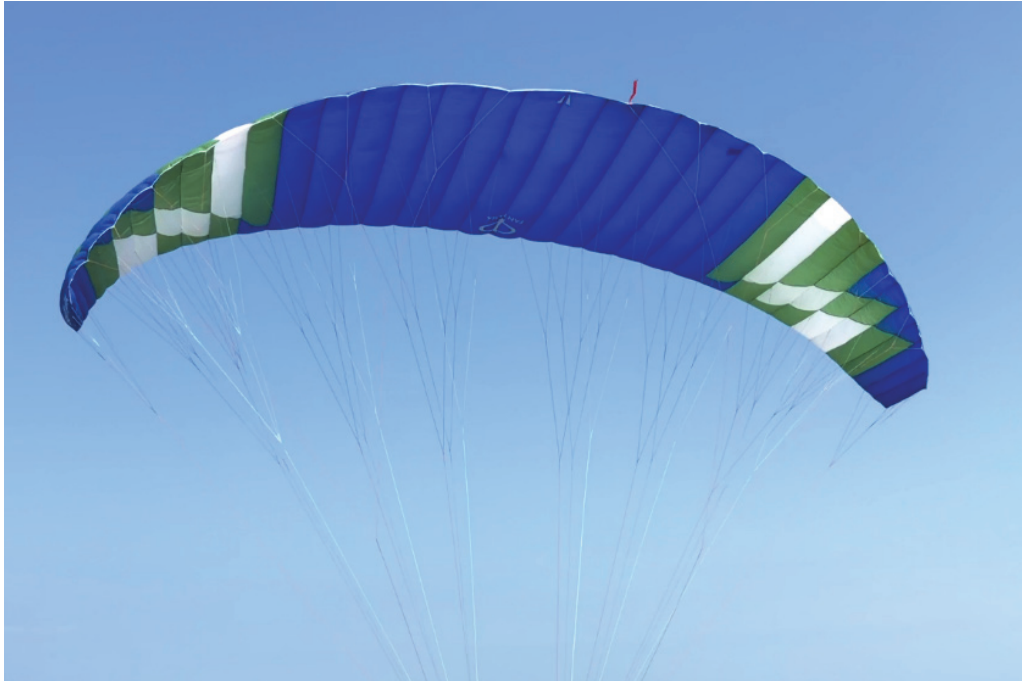
Figure 3: The Pilot's PHI Fantasia 22 Paragliding Canopy

- (1) The paragliding canopy, Model "PHI Fantasia 22 paraglider", and the harness, Model "Advance Progress 3", were examined and found in good shape.
- (2) One of the lines connecting the canopy to the harness was found broken.

During the aging check of paraglider lines, it was found that the C lines shrunk by 20 mm. The wing is an EN-A glider, the amount of C lines shrinking would not highly affect the overall performance and flying characteristic of the paraglider. The paraglider is considered airworthy for the flight.

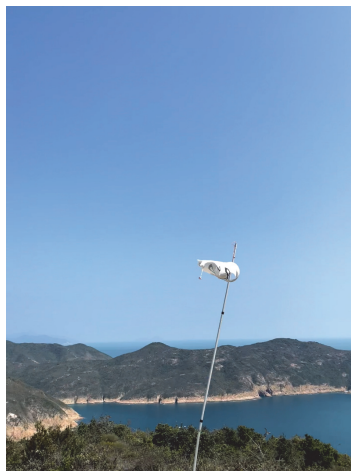
Figure 11: Visibility and the Direction of the Windsack before Take-off

FD took videos at the take-off area before and during the flight. A screen capture in one of the videos showed the visibility in the area and the direction of the windsack³ before the flight.

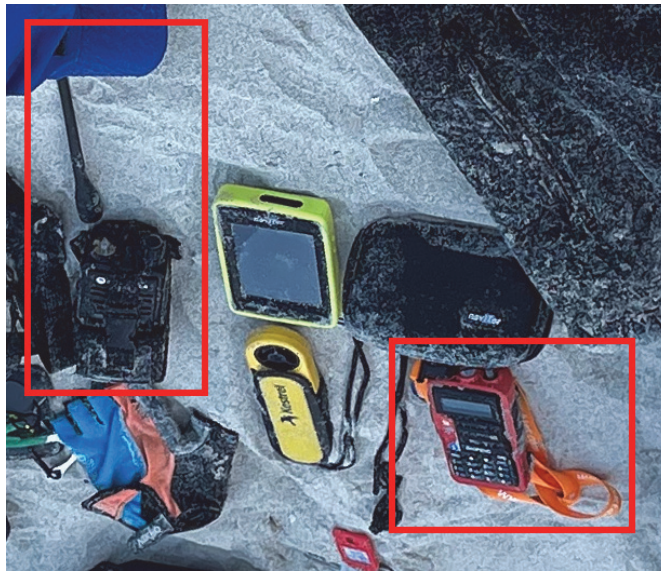
Figure 12: Two Two-Way Radio Transceivers Carried by the Pilot

- (1) The Pilot carried two two-way radio transceivers, including one from P2. Both radio transceivers were damaged by seawater after the occurrence and could not be switched on. Their pre-set frequencies could not be identified.

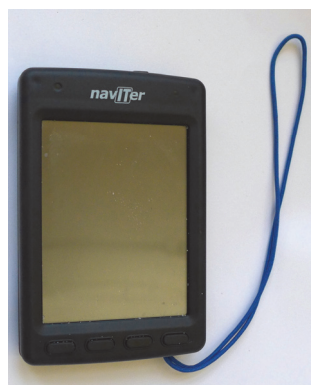
Figure 15: NavITer Hyper Flight Computer of the Pilot

Due to seawater ingress, the circuit boards were damaged and no data could be downloaded for investigation.

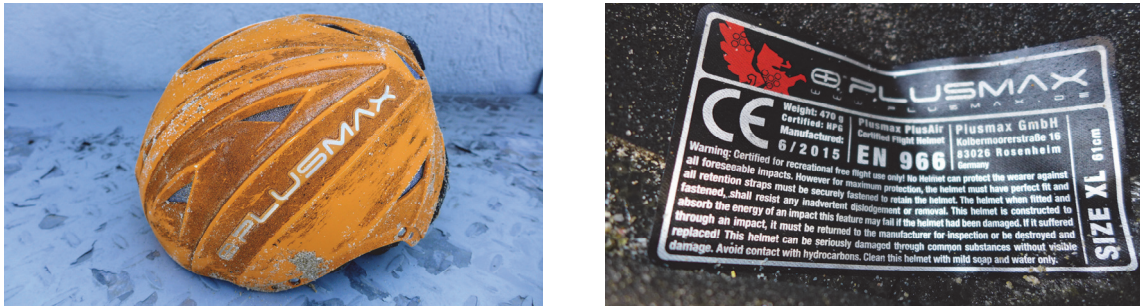
Figure 16: The Helmet of the Pilot and Its Label

- (1) The helmet of the Pilot, Model "PlusAir" of size XL, was made by Plusmax GmbH.
- (2) The helmet was certified to EN 966 standard.
- (3) The helmet was manufactured in June 2015.

- (4) The helmet was examined and no significant damage was noted.

- (1) The helmet of the Pilot was manufactured in June 2015.
- (2) According to the guidance of the HKPA, the helmet lifespans vary but typically range between 3 years for heavy use, to 5 years for regular use, or potentially slightly longer if the helmet remains mostly unused.
- (3) It is apparent that the manufacturer of the helmet, Plusmax GmbH, was out of business and therefore could not be reached for their recommended helmet life span.

The helmet of the Pilot was certified to EN 966 standard which was acceptable to be used for paragliding. However, its lifespan was beyond the periods recommended by the HKPA.

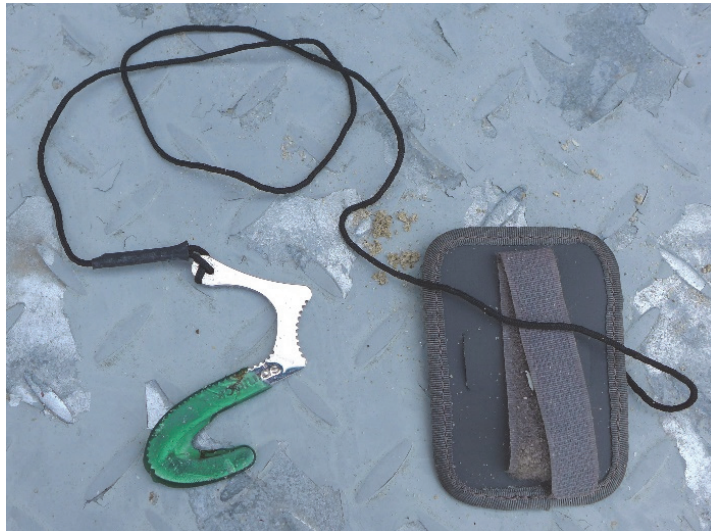
Figure 18: Hook Knife Carried by the Pilot

- (1) The Pilot carried an external flight deck which accommodated his NavITer Hyper Flight Computer, a compass, and a Spinlock safety line cutter (hook knife). The hook knife was still kept inside its container in a pocket of the external flight deck.

- (21) The hook knife was still kept inside its container which was placed in a pocket of the external flight deck. This indicates that the Pilot might not have attempted or was unable to pull the hook knife out for use. [2.7.2.2 (1)]
- (22) The helmet of the Pilot was certified to EN 966 standard which was acceptable to be used for paragliding. However, its lifespan was beyond the periods recommended by the HKPA. (2.7.3)

It is recommended that the Hong Kong China Paragliding Association and the International Paragliding Association remind all participants of paragliding in Hong Kong, who operate over water, the importance of being proficient in the emergency procedures of unexpected water landing, including making the hook knife easily accessible so that they can promptly cut lines or risers if they get entangled.

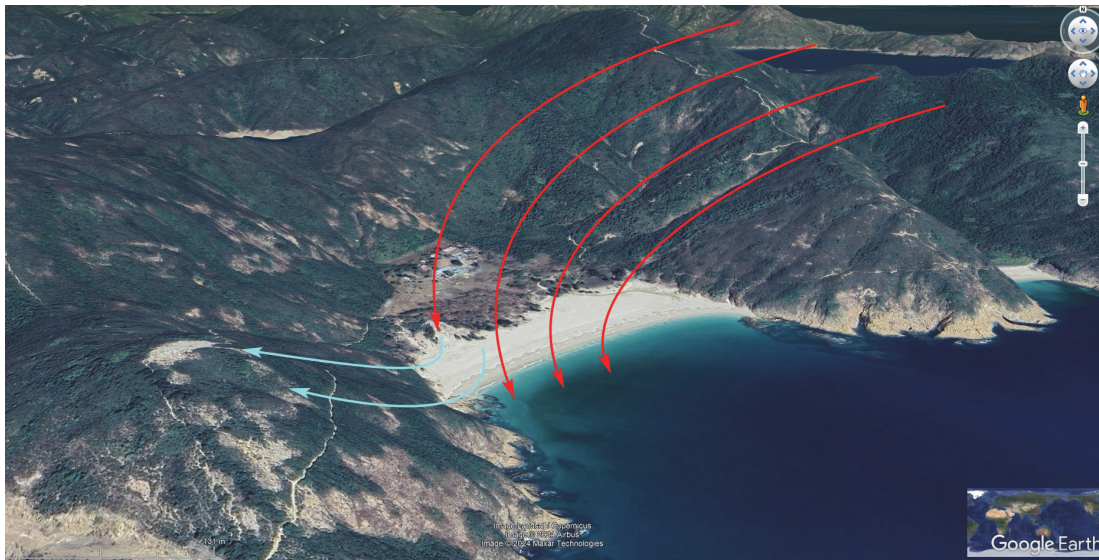
Figure 20: Illustration of 040 Degrees Airflow of Long Ke Wan Paragliding Site

- (4) Due to Coandă effect¹⁰, air has tendency to stay attached to a convex surface. It was likely that the air at sea level of Long Ke beach was flowing offshore from the beach to the sea and sinking, and the air went up and changed its direction again along the Biu Tsim Kok terrain as shown in the following figure.
