Abnormal Runway Contact (ARC)

Investigation Report

Bombardier BD-700-2A12, N899ST

Hong Kong International Airport

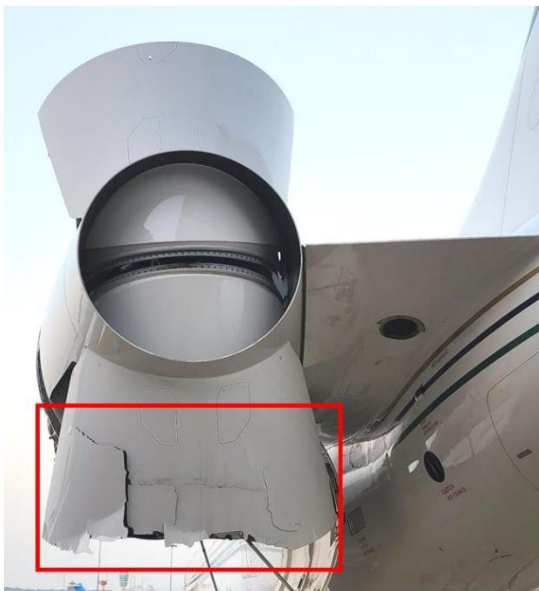
Left Engine Lower Reverser Door

During the landing on Runway 07R at about 2122 hours, the pilot deployed the thrust reverser, and the lower thrust reverser doors of both engines made contact with the runway, causing damage to these doors.

The investigation found that following the mainwheel touchdown, the aircraft's de-rotation was delayed by the pilot's continued aft sidestick input. The aircraft then entered a low speed/high angle of attack (AoA) situation which, when combined with the selection of maximum reverse thrust, induced an upward pitching moment. Consequently, the aircraft pitched up, causing both lower thrust reverser doors to contact the runway.

- (1) The lower thrust reverser doors of both engines were damaged when touching the runway on landing.

Photo 1: Damage on Lower Thrust Reverser Doors (view from rear)
