# **Preliminary Report**

**Boeing 777-333ER**

**C-FITW**

**ARC: Abnormal Runway Contact**

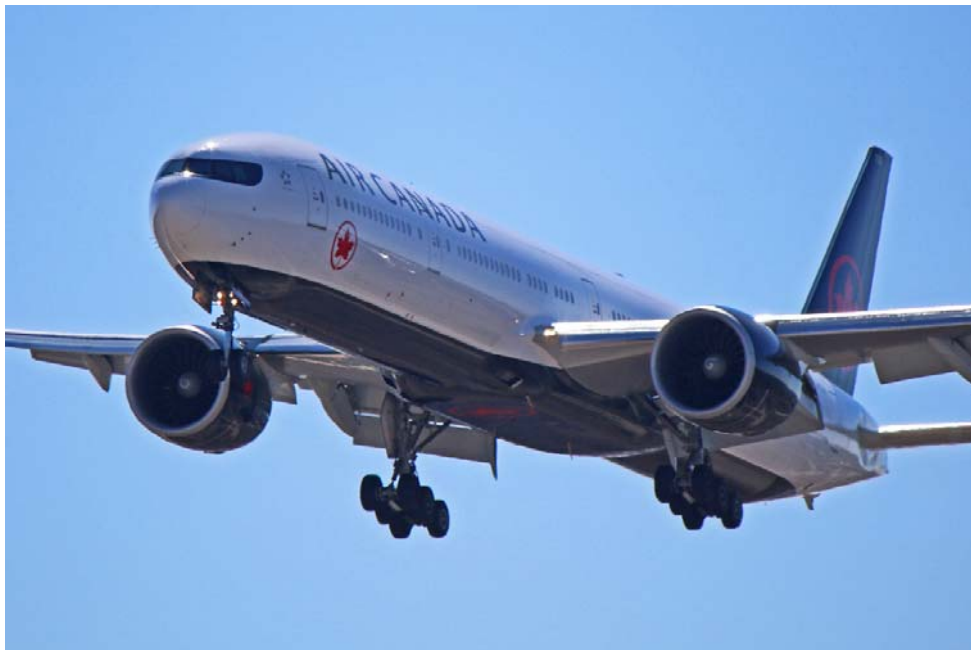
Subsequent inspection of the underside of the rear fuselage indicated the aircraft sustained damage to the rear lower fuselage requiring major repair or replacement of the affected components.

The aircraft is currently unserviceable and is undergoing a major repair process to rectify the lower fuselage damage prior to a return to operational service.
