In-flight Breakup

Safety Investigation Preliminary Report

Robinson R44 II

B-KTK

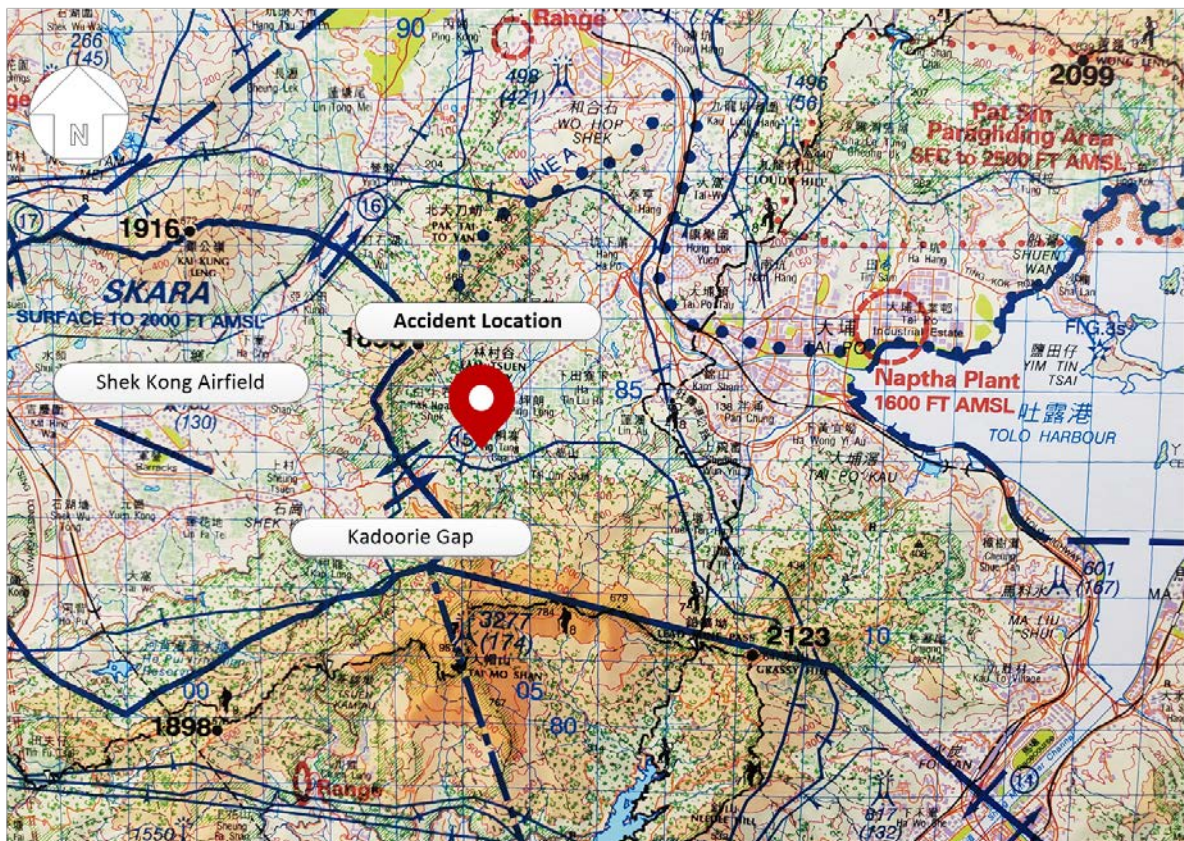
Figure 1: Accident Location

The debris trail of the helicopter following the in-flight breakup was scattered in a south-westerly direction for approximately 500 meters. The debris trail begins near Lam Kam road and finishes at the fuselage impact point.
