**The Shatin to
Central Link Project
Final Report**

Volume 1 of 2

**Expert Adviser Team
Transport and Housing Bureau
December 2020**

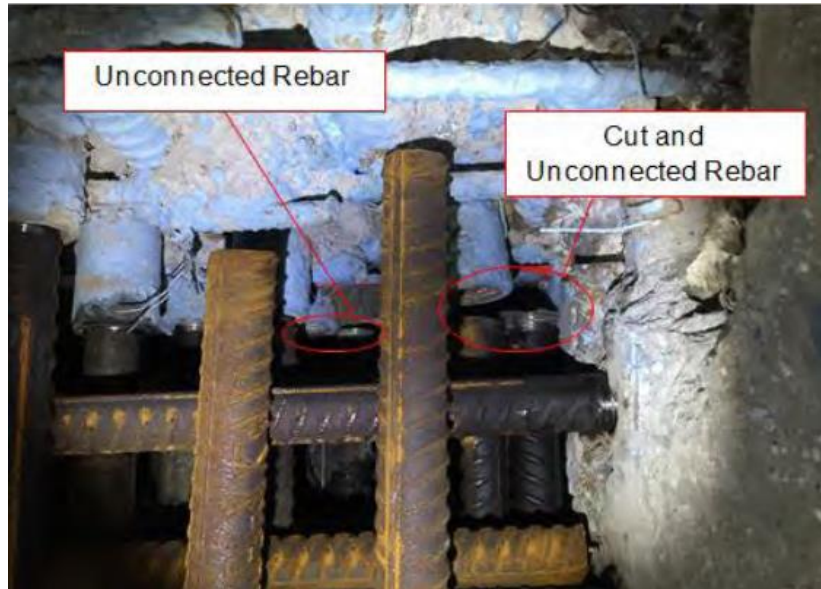
**Figure 3-2 Site photograph at Panel EM100 in NCR 157
before rectification works**

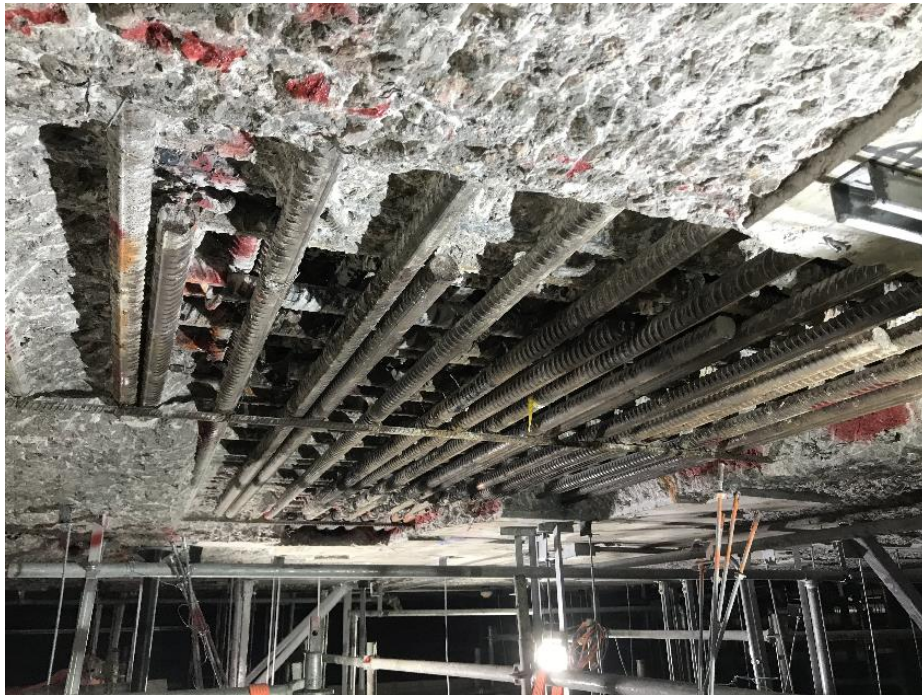
75. The investigation has identified approximately 12% of the inspected area with shallow honeycombing (i.e. less than 50 mm deep) and approximately another 7% of the inspected area with deeper honeycombing (i.e. 50 mm to 350 mm deep) as shown in *Figure 3-4*. A location plan showing the areas with honeycombing is in *Appendix 3-2*.

Figure 3-4 One of the deeper honeycombing areas after removal of honeycombed concrete at soffit of EWL slab

76. Apart from concrete quality issues, other defects were discovered at the honeycombing inspected areas, such as insufficient rebar lap length, water dripping and irregularities in shear link placement.

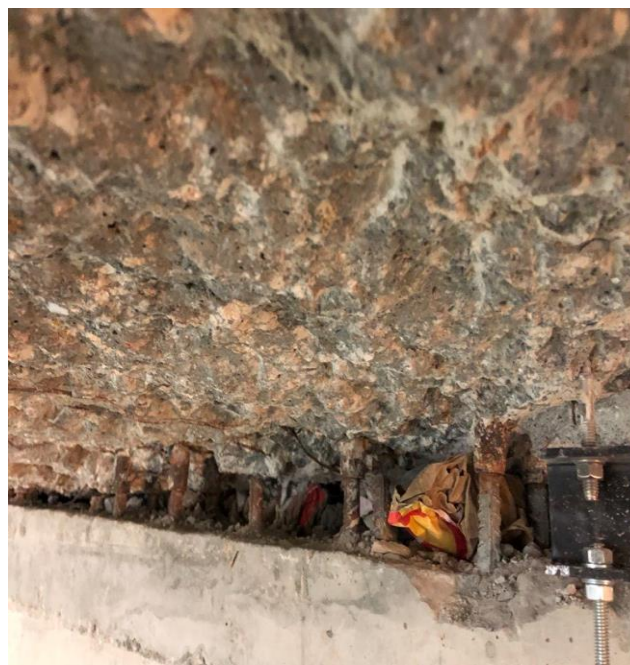
Figure 3-6 Gap between EWL slab and column

85. These gaps reflected unsatisfactory concreting workmanship, which was not identified during supervision of construction works.

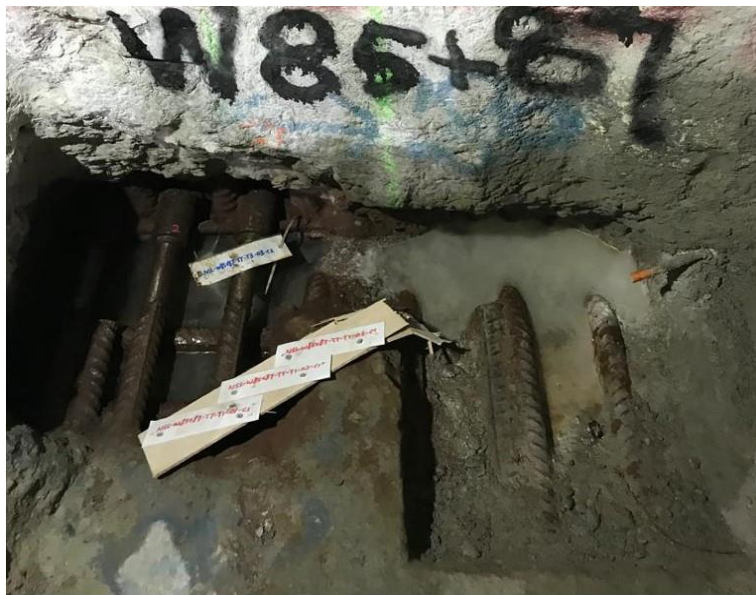
92. In the course of the Holistic Assessment, water seepage was observed in five opening up locations at the EWL slab soffit. At the top surface of the NSL slab, water seepage and ponding were also found at 20 opening up locations. The concrete at these locations had been opened up to expose the coupler connections between the platform slab and the D-wall. To reduce water seepage, remedial grouting works⁵⁵ were arranged by MTRCL at the locations where seepage was observed.

Figure 3-7 Water ponding at opening up location at NSL platform

⁵⁵ Remedial grouting works were carried out on a number of occasions after the completion of the Holistic Assessment. In response to media reports about water seepage in the HUH Extension on 21 July 2020, MTRCL investigated and reported that there were 41 locations with water seepage requiring rectification.

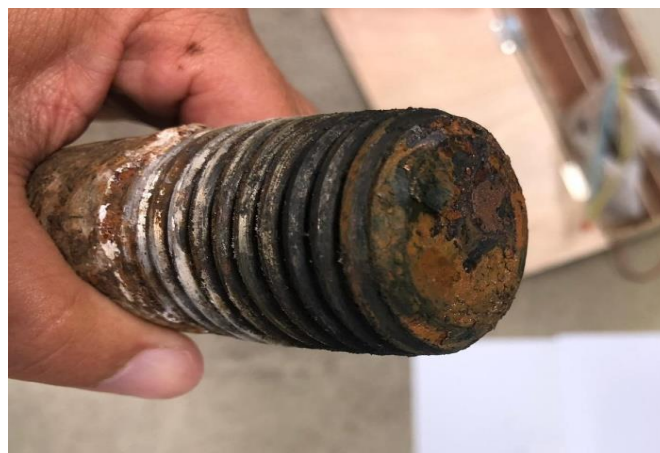
99. From detailed examination, the material specialist concluded that most of the rusts on the samples were rather stable and the rusting process had ceased in most samples. The rusting had likely resulted from moisture trapped in the couplers when the rebars were installed. Formation of fresh rust on some samples from the NSL slab was likely caused by water ponding occurring after the opening up with the couplers submerging in the water for some time. Other apparent signs of rusting were mainly due to trapping of yellowish or brownish sand and not due to corrosion attack.

Figure 3-8 *A corroded threaded rebar under examination*

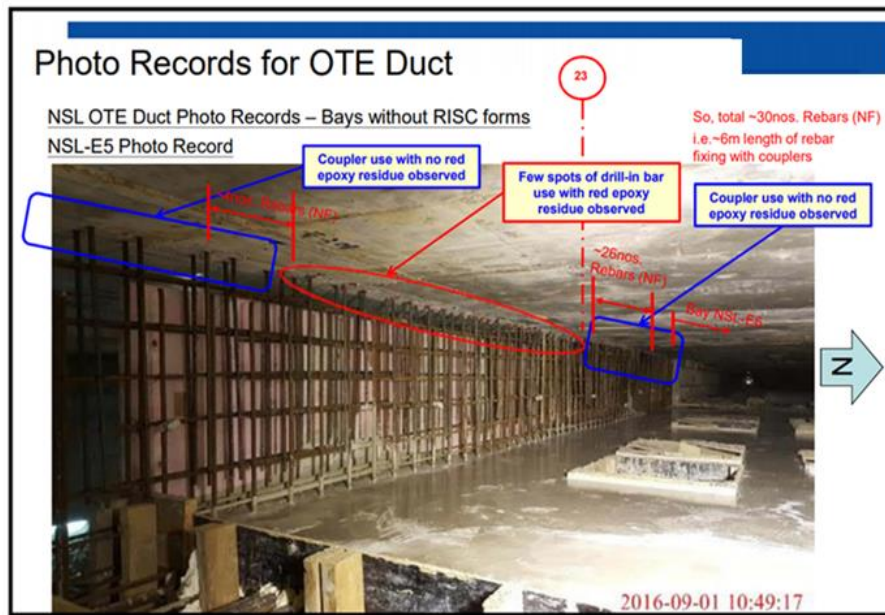
116. According to the original accepted drawings, the vertical rebars of the OTE ducts are connected by lapped rebars. However, Leighton’s as-built drawings showed that these had been changed to coupler connections. From a review of the available photographic records, it was found that about 15% of the couplers were connected to drilled-in bars at the EWL slab. Unfortunately, records of the required pull out tests on the drilled-in bars were not available. A photograph showing the coupler and drilled-in bars in one bay was presented in **Figure 3-10**.

Figure 3-10 Photographic records for OTE duct with rebars installed by couplers and some drilled-in bars

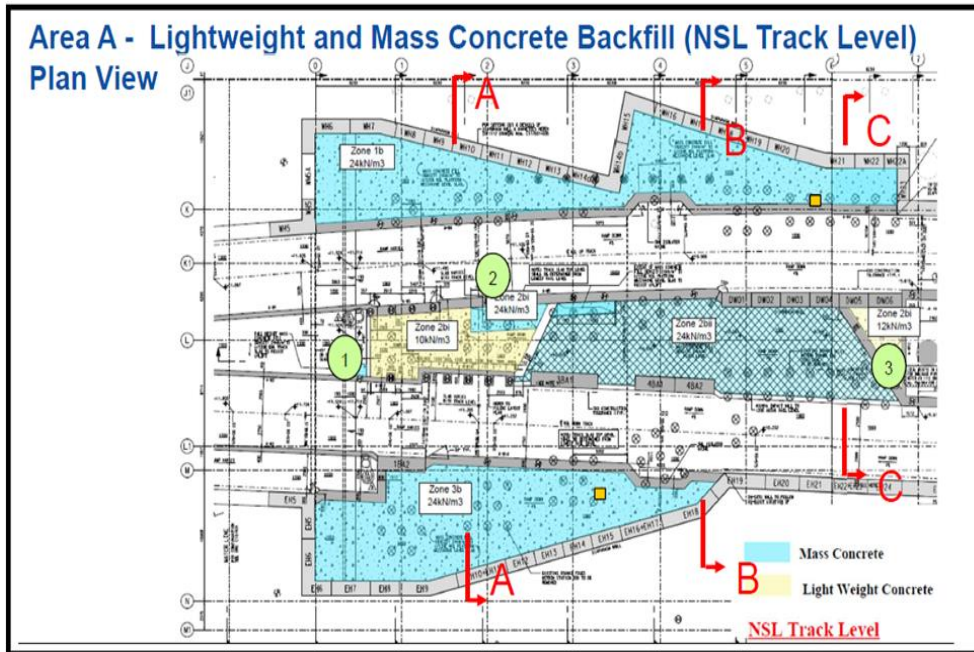
121. Subsequent investigation by laser scanning and coring carried out by MTRCL and Leighton discovered that a significant part of the required backfilled areas at the NSL track level and the NSL mezzanine level had not been filled with concrete. According to the design, the purpose of the concrete fill is for buoyance resistance and the backfilled areas should be completely filled up, i.e. without any voids.

Figure 3-13 Plan view of backfilled areas at NSL Track Level
 (Source : A presentation by MTRCL on Area A – Backfill dated 31 March 2020)

122. Remedial proposal to backfill the voids was submitted by MTRCL to the BA for acceptance. The remedial works commenced in June 2020 and was about 75% complete as at mid-November 2020. The total volume of voids to be filled in the remedial proposal is about 1,750 m³, which is about a quarter of the total volume of backfilled areas supposedly to be completed in Area A.

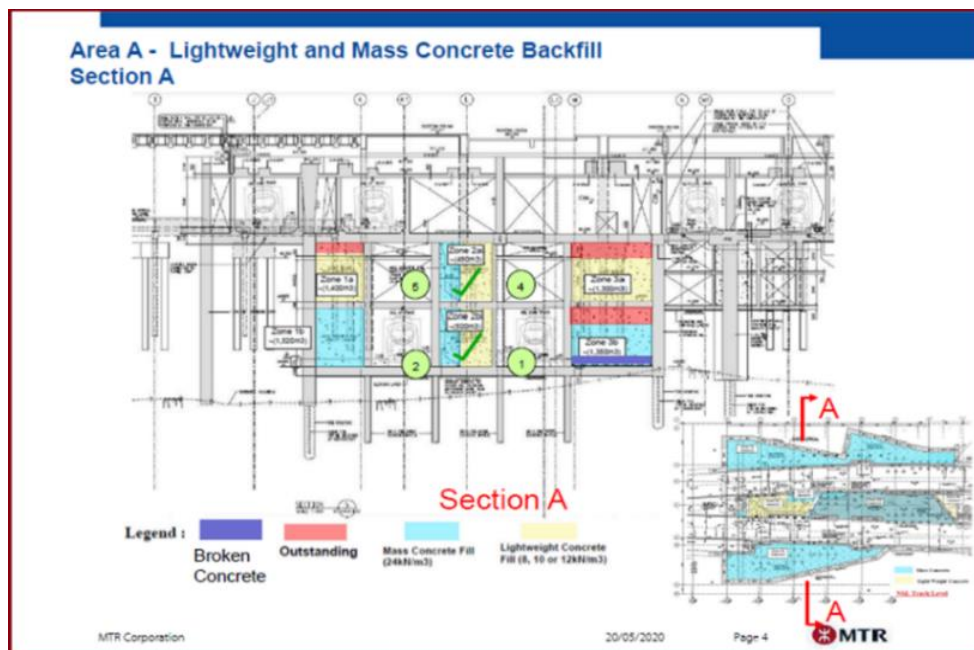
Figure 3-14 A section showing the backfilled areas and voids
 (Source : A presentation by MTRCL on Area A – Backfill dated 31 March 2020)

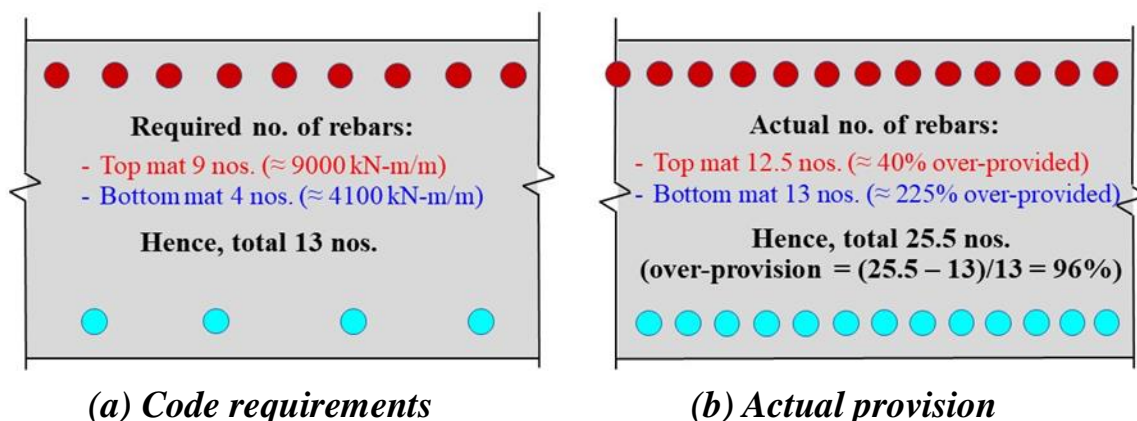
320. A diagrammatic illustration of the code's requirements versus the actual provision of the main rebars at the connection between the EWL slab and D-wall is shown in **Figure 6-1**.¹³³ In this example, the net over-provision was 96%, i.e. the actual provision is almost twice as much as that required by the code.

Figure 6-1 Diagrammatic illustration of over-provision in excess of Code's requirements at the connection between EWL slab and D-wall
