**The Shatin to
Central Link Project
Final Report**

Volume 2 of 2

**Expert Adviser Team
Transport and Housing Bureau
December 2020**

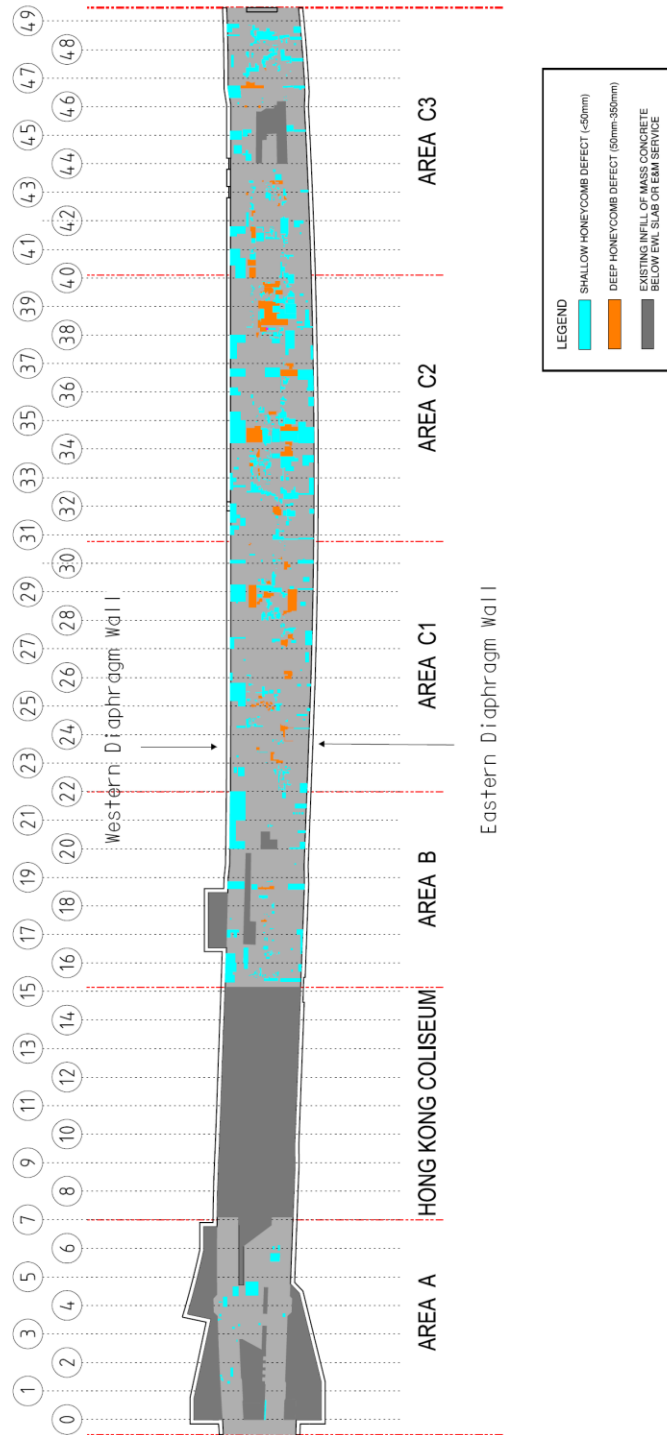
Findings of Honeycombing Investigation at EWL Slab Soffit (as of June 2019)

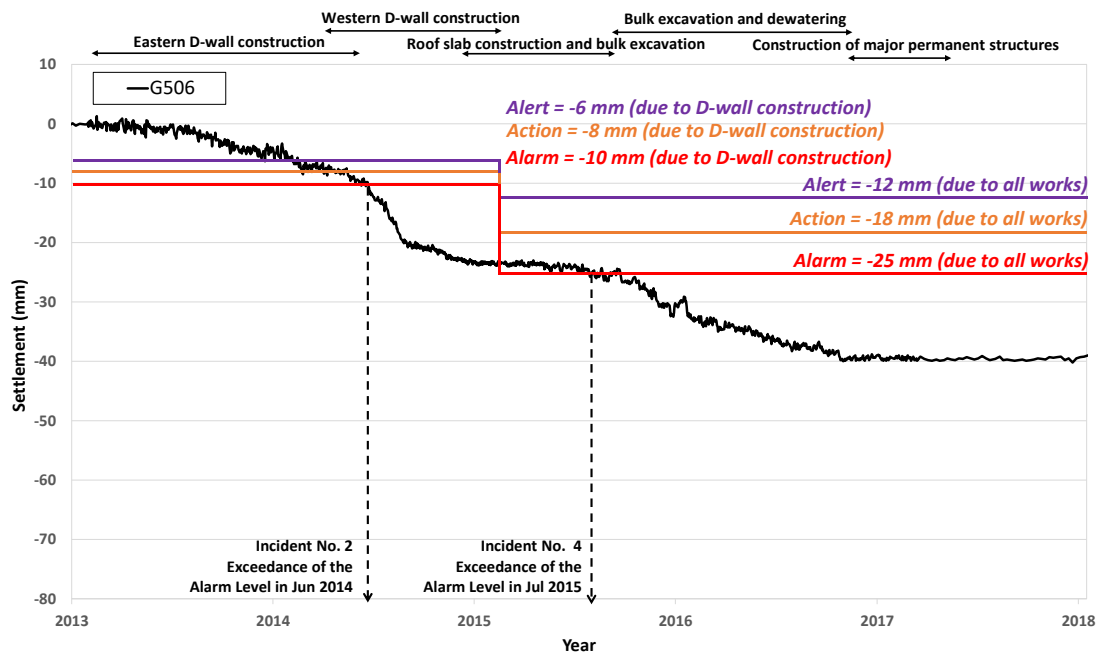
25. For the six selected monitoring points on ground settlement, utility settlement, groundwater drawdown and building settlement, the development of the recorded settlement or groundwater drawdown with time has been examined. All the monitoring points exhibit a notable trend of increasing settlement or groundwater drawdown with time as the construction works proceeded. For example, the typical trend may be illustrated by the timelines of the recorded ground settlement at Monitoring Point No. G506 and groundwater drawdown at Monitoring

Point No. 11202/SCL-DH060SP shown in *Figures 9-2-3* and *9-2-4*, respectively.

Figure 9-2-3 Ground settlement at Monitoring Point No. G506
(Source: Data provided by MTRCL)

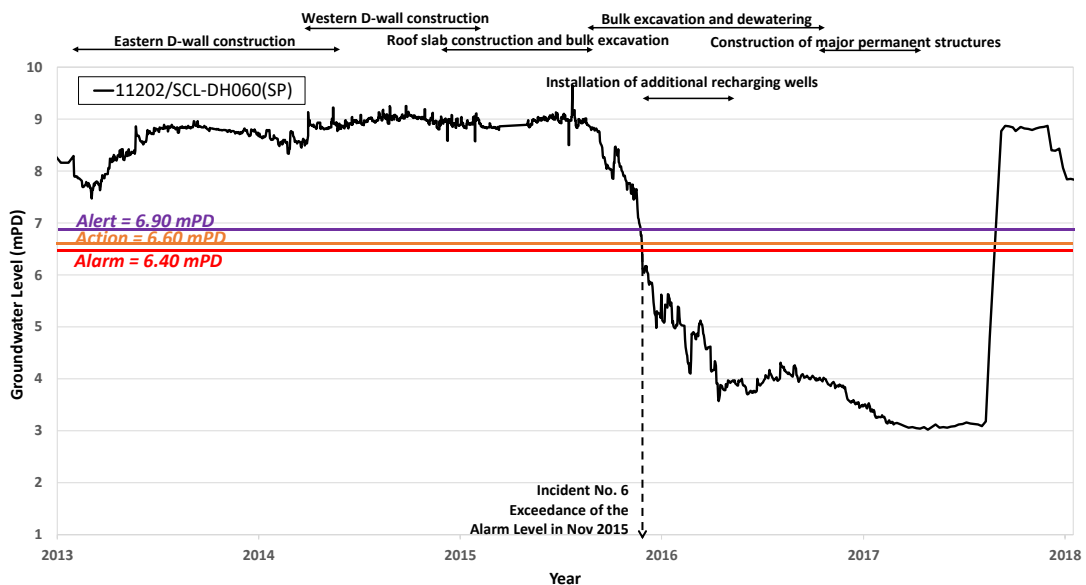
Figure 9-2-4 Groundwater level at Monitoring Point No. 11202/SCL-DH060SP
(Source: Data provided by MTRCL)

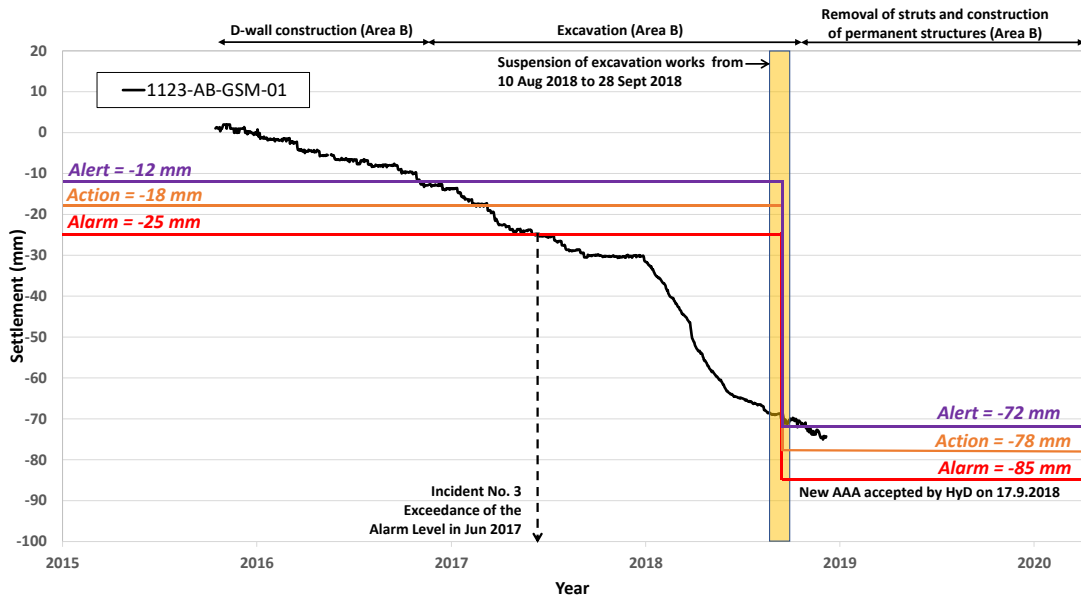
17. For the seven selected monitoring points on ground settlement and utility settlement, the development of the recorded settlement with time has been examined. All the monitoring points exhibit a notable trend of increasing settlement with time as the construction works proceeded. For example, the typical trend may be illustrated by the timelines of recorded ground settlement at Monitoring Point No. 1123-AB-GSM-01 and utility settlement at Monitoring Point No. 1123-AE-USM(FW)-02-A shown in **Figures 9-3-5** and **9-3-6**, respectively.

Figure 9-3-5 Ground settlement of Monitoring Point No. 1123-AB-GSM-01 (in Area B of WAT)
 (Source: Data provided by MTRCL)

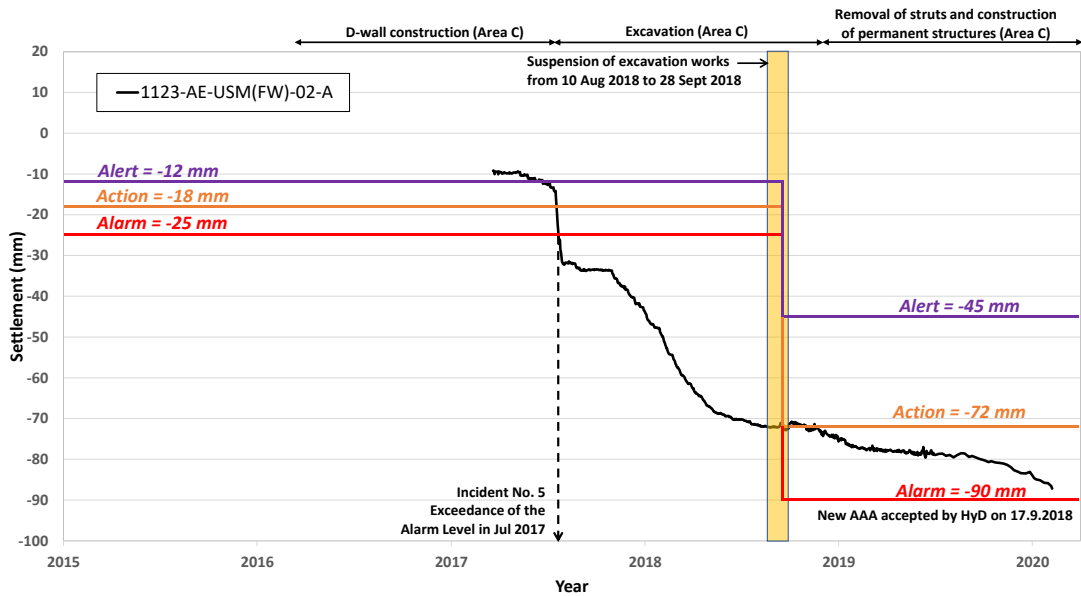
Figure 9-3-6 Utility settlement at Monitoring Point No. 1123-AE-USM(FW)-02-A (in Area C of WAT)
 (Source: Data provided by MTRCL)

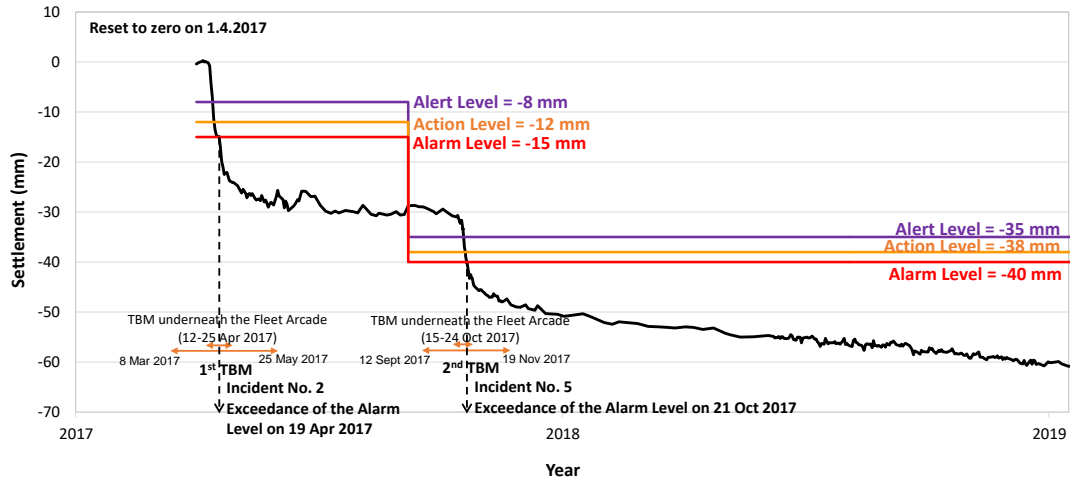
22. At the time of occurrence of Incidents No. 5 to 7, the cutterhead of the TBM had just been advanced to a location which was slightly more than 50 m from the relevant monitoring points. It might be argued that the requirement for suspension of “*all construction activities within a minimum distance of 50 m radius of the instrument of where the Alarm value was reached*” was no longer applicable to the TBM cutterhead, even though the recorded settlement was related to the TBM works. However, since the “*50 m radius*” is a “*minimum distance*” specified in the accepted monitoring and control plan, in EA Team’s view, it should also be applicable to construction activities beyond 50 m from the instrument if the exceedance of the *Alarm Level* at the monitoring point is related to the construction activities. While there is some ambiguity, the EA Team considers that, strictly speaking, the requirement for suspension of works should also be applied to the TBM works which were only marginally beyond 50 m from the monitoring point at the time.

23. The development of ground and building settlements at the four selected monitoring points with time has been examined. All the monitoring points exhibit a notable trend of increasing settlement with time as the construction works proceeded. For example, the typical trend may be illustrated by the timelines of the recorded ground settlement at Monitoring Point No. WCSP-GSM-024 and building settlement at Monitoring Point No. WCSP-BSM-010 shown in **Figures 9-4-4** and **9-4-5** respectively. There is an apparent temporal relationship between the TBM tunneling works and the recorded settlements that resulted in the exceedance of the *Alarm Level*.

Figure 9-4-4 Ground settlement of monitoring point No. WCSP-GSM-024

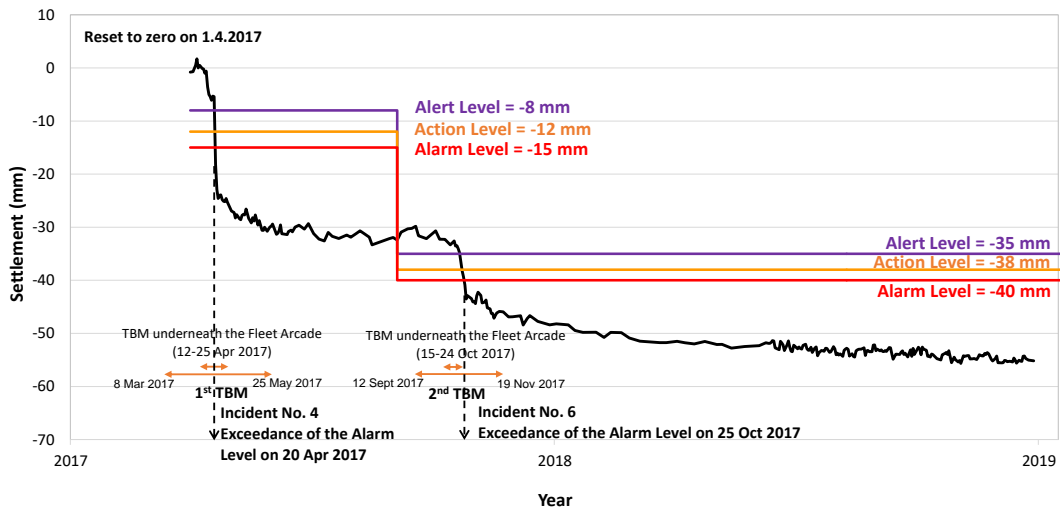
Figure 9-4-5 Building settlement of monitoring point No. WCSP-BSM-010
