Loss of Control Inflight (LOC-I)

Investigation Report

Accident Zlin Z 242 L B-LUK Ma Shi Chau, Hong Kong 24 June 2018

IVR-2025-01

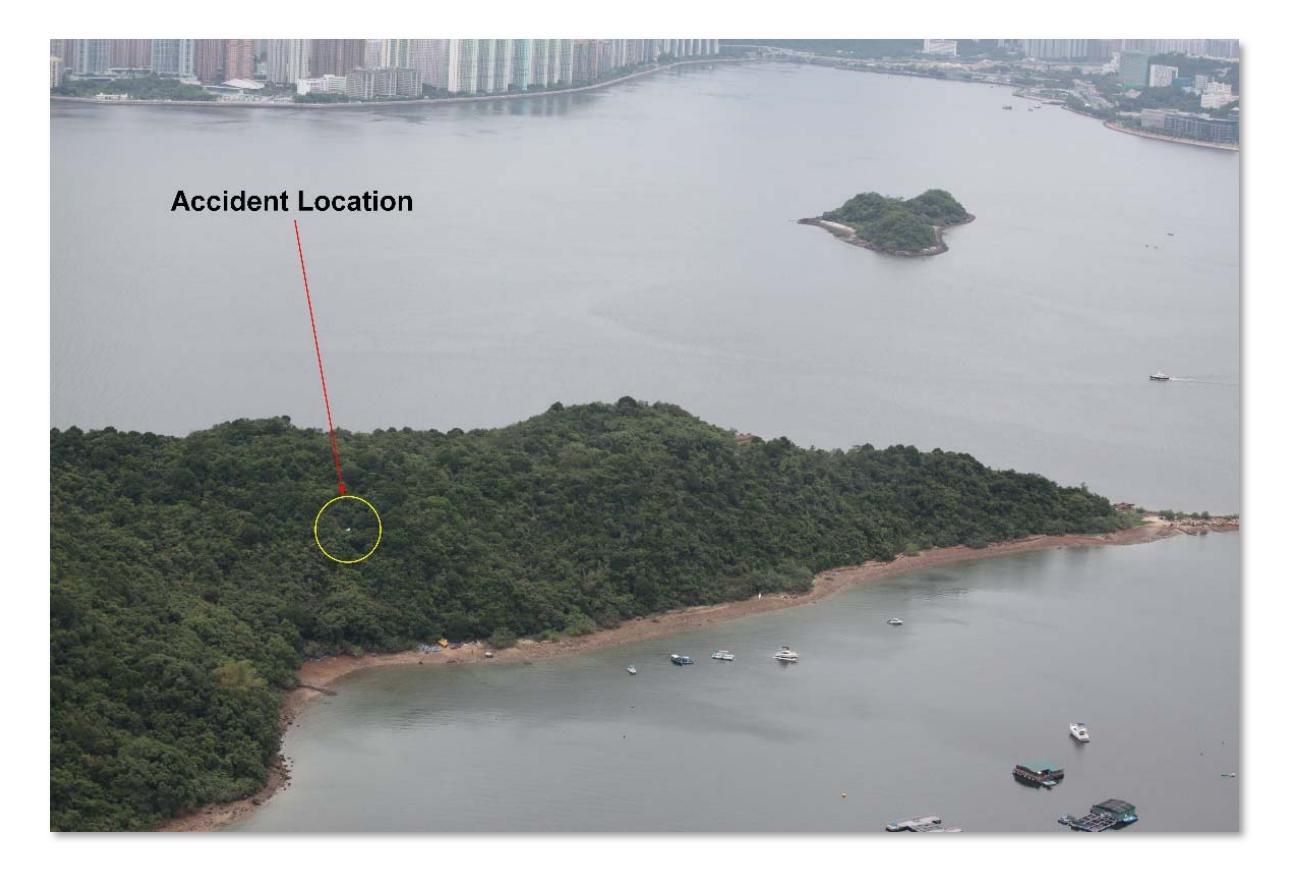
Figure 1: Accident Location at Ma Shi Chau

- (3) The pilot started applying full right rudder to recover when the aircraft was approximately in a 45-degree left bank. The yaw and bank did not cease and the manoeuvre developed into a fully developed spin. The pilot kept applying full right rudder and put the control stick at neutral but the spin continued. The pilot then pushed the control stick forward and kept the ailerons neutral in an attempt to recover. The aircraft then impacted terrain on Ma Shi Chau (Figures 1 & 2).

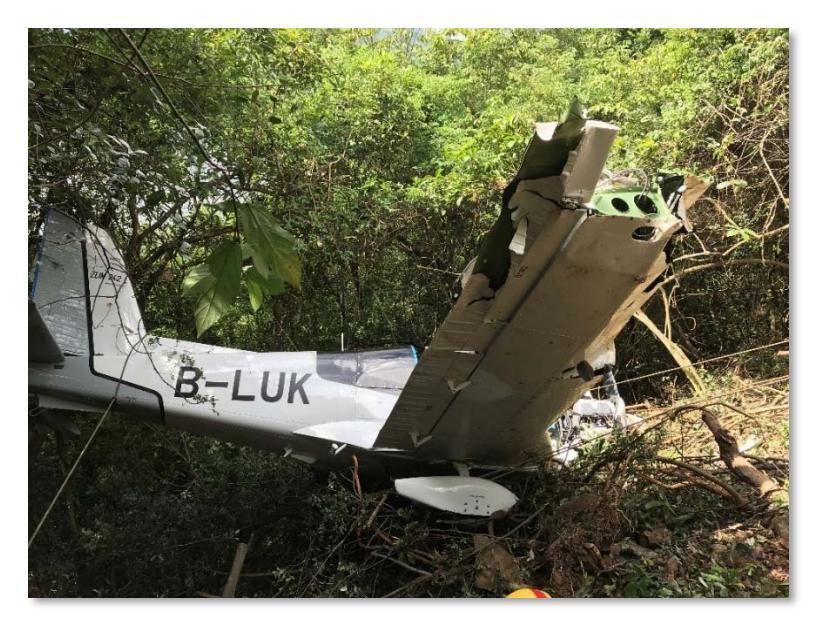
Figure 3: Right Fuselage and Wing

(1) As a result of the impact, the aircraft suffered major damage. The right wing of the aircraft was severely damaged with the outboard auxiliary fuel tank driven upward (Figure 3). The bottom leading edge surfaces of the right wing, the aileron had impact damage. The left wing was relatively intact with impact damage on wing tip and aileron (Figure 4). There was a fuel leak from the distorted main fuel tank. The aft fuselage remained intact. The right empennage area had impact damage (Figure 5).

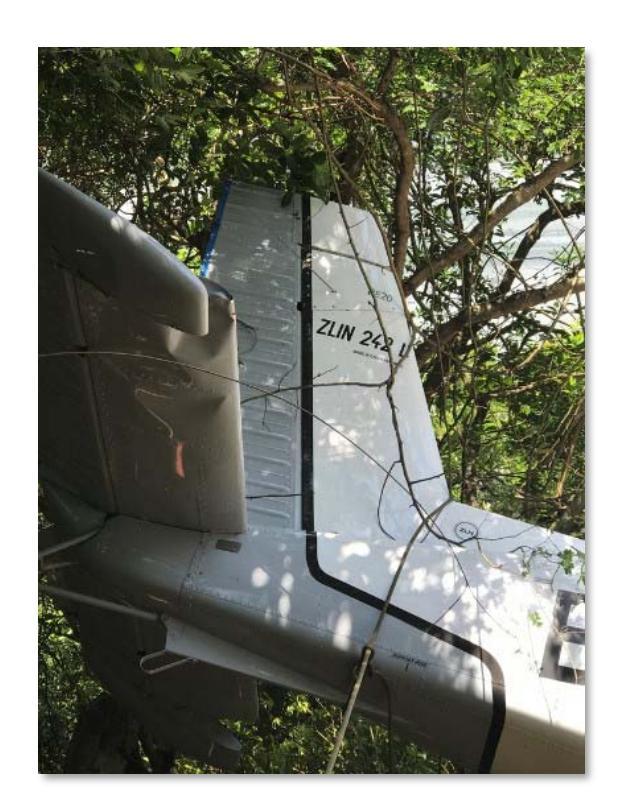
Figure 5: Right Empennage

- (5) Both wing leading edges and the fairings at the wing roots were damaged.
- (6) Impact scoring under fuselage were noted below the cabin area.
- (7) The leading edge of the right stabilizer was damaged and the right elevator undersurface was punctured.

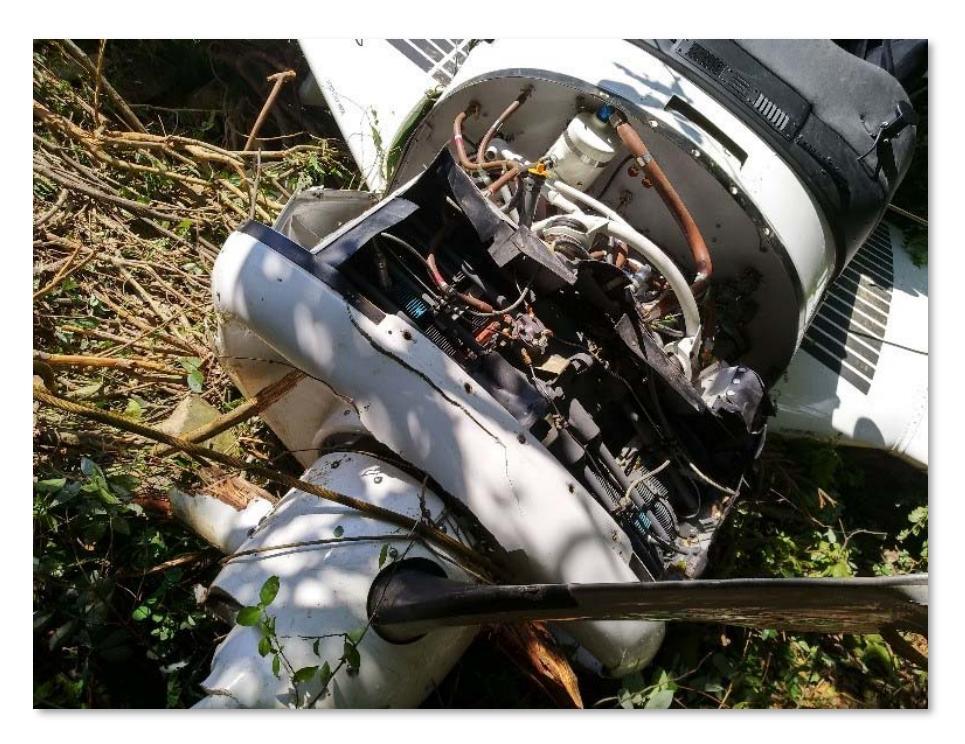
Figure 6: Engine Bay

(2) The engine bay area was damaged and the engine mounts were distorted (Figure 6). Two of the three propeller blades were shattered and the third was damaged at the tip (Figure 7).

- (3) The lower firewall was damaged and the engine mounts distorted and bent.
- (4) The spinner was crushed. Two propeller blades were splintered approximately midway along their diameter with the third blade's outer portion intact.

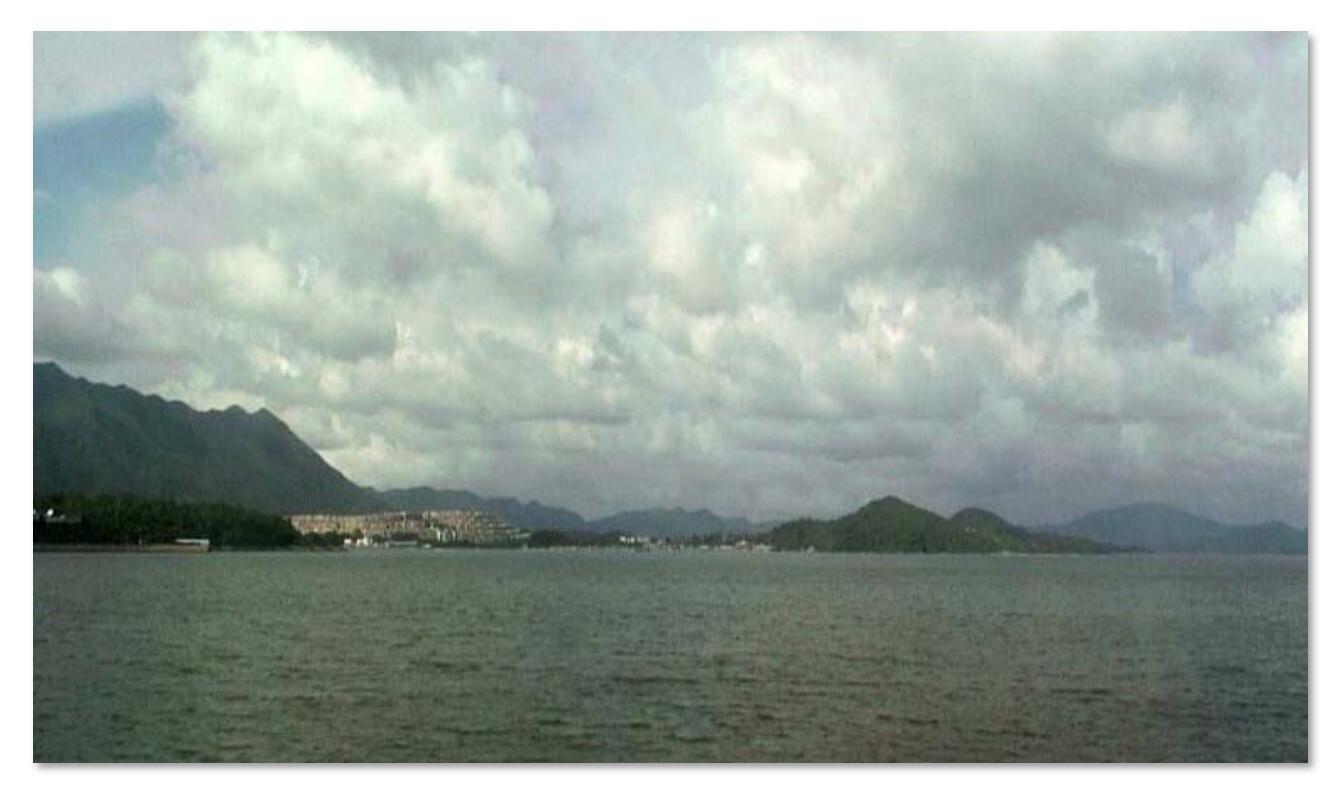
Figure 8: HKO Weather Camera Tolo Harbour at 1634 hrs on 24 June 2018

(2) The weather in the vicinity of Ma Shi Chau closest to the accident time was captured by the HKO camera at Tolo Harbour (Figure 8).
