# Deviation from Intended Flightpath (DEV)

# **Investigation Report**

Serious Incident Boeing 787-8 VT-ANE Approach to Hong Kong International Airport 20 October 2018

IVR-2025-02

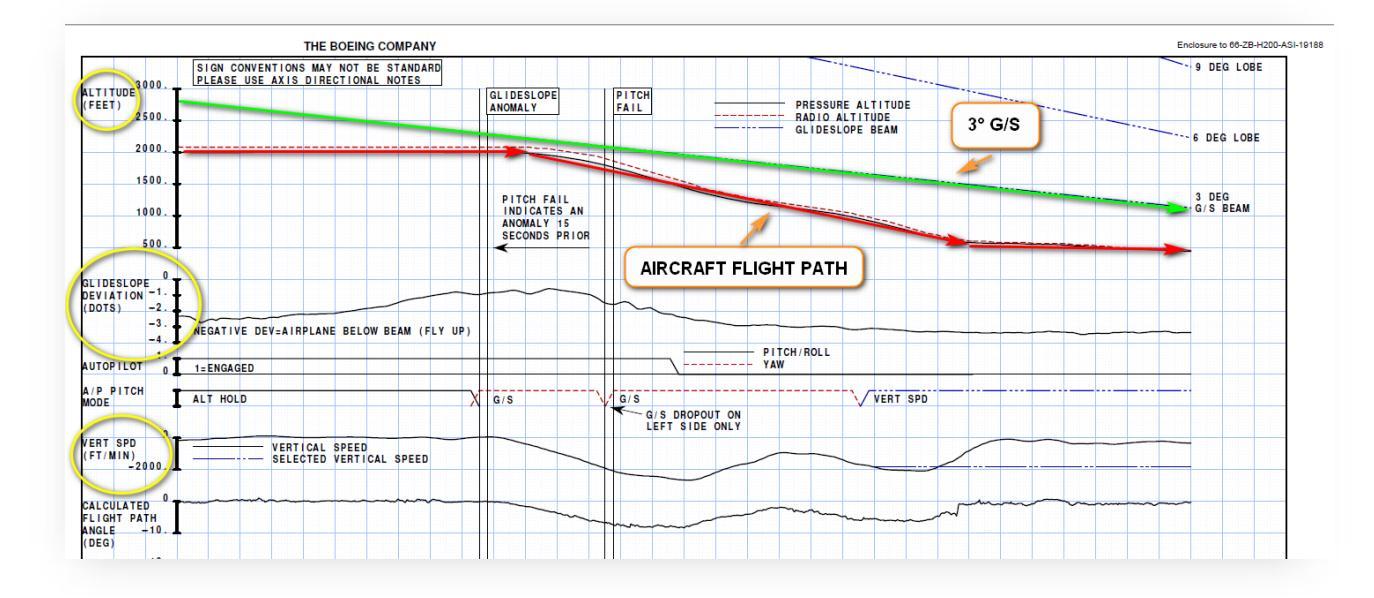
Figure 1: Aircraft Flight Path

- (32) Figure 1 indicates the desired 3° GS and the actual aircraft flight path. The data is from the Enhanced Airborne Flight Recorder (EAFR) via the Boeing Company.

(33) The desired 3° GS is indicated in green along with the actual flight path attained in red. The Altitude, GS deviation and vertical descent rate can be read from left to right.

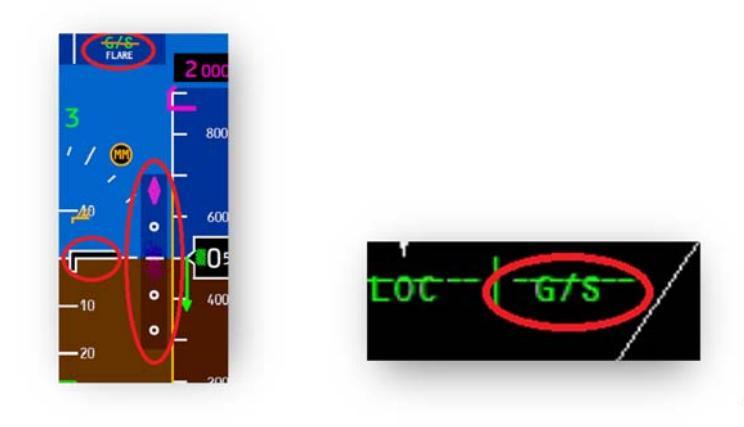
Figure 5: PFD and HUD Indications after 15 Seconds of Glideslope Interference

- The annunciation on the PFD is an amber line through the flight mode G/S and the respective fight director bar is removed. Concurrently, a green line will appear through the HUD G/S indication. Refer to Figure 5.

- Additionaly, an amber AUTOPILOT message appears on the Engine Indicating and Crew Alerting System (EICAS) accompanied by an aural beeper.

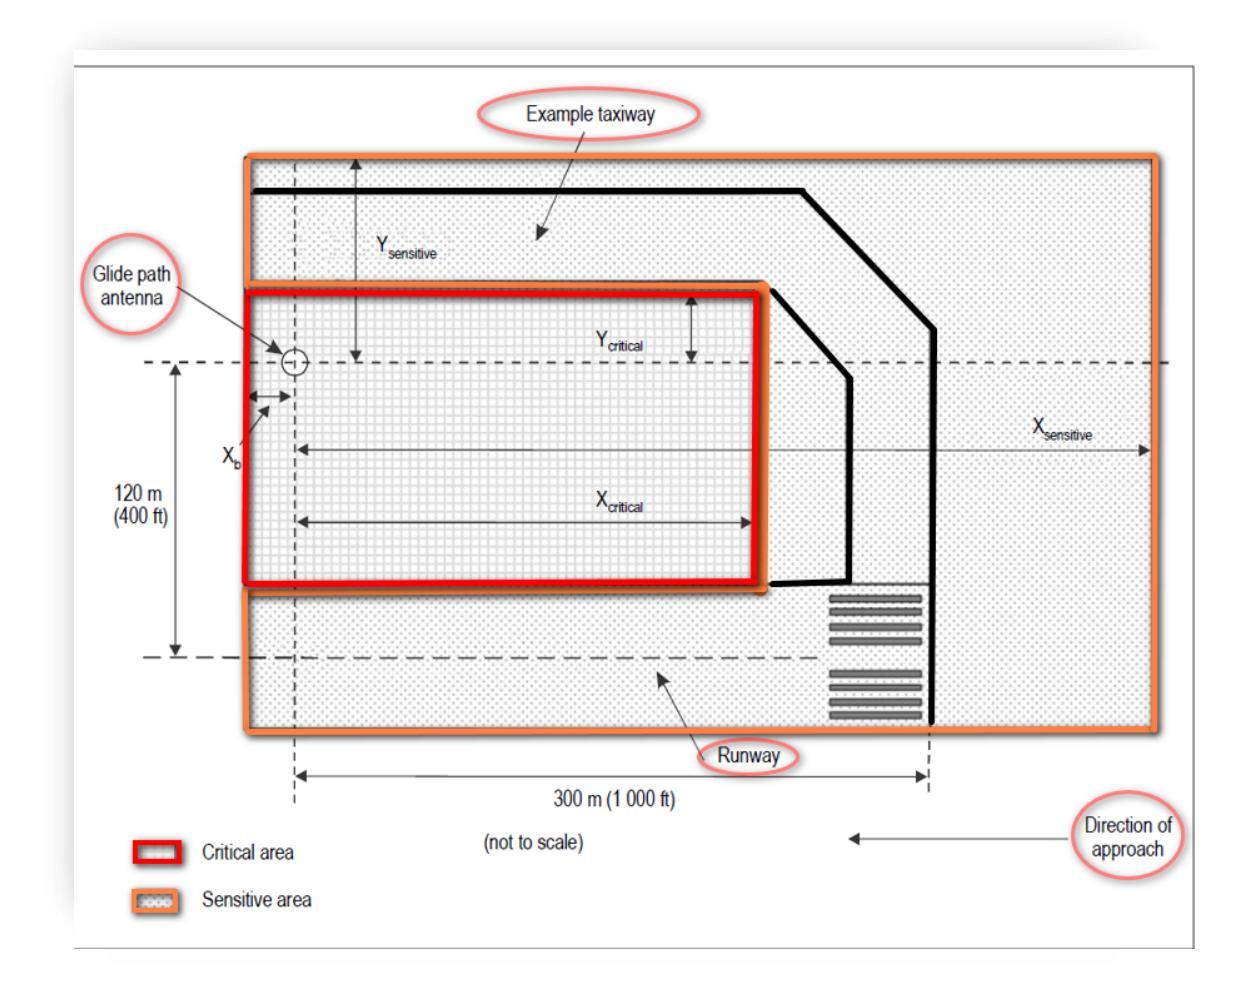
#### Figure 6: Exemplar Glide Path Critical and Sensitive Area

each category of approach. Figure 6 shows an example of the critical and sensitive areas around an ILS antenna.

- (3) In certain conditions, the integrity of an ILS is not protected, and signal disturbances may be experienced, even while the flight crew are conducting an instrument approach. Pilots may experience ILS beam bends and other interference in circumstances where the critical or sensitive areas of the ILS are not protected.
- (4) Operators are advised in the Hong Kong Aeronautical Information Publication (HKAIP) regarding ILS approaches to Rwy 07R that GP signals may be liable to interference from aircraft taxiing in the vicinity of the GP area and warns pilots to closely monitor the ILS profile and rate of descent.

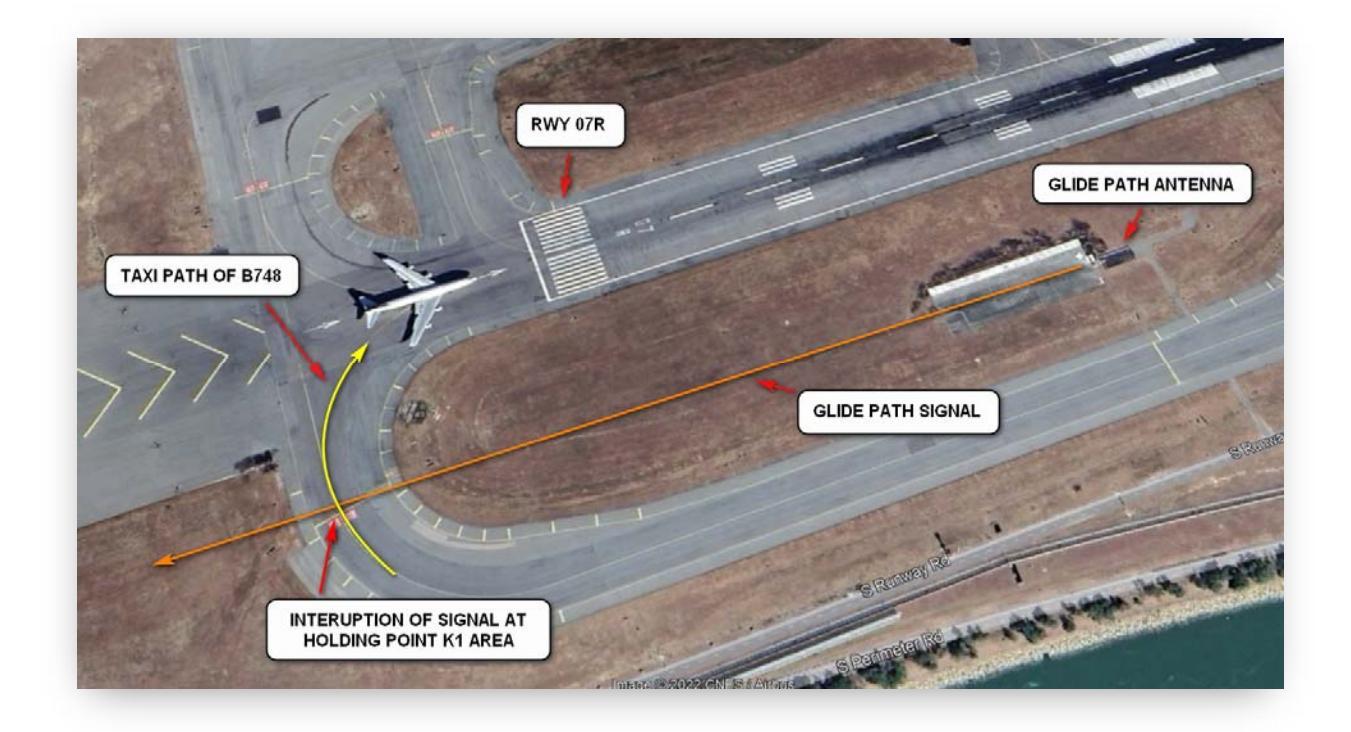
#### Figure 8: Exemplar Glide Path Disturbance

- (1) The glideslope signal disturbance occurred at about the same time that a B748 aircraft taxied past holding point 'K1' and departed. The B748 had been in the Rwy 07R GP sensitive area waiting for landing traffic for 5 minutes and 34 seconds, prior to being cleared to line up on Rwy 07R. During this period, two arriving aircraft made ILS approaches without any problem and made no comments to ATC.
- (2) The investigation team established the movement of the B748 was within the Rwy 07R GP sensitive area, and it is possible that this aircraft's proximity to the antenna along with its large mass as it entered and lined

up on the runway caused the interference to the glideslope signal. See Figure 8.

- (3) The possibility that the presence of the B748 in the sensitive area would cause GP signal fluctuations was not able to be ascertained definitively by the investigation team.
- (4) The investigation team considers that the known possibility of glideslope disturbance on Rwy 07R is sufficiently promulgated with warnings in the HKAIP, ATIS broadcast and by ATC in real time. Additionally, AIC emphasized the possibility in their approach briefing notes as do many operators.
