# **Loss of Control - Inflight (LOC-I)**

## **Investigation Report**

**Niviuk Artik R Paraglider  
Ngong Ping, Ma On Shan,  
Hong Kong  
11 February 2025**

**IVR-2026-04**

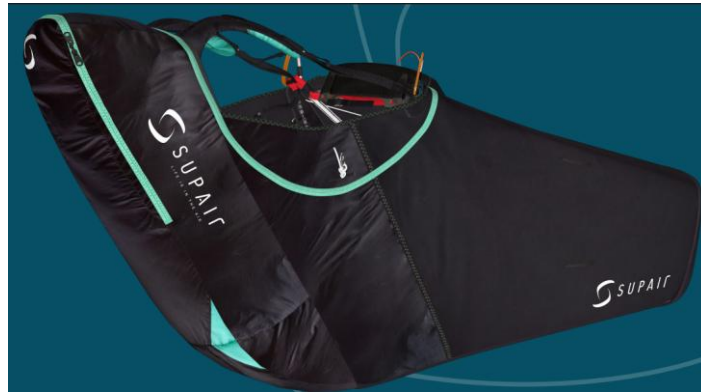
**Figure 6: The Pilot's SUP'AIR Strike 2 Harness**

- (2) During the examination of the Pilot's equipment, it was noted that the reserve parachute was still stored in a pocket of the harness. It was not deployed in the accident.

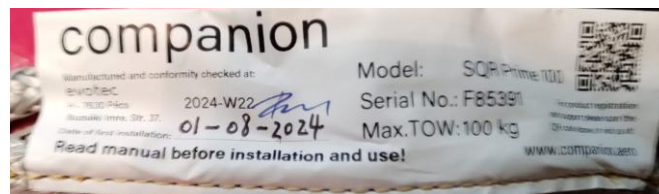
**Figure 7: Data Labels of the Pilot's Reserve Parachute**

- (1) The Pilot also carried a reserve parachute in his harness. The model was "SQR Prime 100" made by Companion / Evotec Ltd with the date of first installation on 1 August 2024. It was certified to EN 12491:2015<sup>9</sup> and NfL II 91/09<sup>10</sup>. It could carry a maximum weight of 100 kg in flight.

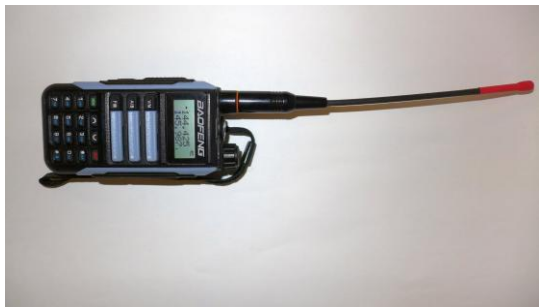
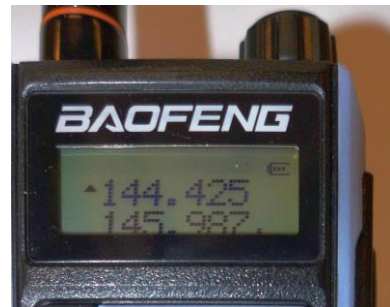
**Figure 13: The Pilot's Transceiver and the Pre-set Frequencies**

The Pilot carried a two-way radio transceiver. During the examination by the investigation team, it was noticed that the active and the standby channels were set to 144.425 MHz and 145.9875 MHz (HKPA's local safety frequency) respectively. The transceiver was tested and functioned normally.

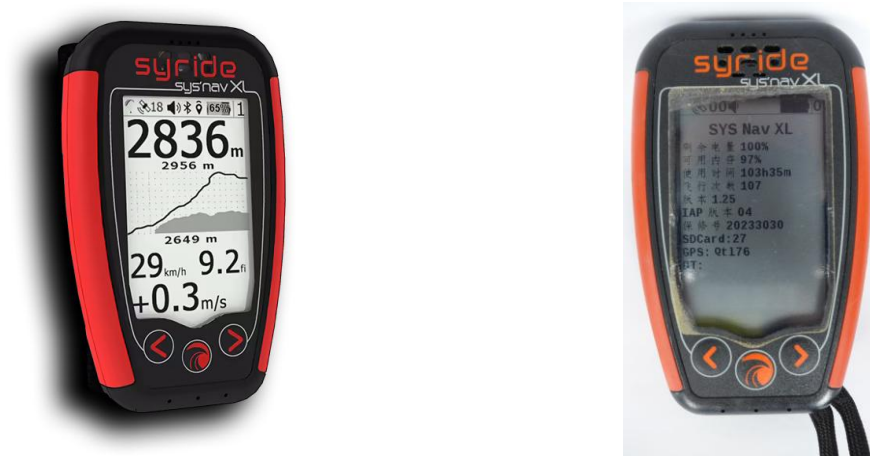
**Figure 15: Variometer Used by the Pilot**

(Source: <https://www.syride.com/en/instruments/XL>) (The Pilot's Variometer)

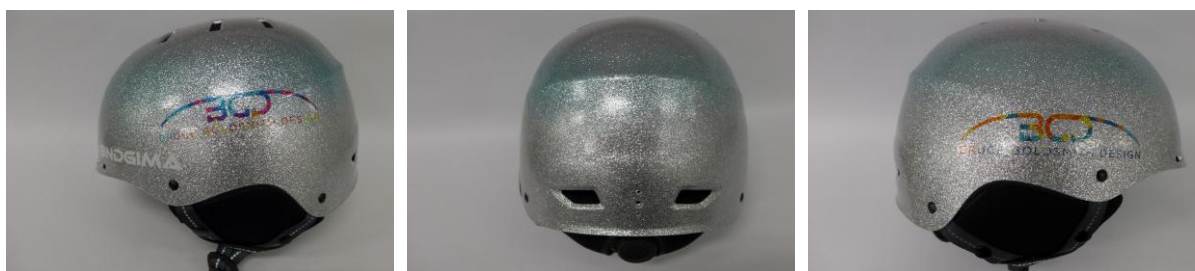
**Figure 17: The Pilot's Helmet**

- (1) The helmet of the Pilot is a BNDGIMA ski helmet, model "BH-58A" of size M.
- (2) No damage was found on the helmet.

- (3) According to a label on the helmet, it was certified to EN 1077. It met one of the specifications recommended by the CAD on their Safety Guidance on Paragliding Activities (CAD Safety Guidance) website.
- (4) According to the Pilot, the helmet was procured in November 2024.

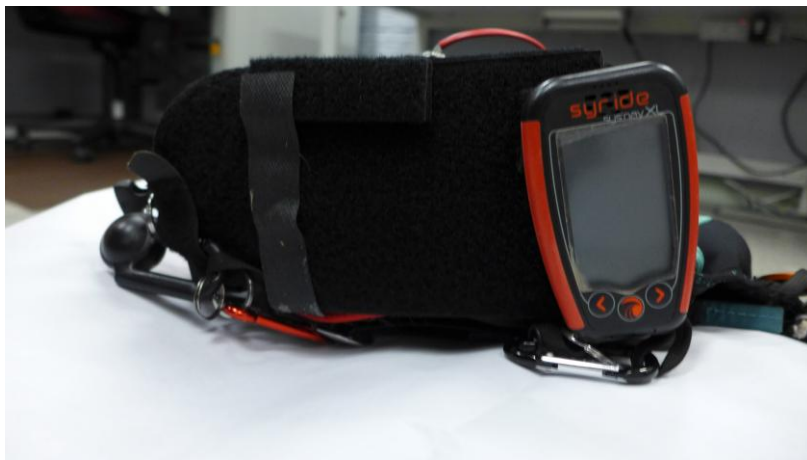
**Figure 18: External Flight Deck of the Pilot**

The Pilot carried an external flight deck which accommodated his variometer.
