Loss of Control – Inflight (LOC-I)

Investigation Report

**Accident to
Ozone Alpina 3 Paraglider
Sunset Peak
Lantau, Hong Kong**

01-2022

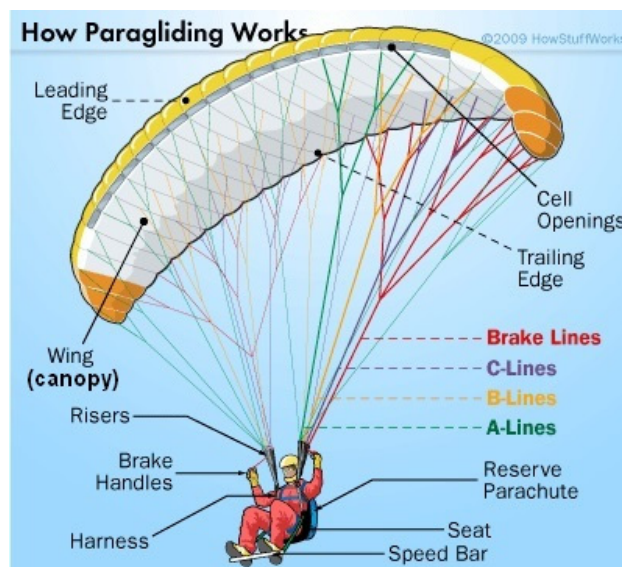
Figure 2: A Typical Paraglider

- (1) A typical paraglider consists of a canopy which is inflated by the wind to form an aerodynamic wing from which the pilot is suspended by a harness equipped with control lines. The inflated wing enables the paraglider to fly forward and downward; to gain height it has to make use of rising air. It has rudimentary means of directional control.

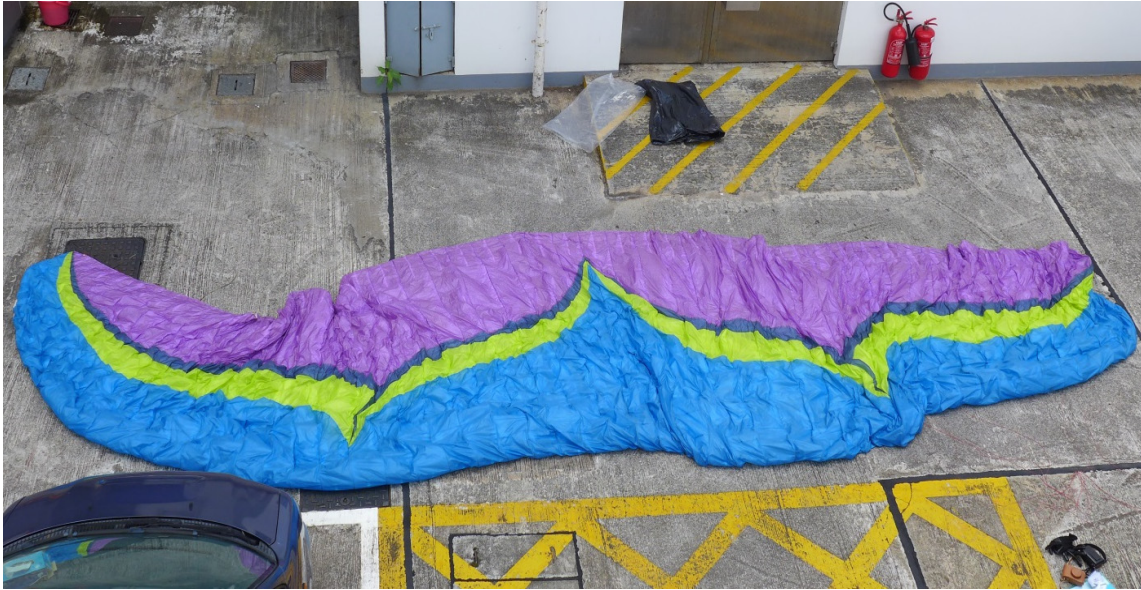
Photo 1: The Paragliding Canopy of the Pilot

- (2) The Pilot operated an Ozone Alpina 3, an EN-C certified paraglider of MS size (Photo 1), which was purchased new in April 2018. It was fitted with an Advance Lightness 2 harness of L size (Photo 2).

- (1) The paragliding canopy was examined and found in good shape (Photo 1). There was a ripped hole (1 cm x 2 cm) found on the canopy (Photo 11). Harness shoulder straps and all lines connecting the canopy were cut during the recovery operation.

- (1) The ripped hole on the canopy was not significant. It would not lead to equipment failure.
- (2) The two small cuts at the harness cocoon had no impact on the operations of the harness. The minor damages were suspected to have been a result of the crash or during the recovery of the canopy.
- (3) The paraglider lines were examined and found within the limit.
- (4) There was no evidence of the failure of the paraglider.

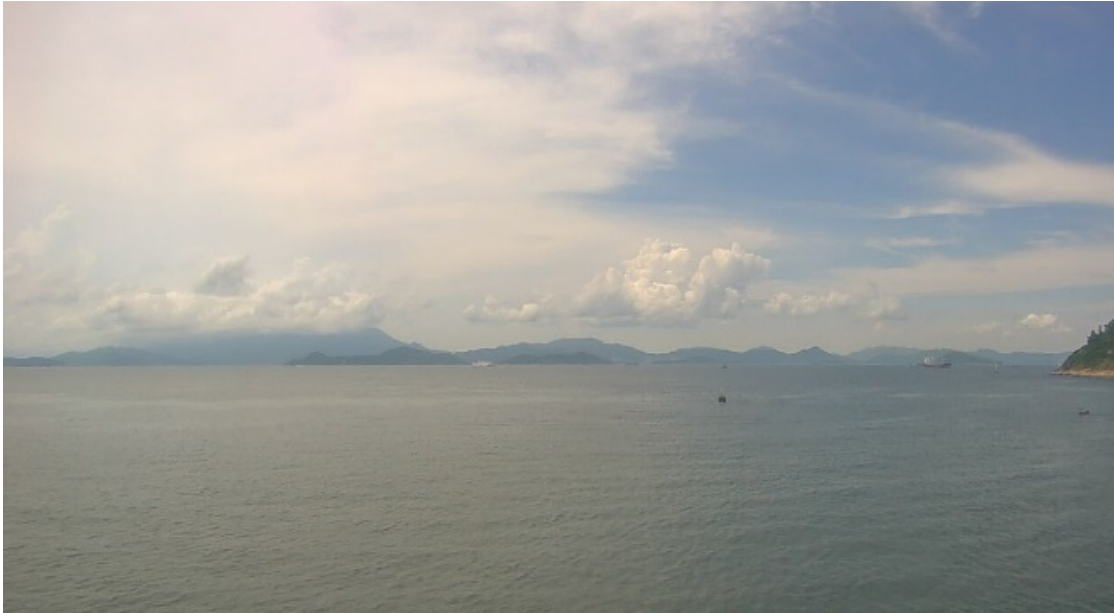
Photo 3: Cloud Base Level at South Lantau at 1345 Hrs on 22 July 2018

The HKO webcam from Lamma Island Yung Shue Wan Pier captured the general weather condition of South Lantau Island during daytime (Figure 6). With the approach of thundery showers before 1400 hrs on 22 July 2018, the tops of Lantau Peak (Fung Wong Shan) and Sunset Peak (Tai Tung Shan) were progressively covered by cloud from 1345 hrs to 1410 hrs on 22 July 2018 (Photos 3 to 7).

Note: The Pilot took off at around 1350 hrs.

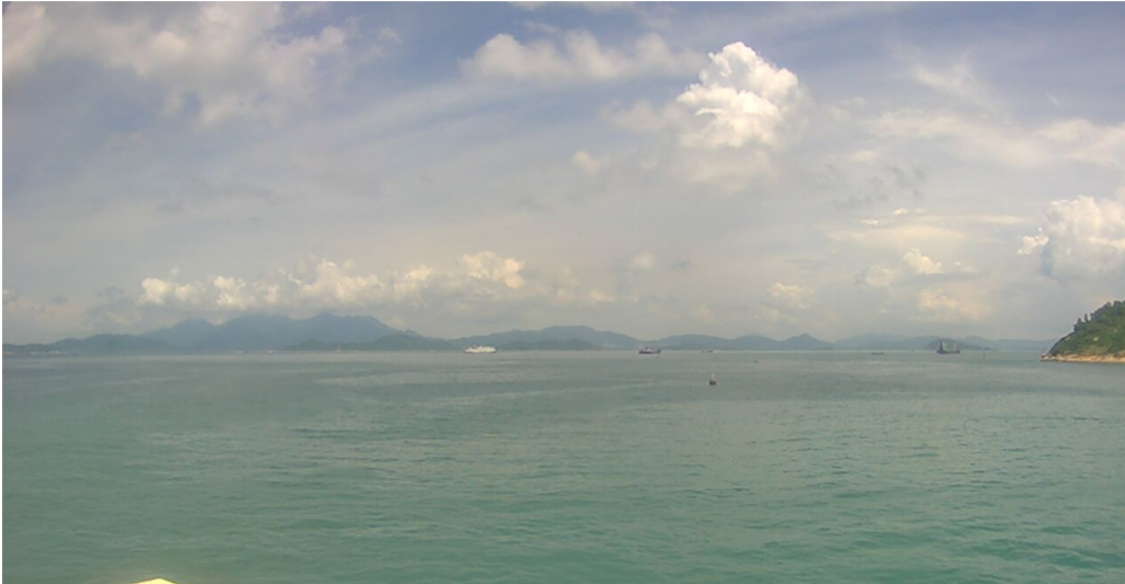
Photo 9: Pak Kung Au Visible at 1130 Hrs on 27 July 2018

On 27 July 2018, Sunset Peak and Lantau Peak were momentarily clear of clouds at around 1130 hrs (Photo 9). This had created a window of opportunity for a GFS helicopter to conduct reconnaissance at the south of Sunset Peak, before taking up another casualty evacuation operation at Shek Pik. At about 1147 hrs, the GFS crew spotted the paragliding canopy and the Pilot at about 680 m AMSL south of Sunset Peak. Refer to Paragraph 1.15.5.(1) for more details on the GFS flight operation.

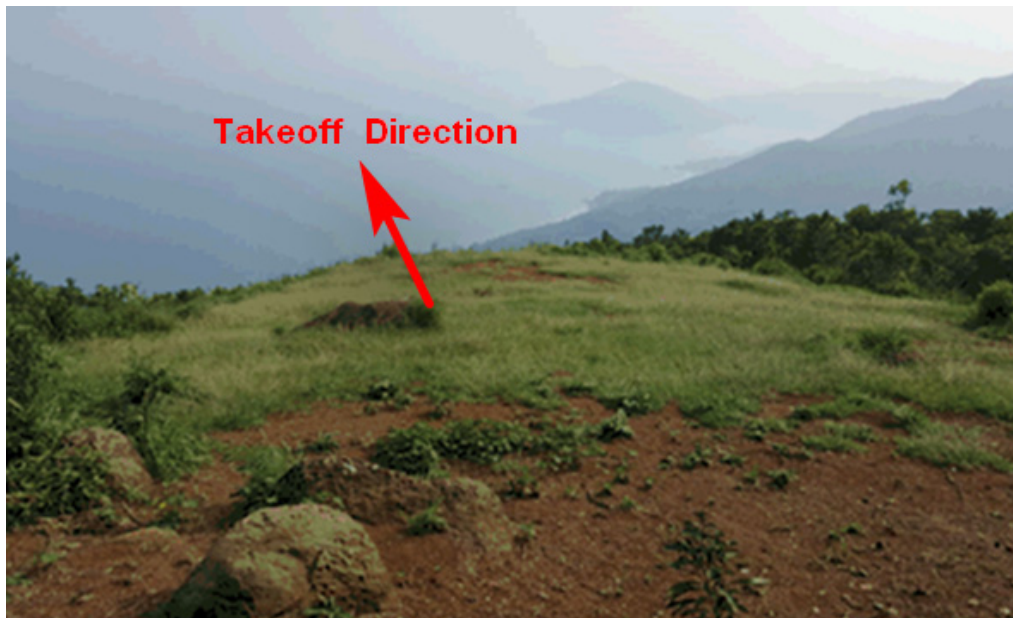
Photo 10: South Lantau East Takeoff Area

- (1) The South Lantau East paragliding activity area in the Lantau South Country Park was located within the Lantau Control Zone, which was defined in the Aeronautical Information Publication Hong Kong (AIP HK) published by the Civil Aviation Department (CAD) (Figure 1). The operating altitude of the area was from the ground surface (SFC) to 2000 feet (609 m) AMSL. The South Lantau East takeoff area (Photo 10) was at about 400 m AMSL, at approximately 1.2 km east of PKA along the South Lantau Country Trail.

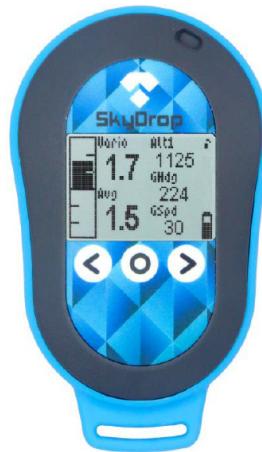
Figure 8: The Type of Variometer Used by the Pilot

- (1) The Pilot's variometer (Figure 8) which was attached to the harness, was recovered by the rescue team on 27 July 2018. This model, SkyDrop, was an integrated device with altimeter, compass and Global Positioning System (GPS) functions. It provided and recorded not only signals of rates of climb and descent, but also GPS positions and pressure altitudes for paragliding activities. Data stored from the variometer in the International Gliding Community (IGC) file could be used for flight track analysis.

The variometer that integrated functions of position and altitude provided a useful source of data to analyse the flight tracking and positions of the Pilot after the accident. With the flight data extracted from the variometer, the investigation team was able to reconstruct the flight path prior to the impact, which in turn is essential to identify the cause of the accident and then in devising safety recommendations and actions in order to prevent future occurrences.

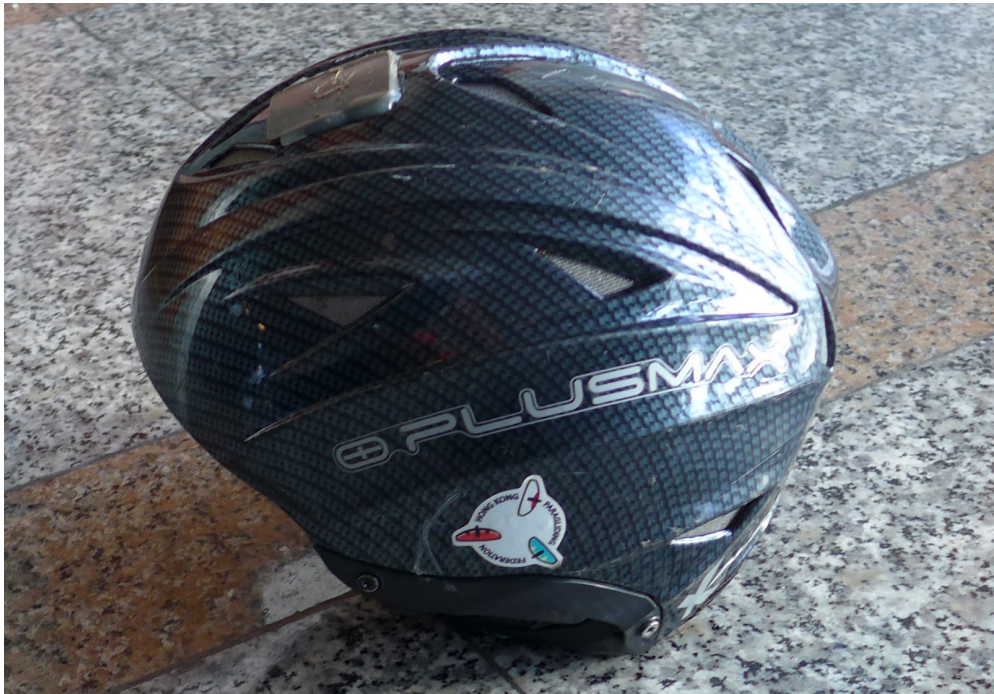
Photo 12: Helmet of the Pilot

The helmet, Model “Plusmax I helmet” (Photo 12), which was certified with EN966 standard, was found detached from the Pilot’s head, approximately midway between

the canopy and the Pilot. The helmet buckle was secured when found and there was no observable damage to the helmet. A camera mount appeared to be missing or sheared off, leaving only the adhesive tab on the helmet.

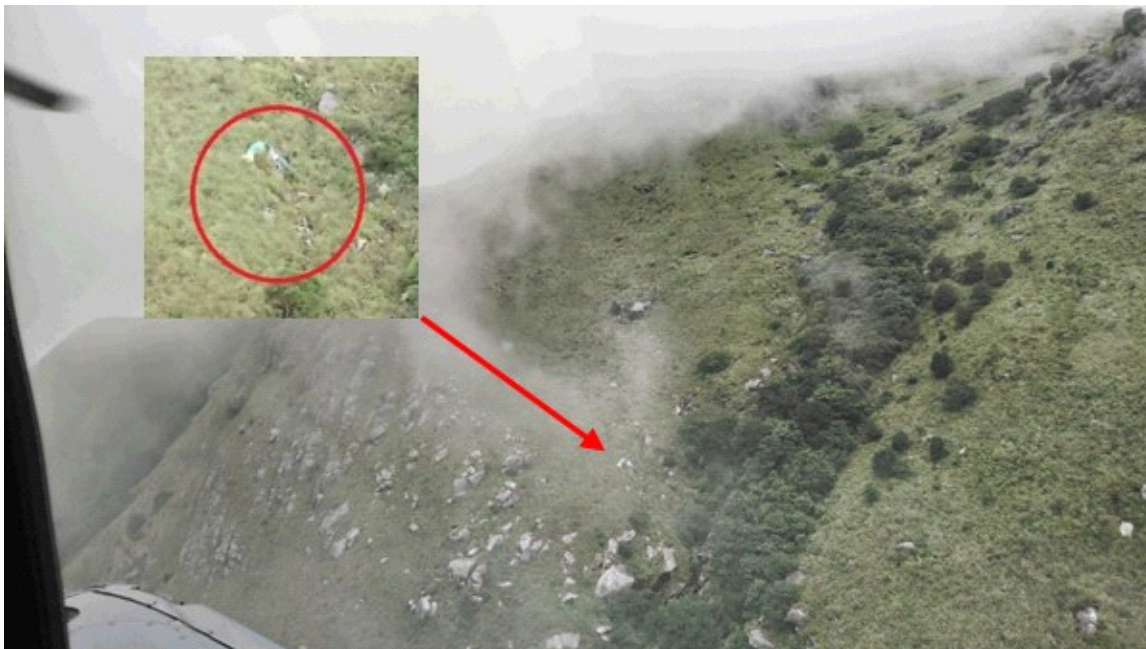
Figure 11: Paraglider Canopy Spotted by the GFS Crew

- (1) In the morning of 27 July 2018, the FSD search command coordinated with GFS to air-troop FSD and CAS search teams to the target location. Before the planned operation, a GFS helicopter operated a casualty evacuation (CASEVAC) flight from Hei Ling Chau to Wan Chai at 1129 hrs. The crew was assigned another CASEVAC operation in Shek Pik after the completion of the first CASEVAC flight. While the helicopter was on the way to Lantau, the GFS pilot decided to conduct an aerial search at the south of Sunset Peak before the CASEVAC operation in Shek Pik. At about 1147 hrs, the GFS crew spotted the paragliding canopy and the Pilot at about 680 m AMSL south of Sunset Peak (Figure 11). After being notified, the Rescue Command then coordinated with the GFS Air Command and Control Centre (ACCC) to deploy mountain rescue teams of CAS and FSD on separate flights to recover the Pilot. The CAS rescue team reached the location at 1234 hrs. The unconscious Pilot was air-lifted by a GFS helicopter to PYNEH which later arrived at PYNEH at 1420 hrs, and was certified dead by a duty medical officer at 1431 hrs.

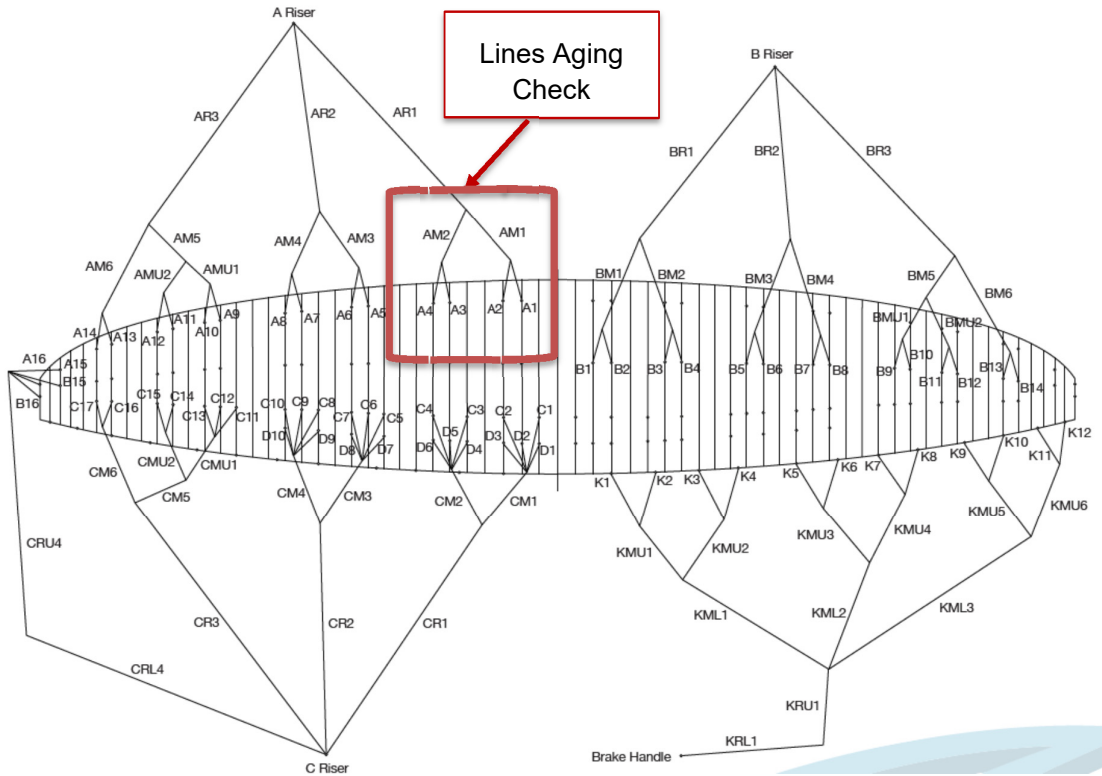
Figure 13: Lines Aging Check at Upper “A Gallery”

Paraglider lines aging check was carried out with the assistance from HKPA Safety Officers on the upper “A gallery” (Figure 13). The difference between manufacturer’s length and calibrated measurement should not be greater than 10 mm. The check revealed that the differences of the four “A gallery” lines were all less than 10 mm (Table 5). There was no sign of significant aging or wear observed on the paraglider lines.

(A)	(B)	(C)	(D)
	Line Length Suggested by manufacturer	Laser Measurement	(B) With Calibration	Difference between (A) & (C)
A1+AM1	1968	1988	1970	-2
A2+AM1	1976	1995	1977	-1
A3+AM2	1930	1949	1931	-1
A4+AM2	1939	1955	1937	2

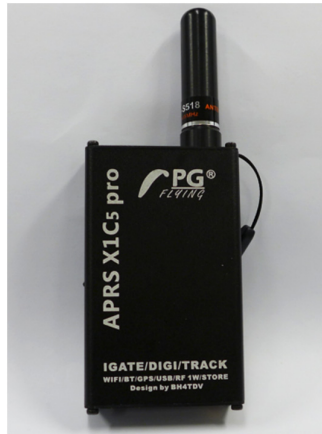
Photo 13: APRS GPS Tracker

After the accident, Hong Kong Paragliding Federation developed an “Automatic Packet Reporting System (APRS) GPS Tracker” (Photo 13) to detect the location of registered paraglider pilots. APRS device provides a reliable GPS tracking and 2-way radio communication during extreme situation, when existing mobile phone/internet networks are not available. The location of the APRS GPS Tracker unit, once activated, can be tracked by other APRS GPS Tracker units and monitored on a website.

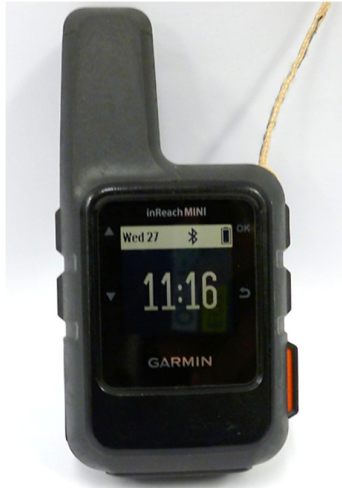
Photo 14: A Typical Satellite Communicator

With a subscription of the satellite service, a paraglider pilot can stay in touch anywhere in the world using a satellite communicator (Photo 14). This device provides a two-way communication that works well even in the absence of mobile phone network. In addition, the flight route can be shared with, and therefore tracked by persons chosen by the pilot. In an emergency situation, the pilot can trigger a distress signal to get assistance from a 24/7 global emergency response coordination centre via the global satellite network with a worldwide coverage.

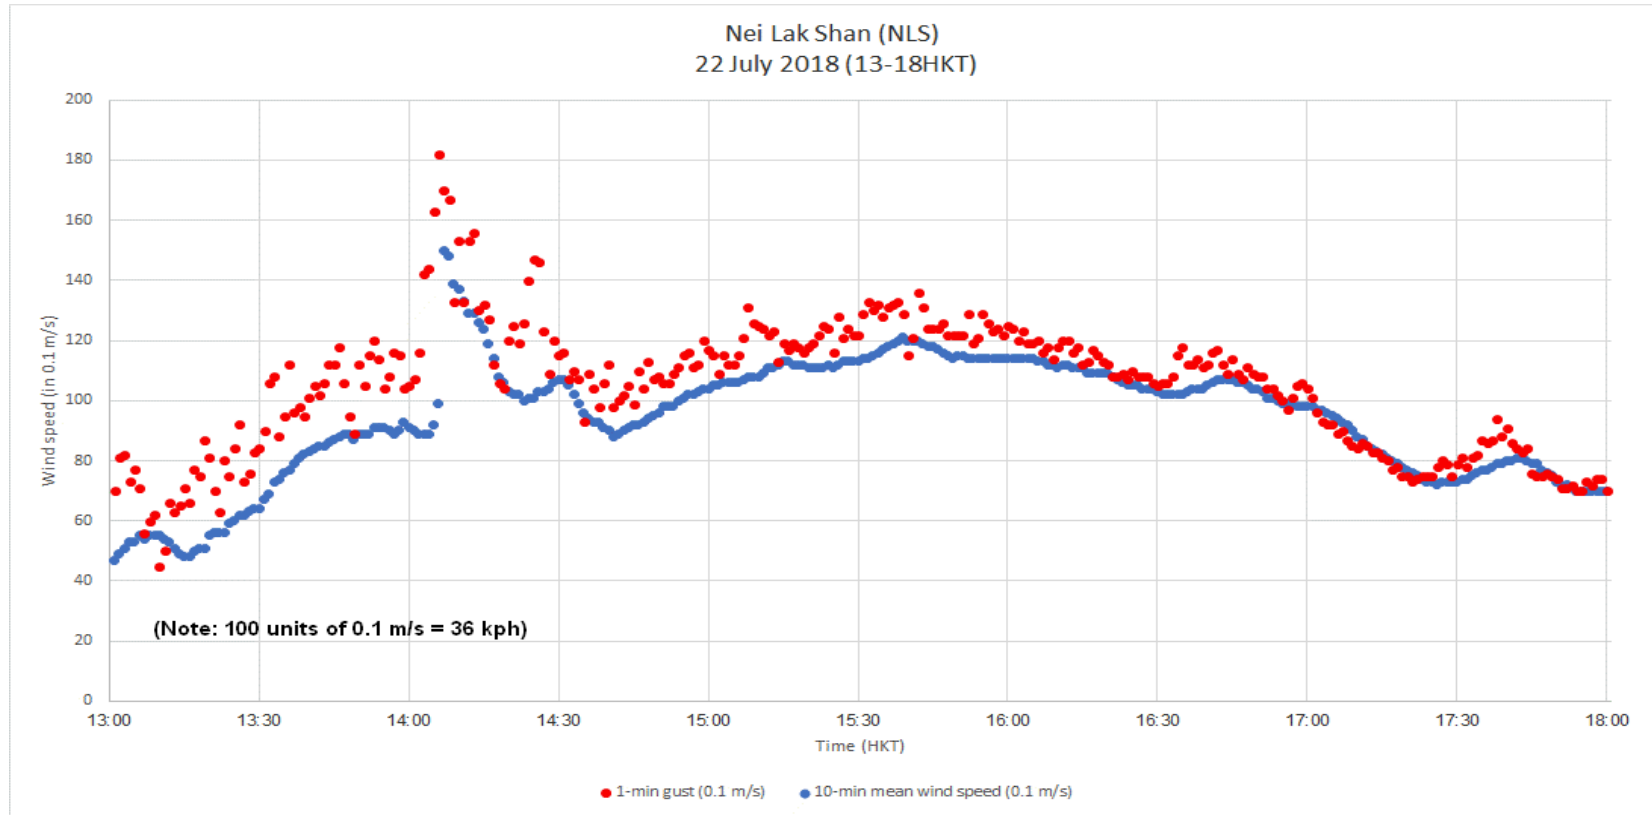
Figure 16: Maximum 1 Min Gust of 66 Kph Recorded at NLS at 1406 Hrs.

Refer to Appendix 8.1, one-minute gusts of up to 56-66 kph were recorded at four weather stations on the high ground of Lantau between 13:52 and 14:06 hrs. The high wind speed exceeded the normal paragliding operating wind condition.
