Collision with Obstacle(s) during Take-off and Landing (CTOL)

Investigation Report

BGD Dual 2 Tandem Paraglider

IVR-2026-02

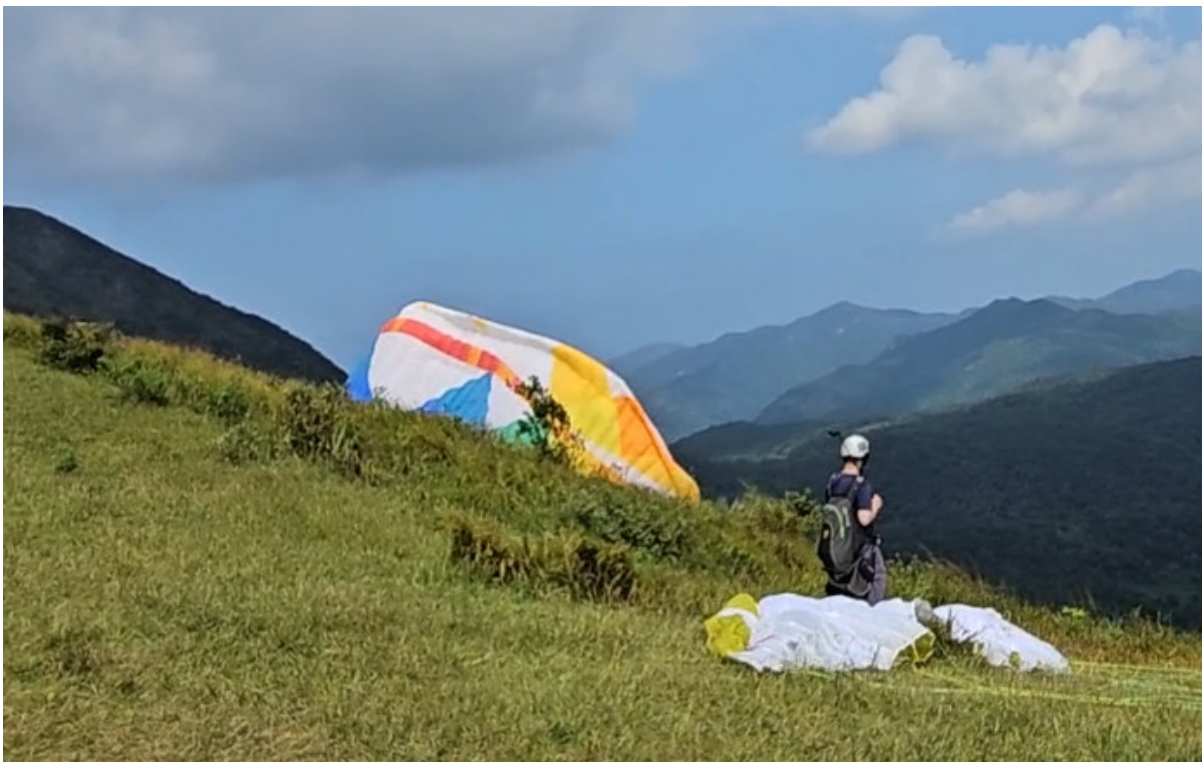
Figure 1: Moment Shortly after the Paraglider Impacting the Terrain

- (1) At about 1328 hours on 2 October 2023, a BGD Dual 2 tandem paraglider took off from Ngong Ping, Ma On Shan, where paragliding activities were frequently conducted. On board were a pilot (referred to “Pilot” hereafter) and a passenger (referred to “Passenger” hereafter).
- (2) Shortly after take-off, the Pilot of the paraglider lost control. The paraglider subsequently impacted terrain.

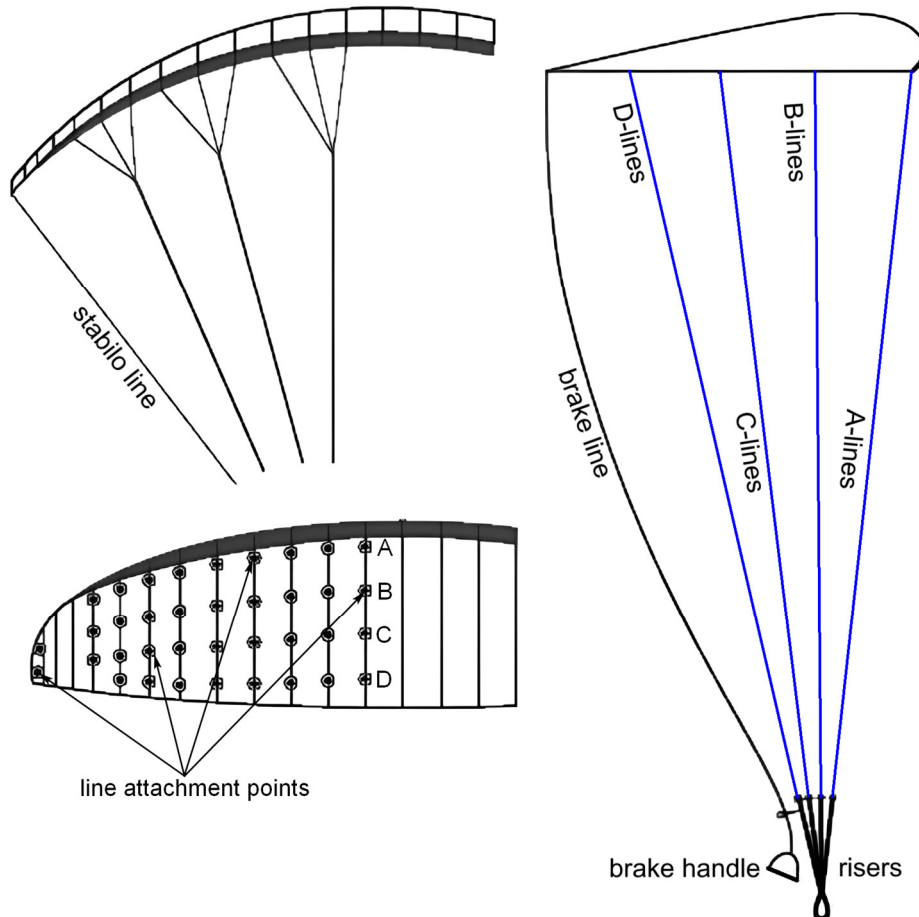
Figure 3: Paraglider Suspension Elements

- (2) From leading edge to trailing edge, the lines carrying weight are typically divided into three to four rows, namely A-lines to D-lines. The A-lines are the closest to the leading edge and the D-lines are the furthest. The lines are connected to the corresponding A, B, C and D risers, through triangular metal elements called maillons. The risers are stitched together in an ear, where a karabiner connects them to the pilot's harness.

- (3) The risers are arranged in such a way that the pulling of a pulley system on the A-riser, pulls consecutively A, B, C and D risers downward and thus reduces the angle of attack of the canopy. This is called the speed system.

- (4) There is a stabilisation panel or stabilo at the two tips of the canopy. They maintain the shape and structure of the canopy. The line specially connected to the stabilo and one of the risers on each side of the canopy is called the stabilo line. This line, often marked with a bright colour, is used to clear a cravatte in a situation where the wingtip is folded up and not producing lift.

- (5) The closest line to the trailing edge is the control line (also known as the brake line or steering line). There are left and right control or brake lines. The control line goes through a pulley and connects to the control handle (also known as brake handle or toggle). The control remains within reach of the pilot's arms if he releases it by accident.

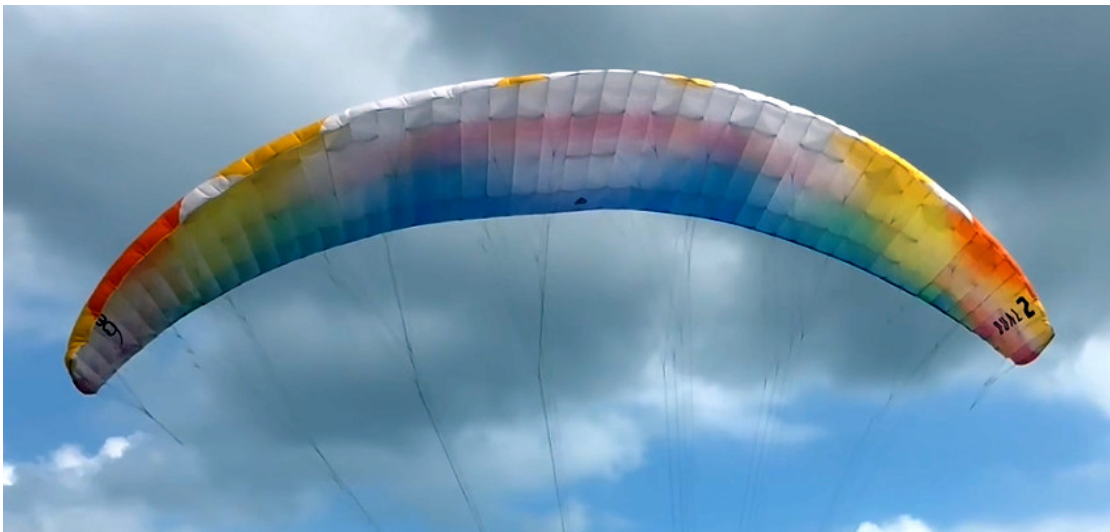
Figure 4: The Canopy of the BGD Dual 2 Tandem Paraglider Used in this Flight

(8) According to the user manual, the BGD Dual 2 tandem paraglider is certified to EN-B. An L size Dual 2 has a flat area of 41.8 m² and a weight range of 120-220 kg. It is suitable for both commercial and recreational tandem flying.

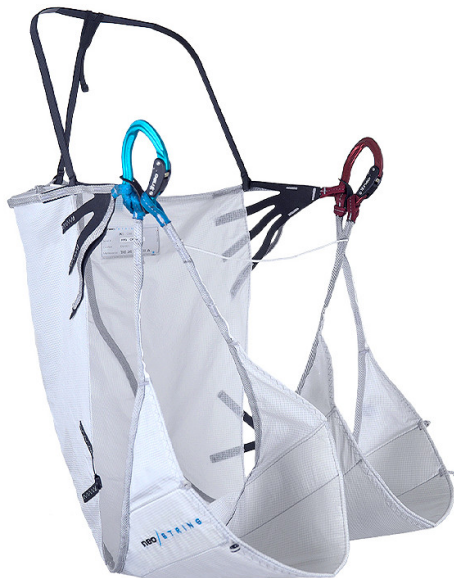
Figure 6: NEO String Harness Used by the Pilot

- (10) The NEO String harness used by the Pilot is certified to EN 1651 & LTF 91/09, 120 kg (maximum pilot/passenger weight up to 120 kg). It can be used for solo or tandem flying.

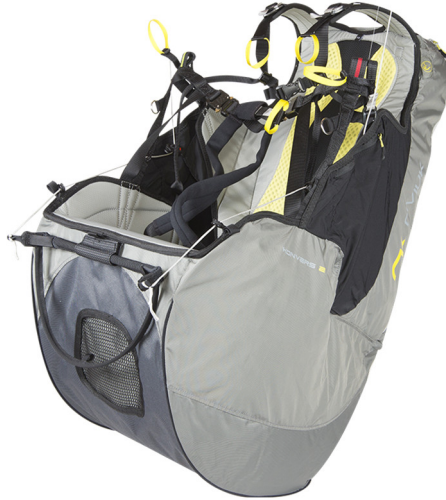
Figure 7: Niviuk Konvers 2 Harness Used by the Passenger

- (11) The Passenger flew with a Niviuk Konvers 2 harness and the size is unknown. It is certified to EN 1651 & LTF 91/09, 120 kg (maximum pilot/passenger weight up to 120 kg). It has an airbag impact pad.

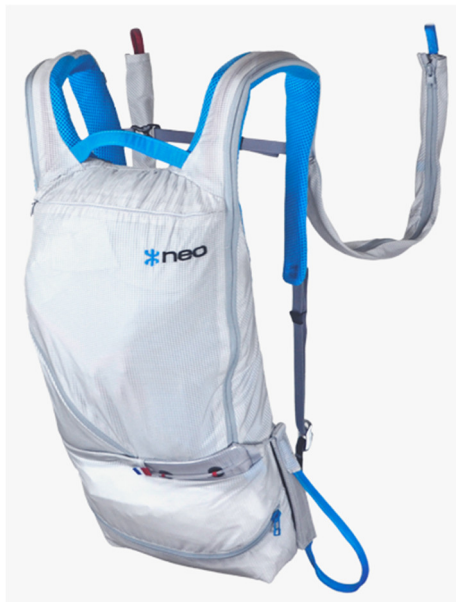
Figure 8: NEO Flying Mode Rescue Backpack Used by the Pilot

- (12) The Pilot carried an NEO rescue backpack with a stowed reserve parachute. It is certified to EN 1651. It was used to connect the paraglider and the harnesses of the Pilot and the Passenger through a set of spreaders.

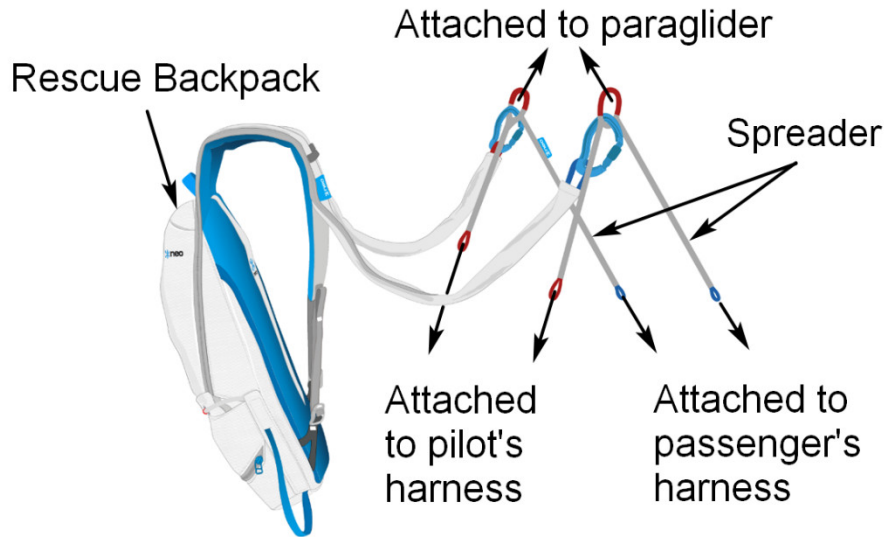
Figure 9: Harnesses and Tandem Spreaders

- (13) For typical tandem paragliding, the harnesses of the pilot and passenger are attached to a pair of spreaders. The spreaders and the rescue backpack (reserve parachute) are subsequently attached to the paraglider.

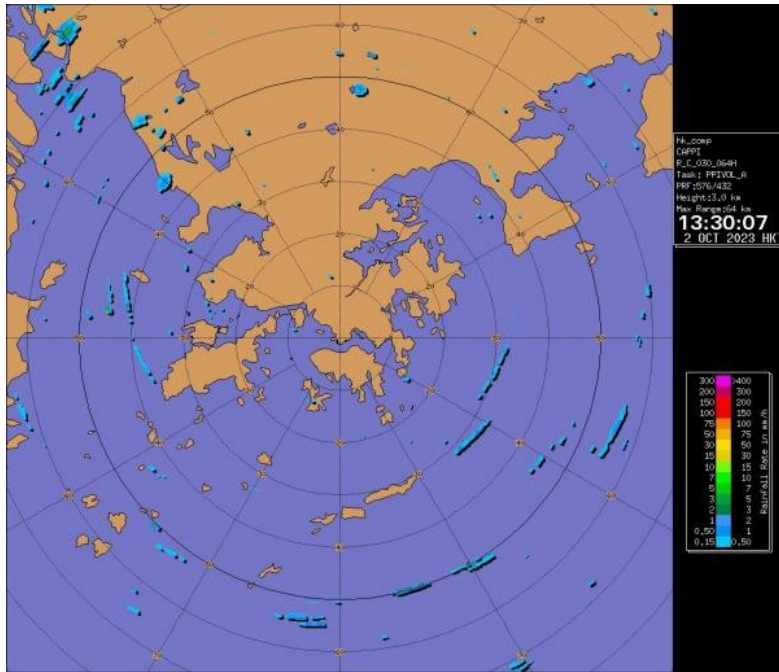
Figure 10: 3-km Radar Image of 64-km Range at 1330 Hrs on 2 October 2023

- (1) The rainfall rate was zero near Ma On Shan according to the Constant Altitude Plan Position Indicator (CAPPI) radar image at 64-km range and a height of 3 km Above Mean Sea Level (AMSL) at 1330 hrs on 2 October 2023 (see Figure 10).

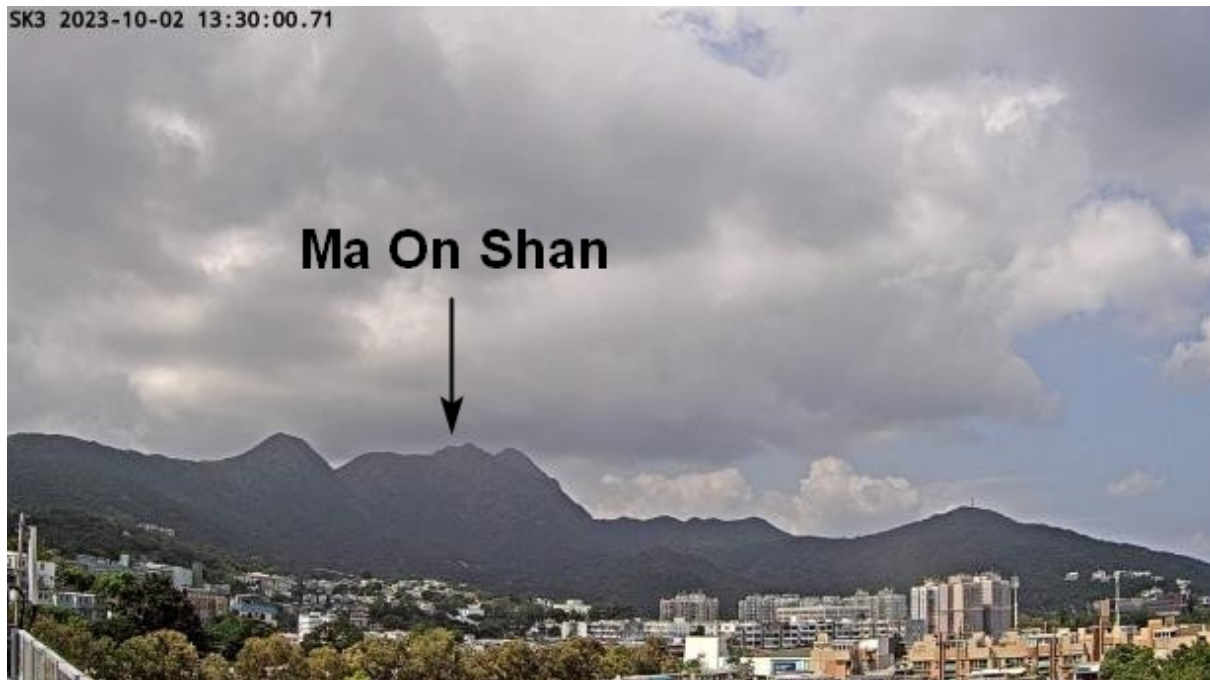
Figure 11: Weather Photo Taken at SKG Station at 1330 Hrs

- (2) The sky was mainly cloudy at Ma On Shan according to the weather photo taken at SKG station (looking towards the northwest) at 1330 hrs on 2 October 2023. The visibility was good.

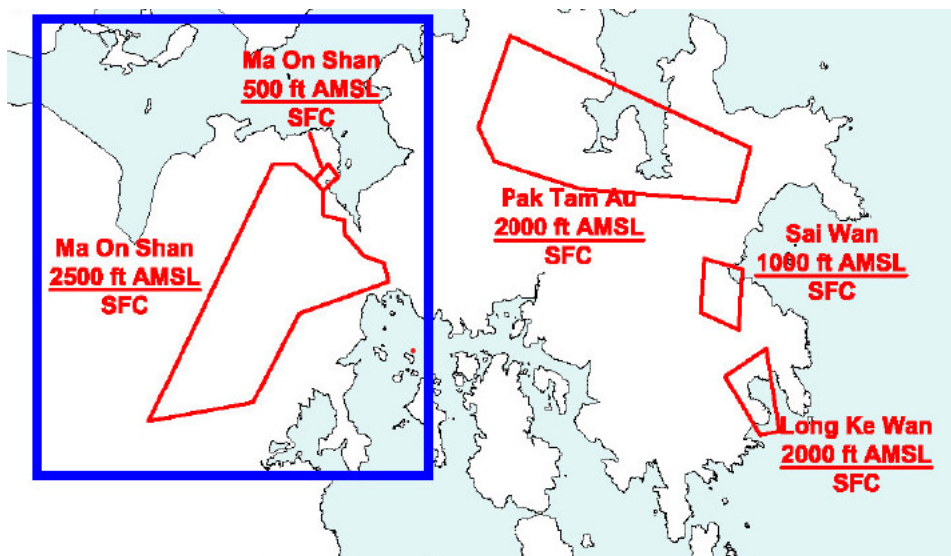
Figure 12: Ma On Shan Paragliding Area in AIP HK at the Time of the Accident

(1) The Ma On Shan paragliding area is within the Ma On Shan Country Park which is located in the central neck of the Sai Kung Peninsula in the eastern New Territories of Hong Kong. It is one of the locations where paragliding activities are frequently conducted. Its boundary and operating altitude can be found in Section ENR 5.5 of the Aeronautical Information Publication Hong Kong (AIP HK) published by the Civil Aviation Department (CAD).

- (3) The operating altitude of the area was from the ground surface (SFC) to 500 ft (152.4 m) or SFC to 2,500 ft (762 m) AMSL, depending on the areas specified in Section ENR 5.5 of AIP HK at the time of the accident.
- (4) The take-off area of the accident flight was at a height of about 1,280 ft (390 m) AMSL.

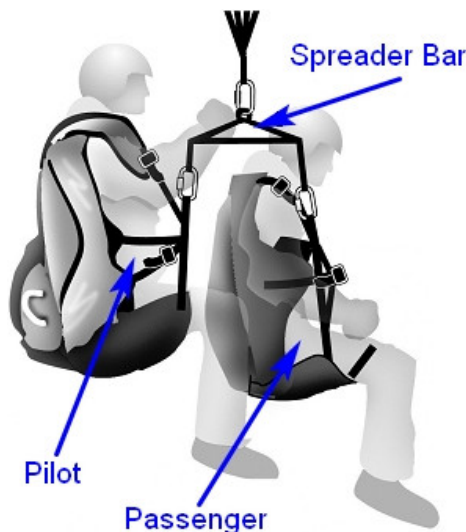
Figure 13: Tandem Paragliding Harness Setup

- (3) Both pilot and passenger sit in their own harnesses. The pilot's harness usually contains the large tandem reserve parachute, which is connected to the dedicated attachment point on the spreader.

- (4) To hook up both the pilot and the passenger to the wing, spreaders are required. These are extra pieces of webbing, connected to the risers, which split in an upside-down Y shape. The passenger is connected to one pair of the front loops of the spreader. Depending on the passenger's weight, the first or second loop is used to obtain the right balance. The pilot hooks into the rear pair of loops. The risers are connected to the middle loops on the spreaders (see Figure 13).

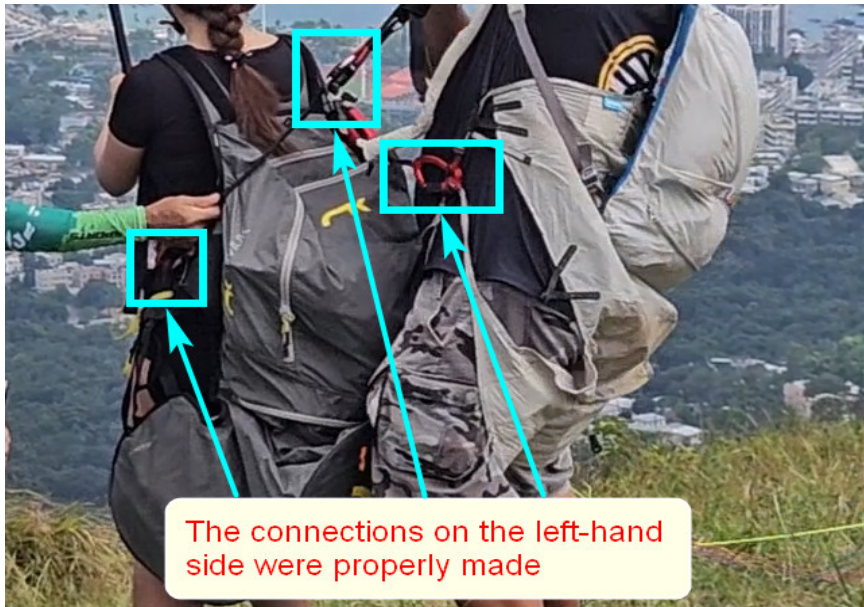
- (1) A detailed review of the video recordings revealed that the left spreader was properly attached to the harnesses of both the Pilot and the Passenger (Figures 15 and 16).

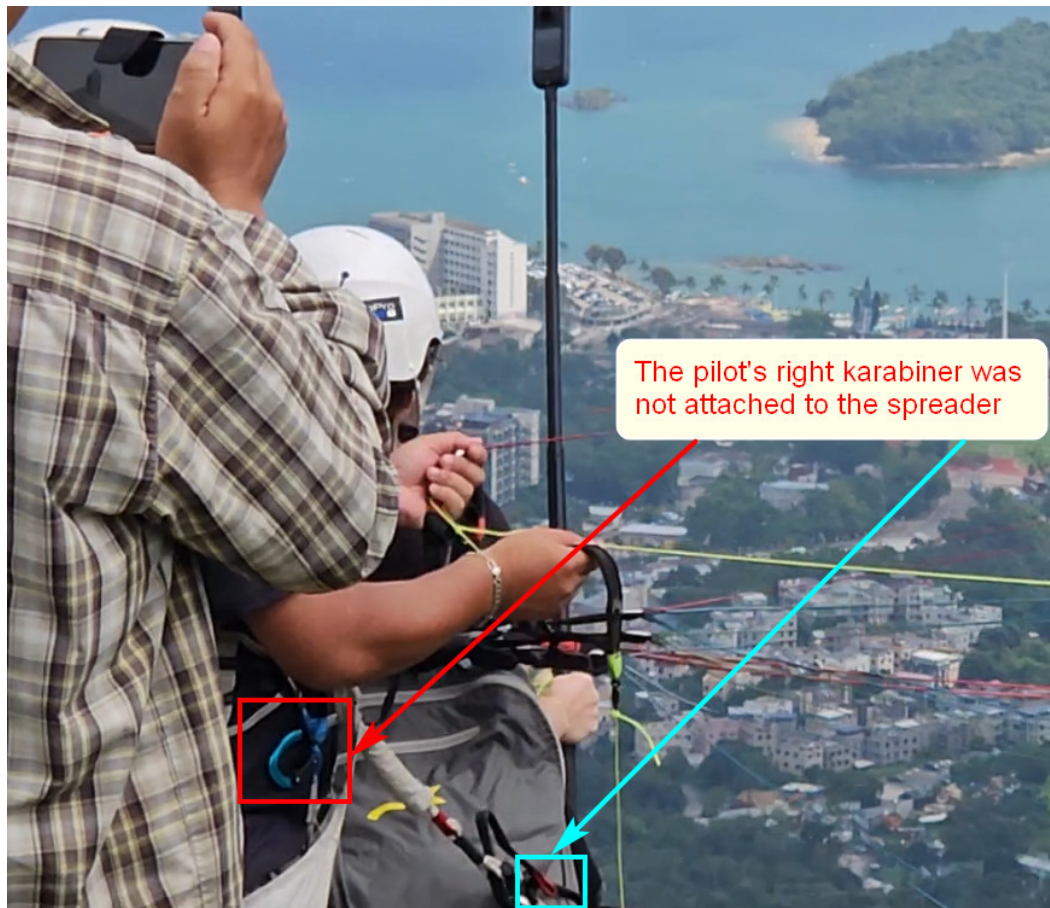
Figure 17: Pilot's Harness and Spreader Connections on the Right-hand Side

- (2) Under closer observation, it was evident that on the right-hand side the Pilot's karabiner (blue colour) on his harness was not attached to the right spreader (red colour) (Figure 17).

The uneven distribution and shifting of the total weight of the Pilot and the Passenger because of the improper attachment between the right side of the harness and the spreader, and the pilot's inappropriate take-off technique, compromised the controllability of the paraglider. The Pilot subsequently lost control of the paraglider, which resulted in a collision with terrain. [3.1 (14), (16), and (17)]

It is recommended that the Hong Kong China Paragliding Association and the International Paragliding Association to re-emphasize the crucial importance of ensuring proper connection of all vital points of a paraglider and the harnesses during the pre-flight check to all participants of paragliding in Hong Kong. This is vital to prevent any potential separation between occupants and the paraglider while in flight.

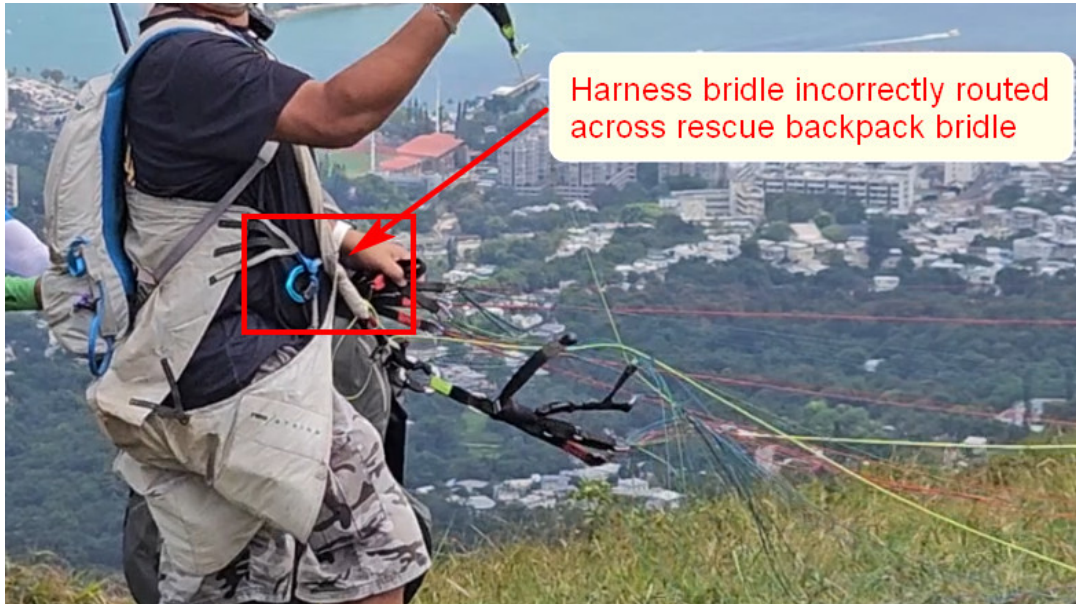
Figure 18: Bridle of Pilot's Harness Crossing That of the Rescue Backpack

- (3) In addition, it was found on the right-hand side that although the rescue backpack was attached to the main karabiner, the bridle of the Pilot's harness was incorrectly routed across that of the rescue backpack (Figure 18).

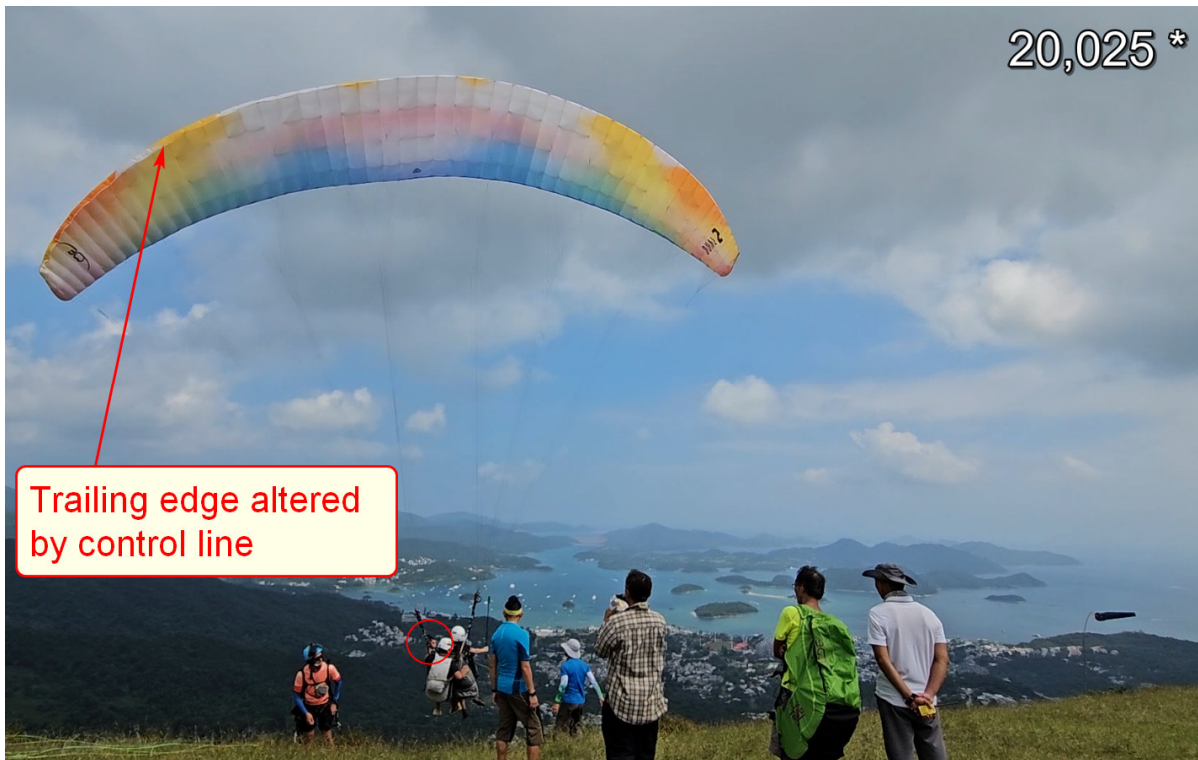
Figure 20: Pilot Still Holding Left Control Handle

- (3) At the same time, his left hand was still holding the left control handle, and the shape of the left trailing edge of the canopy was altered by the corresponding control line (Figure 20).

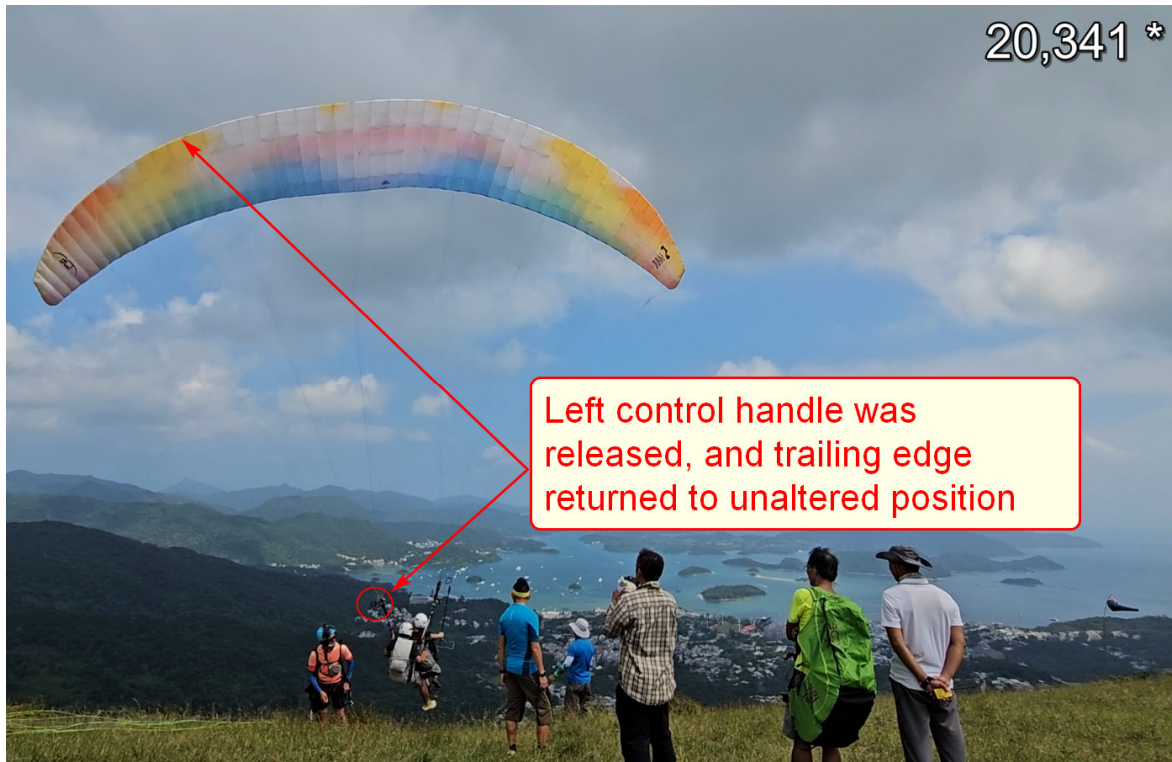
Figure 21: Pilot Released Left Control Handle

- (4) Shortly after that, he also released the left control handle (Figure 21).

- (4) Release of control handles during take-off is one of the most risky habits, especially when flying in thermic conditions or low to the ground. It is because unexpected collapses of canopy or changes in the air mass can occur. The APPI also cautioned pilots that releasing the control handles immediately after take-off is frequently linked to risk of accident in case of asymmetric canopy collapse.

It is recommended that the Hong Kong China Paragliding Association (HKPA) and the International Paragliding Association (IPA) to re-emphasize the importance of maintaining effective control of the paraglider with the control handles during take-off to all pilots in Hong Kong. [3.1 (20)]

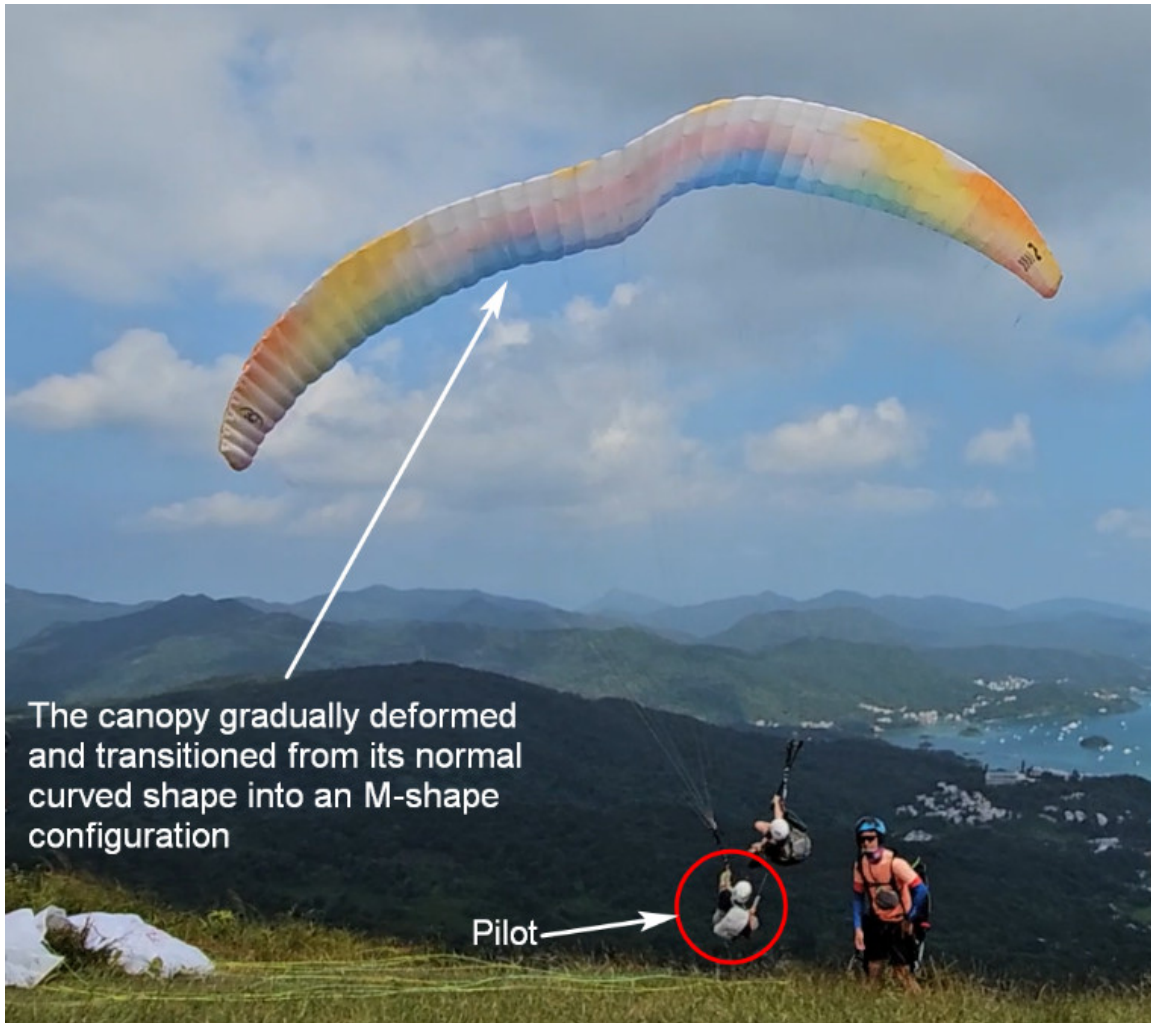
Figure 22: Pilot Losing Control of the Paraglider

- (5) Almost at the same time, the video revealed that the Pilot suddenly descended below the Passenger with only the left-hand side of his harness remaining attached to the spreader. Consequently, the Pilot lost control of the paraglider (Figure 22).

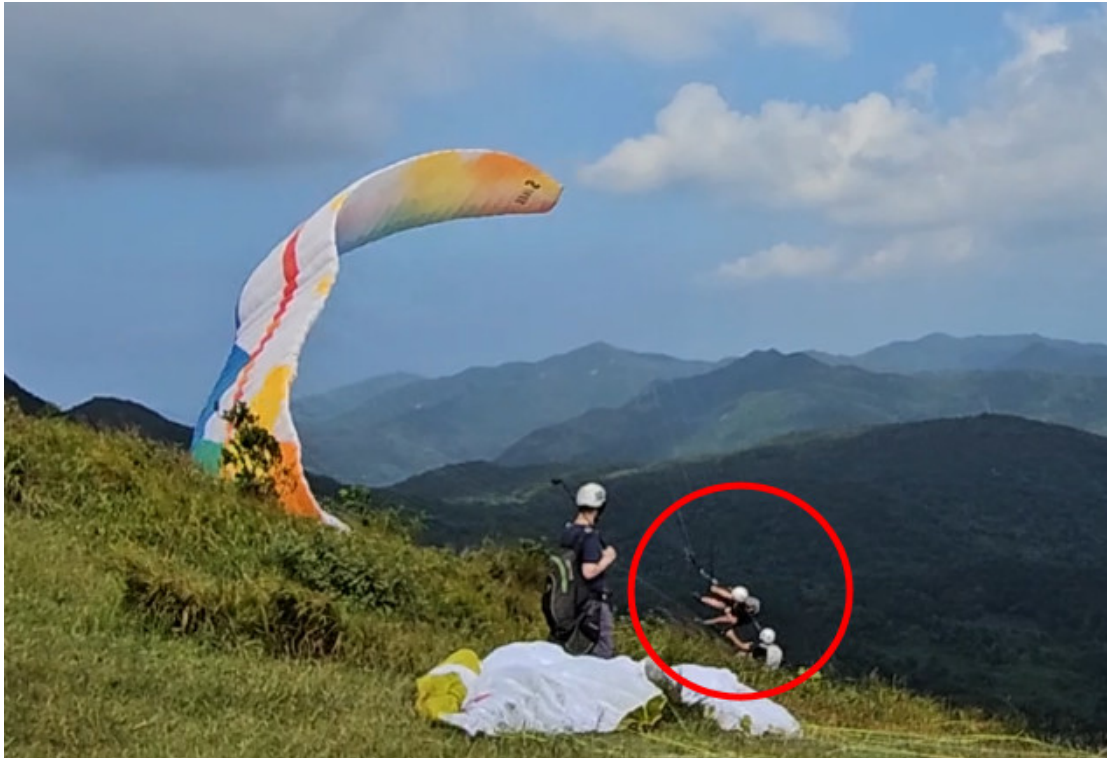
Figure 23: Paraglider Collision with Terrain

- (6) Because of the uneven distribution and shifting of the total weight and the loss of pilot control, the paraglider started to bank to the left, causing the canopy to gradually deform and transition from its normal curved shape into an M-shape configuration (see Figure 22).
- (7) It could be observed in the video recording that the Pilot attempted and managed to re-grasp the left control handle. Almost at the same time, the paraglider collided with terrain (see Figure 23).
