# **Loss of Control - Inflight (LOC-I)**

## **Investigation Report**

**BogdanFly X-wing Paraglider**

**IVR-2026-03**

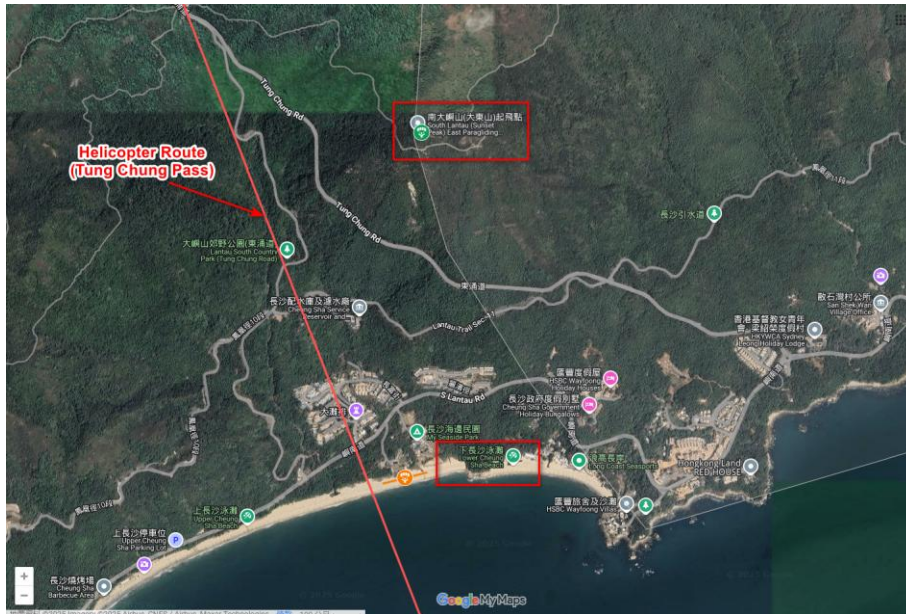
### Figure 2: Take-off Site and Landing Area

- (2) The Pilot had planned to land at Lower Cheung Sha Beach. The normal flight duration was typically two to three minutes. After he had flown for a short while, his paraglider was slowly lifted up towards the cloud by the wind. His companions advised him on a handheld radio transceiver to

apply “big ears”<sup>2</sup> and speed bar<sup>3</sup> to counter the climb. However, no response was heard from the Pilot.

- (3) The wind kept blowing, and the Pilot's paraglider ascended further. Eventually, his companions lost visual contact with it. They persistently tried to contact the Pilot on the radio, but there was still no response from him.

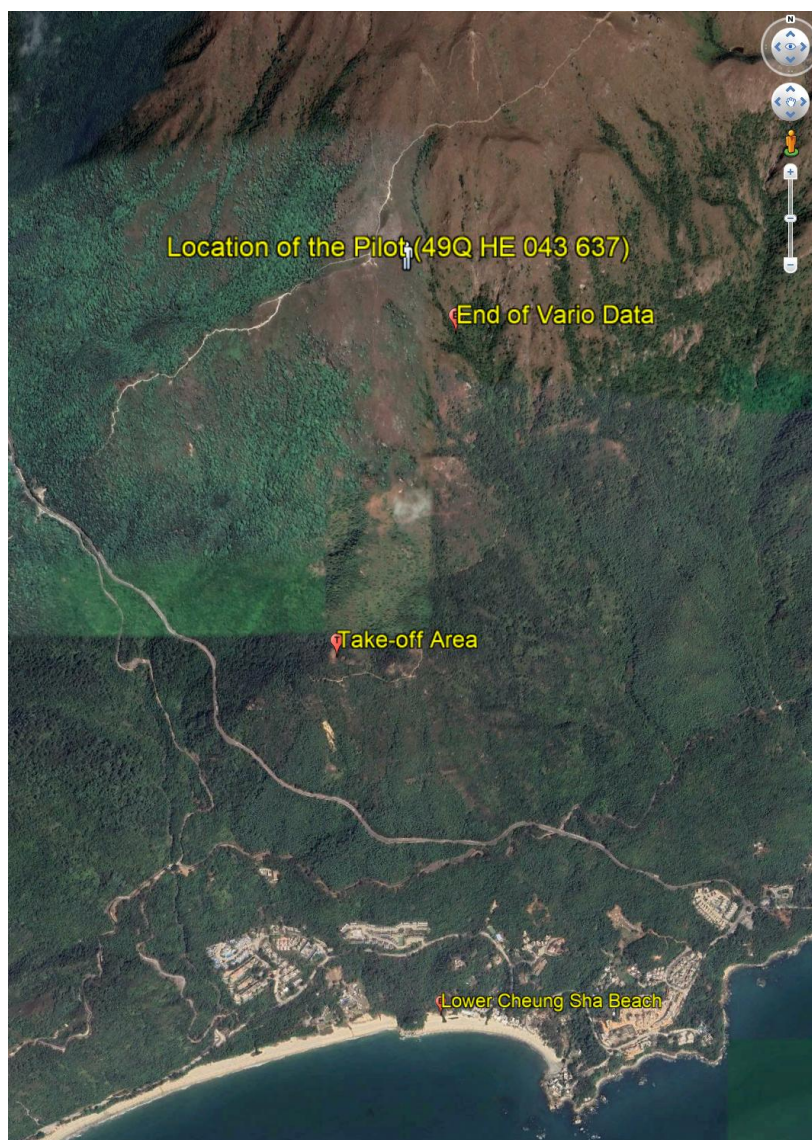
**Figure 3: Location of the Pilot**

Rescuers found him unconscious near Sunset Peak, about 100 metres from Distance Post L015 of Lantau Trail Section 2<sup>1</sup>, at around 2125 hrs. He was still strapped into his paraglider. He was taken to North Lantau Hospital unconscious at approximately 0240 hrs on 18 June 2024. He was later certified dead.

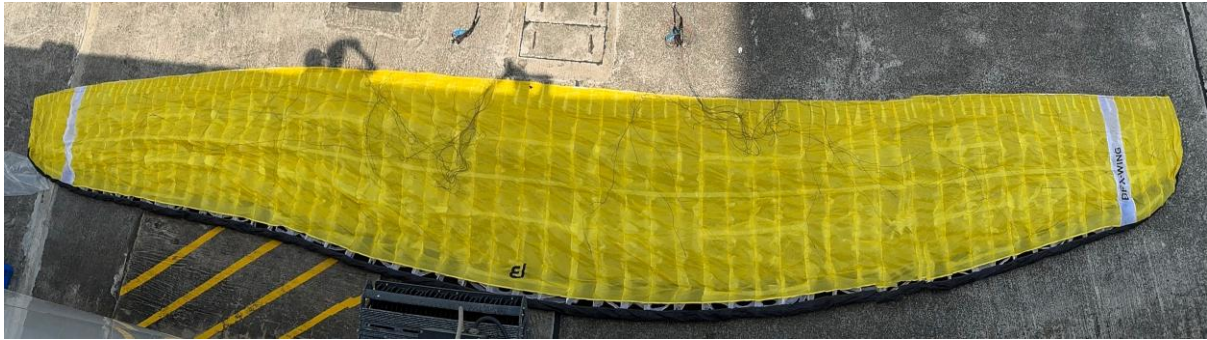
Figure 4: The Pilot’s BogdanFly X-Wing 23 Paraglider

- (1) The Pilot operated an EN<sup>7</sup>-C certified BogdanFly X-Wing paraglider of size 23 (S size). According to the manufacturer, it was produced in October 2023. It was fitted with a “BF V1” harness of S size.

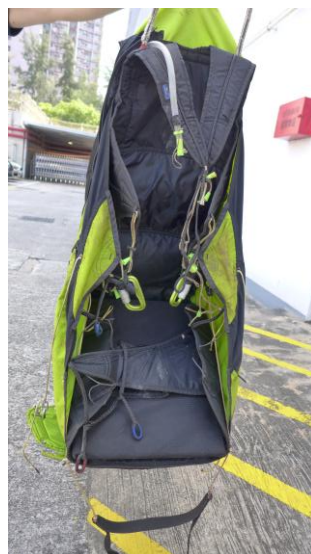
**Figure 8: The Pilot's BF V1 Harness**

- (4) The harness used by the Pilot was an old version of the BogdanFly seat harness which did not have any certification.

- (2) No damage was found on the BogdanFly BF Seat Harness V1.

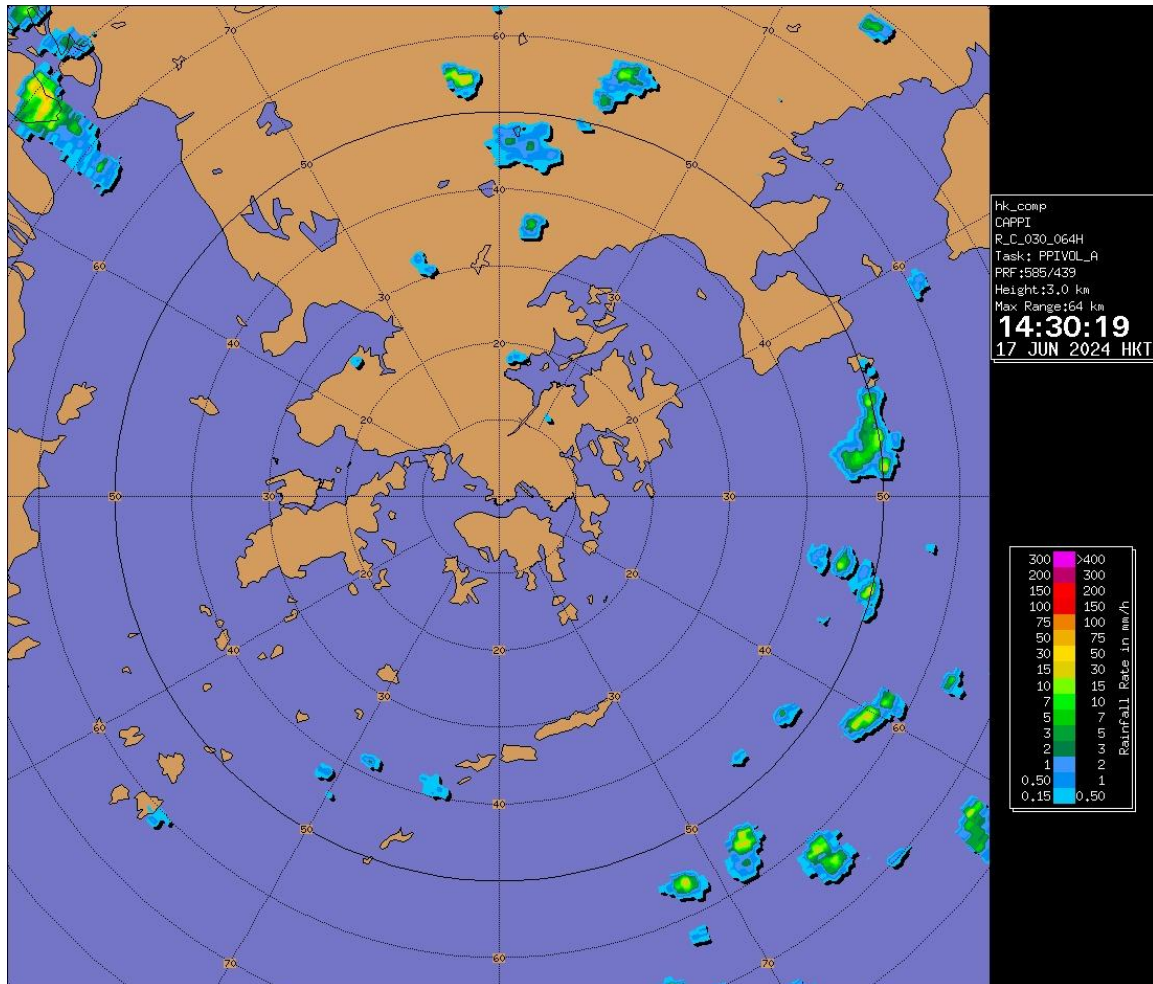
**Figure 11: 3-km Radar Image of 64-km Range at 1430 hrs on 17 June 2024**

- (1) According to the Constant Altitude Plan Position Indicator (CAPPI) radar image of 64-km range at a height of 3 km Above Mean Sea Level (AMSL) above Hong Kong at 1430 hrs on 17 June 2024, the rainfall rate was zero near Sunset Peak.

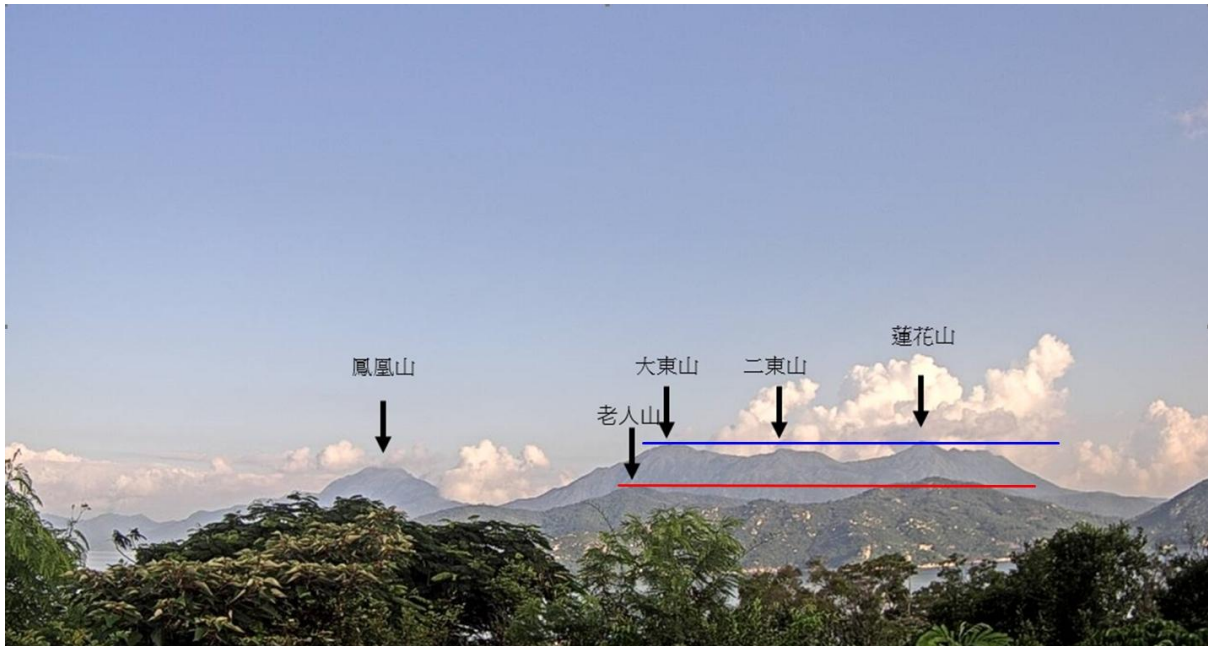
**Figure 12: Landmark Reference**

- (2) According to the weather photo taken at CCH station (Figure 13, looking towards the northwest) at 1430 hrs of 17 June 2024, the hill top of Sunset Peak was fully covered by cloud.

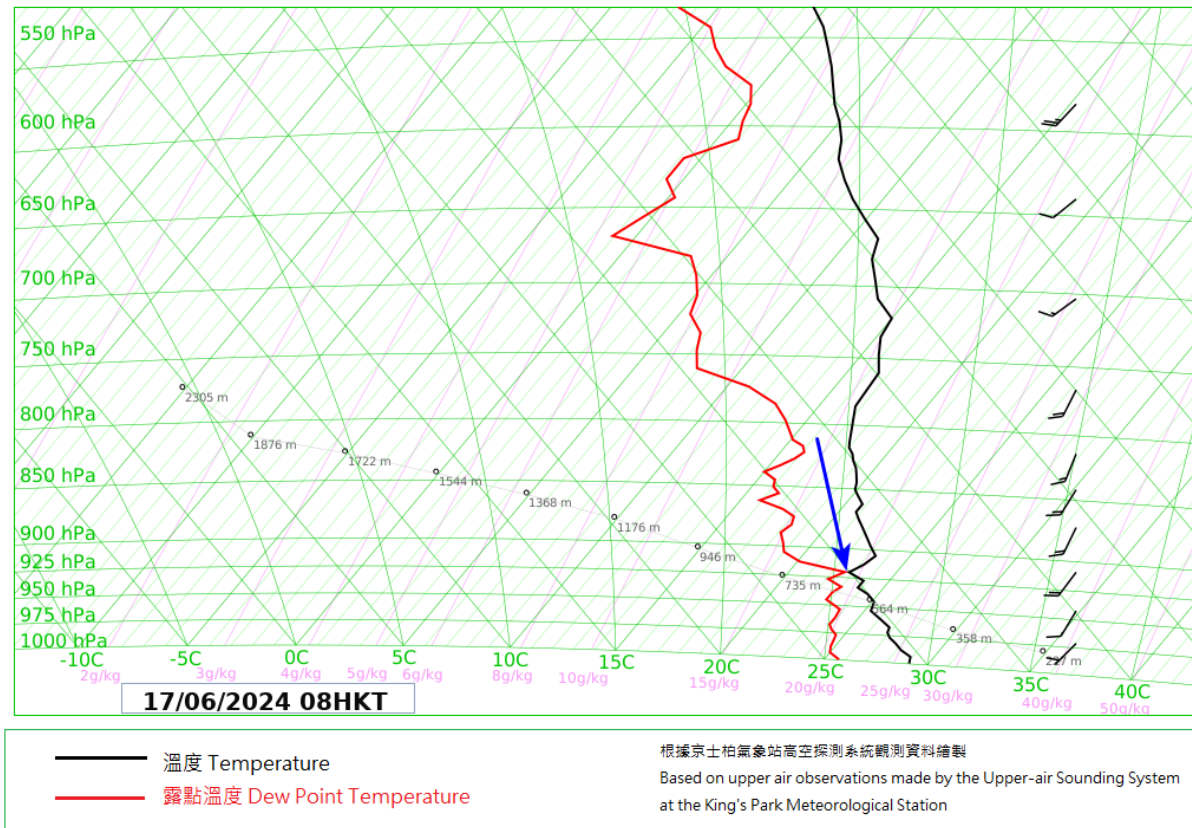
Figure 14: Tephigram at 0800 hrs

- (3) According to the tephigram<sup>15</sup> at 0800 hrs on the day of the accident, the dew temperature (red line) and the air temperature (black line) were equal at a height of about 800 m. This indicated that cloud was formed at this level. Although this tephigram was produced by using temperature, dew-point temperature, wind speed and wind direction data measured by radiosonde at King's Park of Hong Kong at 0800 hrs, it still provided a good reference for the possible cloud formation at Sunset Peak.

The HKO tephigram in Figure 14 at 0800 hrs on the day of the accident showed that the dew temperature (red line) and the air temperature (black line) were equal at a height of about 800 m. This indicated that cloud would be formed at about this level. It provided a good reference for the possible cloud formation at Sunset Peak.

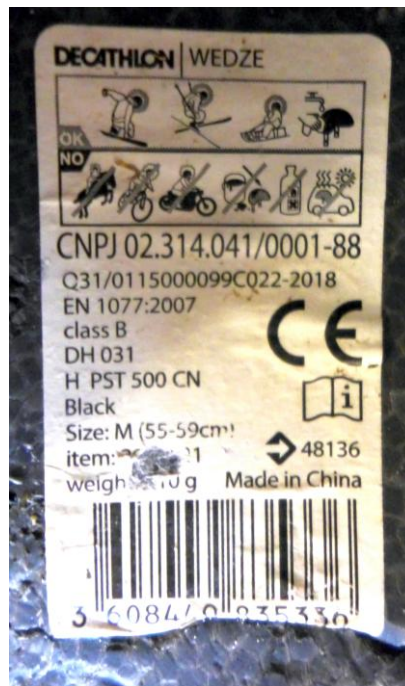
Figure 22: The Certification Label of the Helmet

- (3) According to a label on the helmet, it was certified to EN 1077 Class B. It met one of the specifications recommended by the CAD on their Safety Guidance on Paragliding Activities (CAD Safety Guidance) website (refer to paragraph 1.17.1).

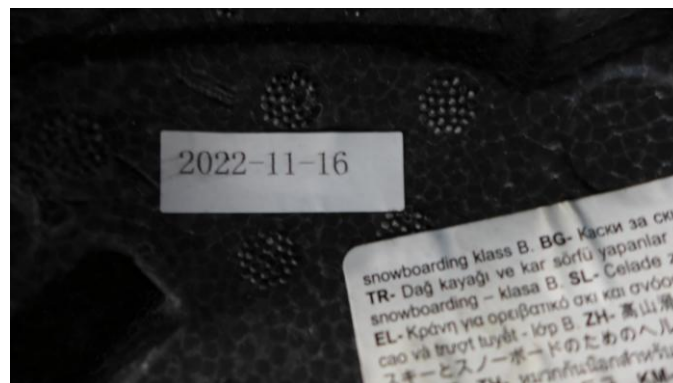
Figure 23: A Label Showing “2022-11-16”

- (4) One of the labels on the helmet showed “2022-11-16”. However, the vendor’s agent in Hong Kong could not confirm that it was the manufacture date.

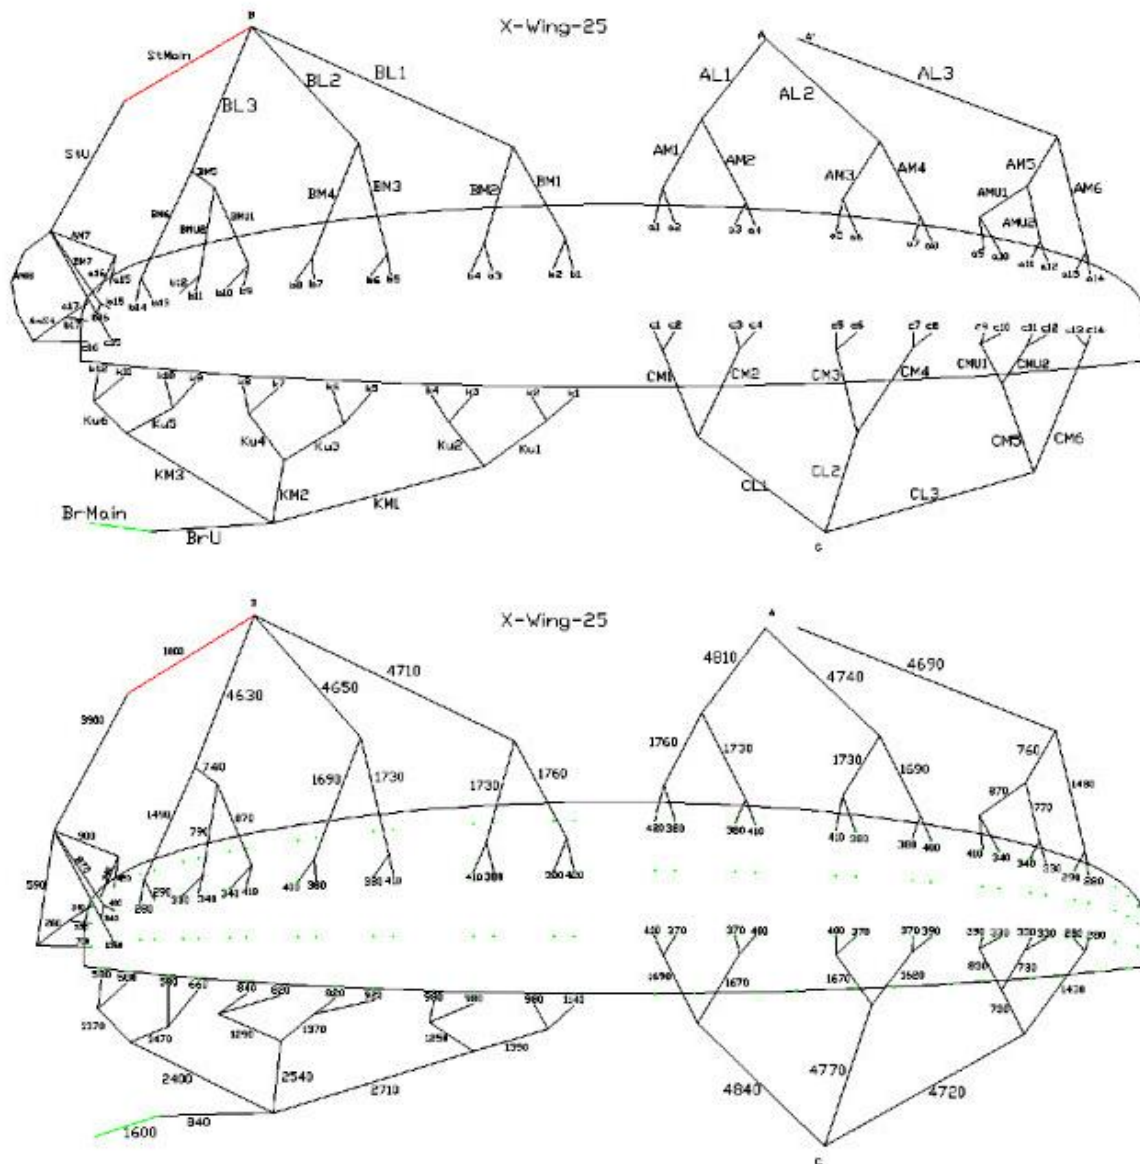
**Figure 25: Line Diagram of BF X-wing**

- (1) The BogdanFly X-Wing 23 Paraglider was examined. The right-hand (RH) C5 loop was found broken due to stress and separated from the tab. The left-hand (LH) StU line and the RH C6 line were found broken due to stress. The line check results are in paragraph 1.16.1.

- (1) An aging check of paraglider lines was carried out to determine their conditions with the assistance of the HKPA expert.
- (2) The results indicated that the canopy was intact. The RH C5 line, the RH C6 loop, and the LH StU line broke probably due to stress. Due to the aging of the Dyneema<sup>®16</sup> lines, the C group has shrunk by an average of 22mm on the LH side and 14.5mm on the RH side of the wing. The lines at the centre of the wing have shrunk less than those on the sides and the tips of the wing, reflecting a normal aging process as the middle wing took more weight and shrunk less.
- (3) The angle of attack of the wing was found increased by comparing the length of different groups of lines, which is 18mm on the LH and 14.5mm on the RH.

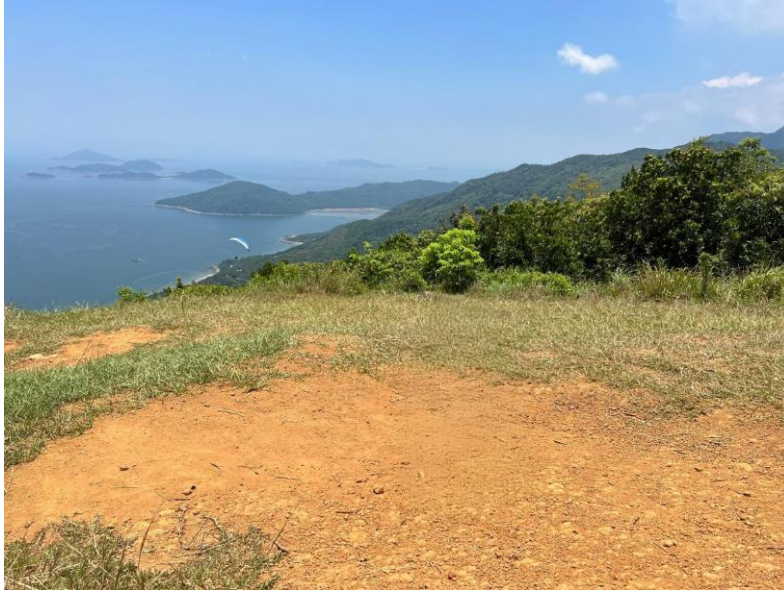
**Figure 34: The Take-off Site on a Sunny Day**

The video of the early part of the accident also revealed that the take-off site at Sunset Peak was misty when the paraglider took off ((b) and (c) in Figure 1). In comparison with a photo of the surrounding area in a sunny day, the visibility was poor at the time the paraglider took off.
