**Collision between Aircraft  
and Tow Tractor  
(Ground Handling)**

**Serious Incident Investigation  
Final Report**

**Airbus A330-343, B-HLT,  
Hong Kong International Airport  
24 January 2020**

**01-2021**

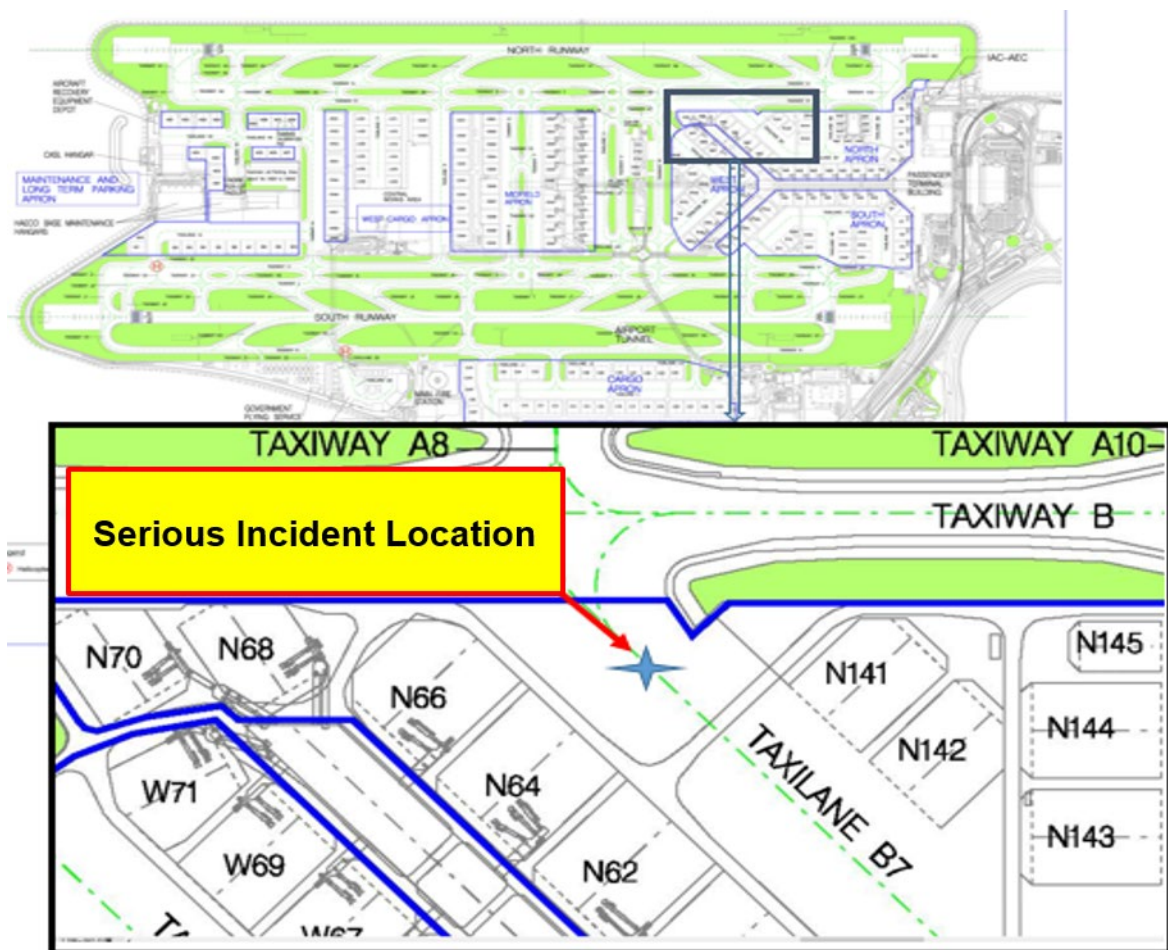
Figure 1: Serious Incident Location at HKIA

- (1) On 24 January 2020 at 1645 hrs, a Hong Kong Dragon Airlines Limited (Cathay Dragon) Airbus A330-343, with registration mark B-HLT and located at Parking Bay N66 of HKIA, was pushed back onto Taxiway B7 for departure to Kaohsiung.
