Loss of Control Inflight

Accident Investigation Final Report

Zlin-Z-242-L
Hong Kong
February 2016

02-2020

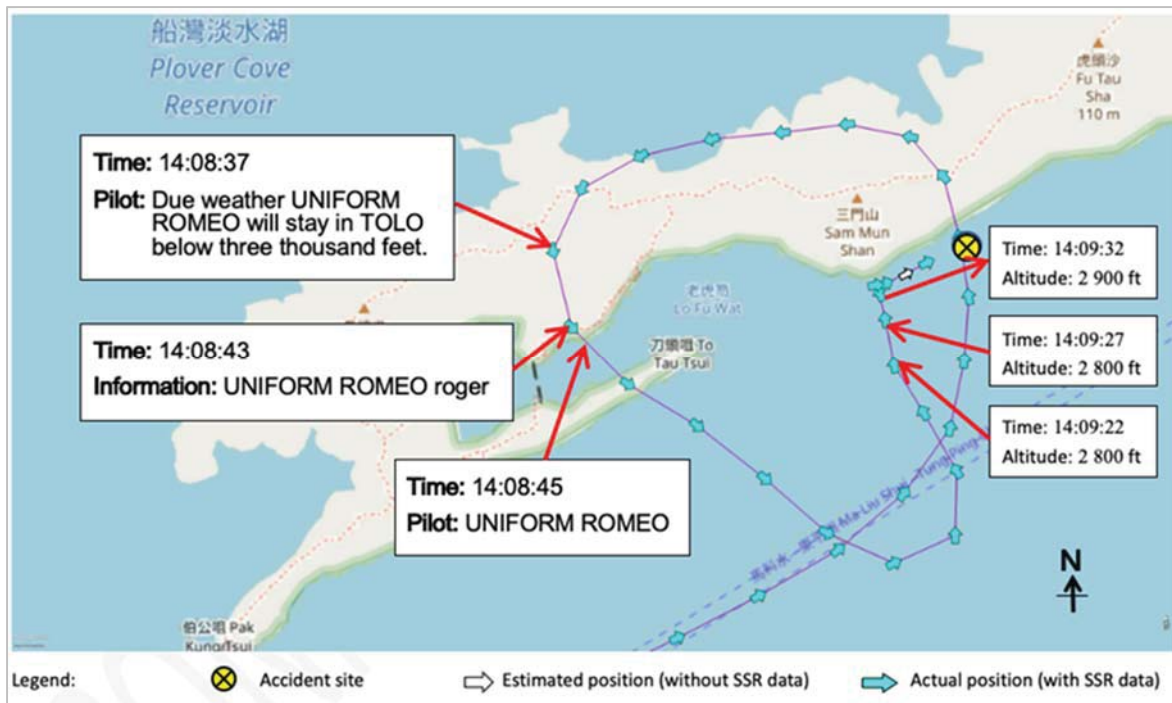
Figure 3 - Radar data with RTF transcript and headings prior to reaching 2,900 ft AMSL

At 14:09:37 hrs, the aircraft began descending rapidly.

At 14:09:57 hrs, the aircraft transponder was not detected by radar; the final transponder altitude interrogation indicated the aircraft was at 300 ft south of Plover Cove Reservoir in TOLO.

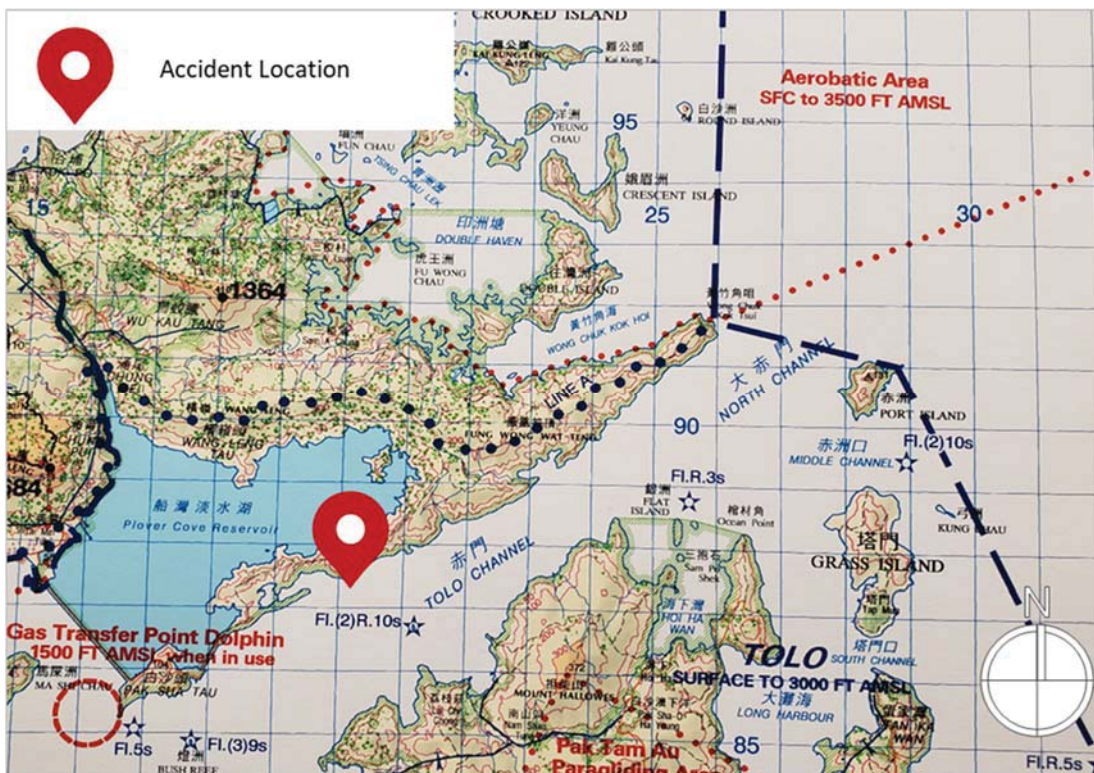
Figure 5 - Accident Location

Between 14:20 and 14:27 hrs, the Fire Services Communications Centre (FSCC) received reports from the public regarding an aircraft crash offshore of Fu Tau Sha at Tolo Channel.

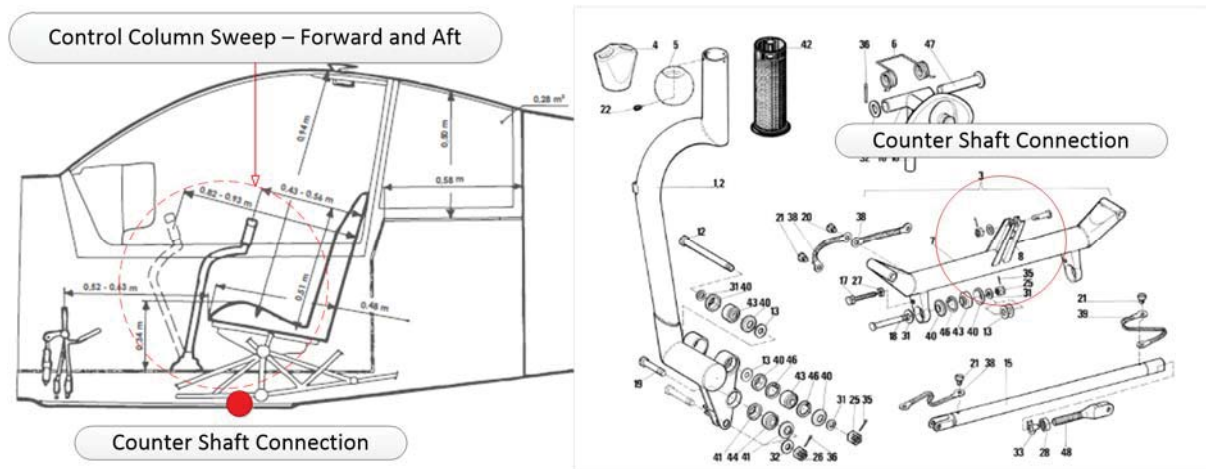
Figure 11 - Control Column Sweep and Counter Shaft Connection Location

This deformation was found at about the middle of the forward side of the countershaft that connects laterally to both control sticks.

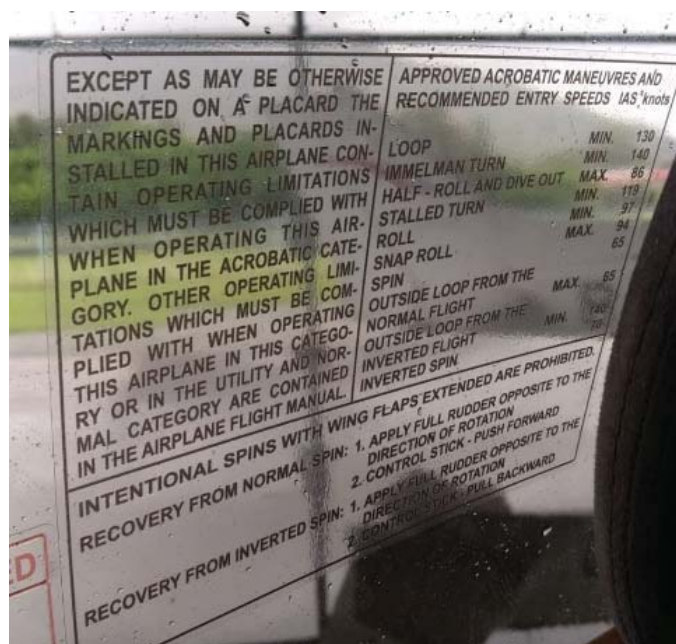
Figure 21 - Spin Recovery Action Placard

A placard located in the aircraft cockpit specifies the recovery action from normal spin according to the AFM:

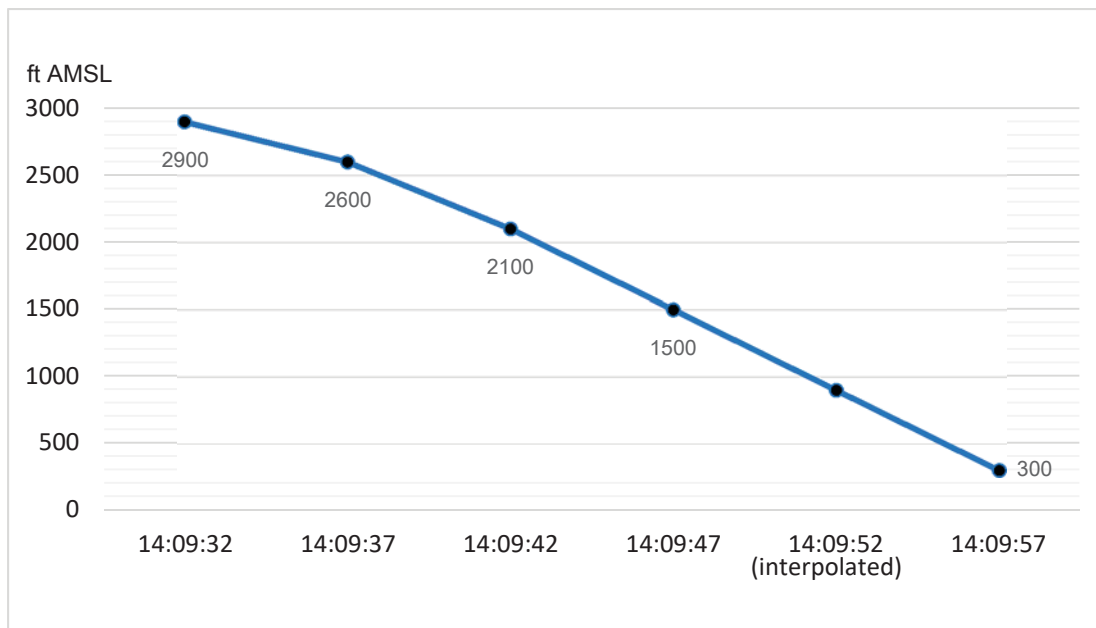
Table 5 - Descent Rate/Altitude (ft) vs Time (s)

Within the 20 s between 14:09:37 hrs and 14:09:57 hrs, the aircraft descended 2,300 ft, from 2,600 ft down to 300 ft AMSL at an increasing rate, with the highest rate of descent over 7,000 ft/min.

The last 300 feet was not recorded on the radar data, interpolation of the available data is linear with a constant rate of descent until impact.
