Aborted Takeoff on an Engaged Runway

Investigation Report

**Serious Incident to
Hong Kong Airlines Airbus A330-343,
B-LNU and Cathay Pacific Airways
Boeing 747-867F, B-LJK at
Hong Kong International Airport
23 December 2017**

03-2022

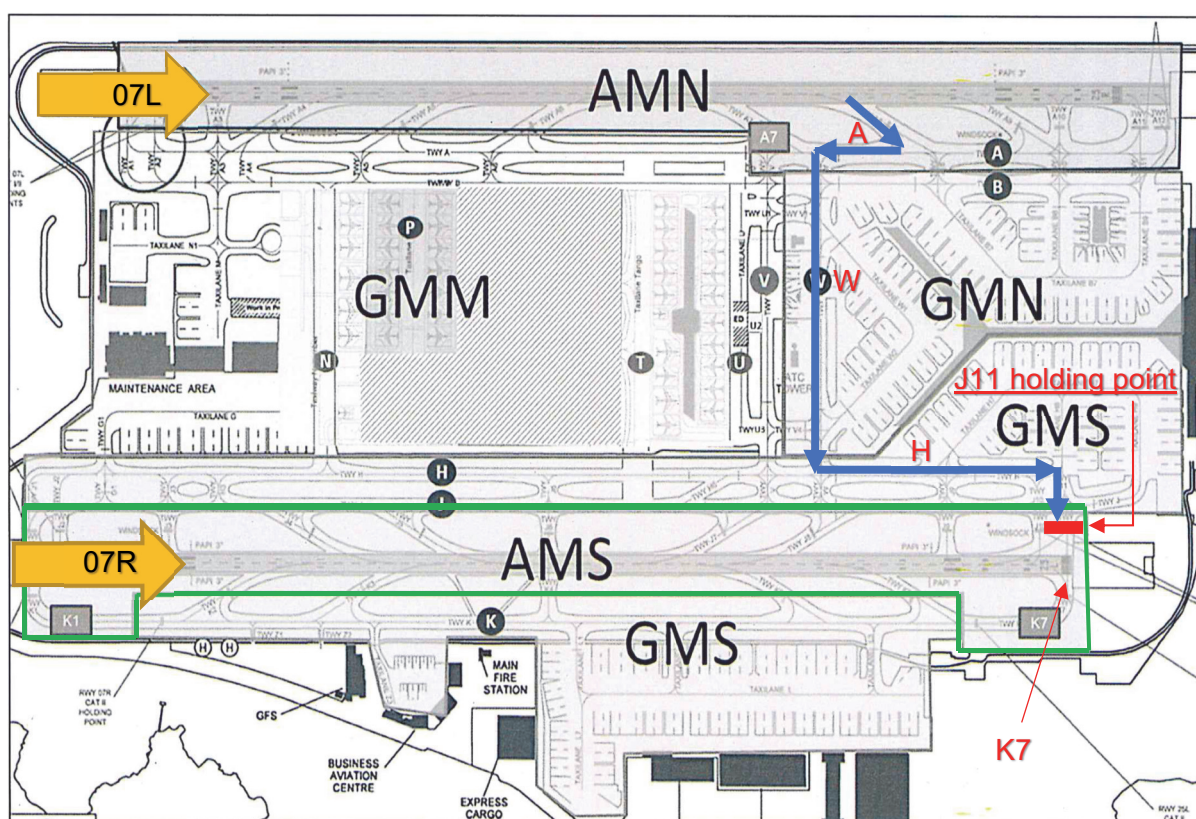
Figure 1 – Areas of controller jurisdiction for Runway 07 operation
(AMS area of jurisdiction delineated in green)

- (2) During the occurrence, RWY07L (the north runway) was the landing runway under the control of the Air Movements North Controller (AMN), RWY07R (the south runway) was the departure runway under the control of the Air Movements South Controller (AMS), and ground traffic was handled by three controllers namely GMN, GMS and GMM as depicted in Figure 1.

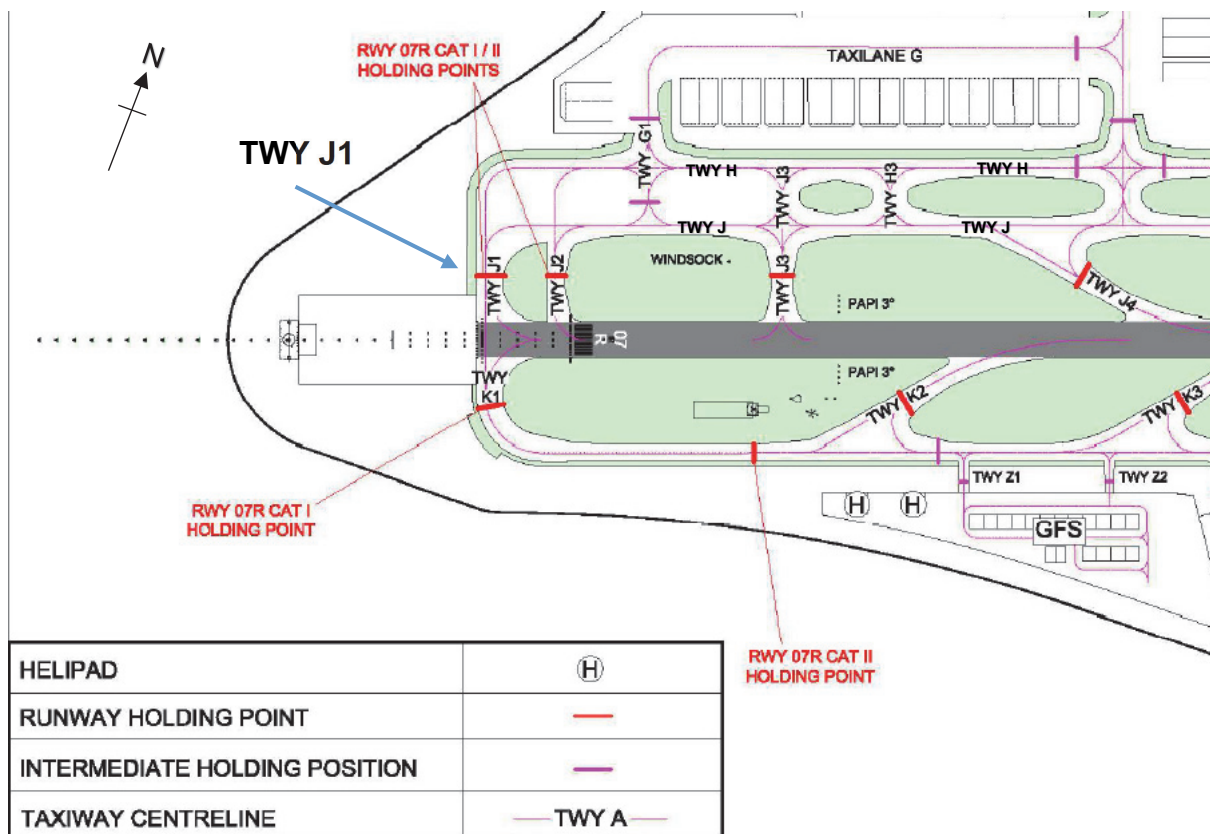
- (4) Figure 2 illustrates the taxiways and the holding points with co-located red stop-bar¹ lights in the area around the threshold of RWY07R at the western end of the south runway. At 20:48 a departure aircraft at holding point J1, after receiving a line-up clearance from the controller, experienced a radio problem affecting communication between the aircraft and the controller. As this aircraft was occupying TWY J1, entering RWY07R via TWY J1 by other aircraft became unavailable.

Figure 2 – Western end of Runway 07R

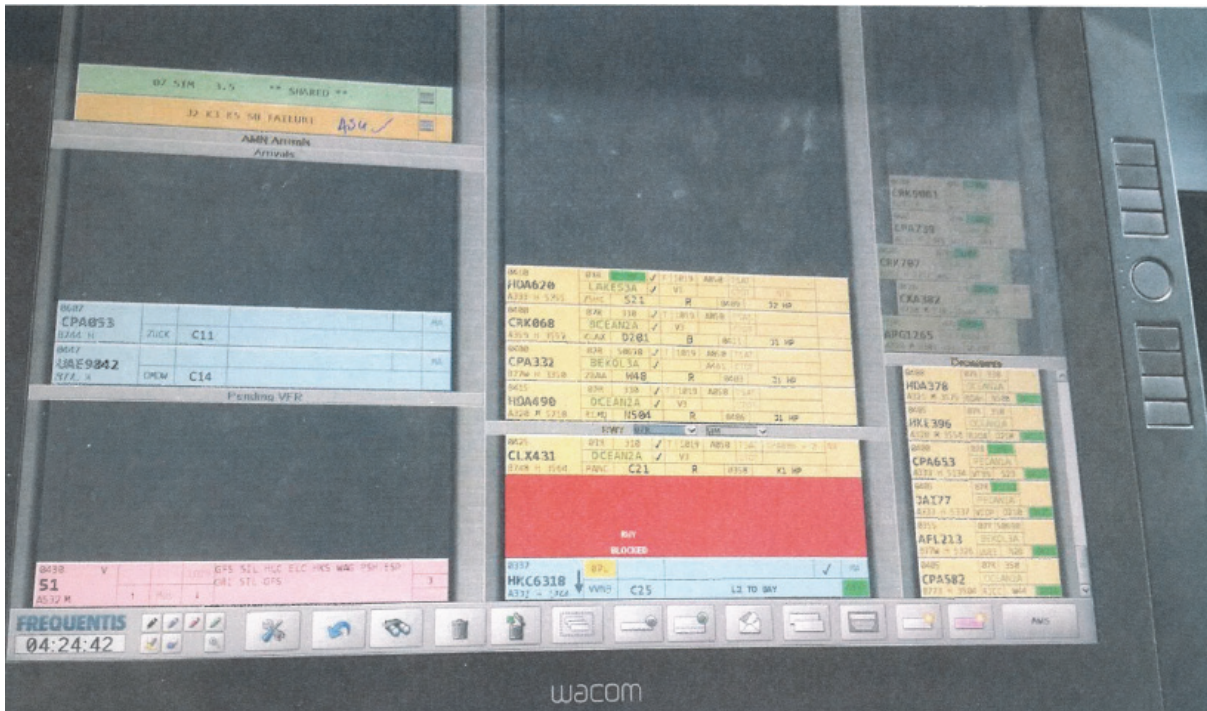
- (a) In the AMS electronic flight strip⁸ (EFS) display board, an electronic ‘Runway Blocked’ strip must be placed together with the aircraft EFS when the aircraft is given permission to cross the runway. The ‘Runway Blocked’ strip will change colour from white to red and become double the normal strip size thus creating a visual prompt to attract the attention of AMS (see example in Figure 3).

Figure 3 – Example of Electronic Flight Strip display board at AMS

- (3) It is considered that a large red 'Runway Blocked' strip (as illustrated in Figure 3) placed together with the AC-CROSS EFS would readily catch the attention of the controller, had the EFS display board been scanned. Even
