Incident Investigation Final Report

Airbus A330-343

Hong Kong International Airport,

1 February 2018

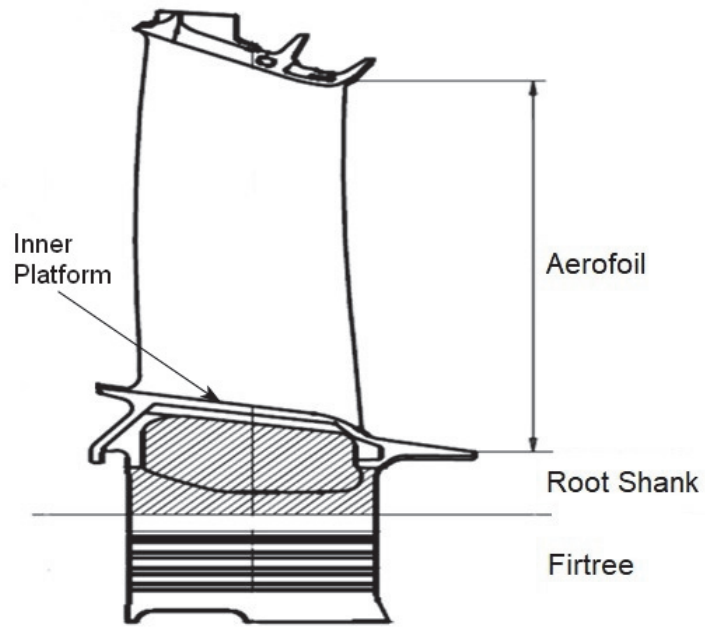
Figure 5: High-pressure Turbine Blade

The engine was stripped down at the engine manufacturer's local overhaul facility. The HPT blade at position 64 had fractured and been released in the aerofoil, just above the inner platform. The inner platform and root section was retained in the turbine disc. Impact damage was noted on other HPT blades, the whole set of IP turbine blades and some of the LP turbine blades. The whole set of HPT blades was sent back to the engine manufacturer for further analysis.
