Runway Excursion (RE)

Investigation Report

**Serious Incident to
Airbus A321-211, B-6366
Hong Kong International Airport
Hong Kong
24 May 2017**

04-2022

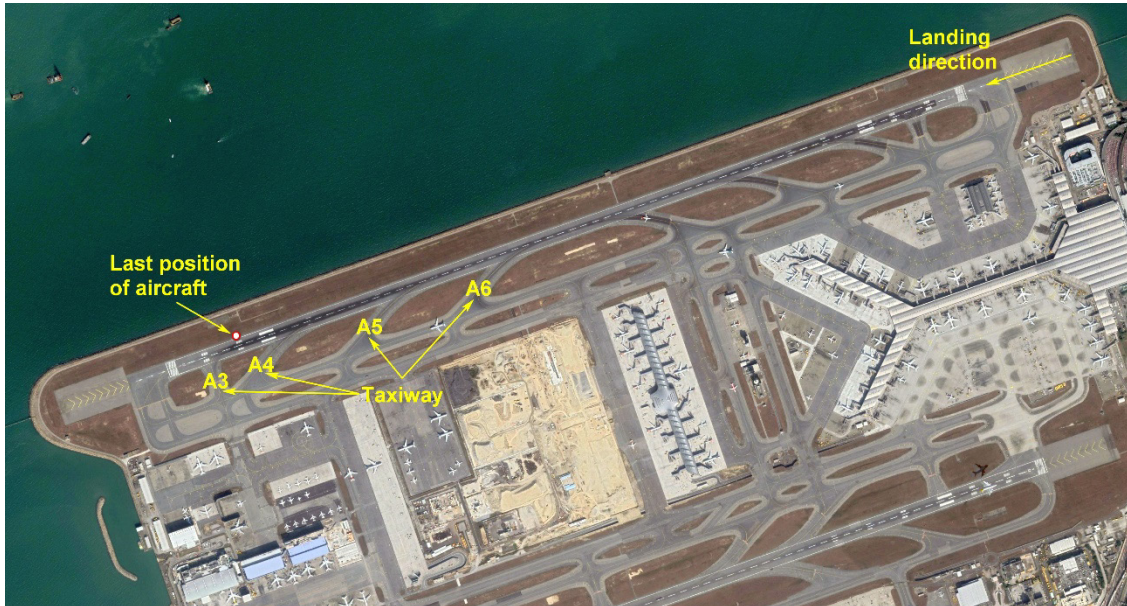
Figure 2: Aircraft Last Position

- (3) On noting that CES765 did not exit the runway at Rapid Exit Taxiways (RET)¹ A6 and A5 after touchdown, ATC instructed it to vacate via Taxiway (TWY) A4 which was another RET. However, the aircraft also missed TWY A4 and veered off the runway centreline to the grass area on the right-hand side of the runway. The aircraft eventually stopped with its nose wheel and right-hand main landing gear (MLG) resting on the grass area

slightly beyond the northern runway edge between TWYs A4 and A3 at about 1051 hrs (see Figure 2).

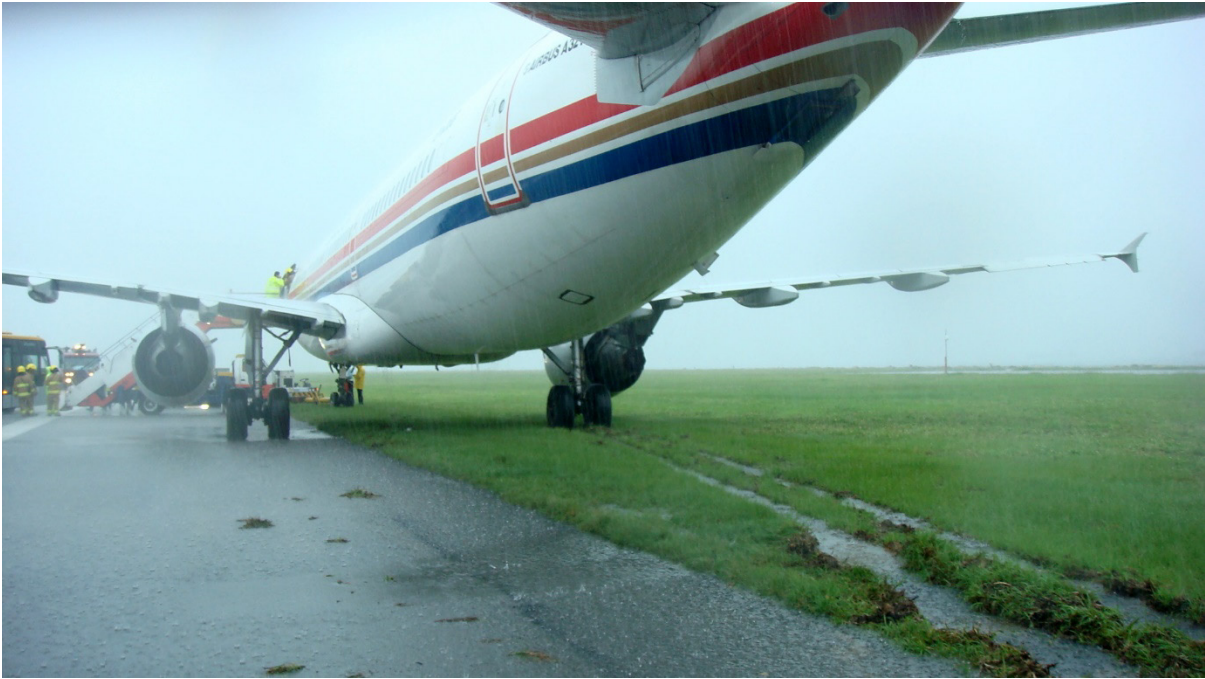
Photo 2: Rear View of the Aircraft

From photos 2, 11 and 12, it seemed that the level of the runway strip was higher than runway drainage. According to the information provided by AAHK, the soil or surface level of the strip was designed and constructed to be flush with the asphalt surface at the edge of the shoulder. In any event, the level of the strip was generally flush with the asphalt surface at the edge of shoulder. The presence of the grass made the strip look higher than the asphalt surface of the runway.

From photos 1, 2 and 8 to 12, it can be seen that the RWY 25R surface behind and in the vicinity of the last position of the aircraft was contaminated with water.

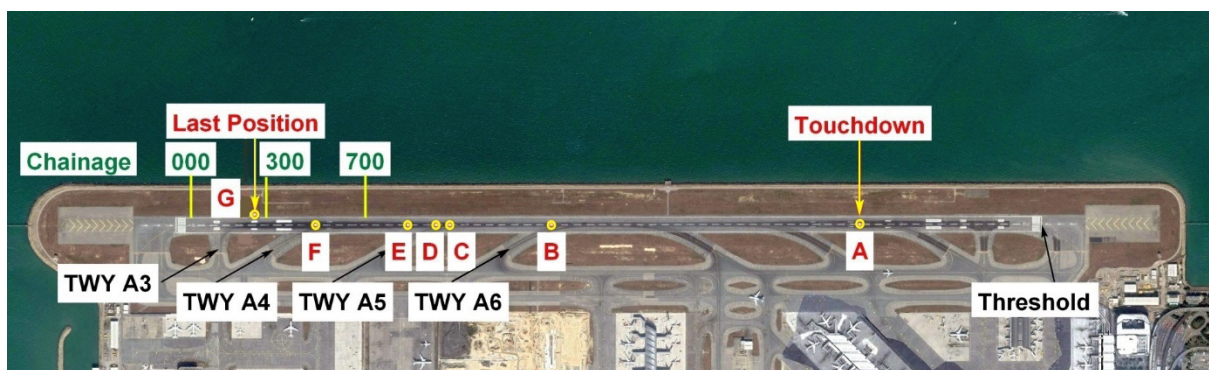
Figure 11: Critical Points of the Rollout

- (1) For the analysis and discussion of the flight data, the rollout after landing is divided into three sections and seven critical points, namely A (the touchdown point) to G (the last position of the aircraft), have been selected (Figure 11). Section 1 is from point A to point B, Section 2 is from point B to point F, and Section 3 is from point F to point G.

- (4) At 10:50:36 hrs, the aircraft decelerated to 42 kt at point F near the entrance of TWY A4. This location was within the section of runway, identified as Chainage 300 to 700 for runway friction measurement and rubber removal purposes (see Figure 11), and with average friction values below the limit then published in AIP HK. At this point, the flight crew turned off the antiskid.

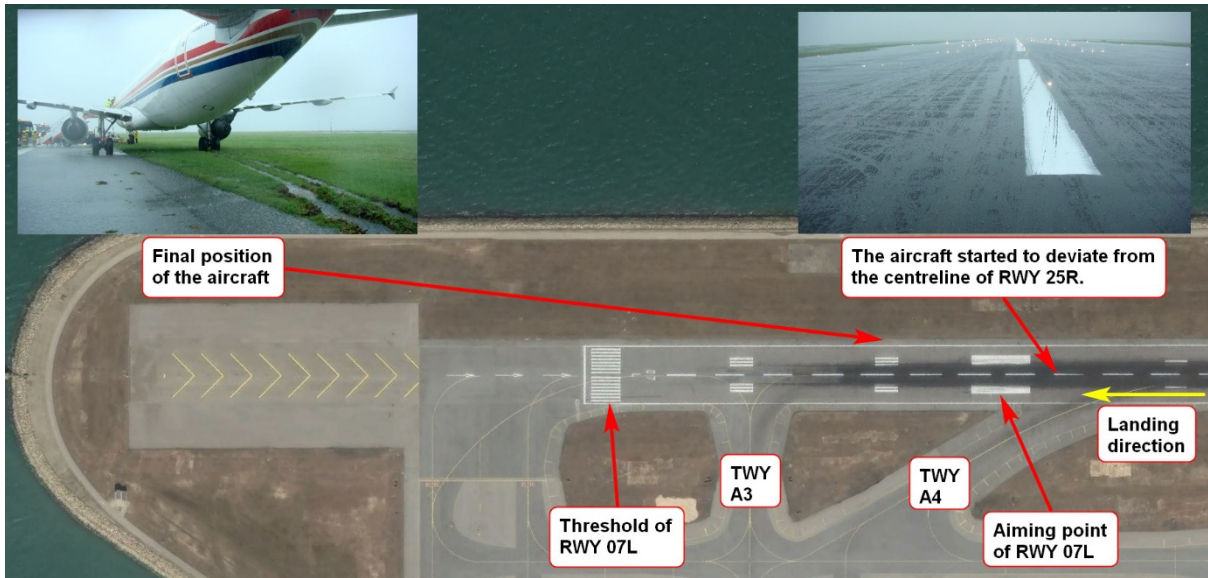
Figure 12: Aircraft Final Position

Tyre tracks could be traced from the aircraft back along the runway indicating that the aircraft started to skid to the right side before reaching the 1 500 ft touchdown marking for RWY 07L.

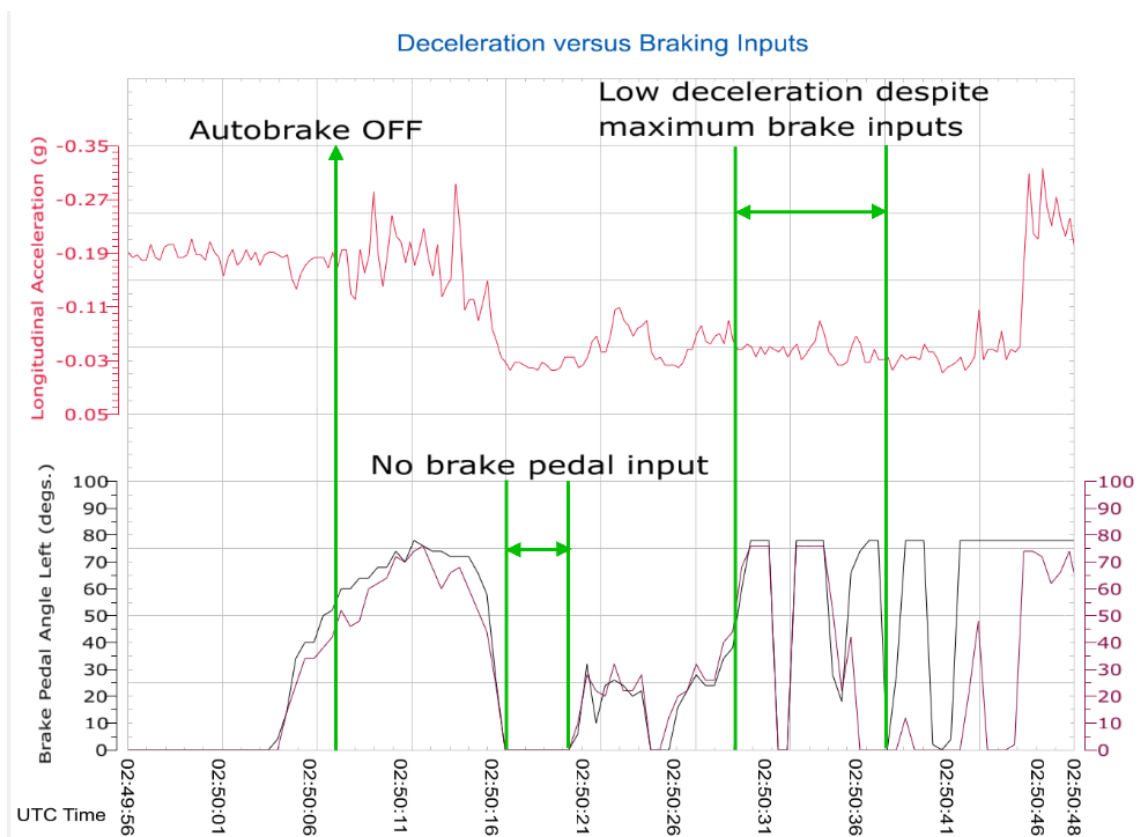
Figure 16: Deceleration versus Brake Pedal Inputs in Normal Manual Braking

- (2) The deceleration was around 0.2 G with a peak of 0.28 G in the following 10 seconds. At about point C, the deceleration then decreased to about 0.02 G when no brake pedal input was noted during the next four seconds (from 10:50:18 hrs to 10:50:22 hrs, from point D to point E). Brake pedal inputs were then noted at 10:50:21 hrs with a progressive increase to maximum at 10:50:30 hrs. However, the deceleration remained at around 0.05 G. It was highly probable that the aircraft was experiencing viscous hydroplaning. The aircraft heading was still maintained at around 253 degrees with rudder inputs. The ground speed decreased from 90 kt to 42 kt at 10:50:36 hrs at point F with both thrust levers put to FWD IDLE.

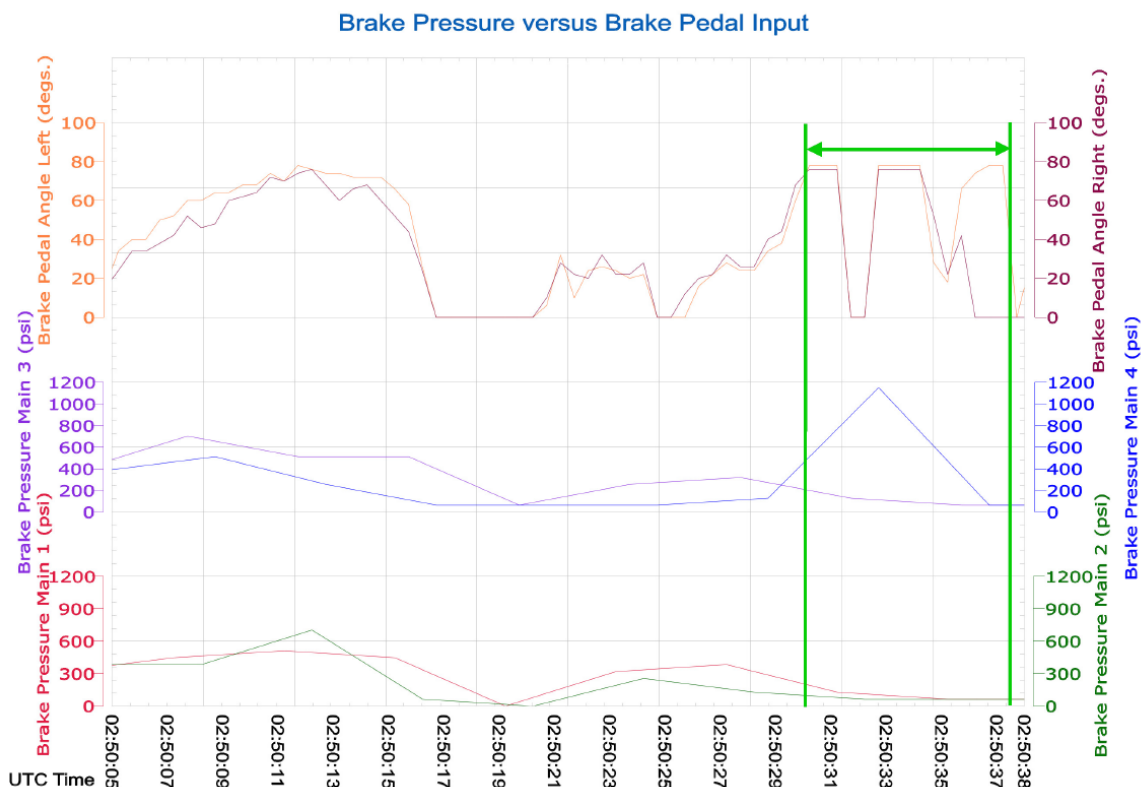
Figure 17: Brake Pressure versus Pedal Inputs in Normal Manual Braking

- (5) The figure above revealed that the brake pressure followed the pedal inputs until about 10:50:30 hrs. From this point on, the brake pressure remained low even though full brake pedal inputs were made. This indicated that the antiskid system was operating by reducing brake pressure to prevent the wheels from locking, which implied that the runway was contaminated with water. The runway section travelled by the aircraft between 10:50:31 hrs and 10:50:38 hrs pretty much aligned with the Chainage range with below average runway friction values.

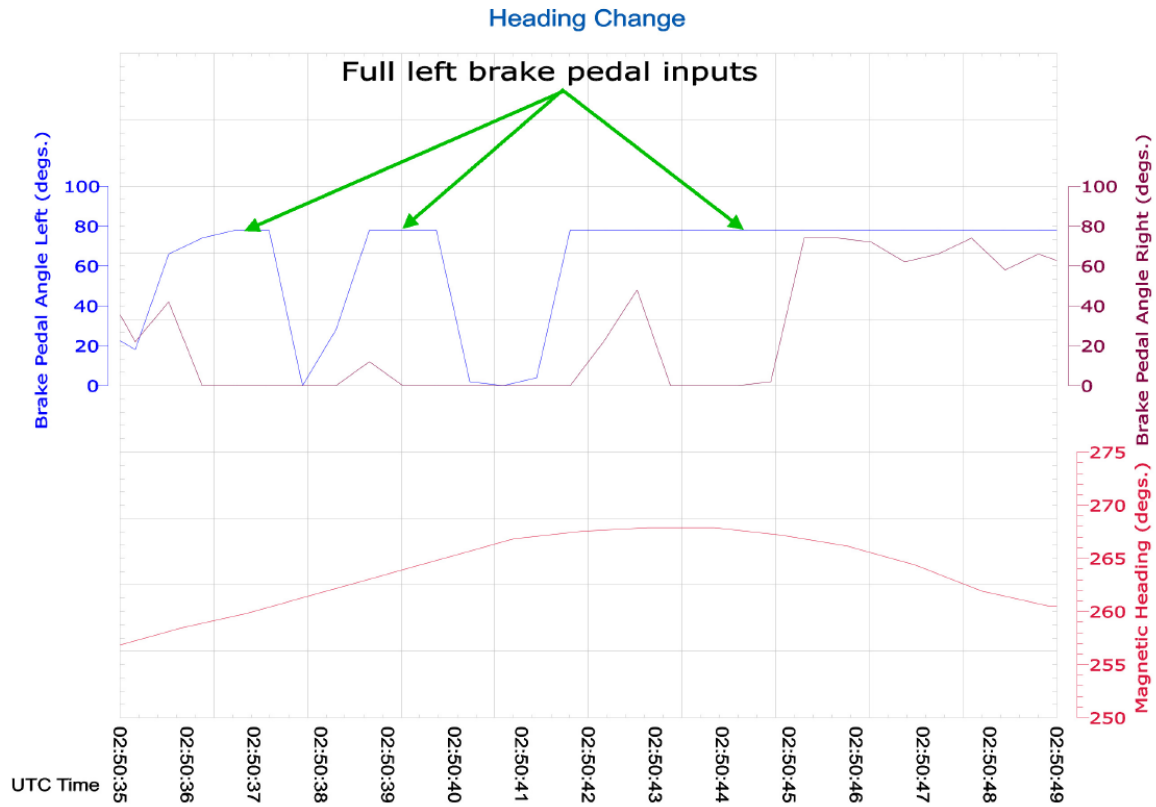
Figure 18: Aircraft Heading and Brake Pedal Inputs

- (1) Starting from about 10:50:36 hrs, the aircraft heading continued to increase towards 268 degrees despite full left brake pedal inputs. The FDR data showed that differential braking was applied with maximum left pedal inputs which resulted in maximum rudder deflection. At the same time, it was noted that both No. 1 and No. 2 wheel speeds dropped from 40 kt to 0 kt while No. 3 and 4 wheel speeds were around 40 kt. This means that the left MLG wheels were locked and skidding occurred after differential braking to the left was applied. The aircraft still continued its deviation to the right. The deceleration did not improve and was still at about 0.05 G with ground speed at about 40 kt.

- (2) Between 10:50:43 hrs and 10:50:45 hrs, the left-hand engine thrust lever was momentarily moved to the full forward throttle position and then retarded to the IDLE position. The right-hand engine thrust lever was then moved to half of the forward thrust position and was retarded to the IDLE position. By doing so, the flight crew was probably in an attempt to re-align the nose of the aircraft with the centreline of the runway. However, no appreciable effect on the aircraft heading was noted.

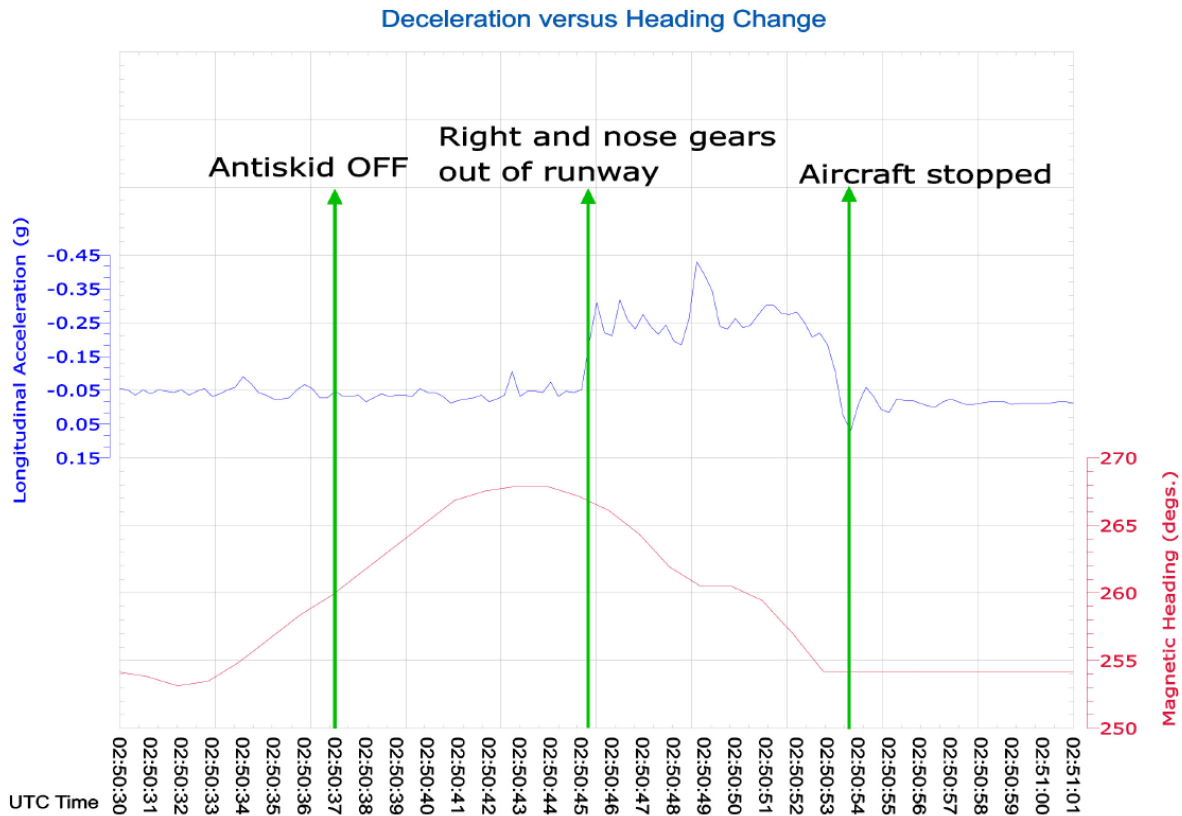
Figure 19: Deceleration versus Aircraft Heading - Antiskid OFF to Aircraft Stop

- (1) Between 10:50:46 hrs and 10:50:55 hrs, the aircraft heading changed to 254 degrees with the deceleration increased to about 0.3 G with a transient up to 0.45 G, probably because the aircraft exited the runway and rolled on the grass verge. The aircraft eventually stopped on the right side of the runway in the touchdown zone of RWY 07L.

- (2) The above figure indicated that the aircraft heading started to change at 10:50:33 hrs. The FDR data showed that the ground speed was 42 kt.
- (3) Since the aircraft landed with a crosswind from the right, a weathercock effect¹¹ might be induced resulting in the aircraft turning to the right despite differential braking to the left was applied. It was highly probable that the lateral deviation to the right was a consequence of the weathercock effect combined with water contamination at the runway portions between Chainage 301 to 700 and friction values probably below the limit.

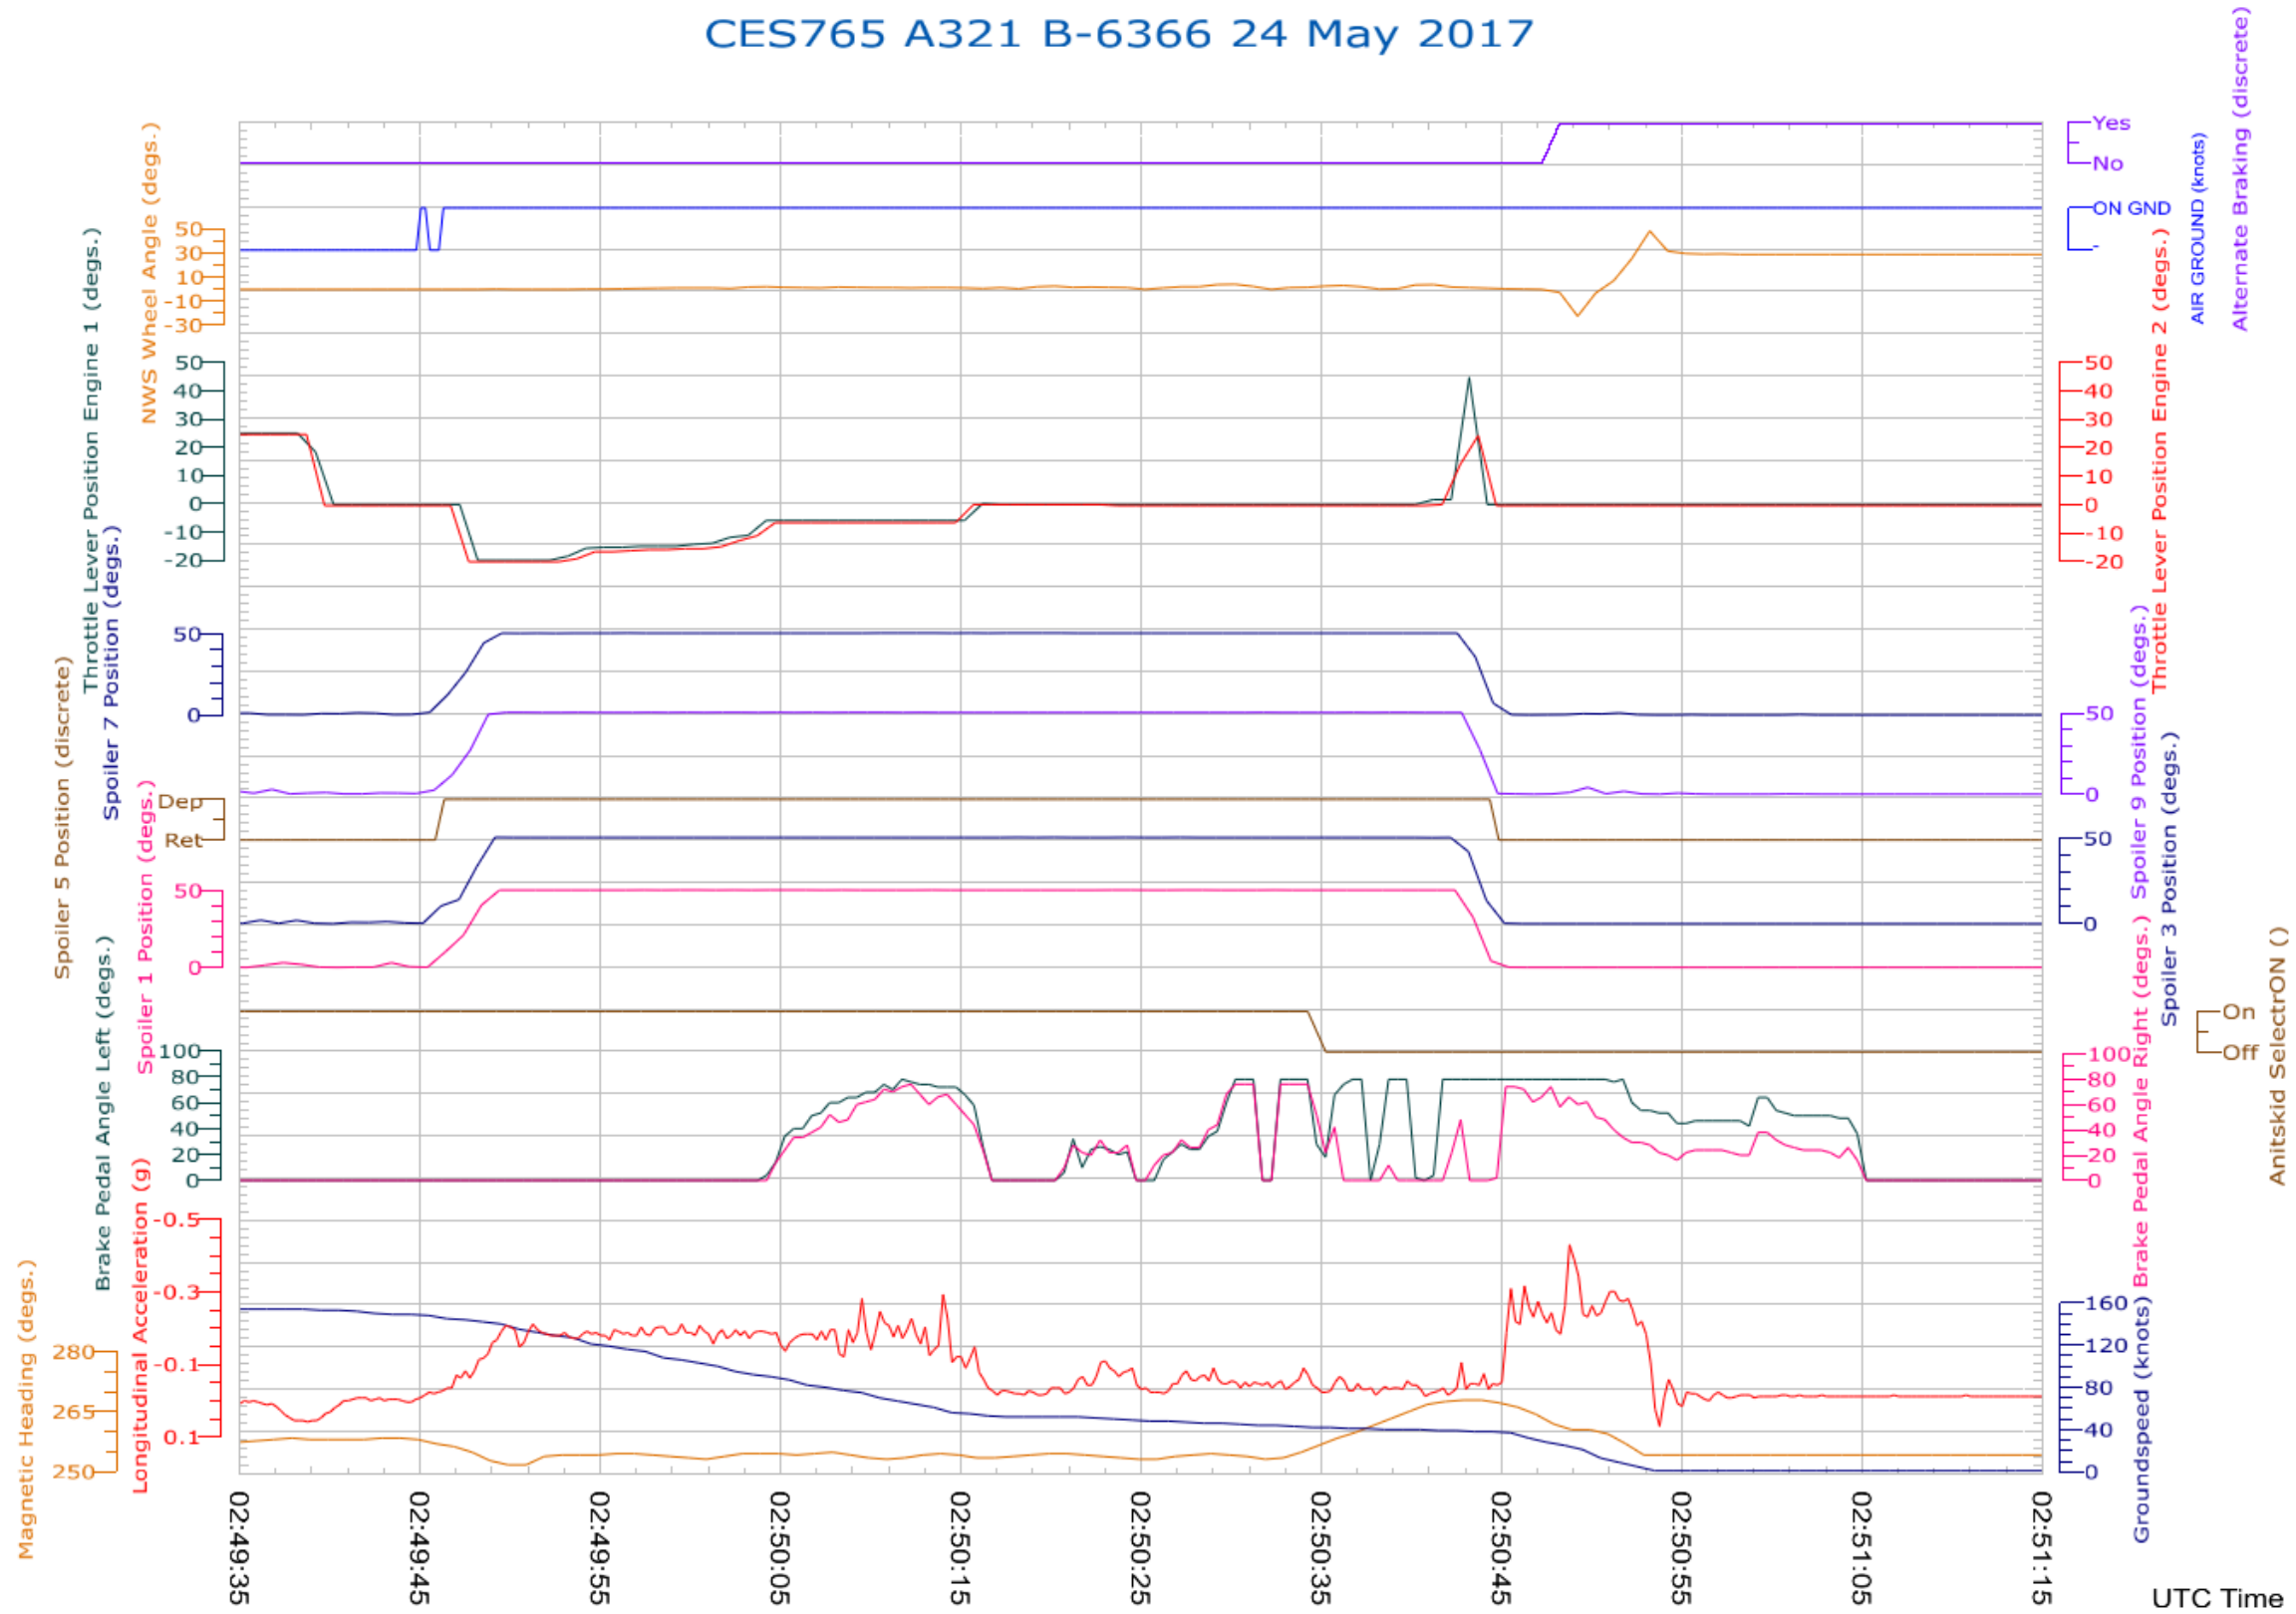
Figure 26: Selected Flight Data Related to Deceleration

distance available, but both thrust levers were left at the FWD IDLE position (see Figure 26 in Appendix 10.2) until the aircraft rolled past point F.
