Air Accident Investigation Authority

Investigation Report

**Accident to Ozone Buzz Z5 Paraglider,
Shek O, Hong Kong**

05-2022

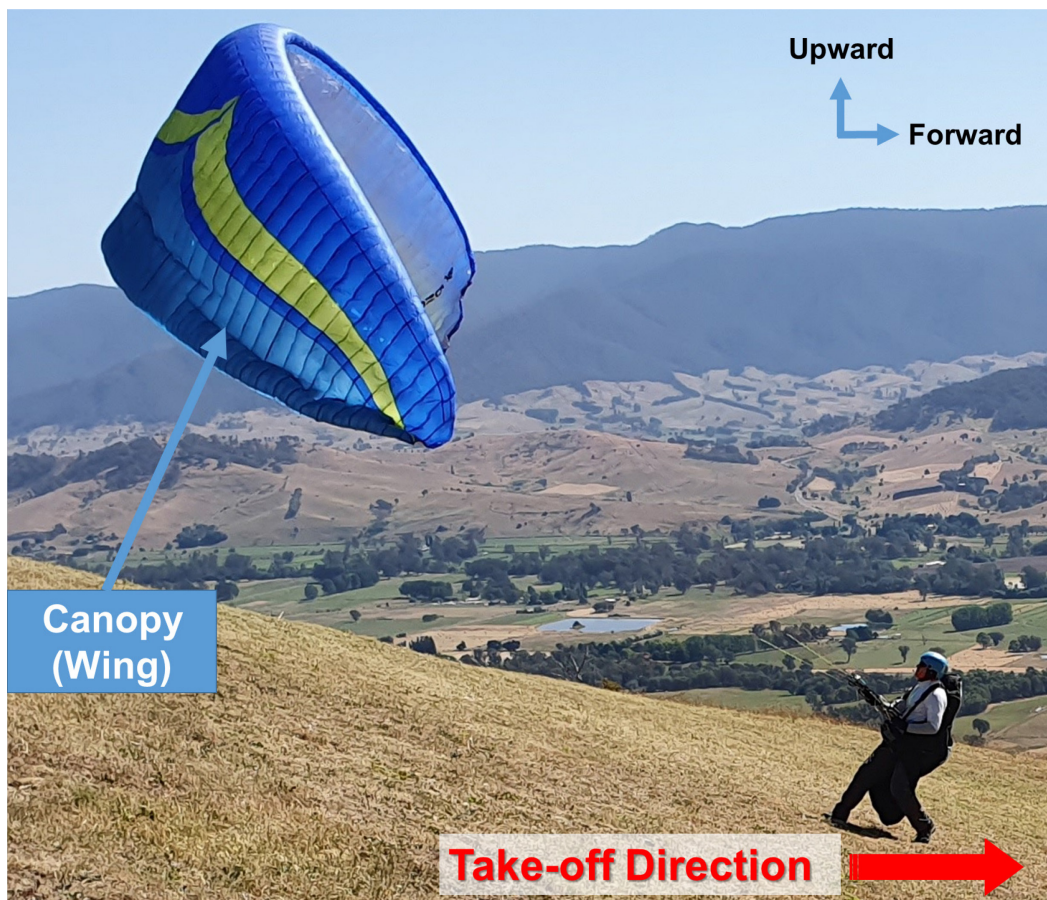
Figure 1: Typical Paragliding Reverse Inflation

- (1) Between 1315 hrs and 1345 hrs on 23 December 2021, two paraglider pilots (the accident pilot (“the Pilot”) and the witness (“Pilot A”)) were carrying out the flight preparation at the Shek O (Dragon’s Back) take-off site and planned to land on Rocky Bay Beach in the south-eastern part of Hong Kong Island.
- (2) Pilot A witnessed the accident flight and was interviewed to share his observations with the investigation team. According to Pilot A, during their flight preparation, the wind was considered suitable for take-off.
- (3) At approximately 1346 hrs, the Pilot started to carry out the reverse inflation (face to the canopy), and then he was suddenly lifted when the canopy was at about 45 degrees to the backward direction (opposite to take-off direction).

- (4) He immediately turned 180 degrees, and moved his upper body facing the normal take-off direction, but he could not make the paraglider move forward. The paraglider continued to move backward and flew into the leeward side of the mountain.

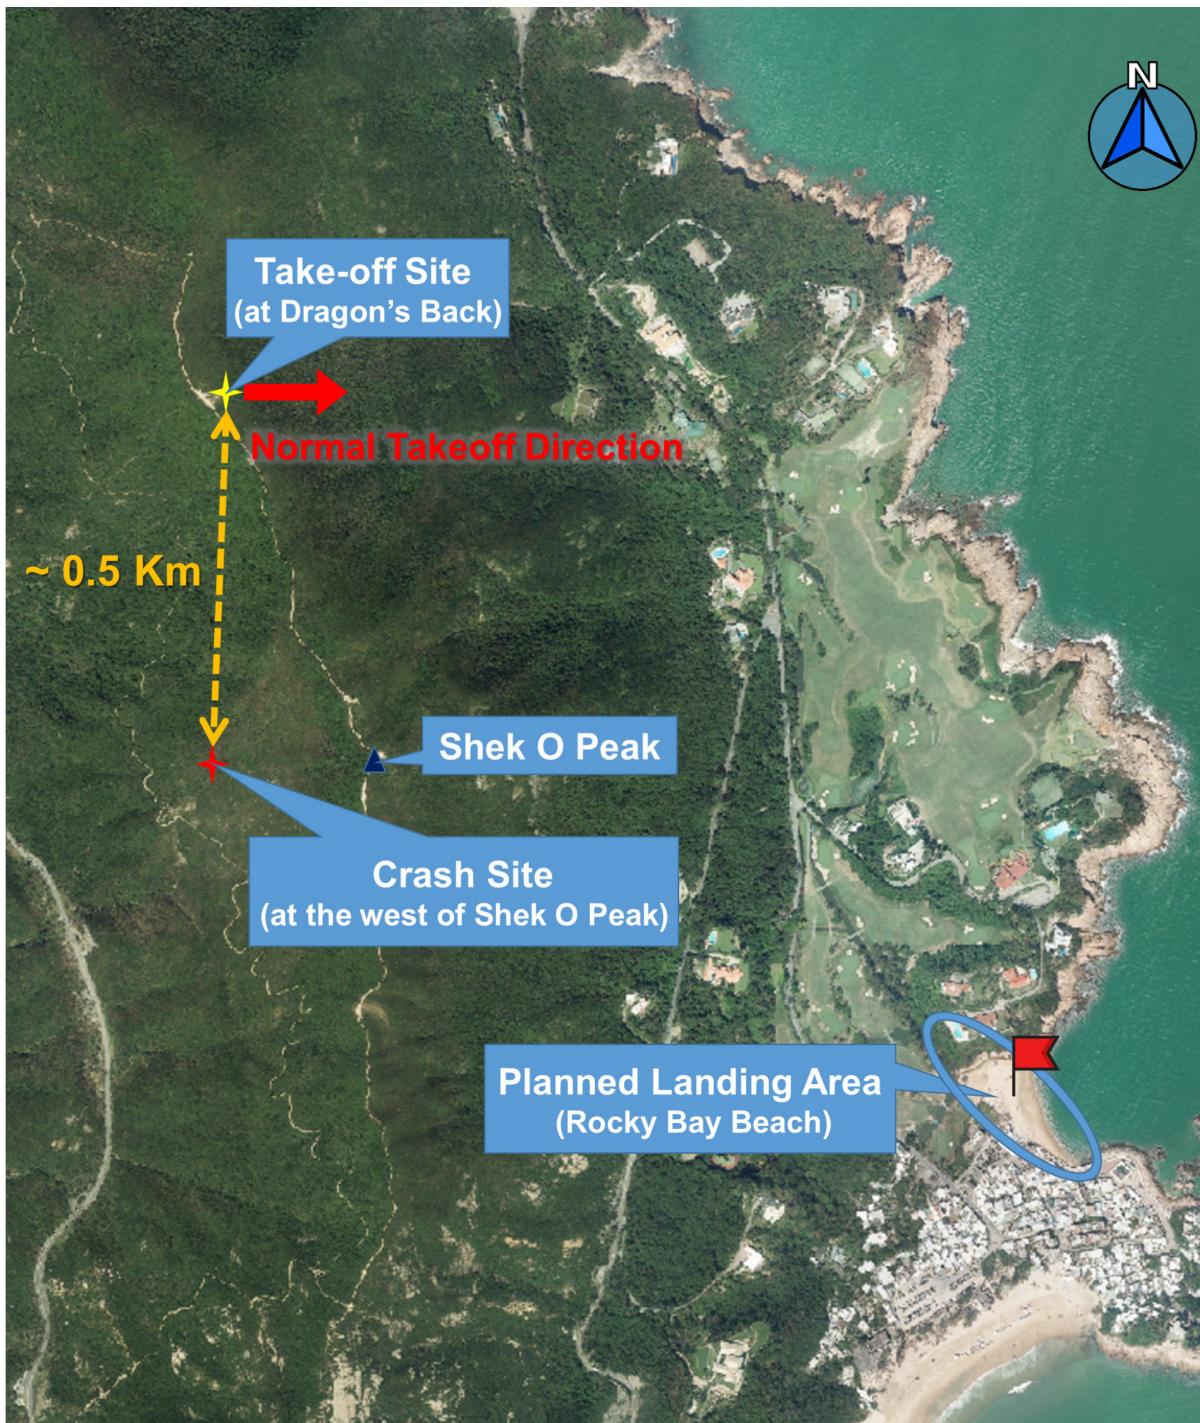
Figure 3: Paraglider Accident at Shek O Paragliding Area

- (5) At approximately 1349 hrs, shortly after the take-off, Pilot A witnessed that the Pilot descended towards a bush area at the west of Shek O Peak.
- (6) At around 1409 hrs, Pilot A called the HKPF for emergency help and reported that the Pilot was stranded on the hillside.
- (7) The FSD immediately launched a Mountain/cliff rescue operation in conjunction with the HKPF and the GFS.
- (8) At 1602 hrs, the GFS located the Pilot and his paraglider on a hill slope at about 230 m above mean sea level (AMSL) west of Shek O Peak, almost half a kilometre south-west from where he took off.
- (9) The Pilot was immediately conveyed to the Ruttonjee Hospital for medical treatment and was certified dead later.

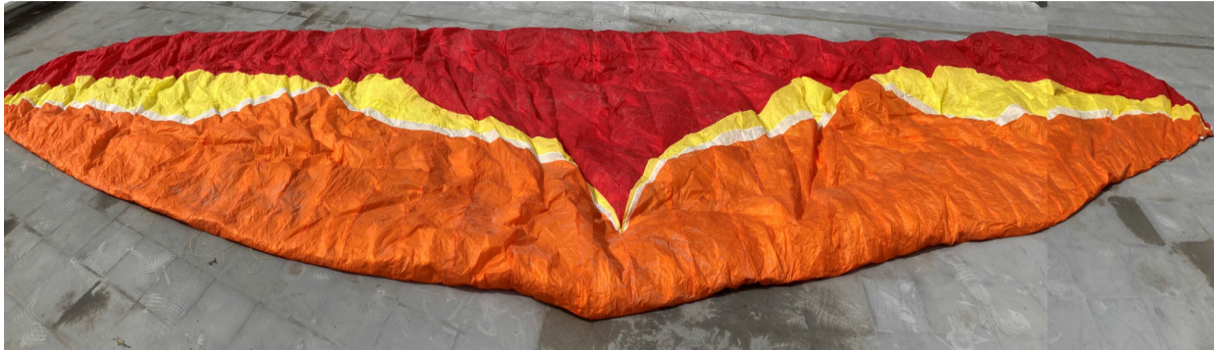
Figure 5: “Ozone Buzz Z5” Paragliding Canopy of the Pilot

- (2) The Pilot operated an “Ozone Buzz Z5”, an EN-B certified paraglider of S size, which was built in 2017. It was fitted with an “Advance Progress 3” harness of M size.

- (1) The paragliding canopy, Model “Ozone Buzz Z5”, and the harness, Model “Advance Progress 3”, were examined and found in good shape.
- (2) All lines connecting the canopy to the harness were cut during the rescue operation.

- (1) The canopy and harness were examined and found in good condition.
- (2) The paraglider lines were examined and found within the limits.
- (3) There was no evidence of failure of the paraglider.

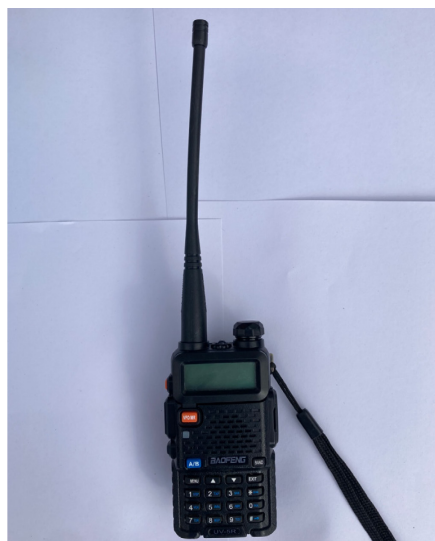
Figure 19: Two-Way Radio Transceiver Used by the Pilot

- (1) The Pilot carried a two-way radio transceiver with frequencies set at 145.9875 MHz and 436.360 MHz.

- (2) According to the radio usage guideline on the HKPA website, 145.9875 MHz was the radio frequency for emergency distress, urgency and safety priority calls while 436.360 MHz was the radio chatting frequency for general communication.
- (3) During the flight preparation, the Pilot carried out the transmission check of the radio transceiver with Pilot A. Pilot A confirmed that the transmission was good and the messages received were loud and clear. The transceiver functioned properly.

- (2) During the wreckage examination on 3 January 2022, the compass, the variometer and the radio transceiver were inspected and no damage was identified.

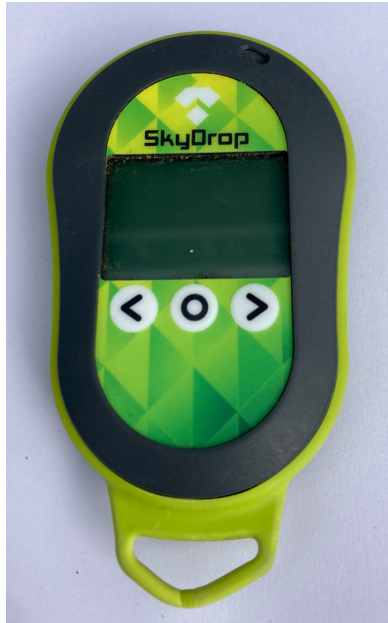
Figure 22: Variometer Used by the Pilot

- (1) The Pilot's variometer, Model "SkyDrop", stored in the harness, was recovered during the wreckage recovery operation on the following day of the accident.
- (2) The variometer was an integrated device with altimeter, compass and Global Positioning System (GPS) functions. It provided and recorded not only signals of rates of climb and descent, but also GPS positions and pressure altitudes for paragliding activities.
- (3) Data stored in the variometer in the International Gliding Community (IGC) file was retrieved for flight track analysis.

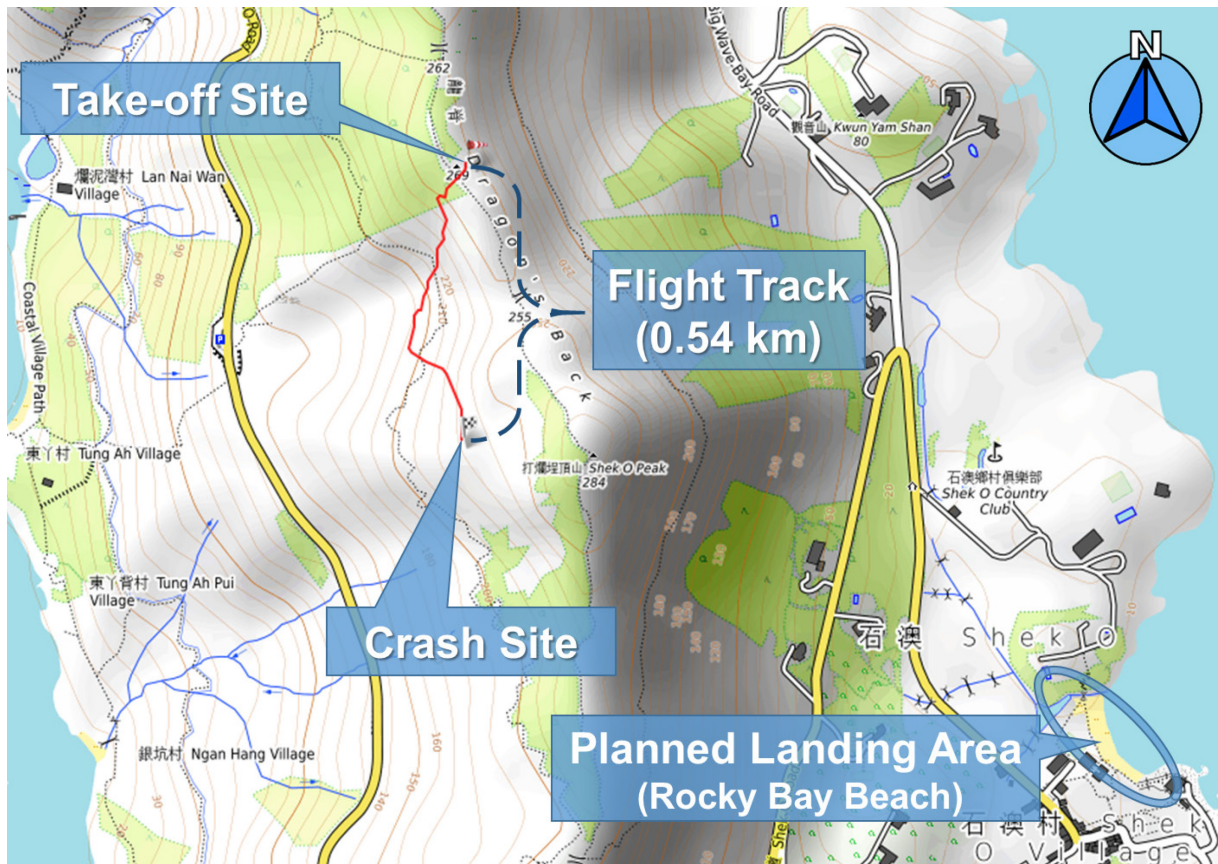
Figure 23: Accident Flight Track

The accident flight track was generated by the "Logfly" application using the IGC File data retrieved from the Pilot's variometer.

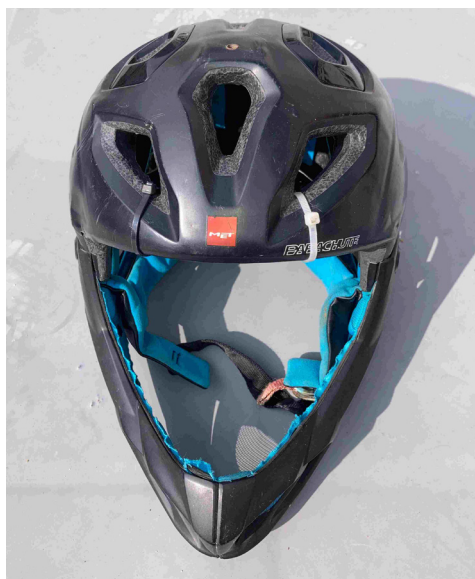
Figure 26: The Helmet of the Pilot

- (1) The helmet of the Pilot, Model “MET M98 – Parachute HES”, which was certified to American Society for Testing and Materials (ASTM) 1952-10 and ASTM 2032-06 standards, was found detached from the Pilot’s head.
- (2) The helmet manufacturer, MET SPA, advised the investigation team that the helmet was also certified to EN 1078:2012+A1:2012 standard.
- (3) The helmet was manufactured in 2015 with serial number (S/N) V150185.

- (4) The examination identified damages on the backside of the helmet, including a crack of 9 cm long in the middle of the backside, and a crack of 14 cm long propagated from the backside to the right-hand side.

- (8) The cause of death as shown by the autopsy appears to be traumatic compression of the cervical spinal cord due to neck injury. (1.13) (2.5.1)
- (9) The helmet of the Pilot was neither designed nor certified for paragliding. (1.15.1) (2.5.2.1)

During the investigation, the AAIA identified the safety matter on the safety standards and the lifespan controls of the helmet. On 31 January 2022, AAIA issued Safety Recommendation 01-2022 to the Civil Aviation Department, Hong Kong; the Hong Kong Paragliding Association; the Hong Kong Paragliding Federation.

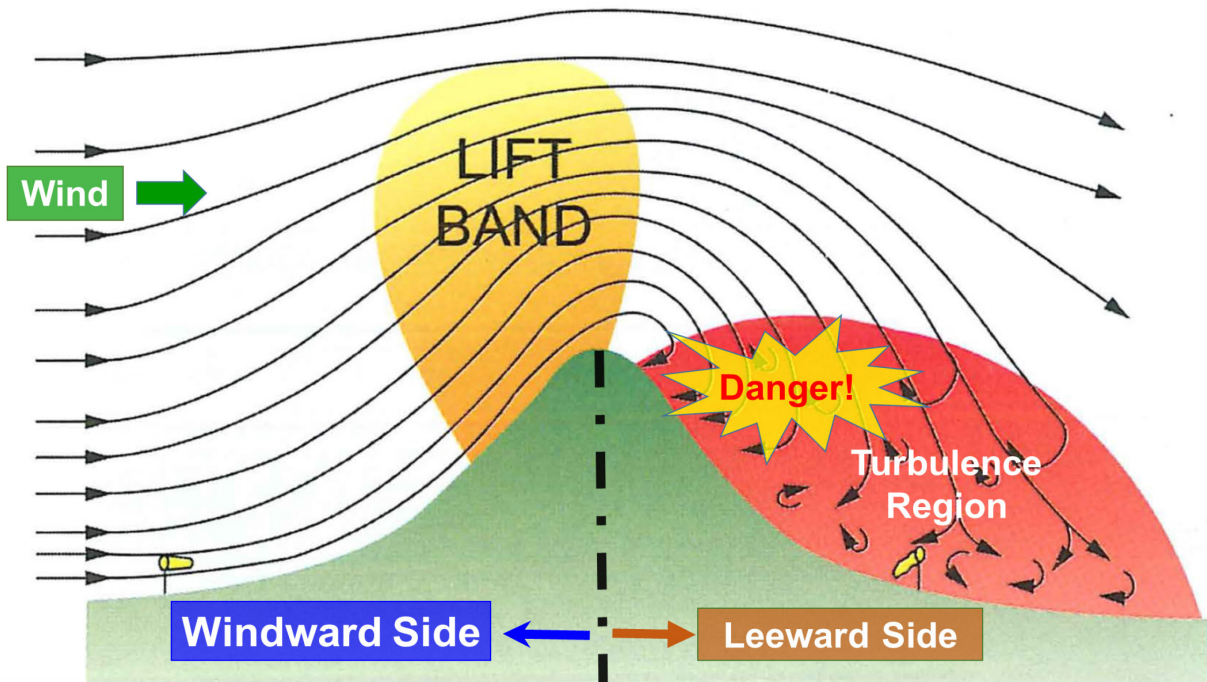
Figure 35: Turbulent Flow on Leeward Side of Mountains

On the downwind side of the mountain (leeward side), the airflow would be very turbulent and unpredictable due to the air circulates created by the mountain itself. Paragliding pilots must pay attention to wind direction and avoid flying near the leeward side of mountains, which is a dangerous region with severe turbulences as shown in the figure below.
