# **Propulsion System Fire (SCF–PP–PSF)**

## **Investigation Report**

**Serious Incident to  
Boeing 747-8F, N624UP  
Hong Kong International Airport**

**20 July 2021**

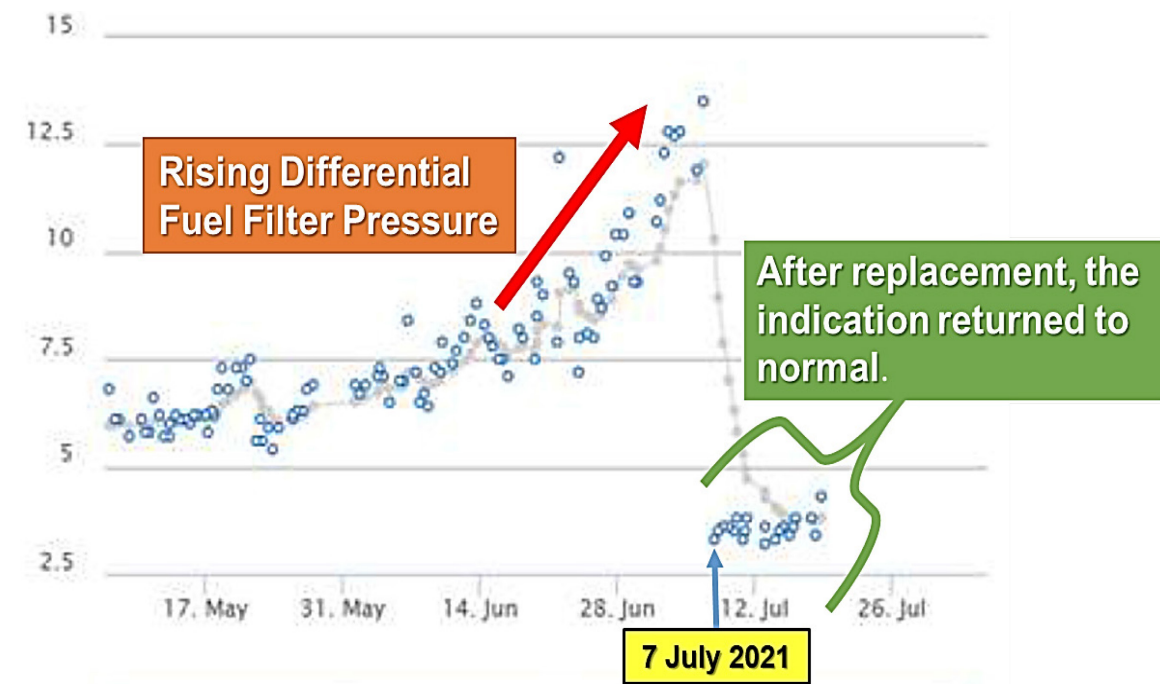
Figure 7: Trend of Fuel Filter Delta Pressure

- (1) According to the operator, the engine was installed as new. The only engine maintenance was the replacement of the fuel filter, main fuel pump strainer and lube flow screen on 7 July 2021 as the engine condition monitoring had alerted of a rising differential fuel pressure indication on the No. 1 engine.
- (2) After the replacement, the pressure indication returned to normal and remained stable until the date of occurrence.

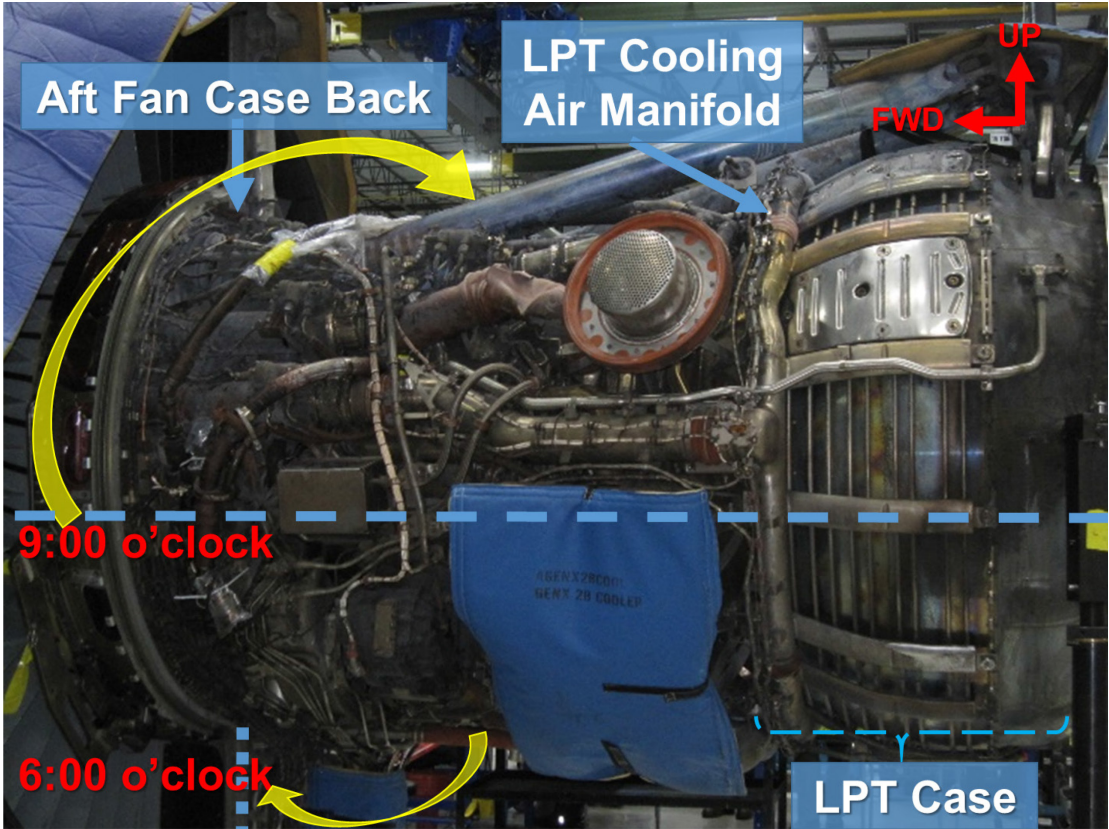
Figure 13: Left Side of Engine

- (1) Prior to the leak check, an external examination of the engine was performed to document the fire damage and a swab sample was taken of yellowish powder residue at about the one o'clock position on the environmental cooling manifold.
- (2) From the aft fan case back to the LPT cooling air manifold on the LPT case, the thermal and fire damage was most pronounced from about the nine o'clock to six o'clock position (aft looking forward).

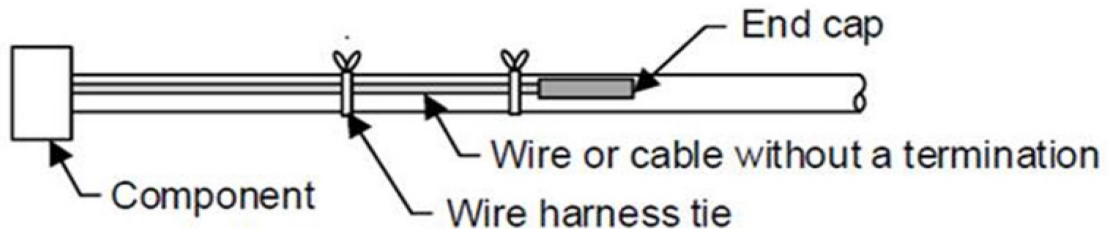
**Figure 19: Standard Practice for Capping the Unused Electrical Wires**

- (6) The Boeing performed a continuity check of the FMU and engine harness connectors. The results were normal.
- (7) After checking with the wiring diagram, it was confirmed that the exposed electrical wires were unused wires with an end cap on the end, as shown in the graphic below.

- (8) The end caps of the electrical wires likely melted as a result of thermal damage. Thus, the electrical wires became exposed.
- (9) The top of the engine, from about 9 o'clock to 3 o'clock position, was covered in a bluish powder residue, and yellowish powder residue at about the 1 o'clock position on the environmental cooling manifold.

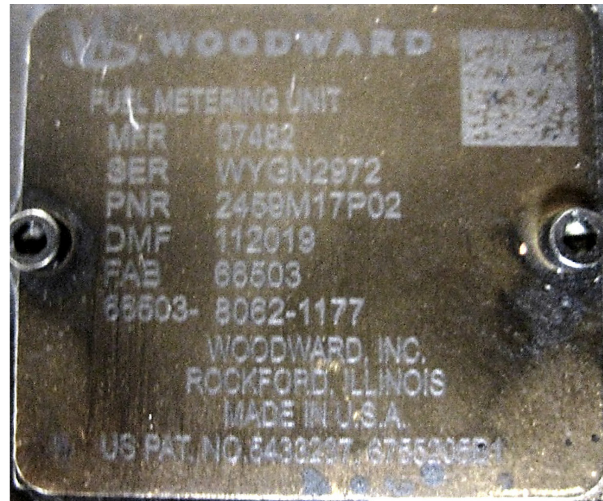
**Figure 27: Data Plate of FMU**

- (1) The FMU was of GE part number (PN) 2459M17P02, Woodward PN 8062-1177, serial number (SN) WYGN2972, which was manufactured in November 2019.

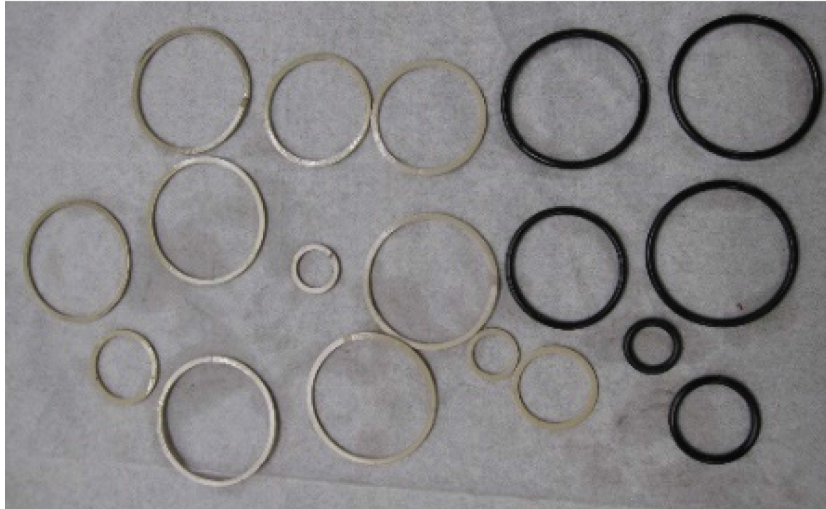
**Figure 31: Condition of Packing & Back-up Split Rings**

- (6) Each fuel port has a primary black packing (O-ring) with a whitish flat backup split ring on either side of the primary packing. The O-rings and the backup split rings were all intact, in good condition, and did not exhibit thermal or heat distress.

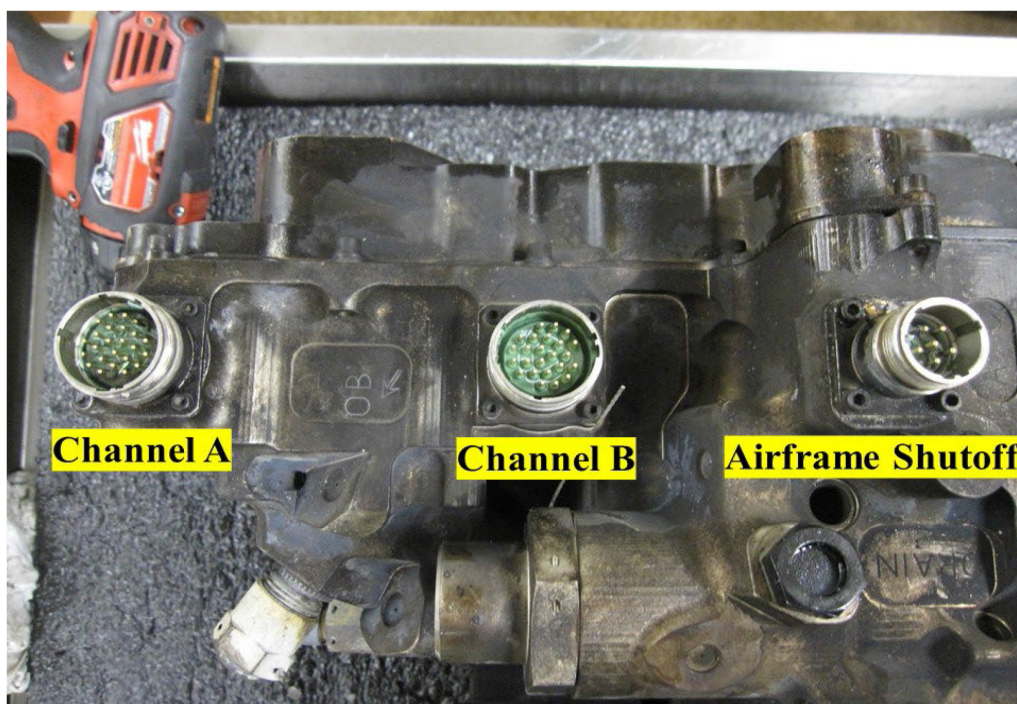
**Figure 32: FMU Electrical Connectors**

- (7) Visual examination of the electric connector plugs (Channel A, Channel B, and Airframe Shutoff (AFSO)) revealed that all the pins were present and intact, and no thermal distress was noted; the Channel A and AFSO green rubber grommet exhibited some minor thermal damage.

- (8) A continuity check was performed on the pin connectors for each of the electrical connectors. The results were found normal.

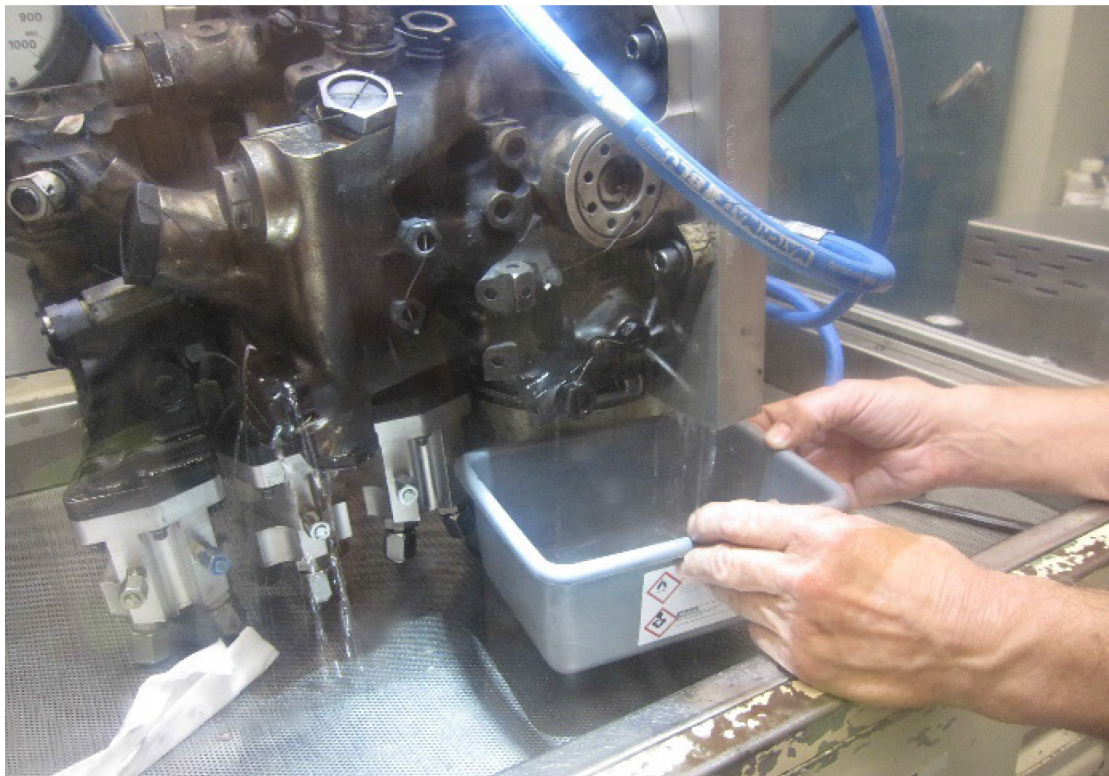
**Figure 39: Calibration Fluid Collected From P1 Bypass Valve Port Fitting**

- (4) The FMU was tilted in such a manner so that the P1 bypass valve port fitting leak could be isolated from the other two leak locations. The objective was to capture the calibration fluid in order to determine the leak rate from the P1 bypass valve port fitting only.
- (5) Again, at about 12 psi, calibration fluid was collected for 1 minute and 445 cubic centimetres (cc) of fuel (0.740 pounds) was collected. The leak observed from the P1 bypass valve port fitting was isolated to a single general location.
- (6) The leak rate of 445 cc per minute at 12 psi corresponded to a 0.038" external leak orifice. This external leak size was compared to a later analysis investigating how this leak had caused N1 to reach the overspeed limit in Section 1.16.3.

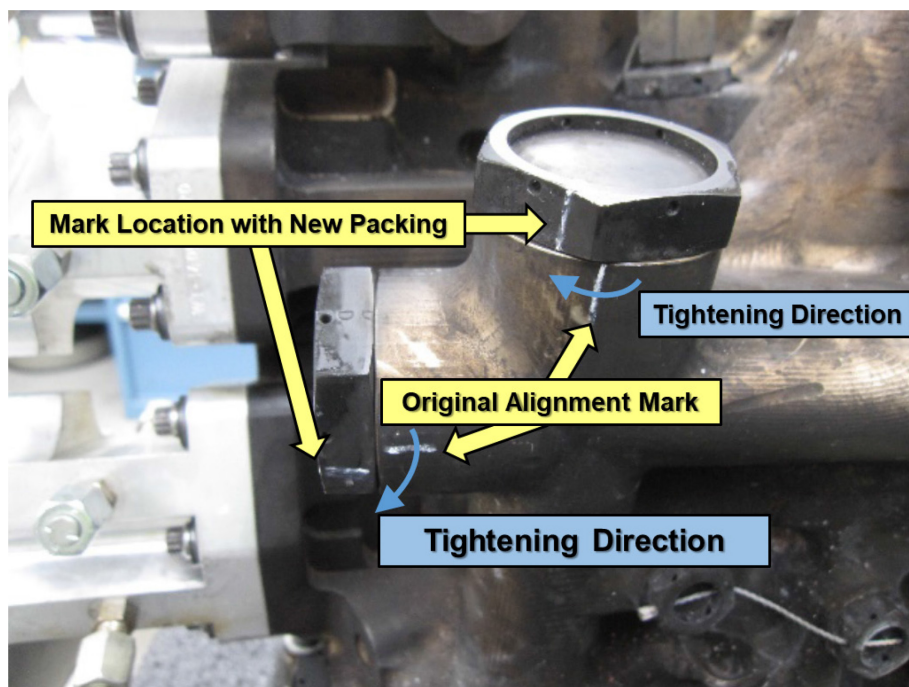
**Figure 44: PB2 Bypass Fitting Alignment Marks With New Packings Installed**

- (5) New packings were installed on the PB2 bypass and P1 bypass valve port fittings and the fittings were reinstalled to the specified torque.
- (6) The alignment marks for the PB2 bypass fittings went past the original “tight” marks in the tightening direction; they appeared to be about a  $\frac{1}{4}$  of a flat past the original “tight” mark.

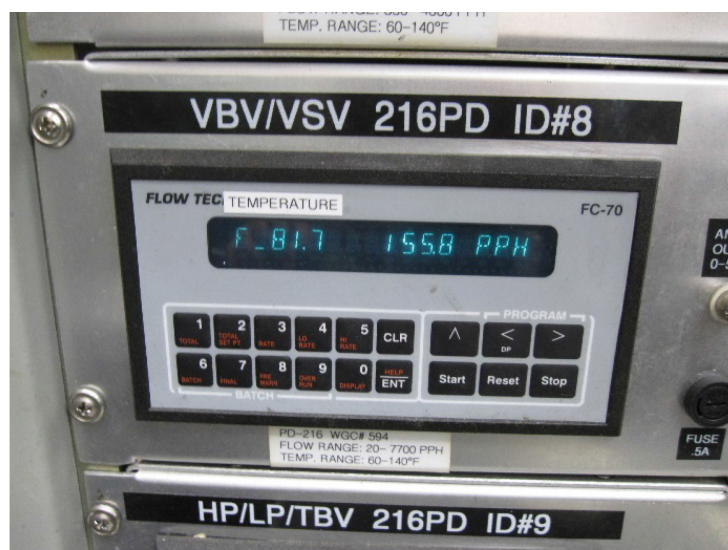
**Figure 50: Leak Rate from P1 Bypass Valve Port Fitting**

- (6) The needle valve was slowly opened to vary the pressure across the metering valve ( $\Delta P = P1-P2$ ) from its normal operating  $\Delta P$  pressure of about 50 psi to the event  $\Delta P$  pressure of about 95.5 psi. The 95.5 psi was a calculated value based on FDR data and not an actually recorded parameter.
- (7) The opening of the needle valve allowed fuel to leak thus increasing the  $\Delta P$ . The fuel flow rate (the simulated leak rate from the P1 bypass valve port fitting) was recorded as 155.8 PPH.
- (8) The leak rate at approximately idle conditions corresponded to a 0.033" external leak orifice. This external leak size was compared to a later analysis investigating how this leak caused N1 to reach the overspeed limit in Section 1.16.3.

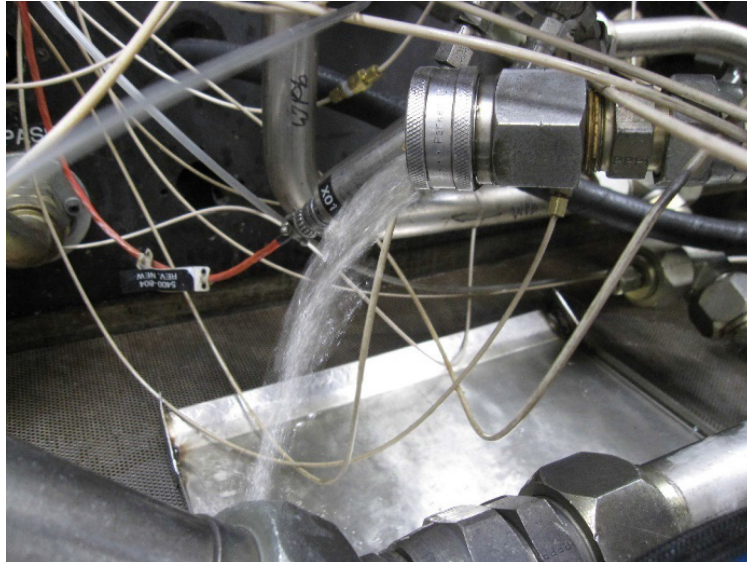
**Figure 51: Fluid Leak from P1 Bypass Valve Port Fitting**

- (9) The amount of flow from the discharge tube was recorded by the flowmeter.

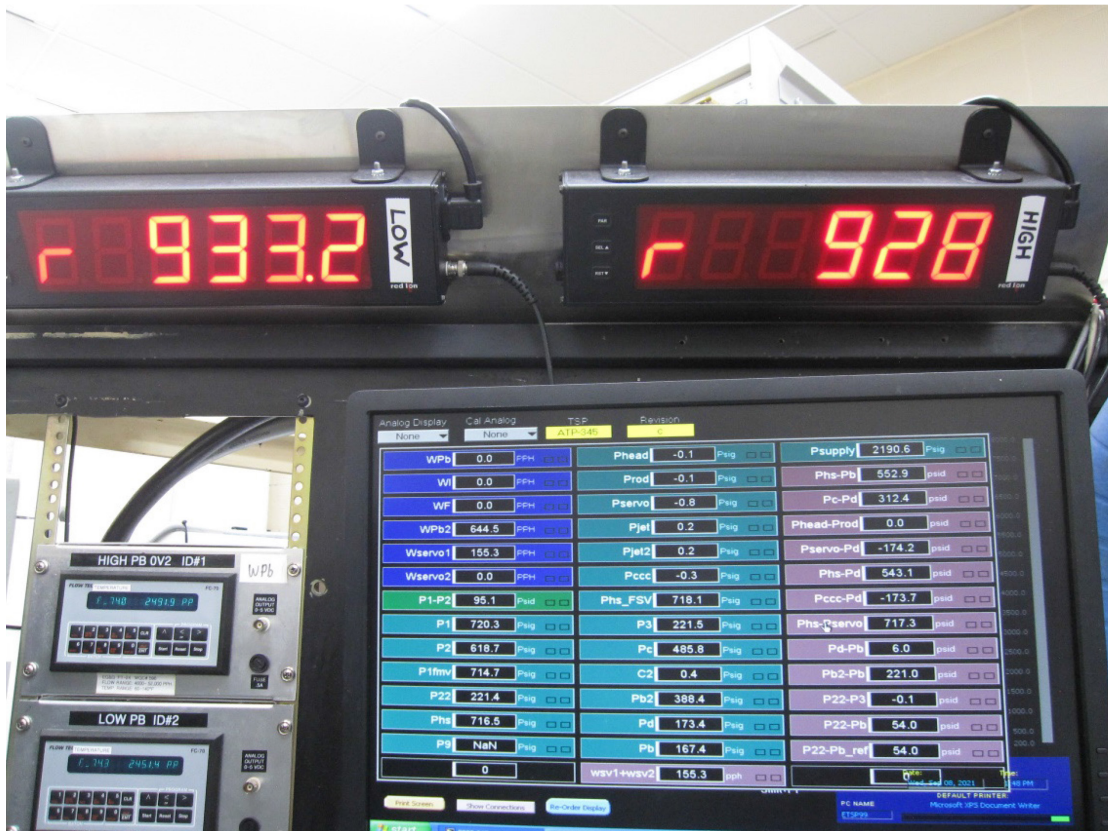
**Figure 52: Meter Flow Rate With Leak**

- (10) After the needle valve was opened to simulate the leak, the metered flow ( $W_f$ ) value changed to 933.2 PPH.

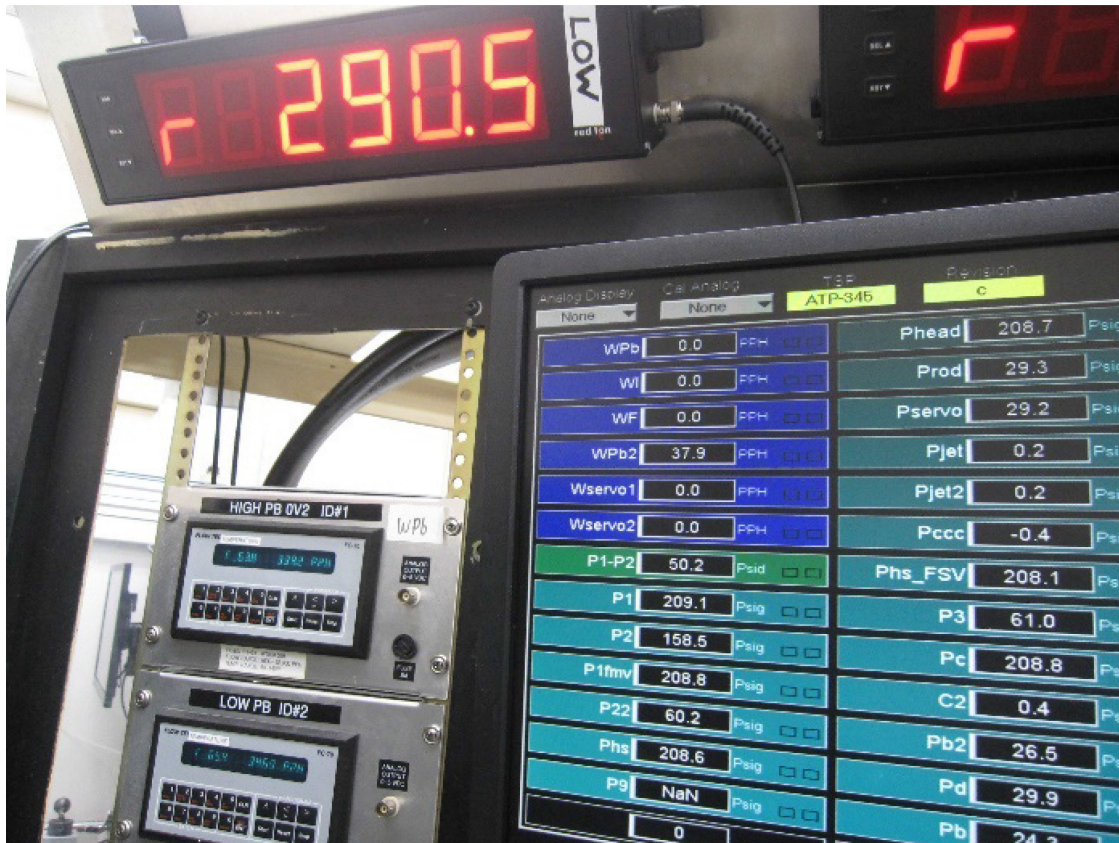
**Figure 54: Near Sub-Idle Test**

- 1)  $W_i$  – Inlet flow - 2254-2346 PPH
  - 2) WPB – Bypass flow - 250-350 PPH
  - 3) PB – Bypass Pressure – 20-70 pounds per square inch gauge (psig)
  - 4) P22-PB – Discharge Bypass Pressure – 50-70 psid
  - 5) LVDT – +0.1897 volt/volt
- (4) With these input values, the metered fuel flow rate from the FMU (WF) was recorded as 291 PPH (limit is 293-313 PPH) and the  $\Delta P$  (P1-P2) was 50.2 psid (limit 40-60 psid).

- (5) When Woodward shipped the event FMU, the as-shipped value for WF was 293 PPH and for  $\Delta P$  was 50.5 psid. So for this test point, WF and  $\Delta P$  valves correlated well with the as-shipped values. It was concluded that the event FMU worked normally near sub-idle conditions.
- (6) The second test was representative of operating conditions at cruise. The input pressures and flow rates were as follows:

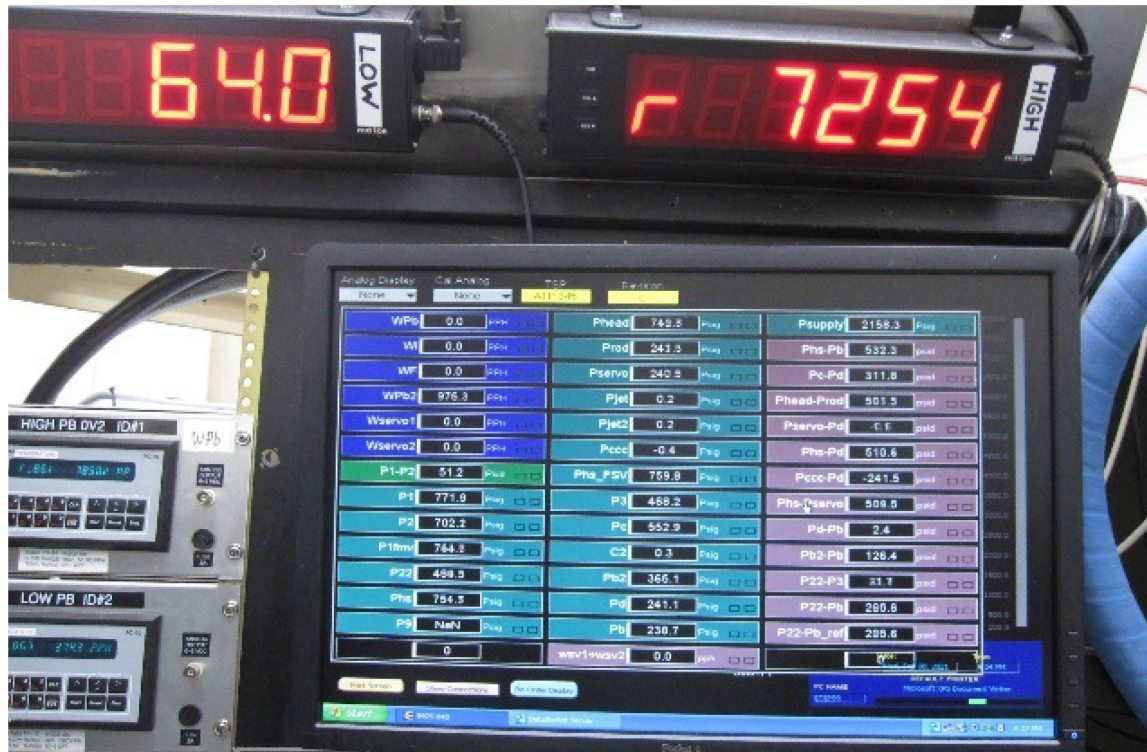
**Figure 55: About Cruise Test**

- 1) Wi – Inlet flow - 40180-41820 PPH
  - 2) WPB – Bypass flow - 6790-7504 PPH
  - 3) PB – Bypass Pressure – 225-235 psig
  - 4) P22 – Discharge Bypass Pressure – 460-480 psid
  - 5) LVDT – -0.1775 volt/volt
- (7) With these input values, the metered fuel flow rate from the FMU (WF) was recorded as 7253 PPH (limit is 6968-7326 PPH).

- (8) When Woodward shipped the event FMU, the as-shipped value for WF was 7207 PPH. So for this test point, WF correlated well with the as-shipped value. It was concluded that the event FMU worked normally about cruise conditions.
- (9) Based on the results of the various leak checks and the modified ATP testing, it is concluded that the event FMU operated normally after replacing the packings and retightening the P1 bypass valve port fitting. No disassembly of the FMU was needed to further support the investigation.

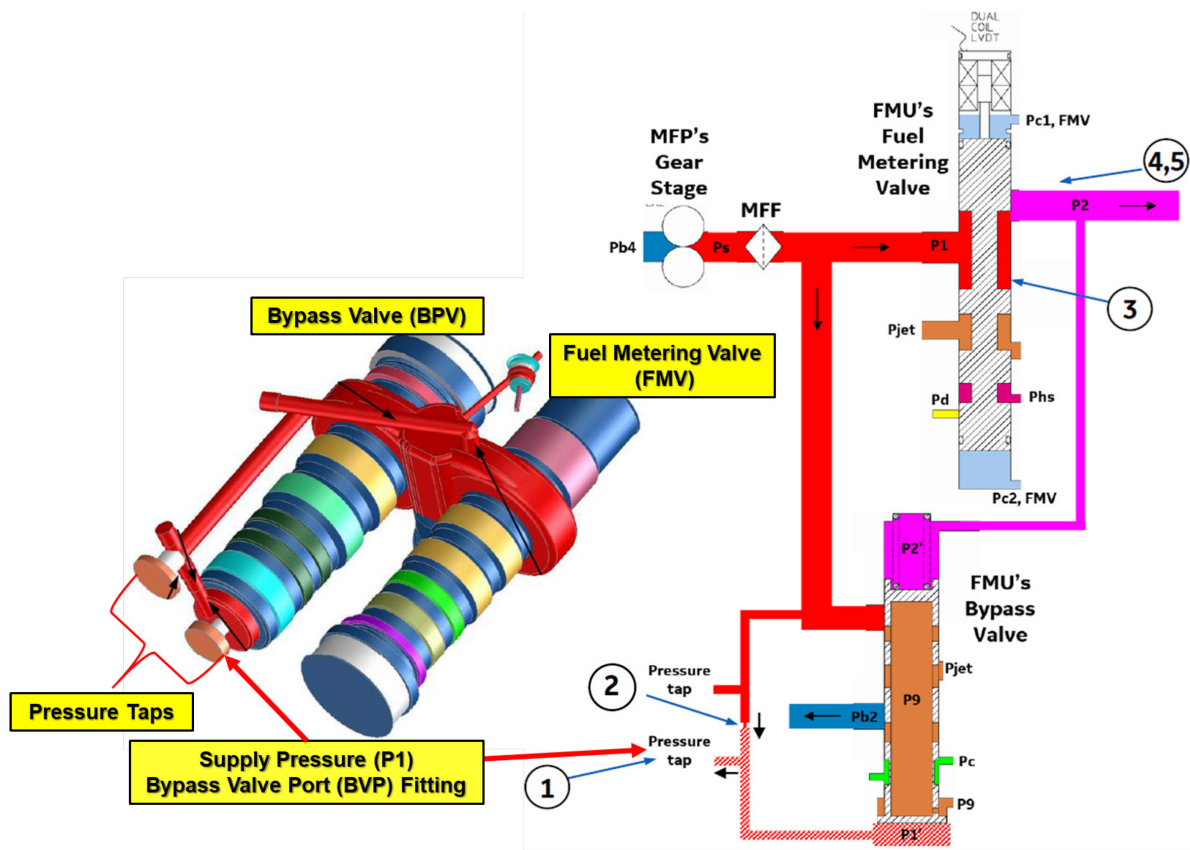
**Figure 57: Internal structure of the FMU**

- (3) The external fuel leak occurred at the P1 BVP fitting, i.e. the P1 sense line of the bypass valve (BPV). See ① in the figure above.
- (4) The leak caused the BPV to sense a different, lower pressure (P1') because flow across the damping orifice was metered. See ② in the figure above.
- (5) The BPV moved to a more closed position, resulting in higher delta pressure across the FMV, and therefore more flow thru the FMV. See ③ in the figure above.
- (6) FADEC commanded the FMV to a more closed position to maintain fan speed. See ④ in the figure above.
- (7) FADEC calculated fuel flow based on FMV position. The actual flow was higher than calculated, due to the higher delta pressure across the FMV. See ⑤ in the figure above.
- (8) When FADEC demanded additional fuel flow to protect against flame-out, additional fuel was sufficient to result in N1 reaching the FADEC overspeed limit.

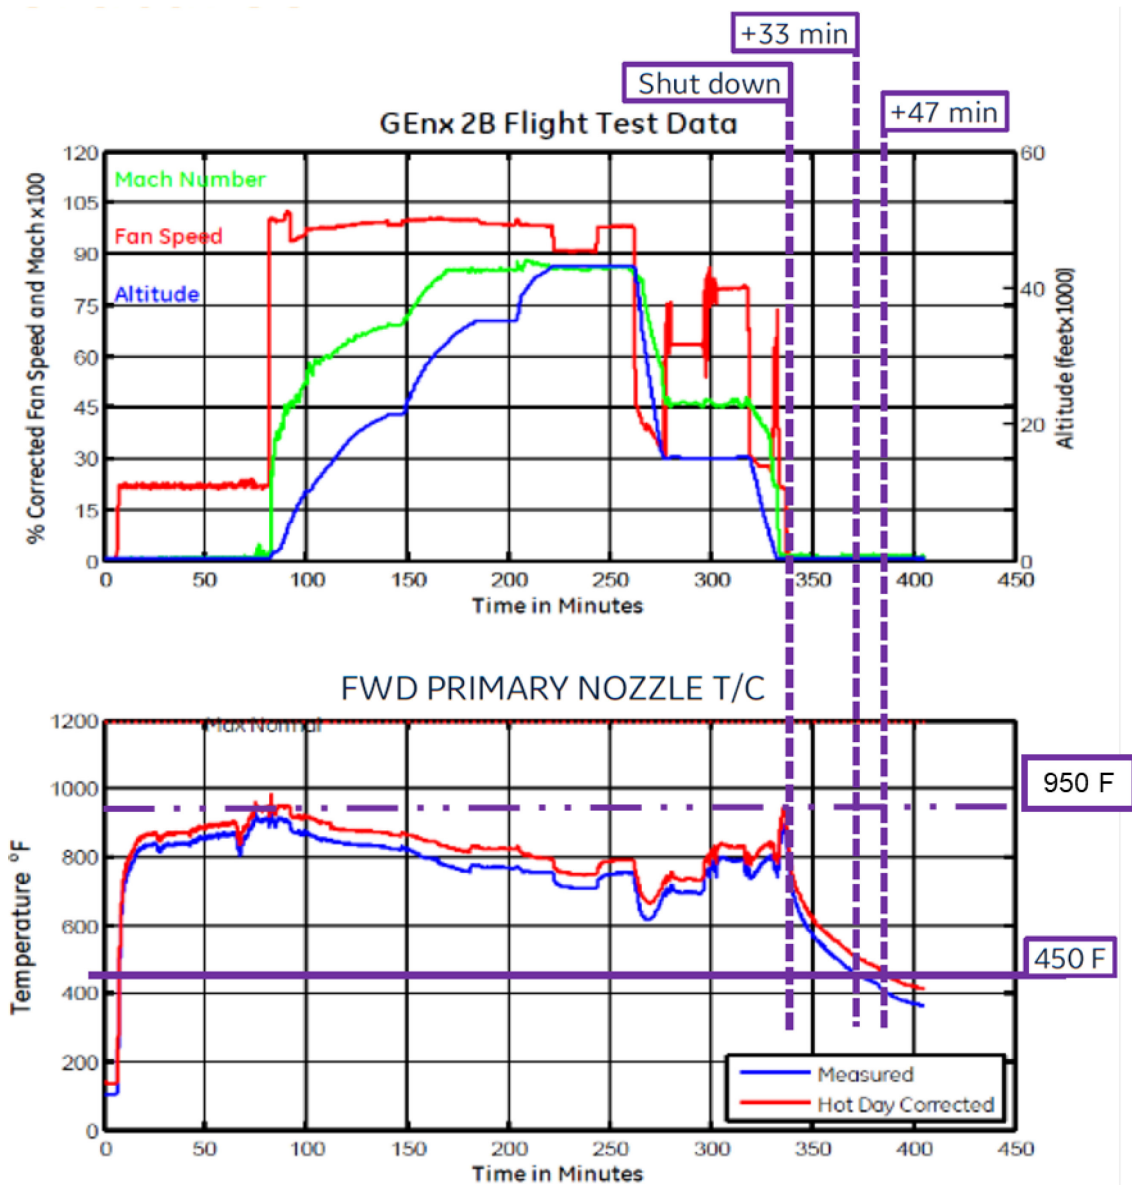
Figure 58: Post-Shutdown Surface Temperatures of Genx-2B Engine

- (2) During normal operation, even at ground idle or after the engine shutdown, the surface temperature of multiple parts in the aft section of the core compartment exceed 450 degrees Fahrenheit (°F), which is the auto-ignition temperature of the fuel in still air.
- (3) After the engine shutdown, forward primary nozzle temperatures was above 450 °F for at least 33 minutes as tested, and 47 minutes when corrected for hot day conditions.

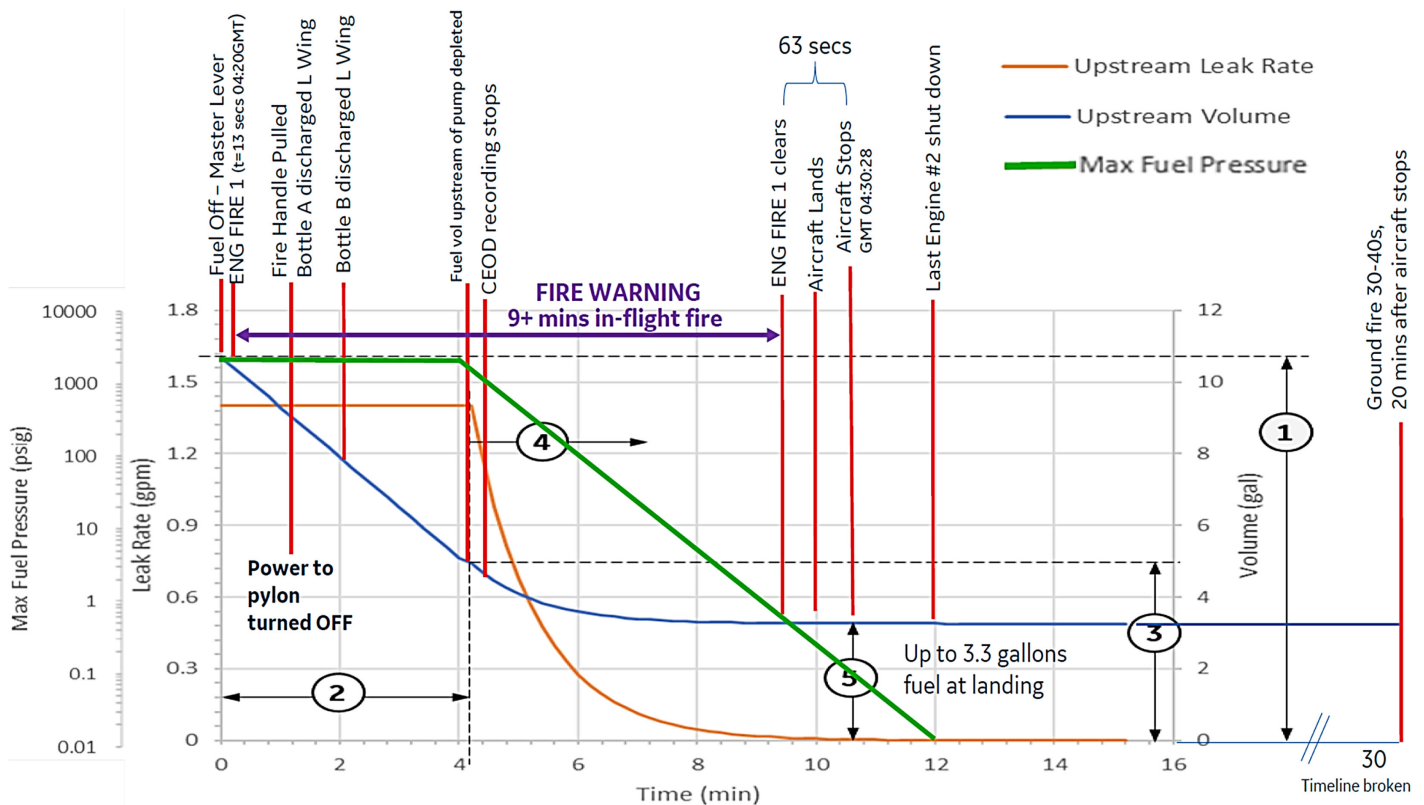
**Figure 61: Timeline of Upstream Fuel Volume / Leak Rate with Key Events**

- (4) When fuel was shut off, 9.7 gallons of fuel ((A): 4.7 gallons + (B): 5 gallons) were trapped between the spar valve and HPSOV. This volume expanded to 10.7 gallons due to the thermal expansion of the fuel. The upstream leak was from the P1 bypass valve port fitting of the FMU. See ① in the figure above.
- (5) The upstream static volume of fuel ((A)) was being drained by the boost pump. Gear stage performance (and the FMU leak rate) was maintained. The FMU leakage continued at the rate of around 1.4 gallons per minute (gpm). See ② in the figure above.
- (6) The upstream static volume of fuel ((A)) was depleted around 4 minutes after shutdown until the trapped fuel from the spar valve to the inlet of the main fuel pump was exhausted. 5 gallons of fuel remained in the total upstream recirculating system ((B)). See ③ in the figure above.

- (7) Gear stage performance degraded as recirculating bypass volume (C) was reduced. The pump performance (therefore FMU leak rate) was assumed to decay linearly with respect to the remaining bypass volume. See ④ in the figure above.
- (8) Bypass volume ( C ) was depleted. The remaining volume approaches 3.3 gallons in the total upstream system. FMU leak was no longer pressure driven but due to gravity/drip only that occurred about 10 minutes after engine shutdown, shortly before landing. See ⑤ in the figure above.

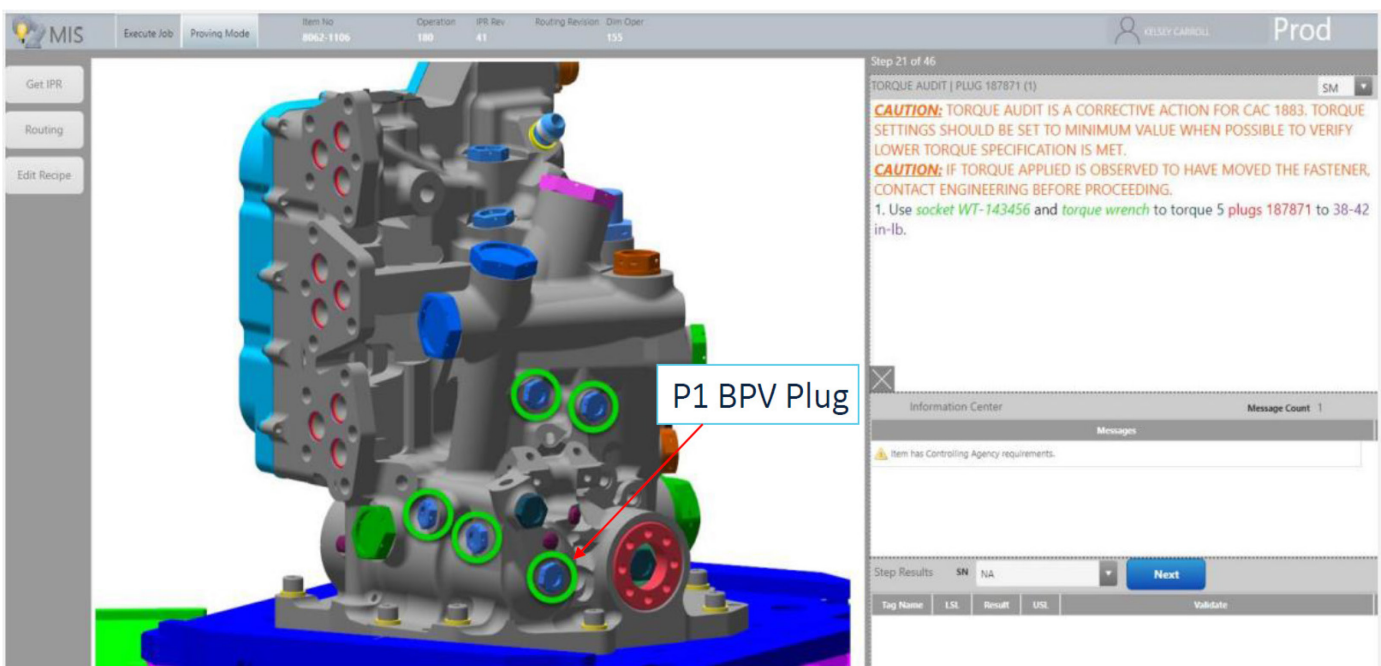
**Figure 62: Revised MIS Instructions to Include Torque Audit**

- (1) The assembly process at the time of unit assembly was to install 7 similar fittings and then tighten them. There was no one-over-one torque verification in place at the time of this unit's manufacture date, 20 November 2019.
- (2) Production Manufacturing Integration System (MIS) instructions for assembling the FMU were revised to include the torque audit on 30 December 2019. Torque audit is 100% torque verification. All threaded plugs are independently verified to proper torque value by an independent operator prior to safety cabling and final inspection.

- (3) After the occurrence, the repair and overhaul facilities also established the torque verification procedure of the P1 bypass valve port fitting on 4 October 2021. The fitting is independently verified to proper torque value by an independent operator prior to safety cabling and final inspection.

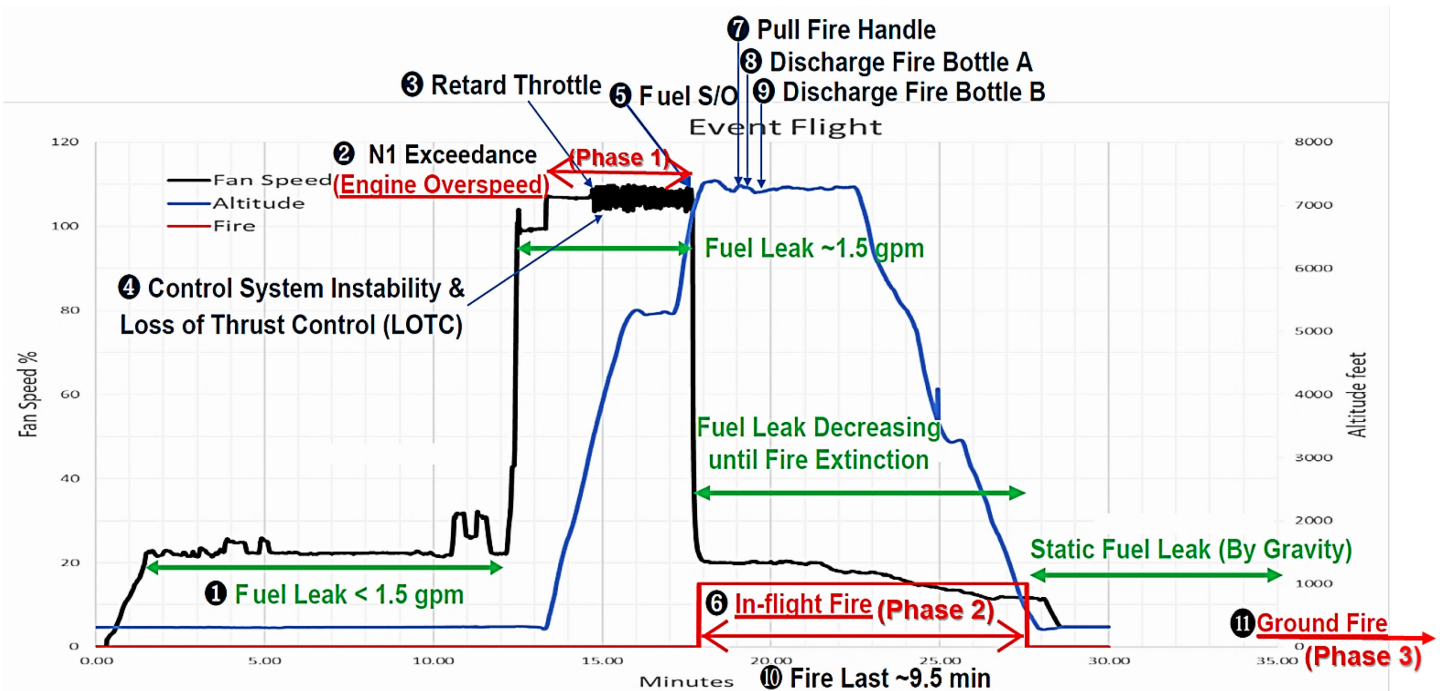
Figure 66: Three Key Phases of the Event

- (1) The FMU leak started at idle. See ❶ in the figure above.
- (2) During the take-off roll, the N1 exceedance warning was annunciated. See ❷ in the figure above.
- (3) The engine did not respond to throttle reduction. The engine control system became unstable and LOTC occurred. See ❸ and ❹ respectively in the figure above.
- (4) Fuel was shut off and the fire started 12 seconds after engine shutdown due to a reduction in under-cowl airflow and ignition on the hot surfaces. See ❺ and ❻ respectively in the figure above.
- (5) The flight crew pulled the fire handle to isolate the engine from the aircraft and discharged fire extinguisher bottle A. See ❼ and ❽ respectively in the figure above.
- (6) The fire warning remained and the flight crew immediately discharged the fire extinguisher bottle B. See ❾ in the figure above.
