Loss of Control – Inflight

Investigation Report

Robinson R44 Clipper II, B-KTK,

19 May 2019

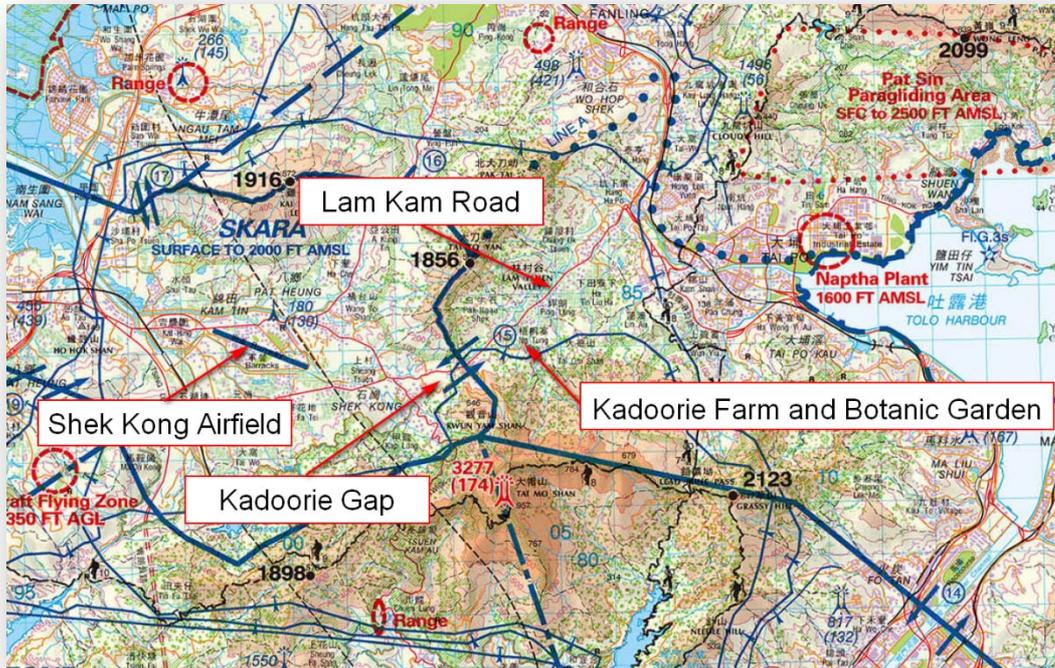
Figure 1: Accident and Wreckage Locations

- (12) A number of witnesses observed components of the post breakup of B-KTK descending and the subsequent impact of the main wreckage.

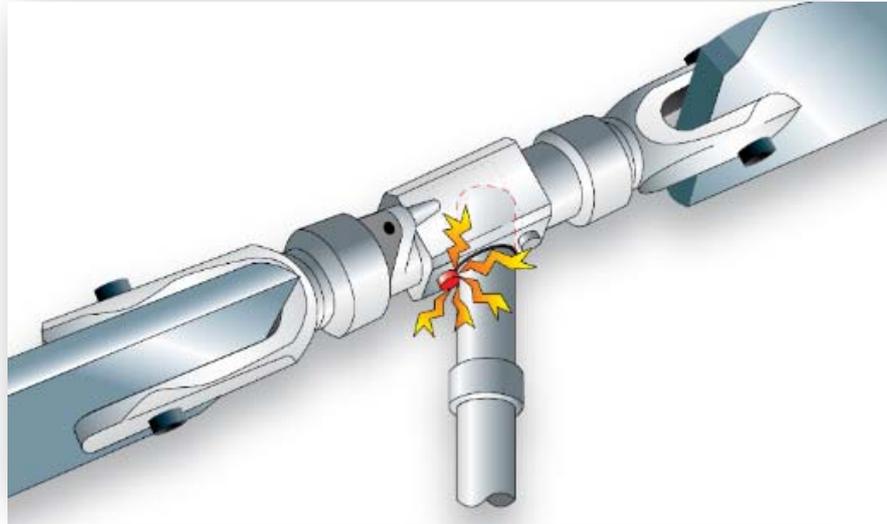
Figure 15: Mast Bumping

- (3) The R44 rotor head design has a maximum teetering angle controlled by a teeter stop, an elastomeric pad mounted between the hub (spindle) and mast, preventing the hub (spindle) from contacting the mast. If the teetering of the hub becomes excessive, it will damage the teeter stop, allowing mast bumping to occur. With each revolution of the rotor, the teetering becomes more excessive and more violent. The violent mast bumping quickly causes damage to, or separation of, the mast.
