Runway Incursion (RI-VAP)

Investigation Report

**Bombardier Global 5000, P4-AVA and
Boeing 737-81B, B-1918**

13 November 2018

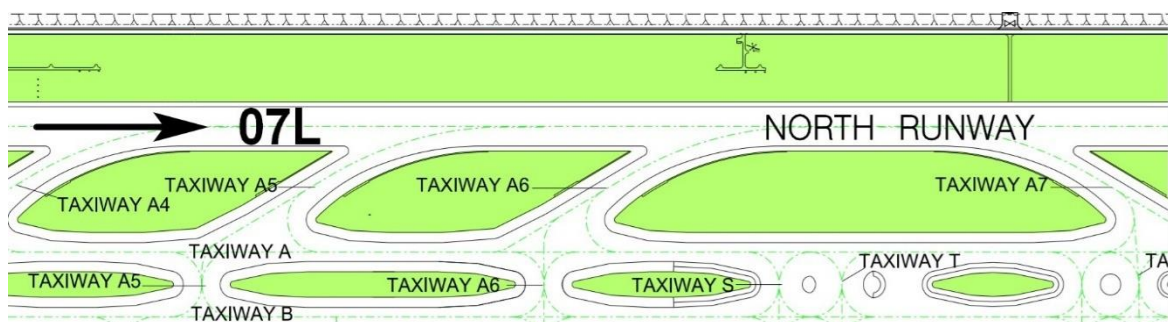
Figure 1: RWY 07L and RETs A5, A6 and A7

- (3) As recorded on the Cockpit Voice Recorder (CVR) of the GL5T, the pilots discussed during the approach on which runway exit to use after landing. They agreed on taking Rapid Exit Taxiway (RET) A7. [See Figure 1.]

- (10) When the controller visually observed the GL5T again after checking on the SIT, he saw the aircraft moving slowly near RET A6. At 19:46:33, the controller asked the pilots of the GL5T if they were taking RET A5. However, the aircraft had already passed A5 by more than 400 metres and the pilots did not reply. Similar to RET A6, RET A5 was designed for use by aircraft landing RWY 25R rather than RWY 07L.

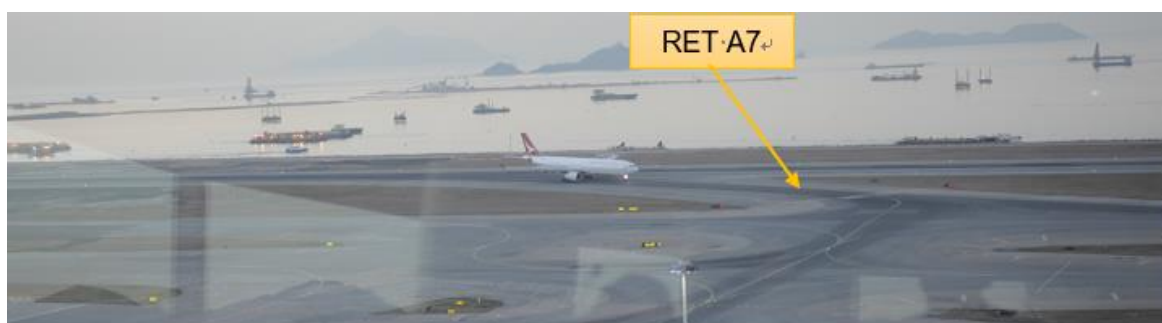
Photo 5: Exemplar Aircraft Vacating RWY 07L via RET A7 during Daytime

- (2) Due to the relatively lower level of depth perception and visual reference during night-time as compared with daytime, it can be challenging for Tower controllers to readily determine the relative motion of an aircraft by solely relying on visual observation. Photos 5 and 6 show an exemplar aircraft in the process of vacating RWY 07L via RET A7 during daytime and night-time respectively. Tower equipment such as A-SMGCS can help Tower controllers in making such assessments.
