Air Accident Investigation Authority

Deviation from Intended Flightpath

Investigation Report

**Serious Incident to
Boeing 787-9, G-VOWS
Waypoint RIVER of Hong Kong
29 September 2019**

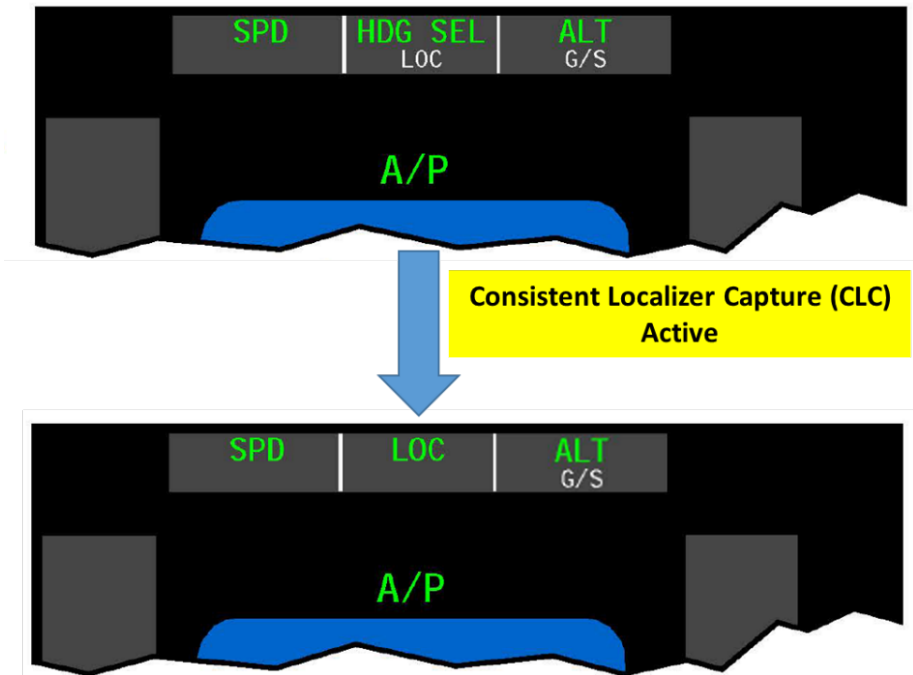
Figure 9: FMA on PFD with CLC Mode Active

- (7) CLC has enough authority to turn the aircraft up to 20 degrees off of the LOC course. This results in the aircraft turning to a LOC intercept angle of approximately 20 degrees.
- (8) During the turn, CLC will automatically transit to the LOC capture control law when the LOC is within parameters for capture and "LOC" will continue to be visible on the FMA.

- (6) It should be noted that "LOC" remained on the FMA despite the failed capture and, in some circumstances, the aircraft might begin to descend below the glideslope while the aircraft was 20 degrees offset from the LOC course.

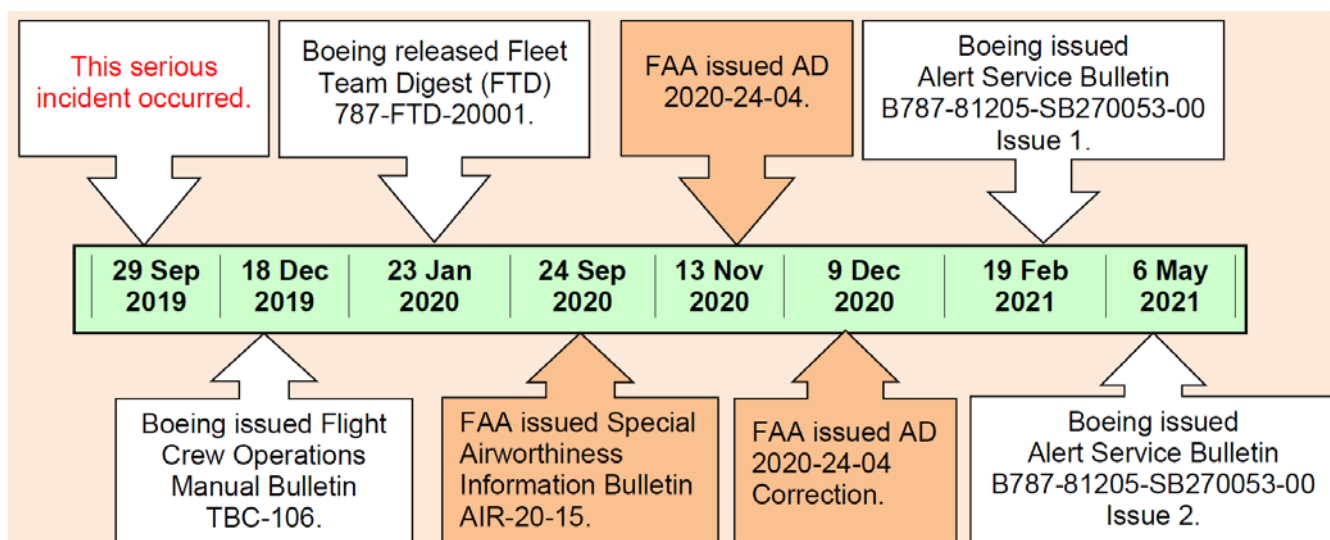
Figure 11: Timeline of Issuance of Related Technical Publications

- (1) Based on the in-service experiences, Boeing and the FAA had published different technical publications to provide operators with up to date information on the development/availability status of product improvements.
- (2) The timeline of issuance of technical publications related to LOC Capture Anomalies of the AFDS is shown in Figure 11.
