# Deviation from Intended Flightpath

## Investigation Report

**Boeing 787-9, G-VBOW**

**18 October 2019**

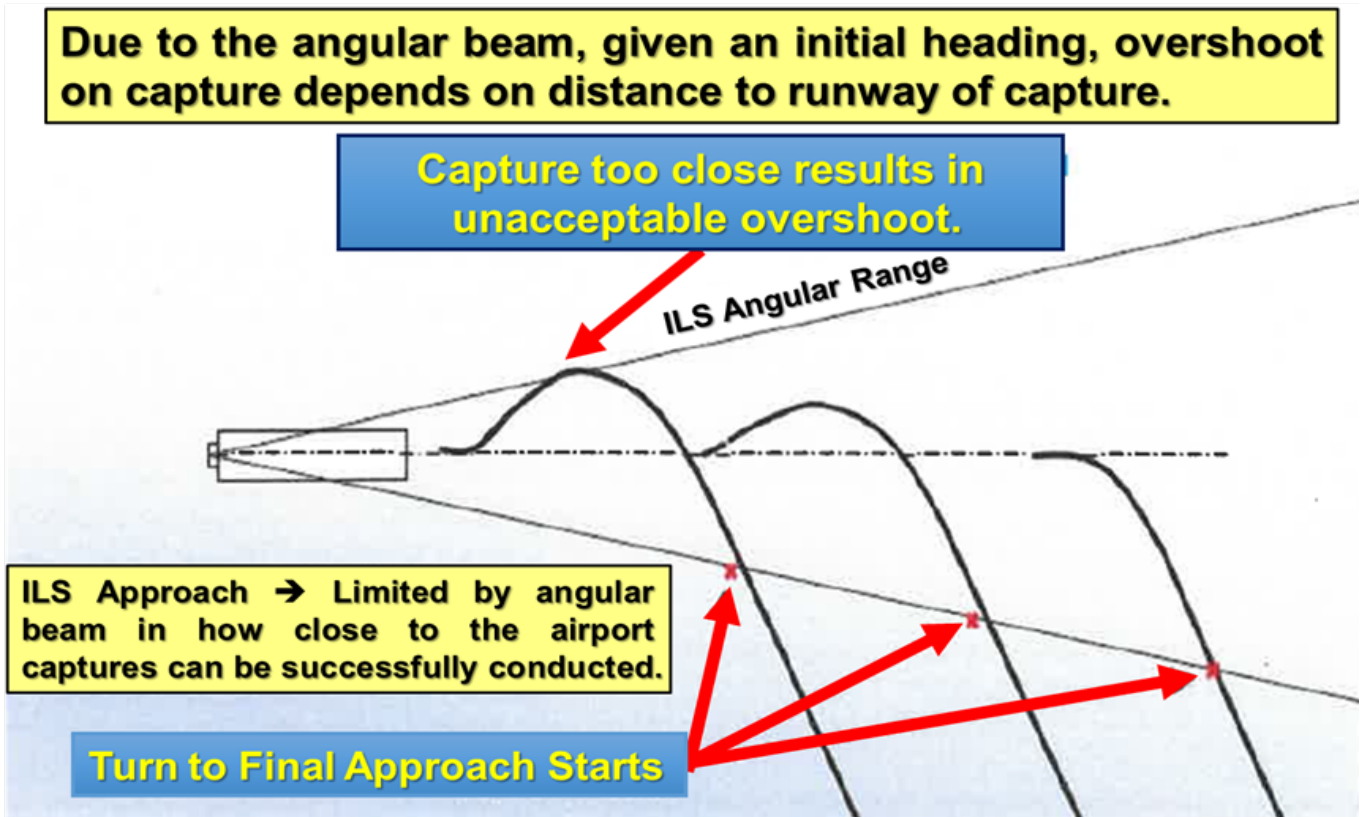
Figure 8: Effect of Intercept ILS Close to RWY

- (2) ILS approach LOC captures that occur too close to the RWY can result in LOC trajectory overshoots as shown in the graphic below.

- (3) The CLC mode reduces the risk of LOC course overshoot in A/P-enabled approaches that require a large turn (>40 degrees) onto the LOC course.
- (4) During an ILS approach, and when tracking a LOC intercept path angle greater than 40 degrees to the RWY extension line, the CLC mode will become active prior to capturing the LOC.
- (5) Using aircraft position (latitude/ longitude) and RWY information from the flight management function, CLC will turn the aircraft towards the LOC course before the LOC is within parameters for capture, in order to avoid overshoot and maximize the chance of capturing the LOC in one turn.
- (6) "LOC" will be annunciated on the FMA when a CLC turn begins and remains annunciated through the transition to LOC capture.

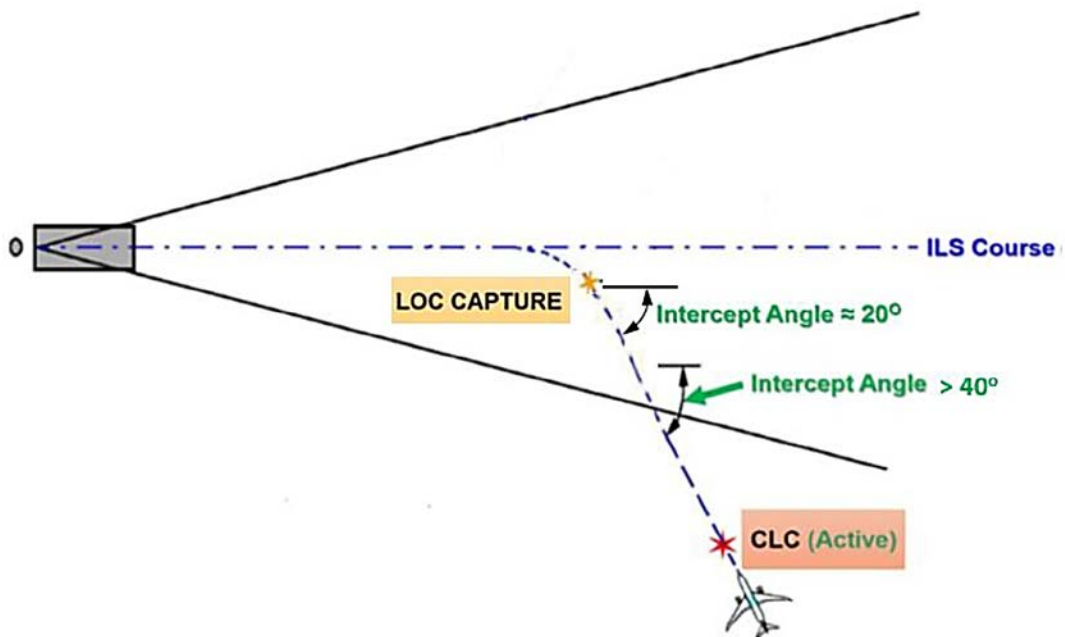
Figure 10: CLC Mode to LOC Capture Mode

- (7) CLC has enough authority to turn the aircraft up to 20 degrees off of the LOC course. This results in the aircraft turning to a LOC intercept angle of approximately 20 degrees.
- (8) During the turn, CLC will automatically transit to the LOC capture control law when the LOC is within parameters for capture and "LOC" will continue to be visible on the FMA.

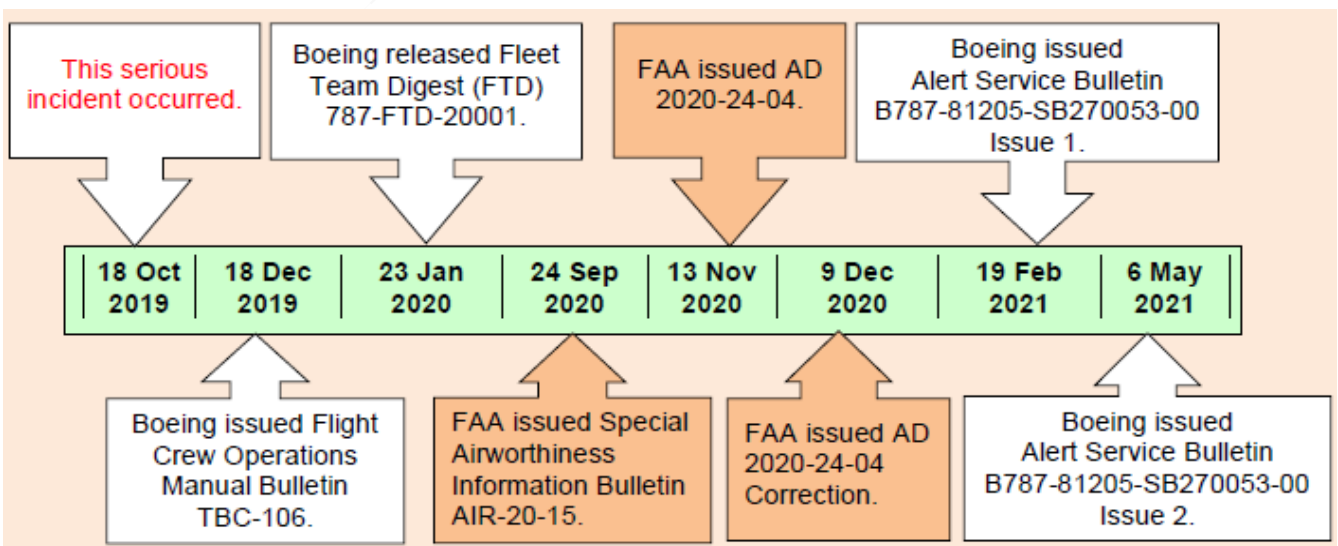
**Figure 13: Timeline of Issuance of Related Technical Publications**

- (1) Based on the in-service experiences, Boeing and the FAA had published different technical publications to provide operators with up to date information on the development/availability status of product improvements.
- (2) The timeline of issuance of technical publications related to LOC Capture Anomalies of the AFDS is shown in Figure 13.

- (2) Later, the FTD was updated to inform operators that:
  - (a) In March 2020, Boeing selected a solution for the condition. New logic would separate the LOC entry criteria from the CLC entry criteria and also add robustness to remove time sensitivity.
  - (b) The FAA released Airworthiness Directive (AD) 2020-24-04 to require operators to add related flight crew procedures to the Aircraft Flight Manual (AFM) with the effective date 18 December 2020.
- (3) The final update of the FTD was released on 10 March 2021 to encourage operators to install FCE Common Block Point (CBP) 5.1 software per Boeing Alert Service Bulletin (SB) B787-81205-SB270053-00 that was released on 19 February 2021 as the final action.
