Loss of Control – Inflight (LOC-I)

Investigation Report

Ozone Rush 6 Paraglider,

Pyramid Hill, Hong Kong

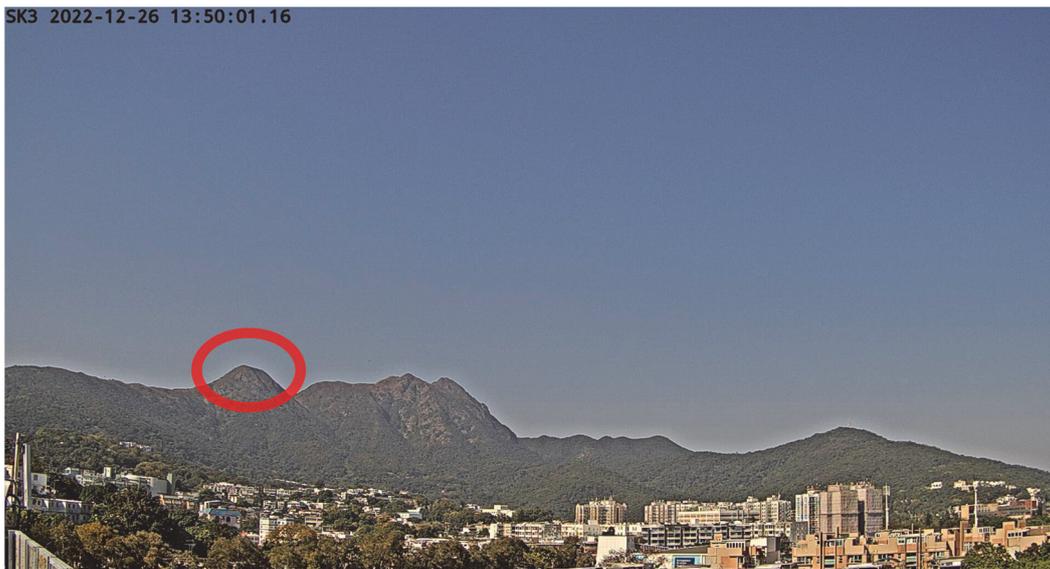
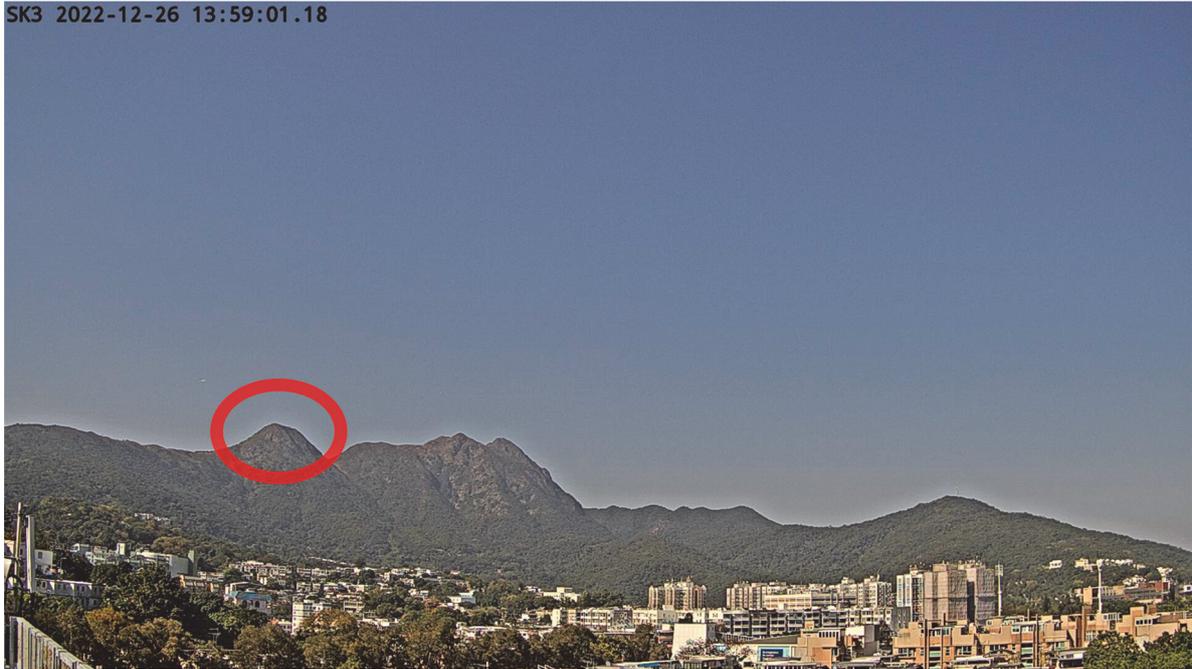
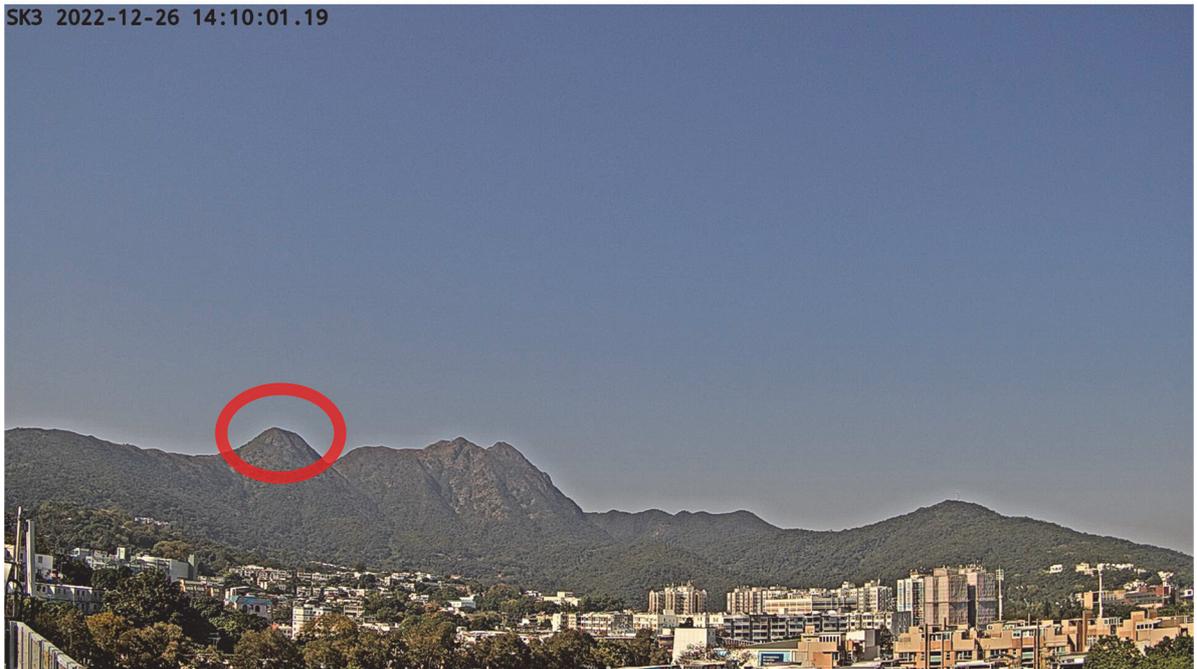
- (3) A review of the weather photos revealed that the top of Pyramid Hill (536 m AMSL) was not covered by clouds from 1350 hrs to 1410 hrs while the visibility was 5 km or above.
- (4) All high ground areas of the Ngong Ping paragliding area (around 380 m to 400 m AMSL) were not covered by clouds during the accident flight.

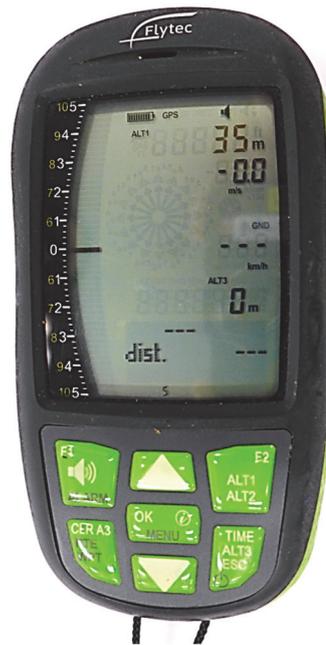
Photo 3: Variometer Used by the Pilot

- (1) The Pilot's variometer, Model "Flytec Element Track", was stored in the flight deck and turned on throughout the accident flight.
- (2) The variometer was an integrated device with altimeter, compass and Global Positioning System (GPS) functions. It provided and recorded not only signals of rates of climb and descent, but also GPS positions and pressure altitudes for paragliding activities.
- (3) Data stored in the International Gliding Community (IGC) file in the variometer was retrieved for flight track analysis.

- (2) The compass and the variometer were inspected and found operational.

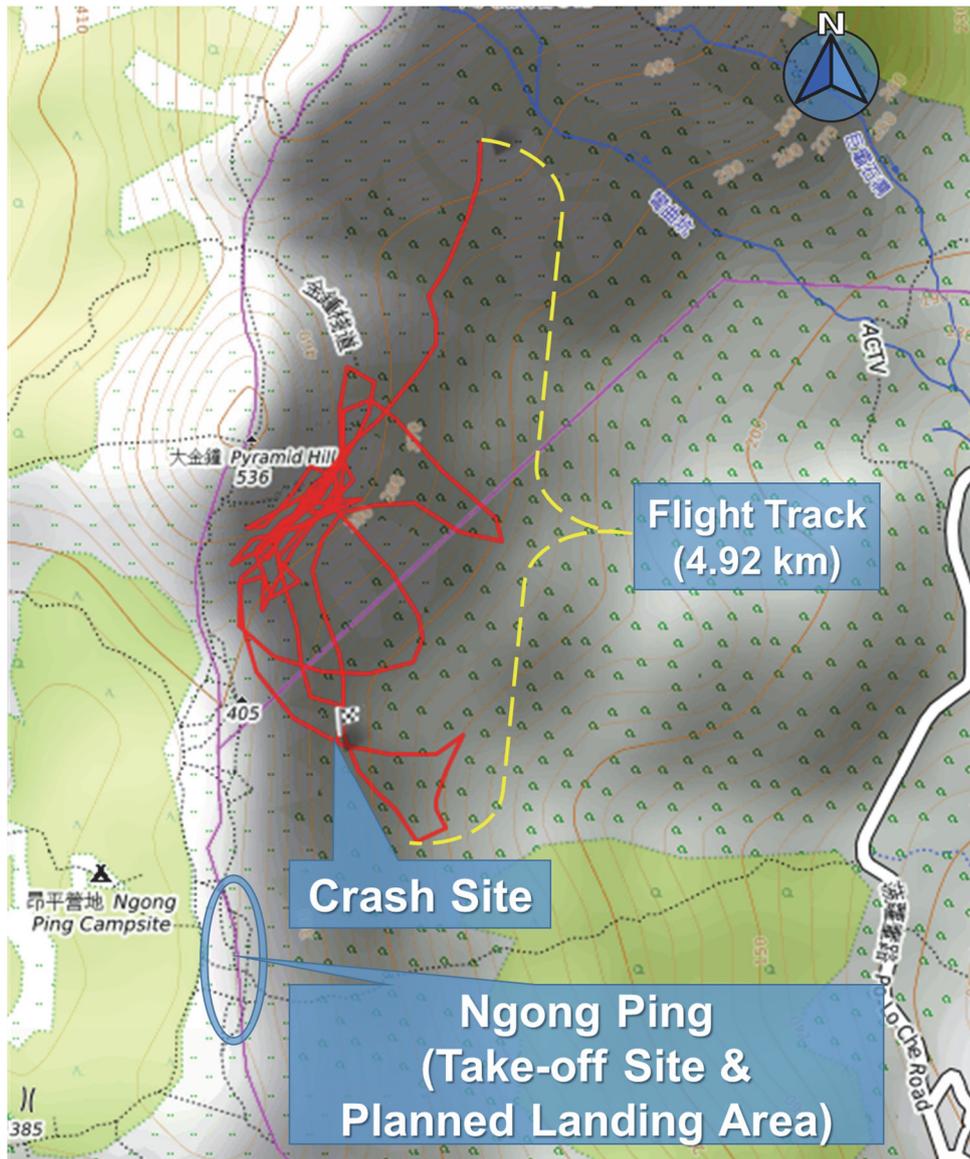
Figure 17: Accident Flight Track

The accident flight track was generated by the "Logfly" application using the IGC File data retrieved from the Pilot's variometer.

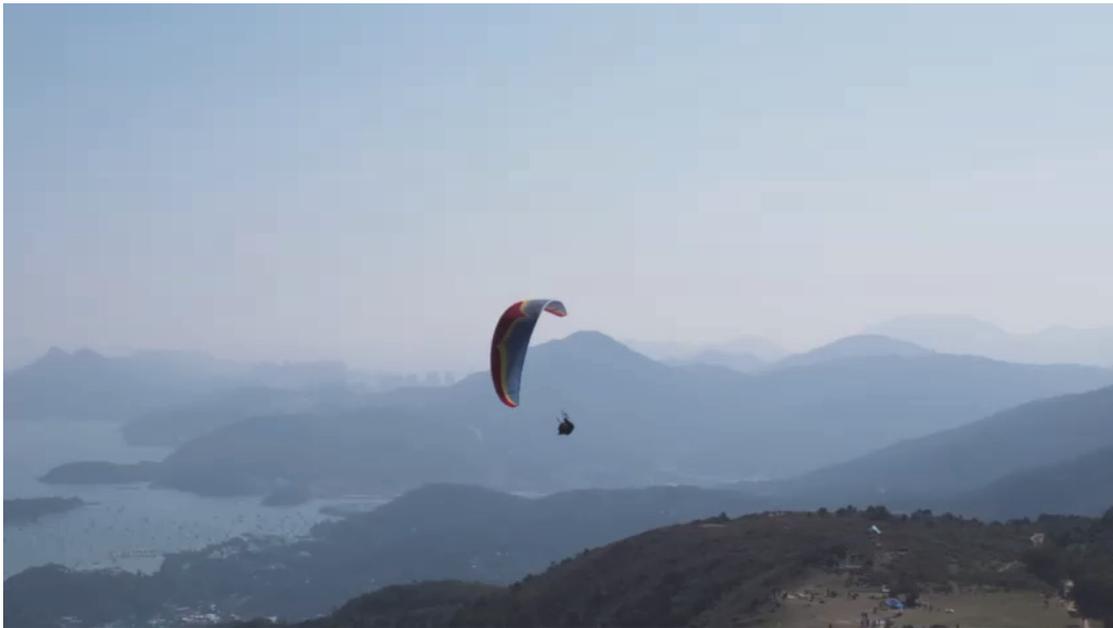
Figure 19: Video Image at 00:00.000 Seconds

- (1) At 00:00.000 seconds in the video (HKT 14:01:14), the Pilot was exiting from the previous left turn.

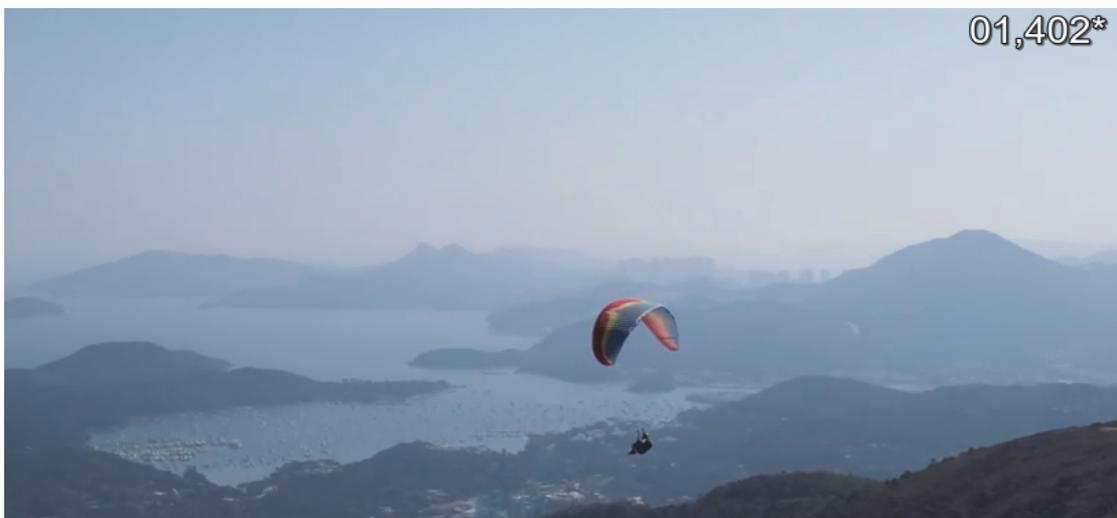
Figure 20: Video Image at 00:01.402 Seconds

- (2) At 00:01.402, the Pilot regained flight trajectory back to the horizon.

- (3) From 00:01.402 to 00:02.404, the Pilot leaned his body to the right. At the same time, the Pilot released the left brake and pulled the right brake. The paraglider then started to roll and yaw to the right, resulting in a right turn.

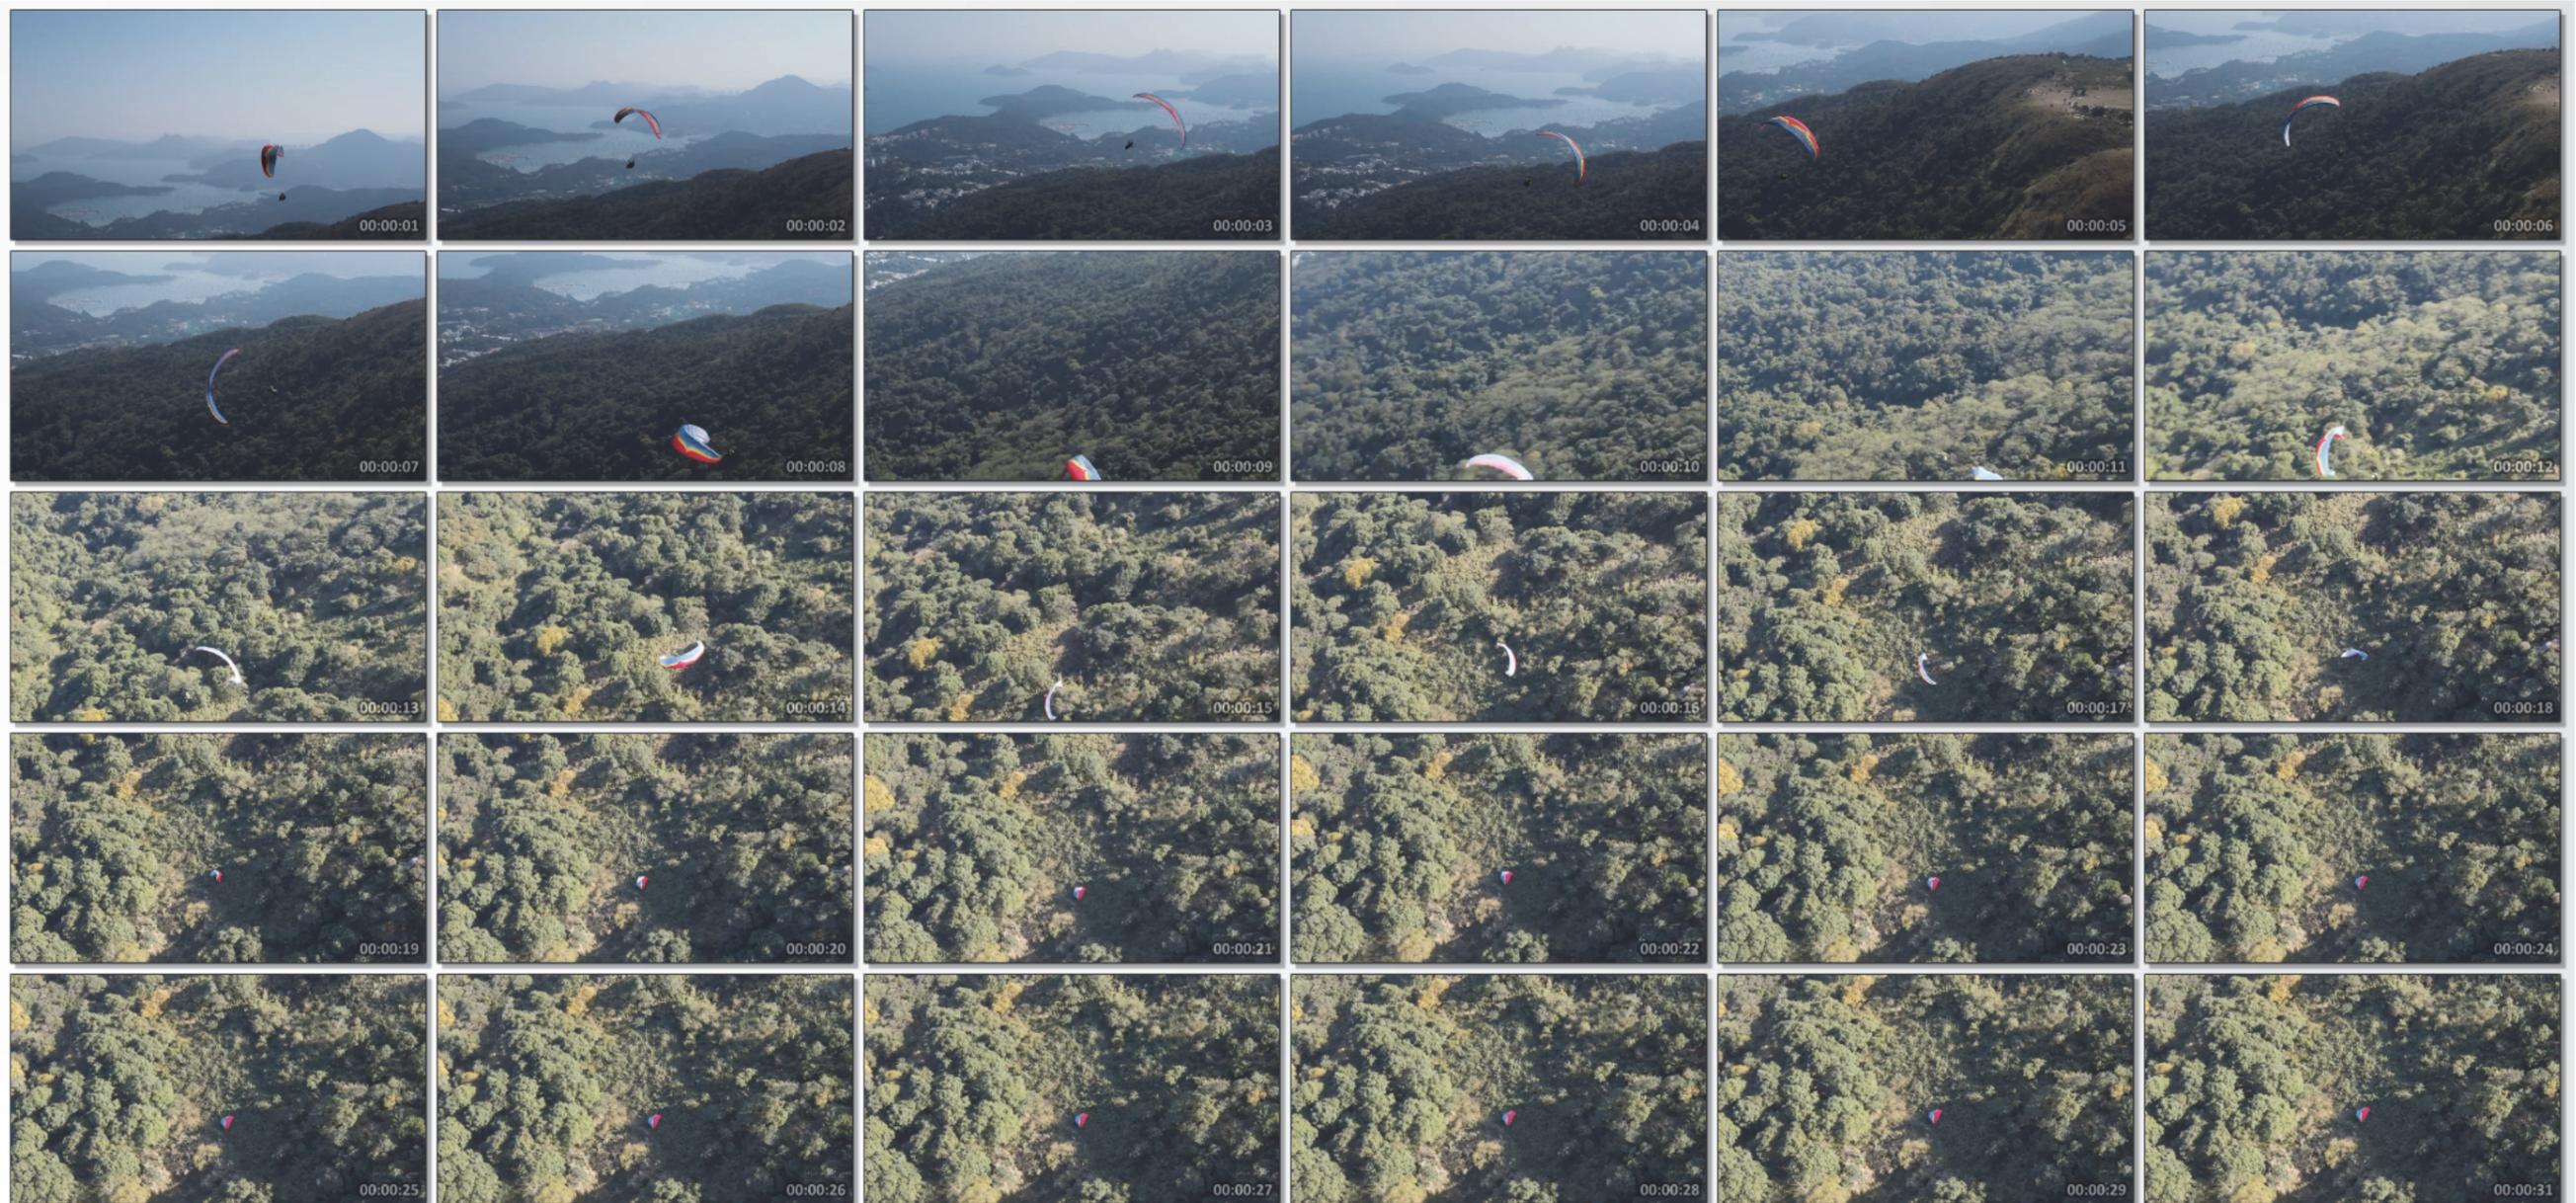
Figure 32: Screen Captures of the Last 19 Seconds of the Incident Flight

At about 1401 hrs, the paraglider was found descending rapidly and became stranded at a bush area in the southeast of Pyramid Hill. The Pilot, who was flying solo, was seriously injured in the accident.
