Loss of Lifting Conditions En-route (LOLI)

Investigation Report

**PHI Fantasia 22 Paraglider
Long Ke Wan, Sai Kung, Hong Kong
15 February 2023**

IVR-2025-05

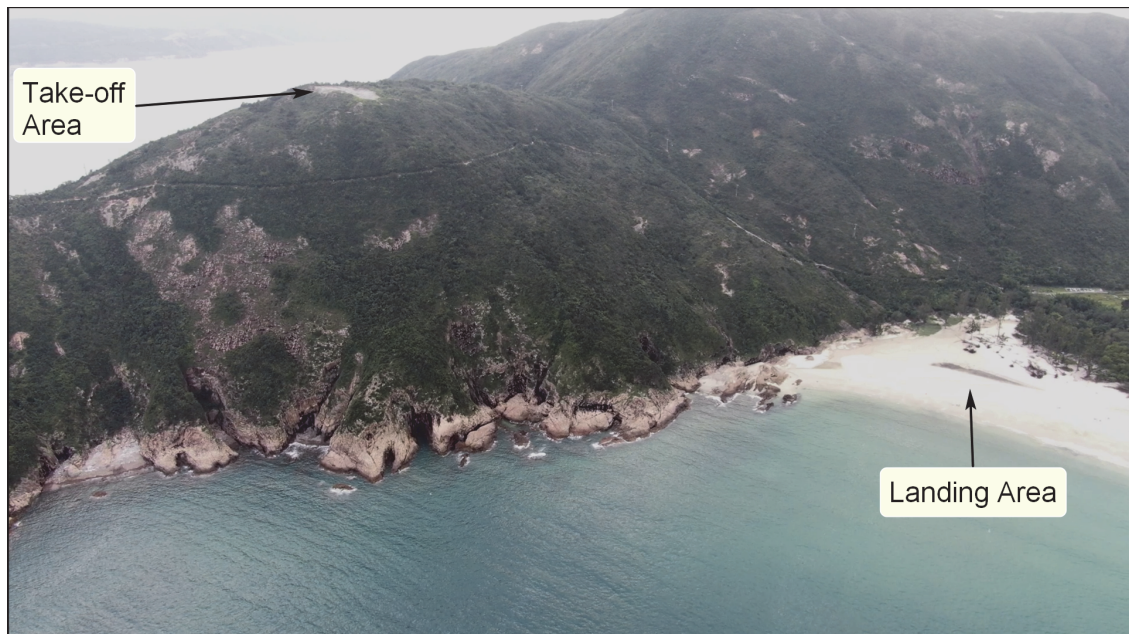
Figure 1: Paragliding Take-off and Landing Areas at Long Ke Wan

to the hiking trail below it. At about 1350 hrs, P2 found that the paraglider landed short of the beach and was in the sea about 60 meters from the beach shore.

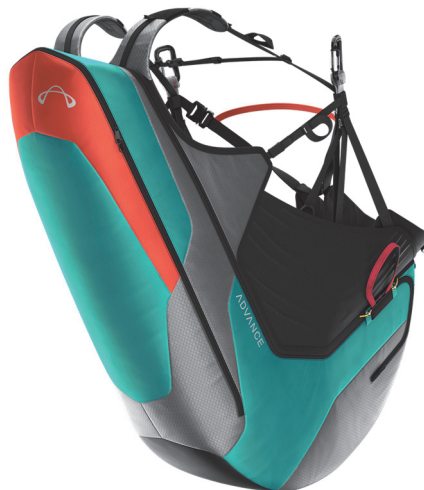
Figure 6: Advance Progress 3 Harness

- (3) The Pilot also flew with an Advance Progress 3 harness of size M. It is certified to EN 1651 & LTF 91/09, 120 kg (maximum pilot weight up to 120 kg). A reserve parachute is stowed in the integrated compartment under the seat.

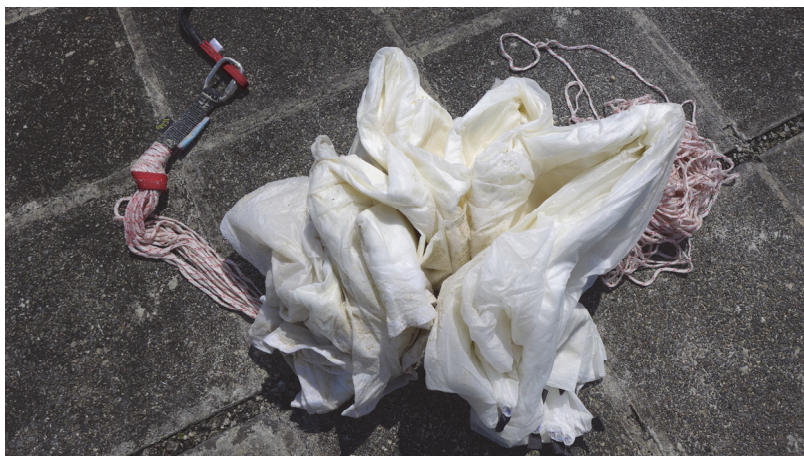
Figure 8: Reserve Parachute of the Pilot

- (4) The paragliding reserve parachute, Model "ALBA 105", was made by ICARO Paragliders. It was not used by the Pilot during the flight. It was removed from the harness compartment by the investigation team for examination after the accident.

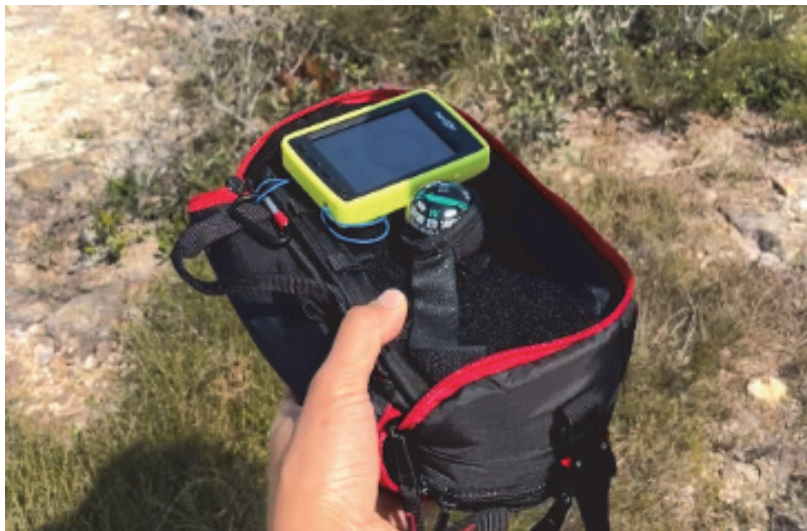
Figure 17: External Flight Deck and Accessories of the Pilot

- (1) The Pilot carried an external flight deck which accommodated his NavITer Hyper Flight Computer, a compass, and a Spinlock safety line cutter (hook knife). The hook knife was still kept inside its container in a pocket of the external flight deck.
