**The Shatin to
Central Link Project
Final Report**

Volume 2 of 2

**Expert Adviser Team
Transport and Housing Bureau
December 2020**

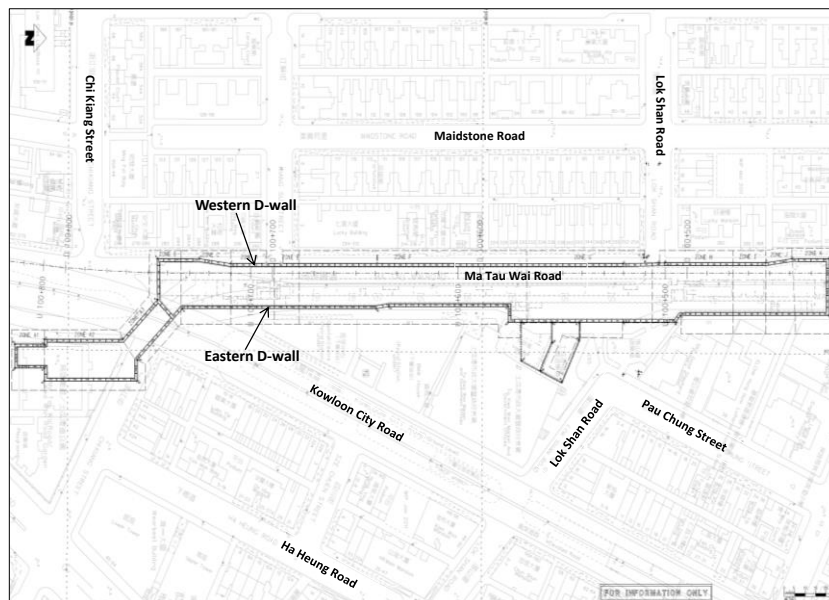
Figure 9-2-1 Layout plan of TKW

4. The settlement audit for TKW was focused on selected monitoring points on the two sides of Ma Tau Wai Road near the Eastern and Western D-walls, where notable settlements were reported to have occurred during the construction works.

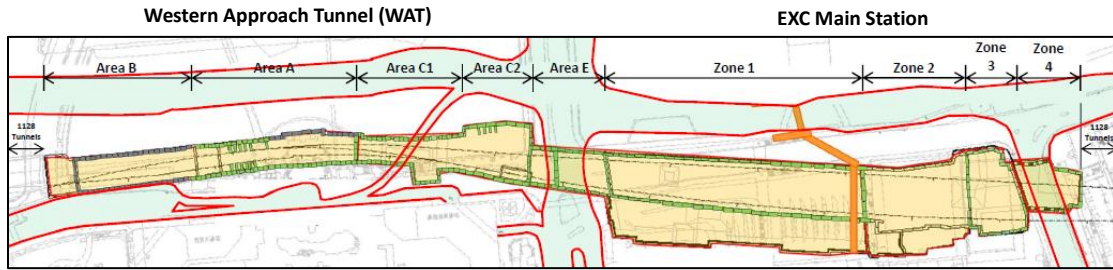
Figure 9-3-2 *Layout plan of EXC*

2. The layout plan of EXC is shown in *Figure 9-3-2*. The 280 m long station structure was divided into Zone 1 to Zone 4 during construction. The associated section of the cut-and-cover tunnel, denoted as the Western Approach Tunnel (WAT), was about 320 m long. It encompassed Areas A, B, C1, C2 and E. There were concurrent construction activities in the area adjacent to EXC, e.g. the Wan Chai Development Phase II (WDII) managed by the Civil Engineering and Development Department.

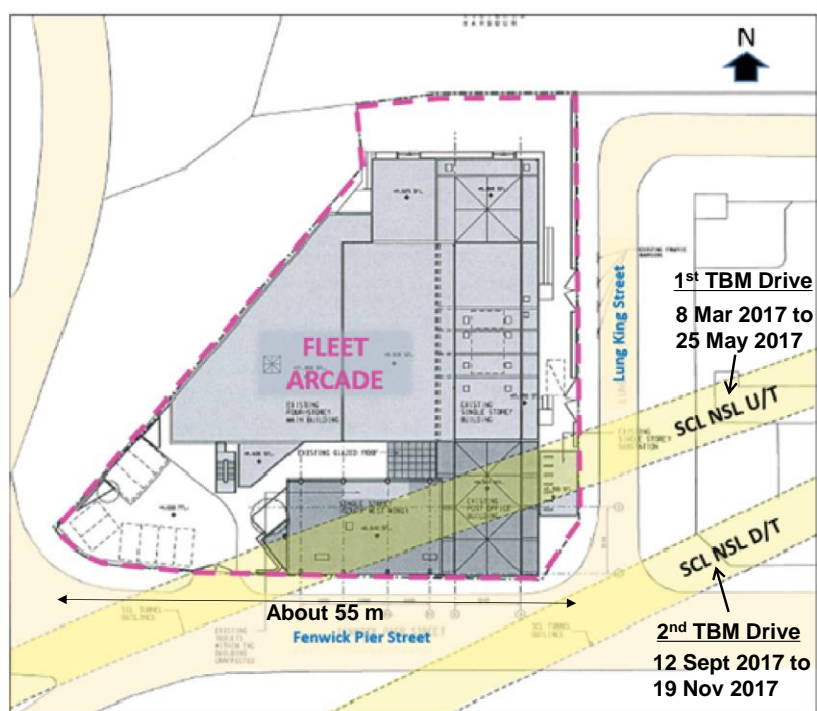
Figure 9-4-2 *Layout plan of the Fleet Arcade and Western Bored Tunnels*

3. The NSL Western Bored Tunnels traversed the southeast corner of the Fleet Arcade at about 30 m deep (see **Figures 9-4-2** and **9-4-3**). The Tunnels comprise an up-track tunnel and a down-track tunnel, which were constructed by tunnel boring machine (“TBM”) under Works Contract 1128 of the SCL Project. Each tunnel has an external diameter of about 7.5 m.
